**Accident Investigation Board of Finland  
Annual Report 2005**

## MISSION OF ACCIDENT INVESTIGATION BOARD

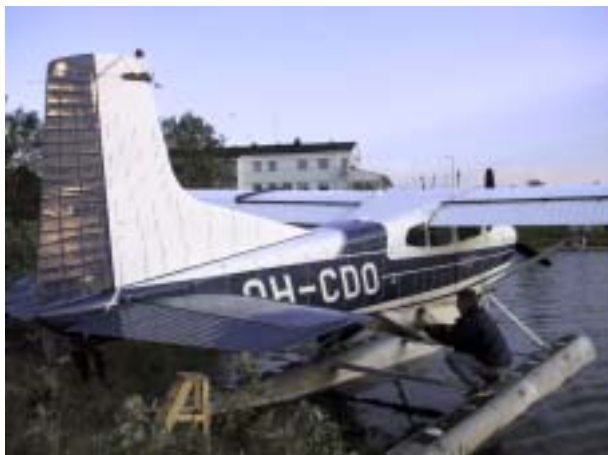
#### **B 2/2003 L**

#### **Aircraft accident in Enontekiö on June 25, 2003**

The investigation commission stated that the cause of the accident was the pilot's procedure to climb above the ground effect without reducing the pitch angle. The aileron and flap connection of the R/STOL kit of the aircraft combined with the aileron type caused the right wing to tip stall in take off configuration. The pilot did not recognise the stall and did not act in the required sense to recover.

The investigation commission recommended that the appropriate authority should take measures to inform pilots as comprehensively as possible about the stall behaviour of the Robertson STOL Cessna 185 aircraft. The aircraft flight manual supplement should also contain a warning of this. The commission also recommended that the Finnish Flight Safety Authority would revise the regulations OPS M3-6 and AIR M11-2 so that all persons on board must always wear a life vest during water operations.

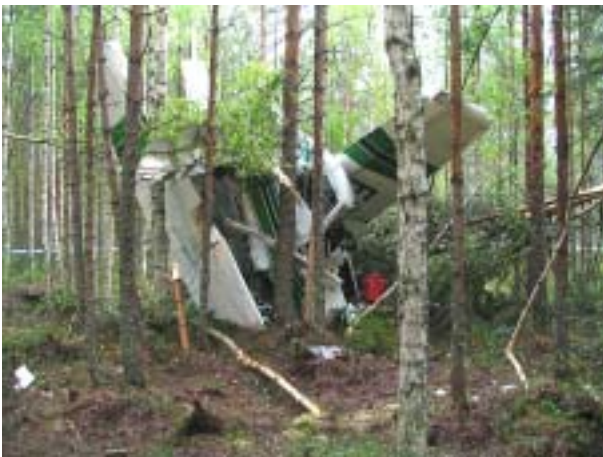
**B 2/2004 L**

**Aviation accident in Pieksämäki on June 16, 2004**

Although the aircraft was destroyed in the ground impact, practically all parts could be inspected. Both cockpit doors were locked with padlocks. The forward hinge pin of the left door was partially in place, the aft hinge pin was missing altogether. The control system of the plane was intact and the flaps were 10 degrees extended. The engine ignition cables were in bad condition and one spark plug was not operative. The leakage on one of the engine's cylinders was clearly beyond the maintenance tolerance. The defects have not had noticeable effect on the functioning of the engine. The propeller had been rotating and the engine was probably running at the time of impact. Neither a technical fault, contributing to the accident, nor an indication of malfunction was noticed in the aircraft.

The cause of the accident was the reduction of speed, caused by the deficient monitoring and control of speed that led to the loss of control and stall of the aircraft on the base leg of the landing pattern. At the prevailing altitude the pilot could not recover the aircraft from the dive and impact to the ground was inevitable.

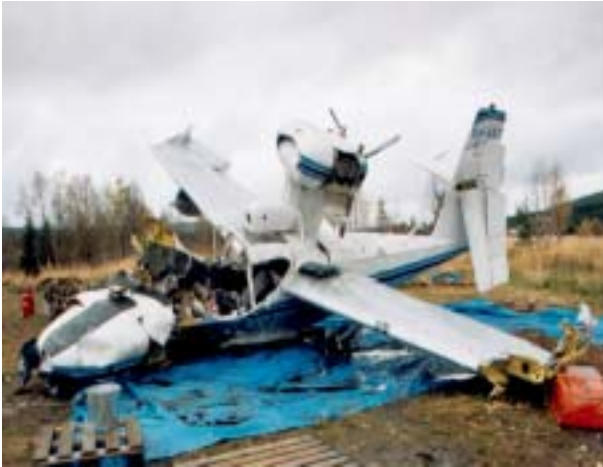
**B 4/2004 L**

**Aviation accident in Äkäslompolo, Kolari on  
September 19, 2004**

The aircraft reached the north shore of lake Äkäslompolojärvi near cruising speed at an altitude of approximately 30 - 50 meters. Close to the shore the upper ear of the left horizontal stabilizer's rear attachment fitting broke completely off as a result of fatigue. Subsequently, the stabilizer twisted downward whereupon the forward attachment ear also broke due to the force of the air stream. The stabilizer remained attached to the airplane only by the lower ear of the rear attachment fitting. As a result of the damage the pilot was unable to control the aircraft and it crashed into the lake, canted to the right. The right wing tip struck the water's surface first, causing the aircraft to be flung to the left, with the left wing and forward fuselage taking the largest force of impact. Both occupants sank along with the plane to a depth of approximately ten meters and perished by drowning.

subjected over a relatively prolonged period to forces exceeding the material's fatigue tolerance and failure had ensued. In the inspections no indications were found that the attachment ear had been entirely broken for long. When final breakage of the attachment point occurred, the surface area of the horizontal surface remaining intact was small. No indications were found that the damaged surfaces had chafed together. This points to the conclusion that after the final breakage of the attachment ear, the stabilizer, due to the effect of the air stream, also broke loose from the forward ear which had been weakened from prior vibration. The air stream then bent the stabilizer downward, whereupon the elevator trim torque tube twisted off and the structure joining the elevators was torn. At that time the aircraft's vertical control capability was almost completely lost.

The cause of the accident was fatigue breakage of the upper ear of the left horizontal stabilizer's rear attachment fitting which, as it progressed, finally led to breakage of the entire attachment point, whereupon the stabilizer was able to twist downward. At that time control of the aircraft was lost and it crashed into the lake.

On October 7, 2004 the investigating committee informed the Finnish Civil Aviation Administration's Flight Safety Authority of its findings and of the stabilizer attachment ear breakage. Because in following current aircraft maintenance and inspection directives it is nearly impossible to detect an incipient fatigue fracture in an attachment point, the investigating committee recommends that the authorized aviation authority undertake measures to ensure the reliability of stabilizer attachments.

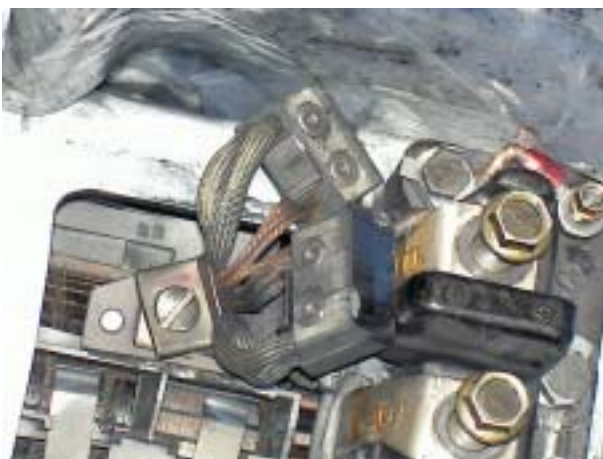
**C 2/2004 L**

**Serious electrical power supply failure at Pori terminal area on March 1, 2004**

The electrical power supply failure was caused by a left generator failure during the flight. After the generator had failed, only the left battery powered the left side electrical system. A modifica-

During the investigation it was evident that the generator brushes were worn out before the scheduled overhaul time. The generator manufacturer accomplished material investigations, but they did not find a definite reason for premature brush wear. Pilots did not respond correctly to the generator failure, which led to major problems during the flight and to this incident.

The electric power supply failure was caused by a left generator failure. The following facts contributed to the incident:

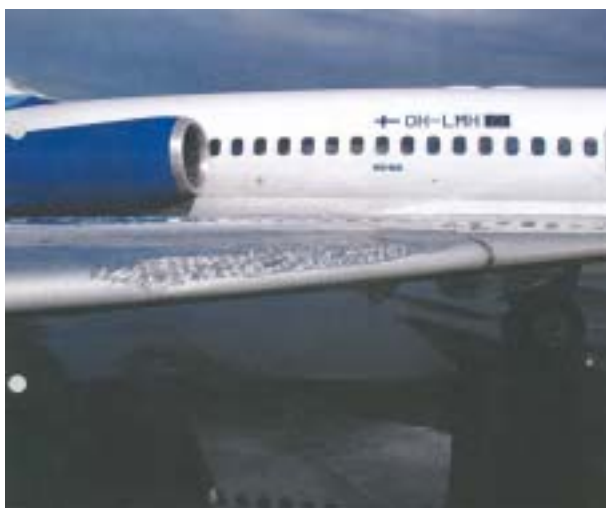
**C 4/2004 L**

**Taxiing incident at Helsinki-Vantaa airport  
on August 18, 2004**

The reversing aircraft was an ATR 72-201 and the parked aircraft was an MD-82. The ATR was departing to a scheduled flight and the crew intended to perform a power push-back procedure to a position where they would have been able to start normal taxiing. A ramp foreman was standing outside the aircraft and he was in charge of the push-back. He was giving hand signals to the crew in order to guide them in manoeuvring the aircraft (marshalling). The aircraft failed to stop in a correct position and consequently collided with another aircraft behind. Both aircraft sustained minor damages.

The investigation revealed that the taxi line paintings on the apron were inadequate, and that the pilots were not properly informed about the abnormal taxiway arrangements, which were in force in the apron due to construction works at the time of the incident. Furthermore, the ramp foreman did not use correct hand signals when marshalling the aircraft and the instructions concerning the procedures and responsibilities during power push-back were ambiguous. In addition, there were no instructions concerning these procedures in the aircraft's operating manual.

The probable cause for the incident was, that the flight crew did not receive a stopping signal from the marshaller, nor did they make initiative to stop the aircraft in correct position, because the taxi line paintings were not visible to the marshaller's position or to the cockpit. A contributing factor was the fact that there were different views about the responsibility for stopping the aircraft among the pilots and the ramp workers, which interfered with the instructions.

The investigation commission issued one safety recommendation. Finnair Oyj should include a description of the power push-back procedure in its operation manuals. This description should be available to all personnel involved in a push-back procedures.

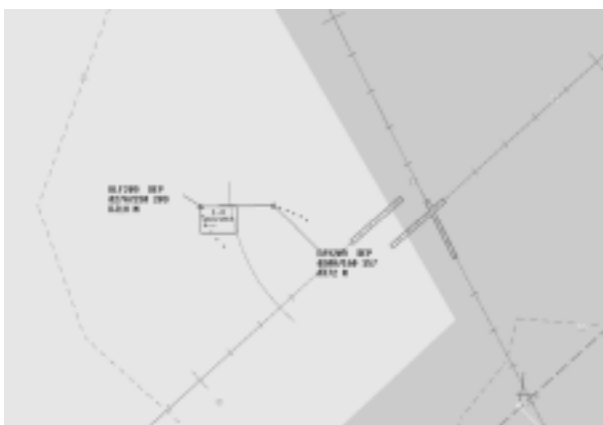
#### **C 5/2004 L**

#### **Loss of ATC separation west of Helsinki-Vantaa airport on August 30, 2004**

The air traffic control separation was lost, since BLF209 slowed down its vertical speed more than the controllers had estimated. Contributing factors were: 1. The radar controller cleared BLF209 to turn right towards ANTON across the flight path of EAY209, although the required vertical separation between the aircraft had already been lost; 2. The radar controller issued no other restrictions to either aircraft than the vertical speed restriction for EAY209.

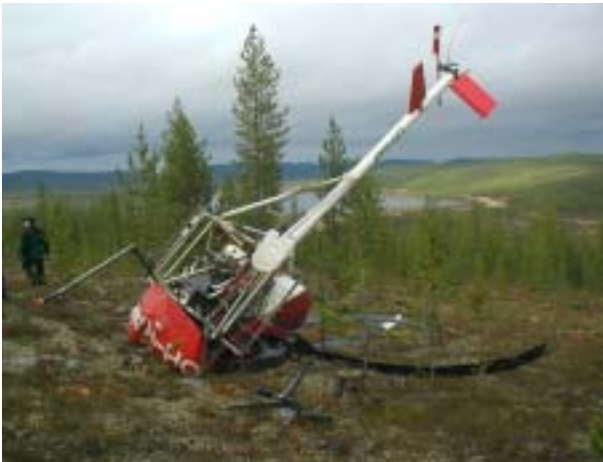
**C 6/2004 L**

**Helicopter accident in Pirunpäävaara, Inari  
on October 5, 2004**

The opinion of the Accident Investigation Board is that a sudden change in the wind direction and/or speed caused a rapid rotation of the helicopter to the right. Large and rapid movements of the pedals caused a stall of the tail rotor and the pilot did not gain control of the helicopter. A contributing factor was the pilot's limited flying experience in reindeer management flights in demanding mountain and wind conditions.

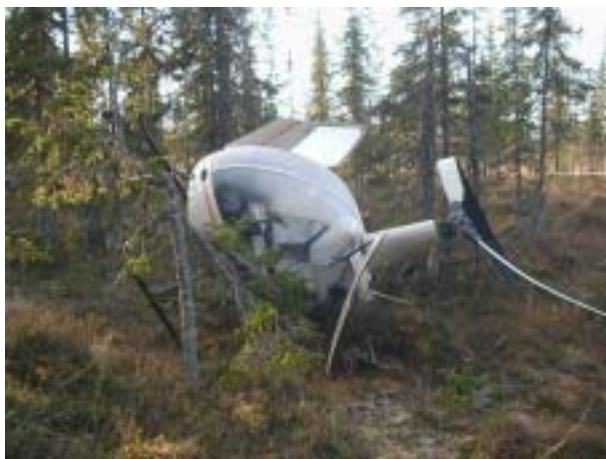
**C 7/2004 L**

**Helicopter accident in Naruska, Salla on October 16, 2004**

The helicopter was hovering low at an altitude of about 50 meters and began to move turning simultaneously to the right. Suddenly a bang was heard and the low-RPM warning alert was activated at the same time. The helicopter's engine had failed and the helicopter began to lose altitude continuing the turn to the right. About ten meters before ground contact the rotor blades struck trees and were broken, after which the helicopter was no longer controllable.

The distributor wheel on one of the helicopter magnetos was broken during the flight and adjusted the ignition timing earlier so that the engine stopped. Due to the low flight altitude and speed the forced landing to the terrain failed.

The investigators recommended, that the Finnish Flight Safety Authority should require that the condition of the distributor gear teeth on TCM (Teledyne Continental Motors, formerly Bendix) magnetos in use on helicopters always to be checked in connection with 100-hour service inspections. The investigators further recommended that in field conditions the flight operator should properly transport and store the fuel intended for aircraft use, as well as use a chamois or equivalent filter when refueling aircraft in such conditions. In addition, the flight operators should encourage the pilots to report about backfiring cases at engine start up.

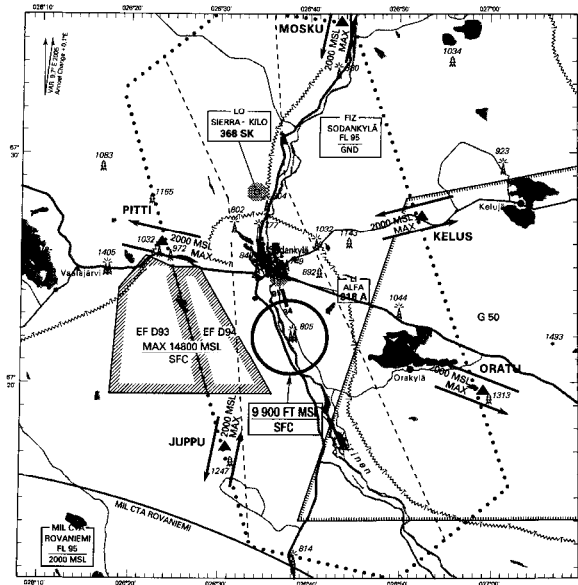
**C 8/2004 L**

**Four helicopters flying within a danger area  
in Sodankylä, November 19, 2004**

The Utti Jaeger Regiment should direct its pilots' attention to the obtaining of necessary information for cross-country flights. The need for, and use of, a VFR bulletin in flight planning should be particularly emphasized. The Utti Jaeger Regiment should also clarify the usefulness of the AIS and MET pages on the Civil Aviation Administration's Internet site in its operation. For this reason, flight detachments or individual aircraft should have wireless Internet connections available for their use when operating from outside bases.

The Civil Aviation Administration should obtain aviation authority approval for weather pages (MET) published on the Internet, as well as see that airport flight briefing areas have a printer-equipped Internet connection for pilot use so that flight safety information published on the Internet can be utilized in flight operations.

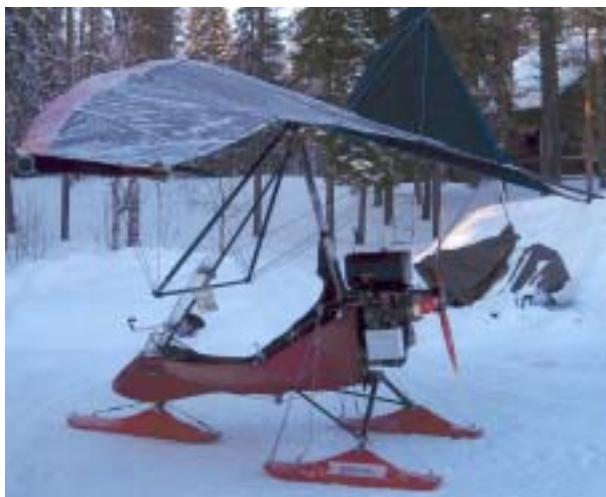
C 1/2005 L

**Ultra-light aircraft accident at Vammala Ylistenjärvi on January 6, 2005**

The aircraft had climbed up to 10–30 meters height and travelled 300 meters before it crashed at an angle of approximately 45 degrees. The aircraft was tilted to the right approximately 30 degrees. The location of the crash-site were 61° 15' 16" N and 22° 55' 46" E. and the elevation was 89 meters above the mean sea level. The ultra-light aircraft sustained major damages.

The cause of the accident was the pilot's decision to practise taxiing and short flights without training in the weather conditions which were clearly below minimum requirements.

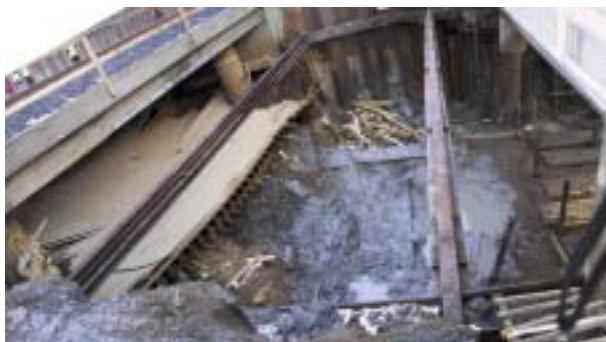
#### **C 11/2003 R**

#### **Collapsing of railway bed in Urpia underpass site at Vantaa on December 20, 2003**

In order to prevent corresponding hazardous situations and incidents, the Accident Investigation Board of Finland recommends that for each worksite an unambiguous written specification should be drawn up on the detailed responsibilities and obligations of the workers in terms of the operating condition of the track and on their rights to engage auxiliary personnel and set restrictions to traffic operation. Moreover the Accident Investigation Board recommends that in underpass and

bridge worksites, for every work phase that impacts the stability of the railway bed and the track, an approved plan be required before the commencement of the work in question, and that the response measures to different situations be underscored and integrated in the training provided by the Emergency Center.

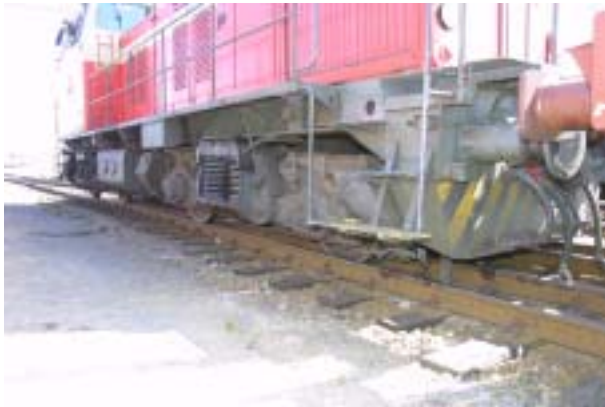
**C 5/2004 R**

**Front wheelset of locomotive derailling in  
Kokkola on May 12, 2004**

The wheelset of the locomotive derailed as caused by an excessive height deviation in the turnout.

The Accident Investigation Board of Finland recommends that after each derailment incident on a railway yard, the turnouts and points and switches area should be inspected and the gauge and the height deviation checked by measuring. As based on the measurement results, any requisite local corrections should be effected.

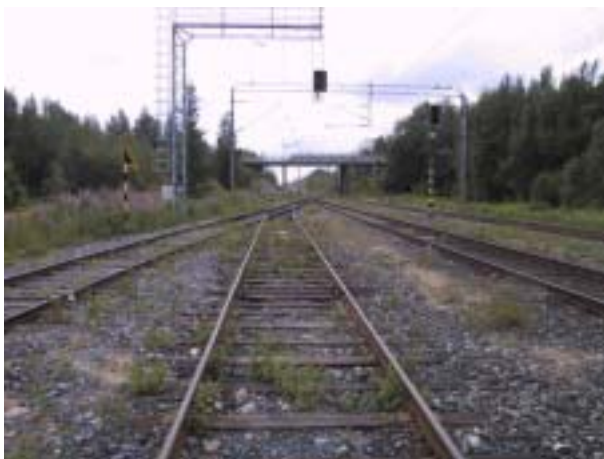
**C 7/2004 R**

**Incident between Kempele and Liminka, Finland, caused by an escaping rail-sleeper wagon, on June 15, 2004**

The incident was a result of a failing securing of the immobility of the wagon that then escaped onto the railway line. The immobility of the wagon had in fact been secured by an air brake as its idle time was only to be very short. But the brake shoe having taken an inappropriate position, turned and the brakes disconnected. The inappropriate position of the brake shoe was only discovered after the wagon had escaped and it had been fetched back again. As contributing to the escaping of the wagon to the railway line was the fact that Kempele railway yard inclines toward the railway line.

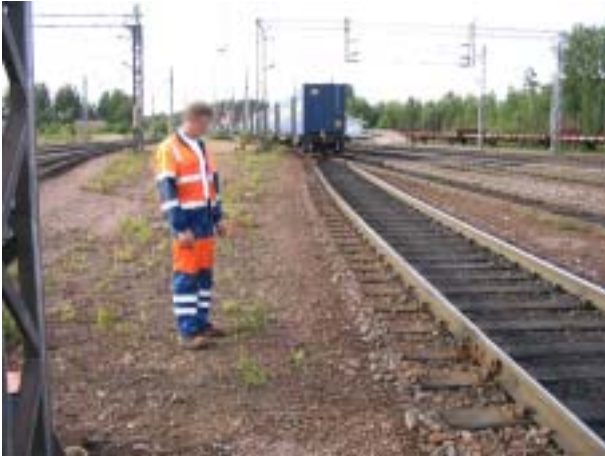
**C 9/2004 R**

**Member of train crew injured in shunting work on Hamina railway yard on July 15, 2004**

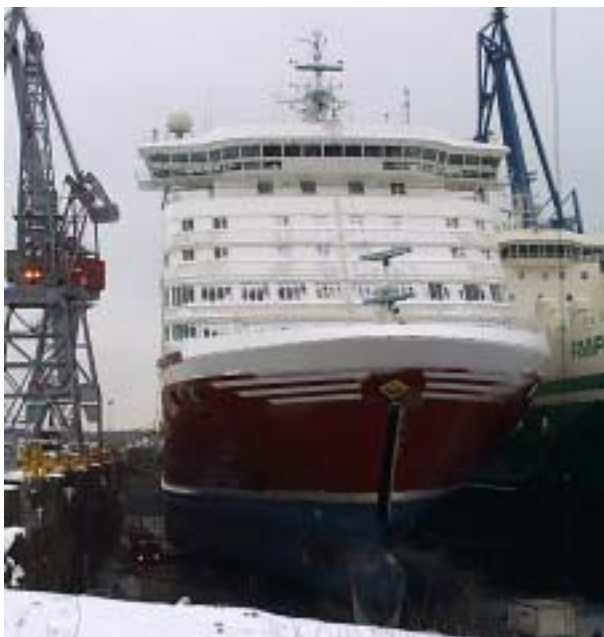
#### B 1/2001 M

**Passenger-car ferry ms ISABELLA, grounding in Staholm, Åland on December 20, 2001**

In ISABELLA's case the internal rescue tasks were mainly executed well. However, the maritime authority's instructions don't adequately support the definition of ships rescue plan on concrete level. ISABELLA's rescue plan was inadequate in the dealing with passenger crowd behaviour, when defining the distribution of crew resources. Additionally, some communication links of the rescue organisation were insufficient in some parts.

The accident investigation commission addresses safety recommendations to the Finnish Maritime Administration (FMA) for changing the piloting test. Ship owners are recommended to enhance the training for integrated navigation systems and further develop standardised bridge routines. Furthermore the commission recommends that FMA requires and controls that the safety plans of vessels include optional scenarios of action according to different situations and requirements related to communication and command arrangements.

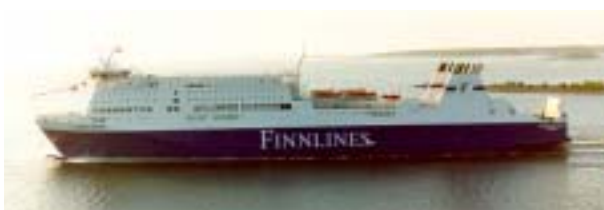
**B 1/2004 M**

**M/V FINNCLIPPER, grounding off Kapellskär  
20.01.2004**

The reasons which lead to the accident were inadequate familiarization to the ships handling and its equipment, lack of use of the steering- and navigational equipment and lack of bridge resource management.

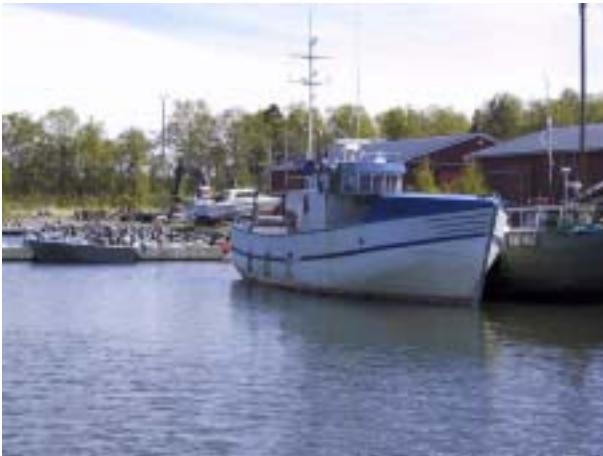
**C 3/2001 M**

**F/F SARA, collision with an unknown vessel southeast of Gotland, March 21, 2001.**

There were no physical injuries to the persons onboard. SARA's hull was damaged to such an extent that the hull insurers considered her a total loss.

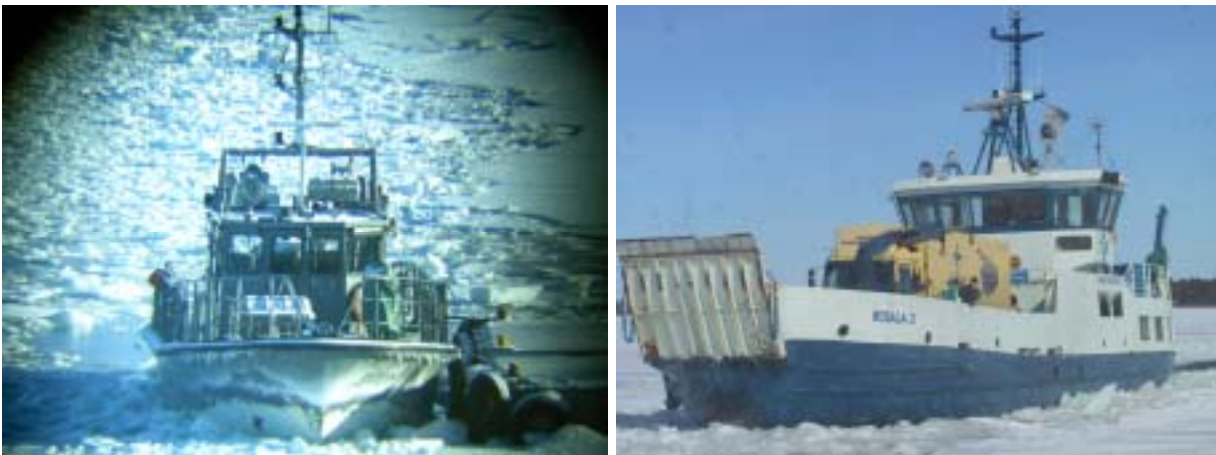
### **C 3/2004 M**

#### **The navy allweather craft HÖGSÅRA and archipelago ferry ROSALA II, collision in the narrow fairway on the north side of Örö on 16.3.2004**

On a scheduled trip to Fort Örö the archipelago ferry ROSALA II collided with the Navy all-weather craft HÖGSÅRA that had departed Örö to an unscheduled voyage. The collision took place on March 16, 2004 in dense fog as the vessels proceeded in the narrow fairway, which had been opened through the ice-covered sea. The fairway is not marked in the general traffic charts but it is surveyed and marked for the use of the local archipelago traffic.

ROSALA II had 2 passengers and crew of 3 and as cargo one lorry. HÖGSÅRA had 13 passengers and crew of 3. No physical harm was caused in the accident. HÖGSÅRA got serious damages to her bridge but ROSALA II got only minor damages. There was significant delay in informing the authorities of the collision. This delay did not endanger persons involved.

The investigators recommend that coastal passenger traffic operators and the service traffic of the military craft should have common practices to avoid collisions and risk situations for the use of shared fairways.

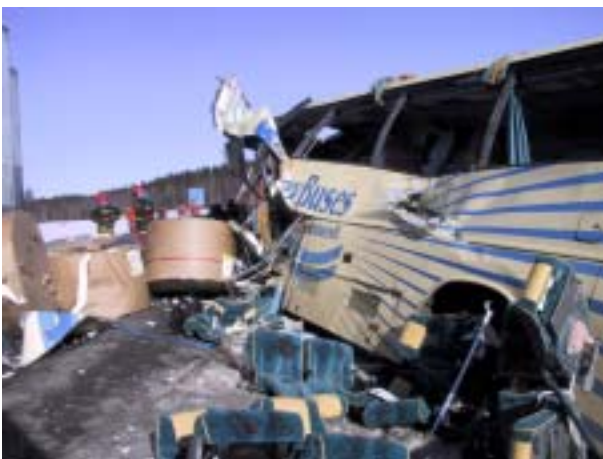
**A 1/2004 Y**

**A head-on collision involving a heavy vehicle combination and a charter coach on highway 4 at Konginkangas near the town of Äänekoski on 19 March, 2004**

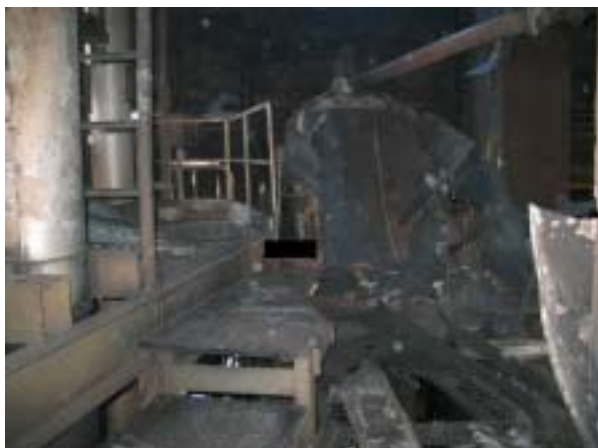
**B 5/2003 Y**

**Explosive fire at melt shop in Tornio on 19 September, 2003**

In order to avoid any similar accidents the Investigation Commission recommends that dangerous work assignments be identified and instructions for carrying them out be compiled. Potentially dangerous malfunction, fault, and abnormality situations should similarly be defined and detailed instructions to deal with them should be drawn up. Abnormal situations that have occurred should also be registered. The board of investigation further recommends that EU directives should require the valve manufacturers to compile instructions concerning the usability of valves with different gases. Among other things, the instructions should take into consideration the circumstances and purpose of use. In order to guarantee the cleanness of oxygen lines the investigation commission recommends that a plan and instructions should be drawn up for ensuring the sufficient cleanness of the piping. Furthermore, any valves connected with dangerous operations should be included in the preventive maintenance systems of the companies.

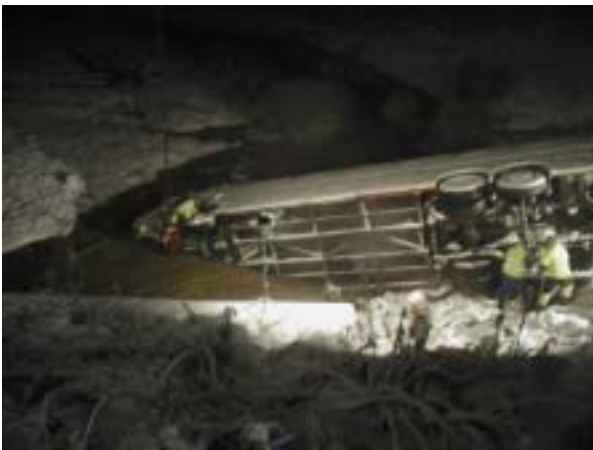
#### **B 2/2004 Y**

#### **Sliding of a coach off the road and into a river at Halikko, Southwest Finland on 22 December, 2004**

With the purpose of avoiding similar accidents, the investigation commission recommends that norms to be drawn up for the bus and coach industry stating the standard safety practices applicable to bus and coach traffic and providing the necessary preconditions for continuous development of safety measures. The investigation commission also recommends testing to be carried out of the tyres of heavy vehicles with a view to acquiring information on optimal tyre models for winter motoring. Bus and coach traffic safety could be further improved if bus and coach operators and drivers were provided with, and made use of, real-time information about the driving conditions on their own particular driving route during periods of poor weather.

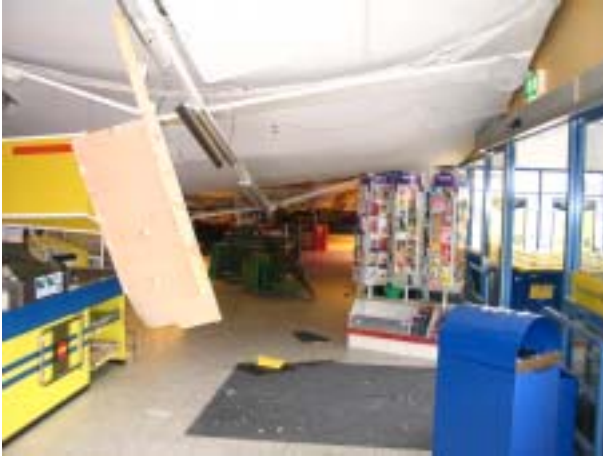
**B 2/2005 Y**

**Collapse of the inner ceiling structures of a local supermarket in Sysmä on 27 April, 2005**
