Investigation report

D6/2010L

An ultralight amphibian aircraft crashed into water in Taipalsaari on 26 June 2010

SeaMax M-22

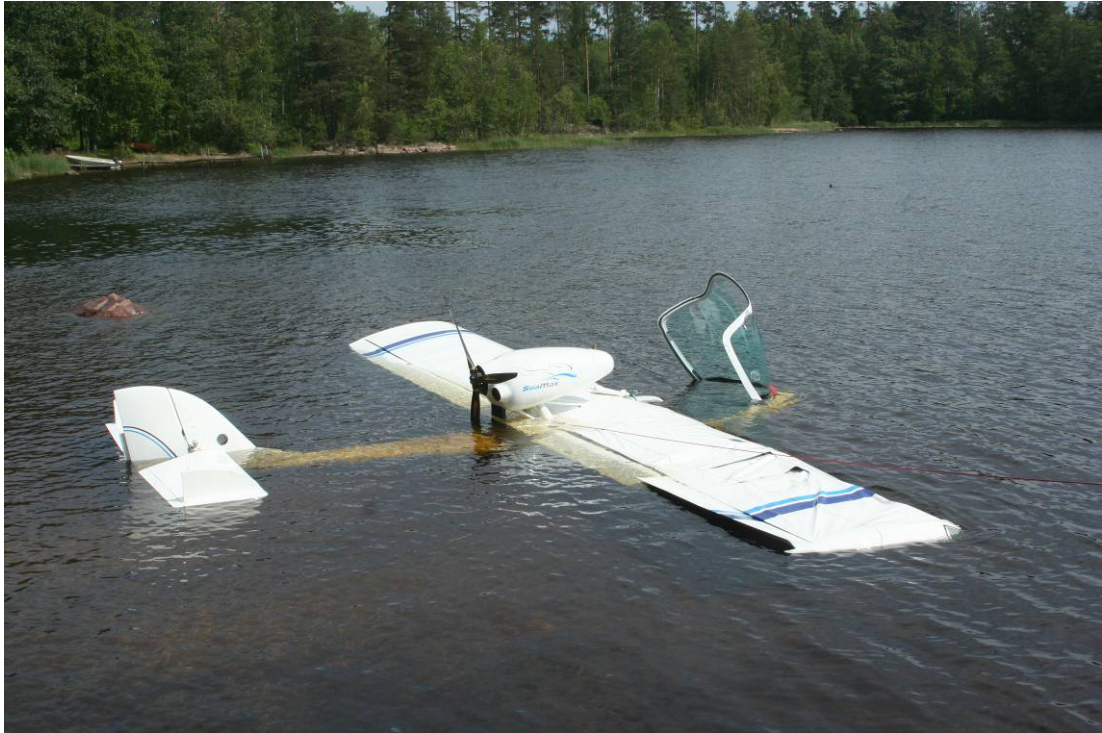
Figure 2. The destroyed aircraft waiting to be lifted from water. (Southern Carelia Police Department)

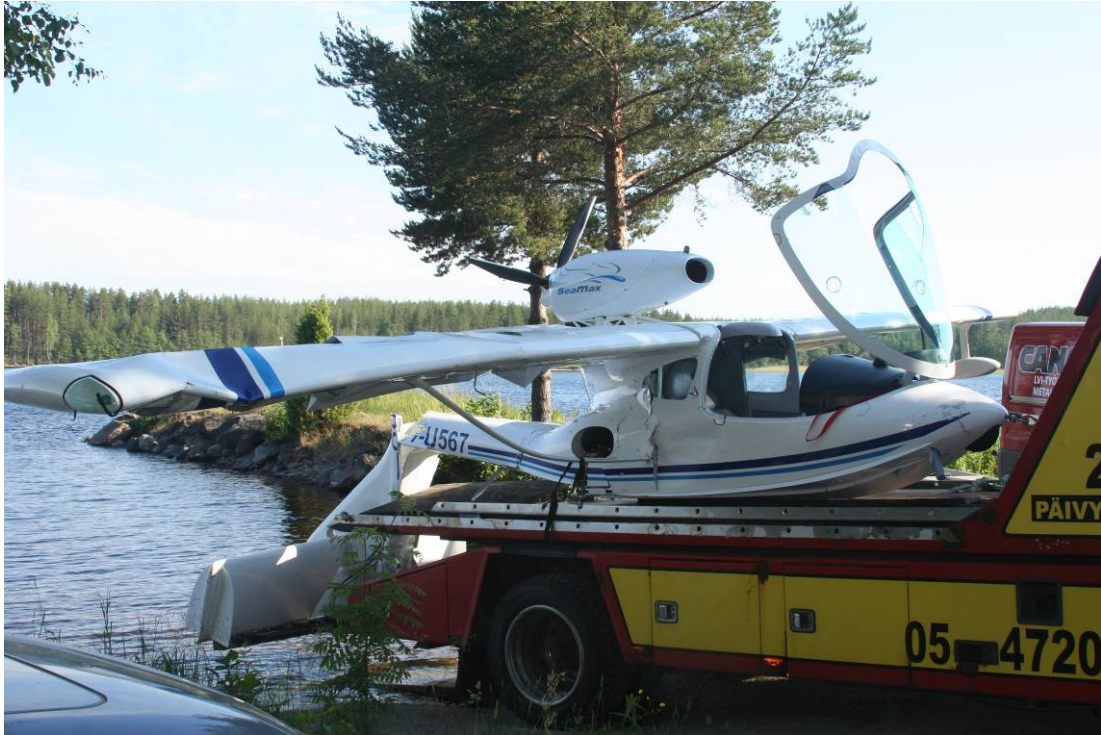
The aircraft was destroyed in the accident. The rear part of the fuselage had broken off at the root of the tail (Figure 3). The area of fuselage below the engine mounting and wing has sustained considerable damage. The extra weight fitted in the aircraft nose to be used on flights with only one person on board had partly fallen through the fuselage. The engine carburettors and exhaust pipe had been torn off. The wings were badly damaged, the right wing more severely than the left. Soil and water was found in the pitot-static tubes, which were otherwise intact. The soil and water had probably got into the system after the accident. The elevator push rod had broken off at the same location as the fuselage. The fracture surface of the broken push rod was inspected, which showed that the fracture was not due to fatigue. No water was found in the chemical test of fuel.

Figure 3. The aircraft straight after recovery from water. (Southern Carelia Police Department)

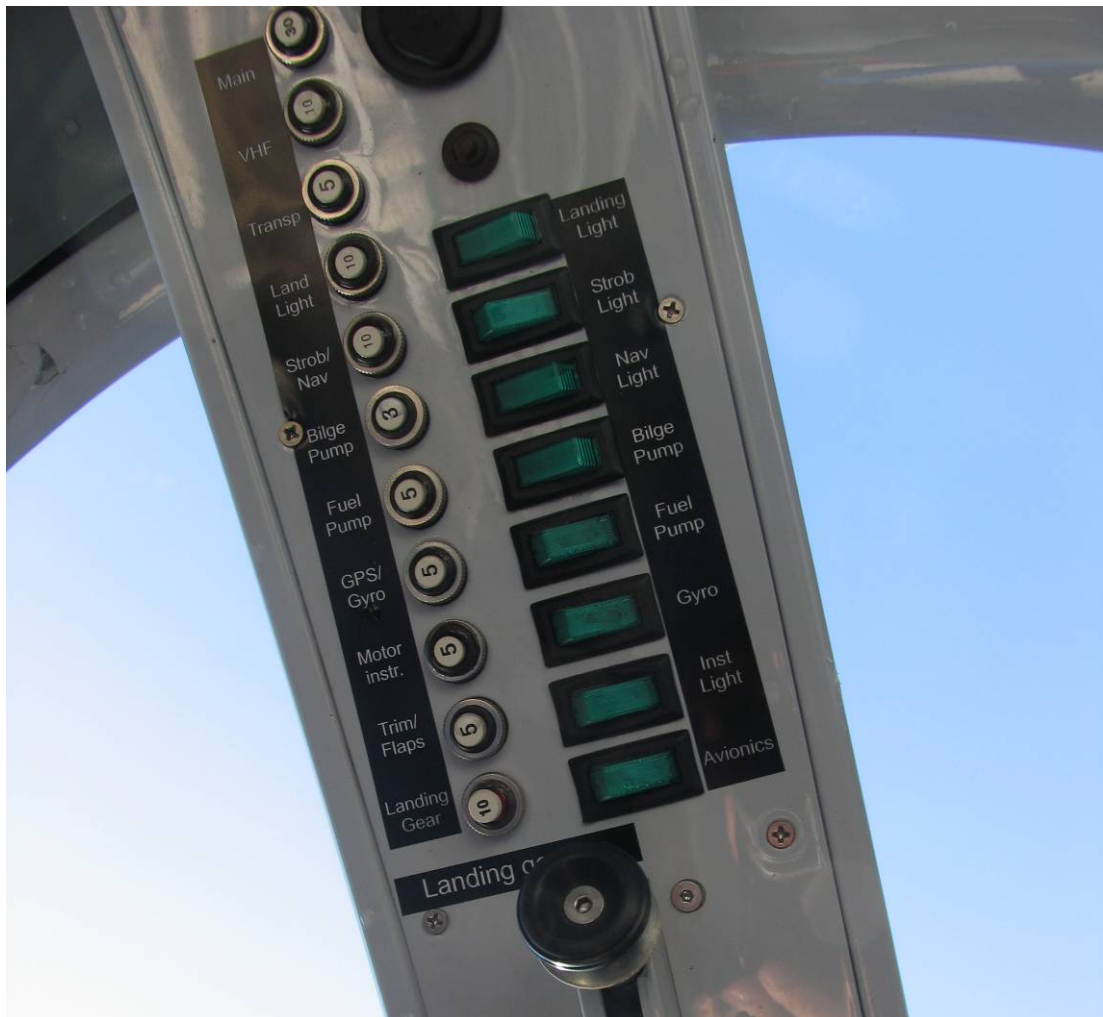
In normal operations, water may have entered the fuselage at several points. There are openings in the landing gear wells, through which water may have got into the fuselage in rough sea conditions. The bilge pump opening may also have let some water in while the pump was not in operation. In addition, there is an opening in the lower part of the rudder, through which some water may have flowed into the fuselage. The bilge pump is located inside the fuselage, in the lower part of the step designed to facilitate water planing. It would have been very difficult to detect any water in the fuselage, since there is no sensor or inspection hole for the purpose. The operation of the bilge pump can be heard if the engine is not running. In test conditions, the bilge pump removed about 20 litres of water per minute (about 3 decilitres per second).

The flight manual and operating manual give no instructions on how to remove water from the aircraft. The performance values for the bilge pump are not provided either. According to the operating manual, the aircraft may not be operated if the waves are higher than 20 cm. While the aircraft stands parked in water, water should be removed at 30-minute intervals. The check list instructs to remove water and then turn the bilge pump off. Pilot interviews revealed great differences in bilge pump operation and different views on water tightness of the aircraft: some pilots use the bilge pump only occasionally, others nearly all the time. According to the aircraft manufacturer, there is an auxiliary device related to the water removal system on sale in Brazil, but at least in Finland the owners of this aircraft type did not know about such a device.

Figure 4. Bilge pump operating switch.

In the original draft report, there was a safety recommendation concerning the removal of water from the hull. After the draft Final Report was sent to the aircraft manufacturer for comments the manufacturer published a technical information letter on the subject and updated the Aircraft Operating Instructions & Aircraft Flight Training Supplement manual. Therefore the safety recommendation was moved under the chapter “Actions taken”.

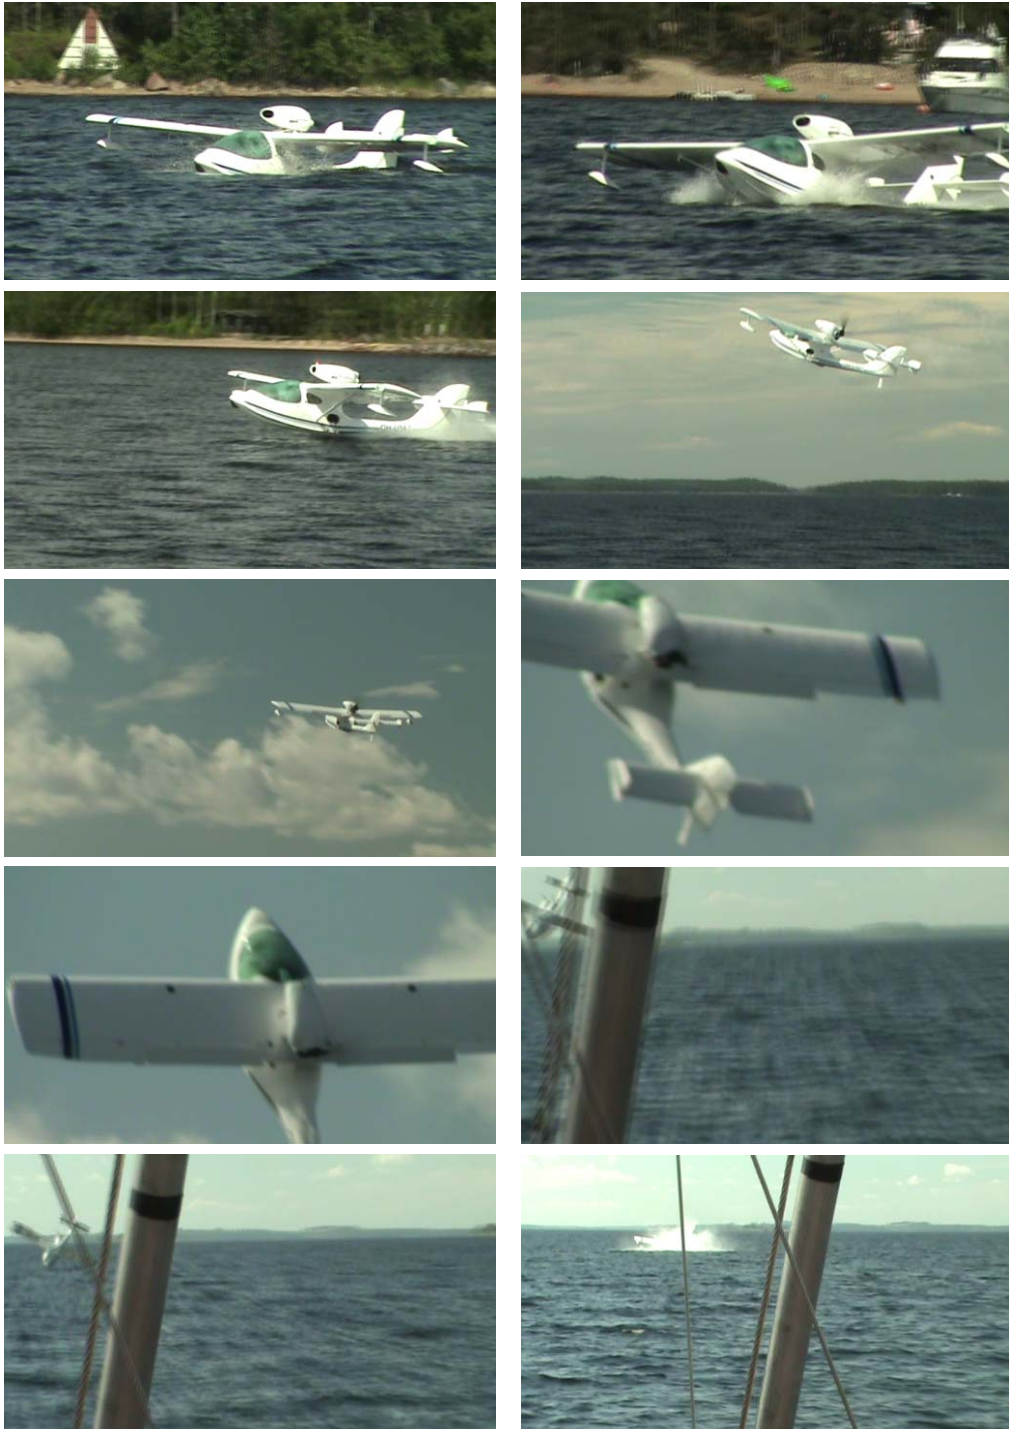
The water planing attitude on take-off was slightly different from usual, which may have been caused by higher resistance of the rough sea, a take-off mass higher than usual and a centre of gravity problem. The flight path of the aircraft also indicates a centre of gravity problem (Figure 5).

Figure 5 shows pictures extracted from a video of the accident. The flight path of the aircraft could be concluded from the video. Wave height was about 30 cm. The elevator seemed to be working. The pictures show that the water rudder was down on take-off, and the ultimate loss of control at the final stage of the flight can also be seen. As shown on the video, the sharp nose-up movement occurred at the same time as engine power was quickly reduced. In aeroplanes where the engine is located above the centre of gravity, reducing power causes a pitch up moment. Nevertheless, in SeaMax this movement is very small. Propeller slipstream makes the elevator and rudder much more effective. In this accident, probably the most significant factors causing the nose-up movement were the centre of gravity problem and a loss of elevator power when the effect of slipstream ceased.

Figure 5. A series of pictures of the accident. The pictures are positioned in a chronological order from left to right and from above downwards.

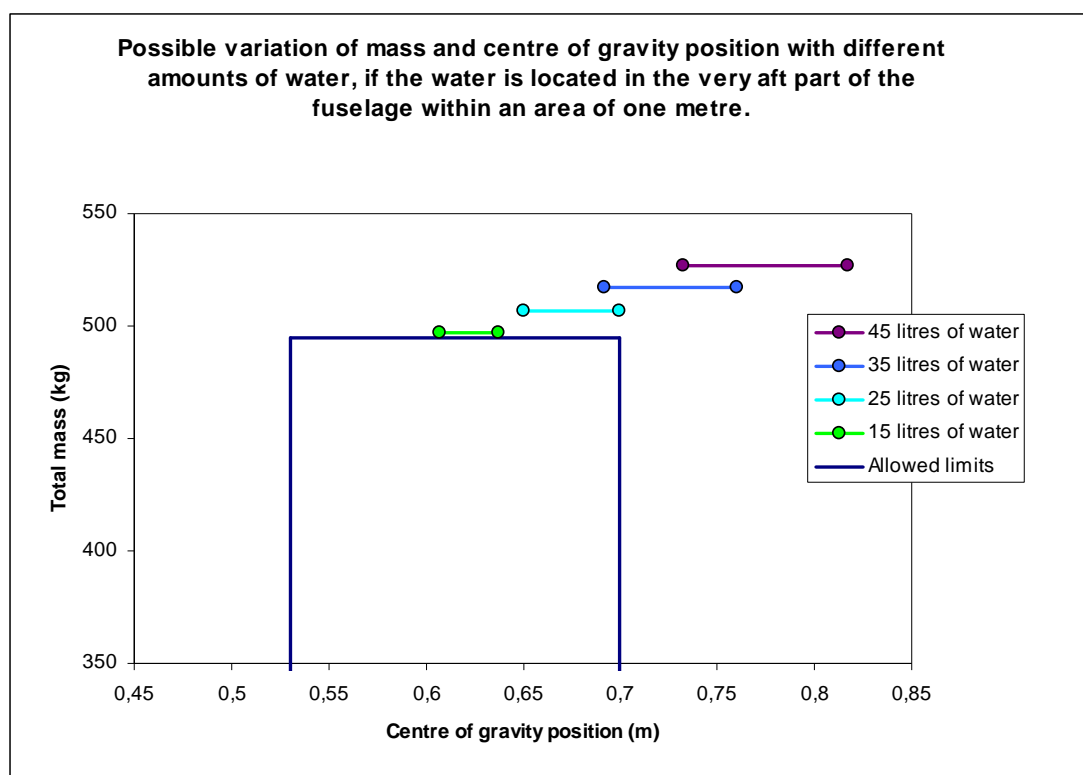
It is well possible that some water had got into the aircraft. Based on the mass and balance calculation, there should have been tens of litres of water before the centre of gravity would move outside the allowable limits (Figure 6). The arching parts of the aircraft fuselage are open in the middle, and at a high pitch angle, any water inside could flow to the rear part rather rapidly. The effect of water movement has not been taken into account in this calculation, since it was estimated that a static centre of gravity calculation will explain most of the suspected centre of gravity problem. The aircraft fuselage can easily hold tens of litres of water.

Judging from the uncontrolled nose-up movement, the aircraft centre of gravity was probably behind the aft limit. In the investigator's opinion, this was caused by a significant amount of water in the rear fuselage. The amount of water and its effect on the aircraft centre of gravity is illustrated in Figure 6, taking into account the loading of the aircraft in the accident situation including the fuel and the pilot. The figure shows how the centre of gravity position may vary if the amount of water (its centre of gravity) is located in the very aft part of the fuselage, within an area of one metre in length. It can be seen in the picture that if the amount of water is 25 litres, the centre of gravity position will remain between the allowed forward and aft limits, even if all the water is in the rearmost part of the fuselage. However, the maximum certificated take-off mass would be exceeded with a smaller amount of water. There must be over 25 litres of water before the centre of gravity moves behind the allowable aft limit.

Figure 6. Effect of different amounts of water on the centre of gravity position.

The movement of the water may also have rocked the aircraft and made it more difficult to control. After take-off, the water probably ran to the rear part of the fuselage due to the aircraft climb attitude. This moved the centre of gravity even farther aft, decreasing the longitudinal stability of the aircraft and making it harder to control during climb. In the end, the aircraft became unstable and the pilot lost control immediately when reducing engine power. Figure 6 shows that a few litres of water would not have been sufficient to move the centre of gravity behind the allowed limit.
