Investigation report

L2013-01

Helicopter accident on a heli-sawing flight near the city of Tampere on 10 January 2013

Hughes 369D

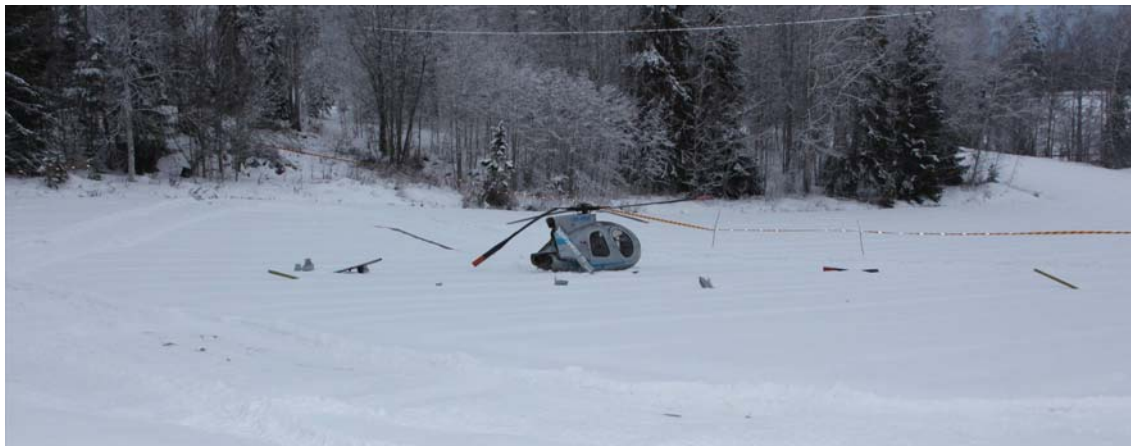
Figure 1. The accident site.

Both of the helicopter's skids broke off in the collision with the ground. The airframe was lying on its bottom on the ground. The lower section of the left windshield was shattered next to the antitorque pedals. One of the main rotor's five blades was broken off close to the root of the blade. Another blade was bent downward and its leading edge was crushed. The third blade was bent upward and the remaining two blades seemed intact. The rotor blades had struck the tailboom, slashing it into three separate sections. The root of the tailboom was bent towards the right side of the airframe and the middle part lay approximately eight metres from the airframe, in front of the helicopter in its original heading. The empennage section, including the tail rotor, the tail rotor gearbox and the horizontal stabiliser, which were still attached to the empennage, lay approximately seven metres to the right of the airframe in relation to the track of the helicopter. The vertical stabiliser lay next to them. In addition, two pieces of the tail rotor's driveshaft and a fibre cowling from above the engine's compressor were close to the airframe. The stabilisers and the driveshaft parts had rotor slash marks on them. The tail rotor was intact. The helicopter's seats had maintained their integrity.

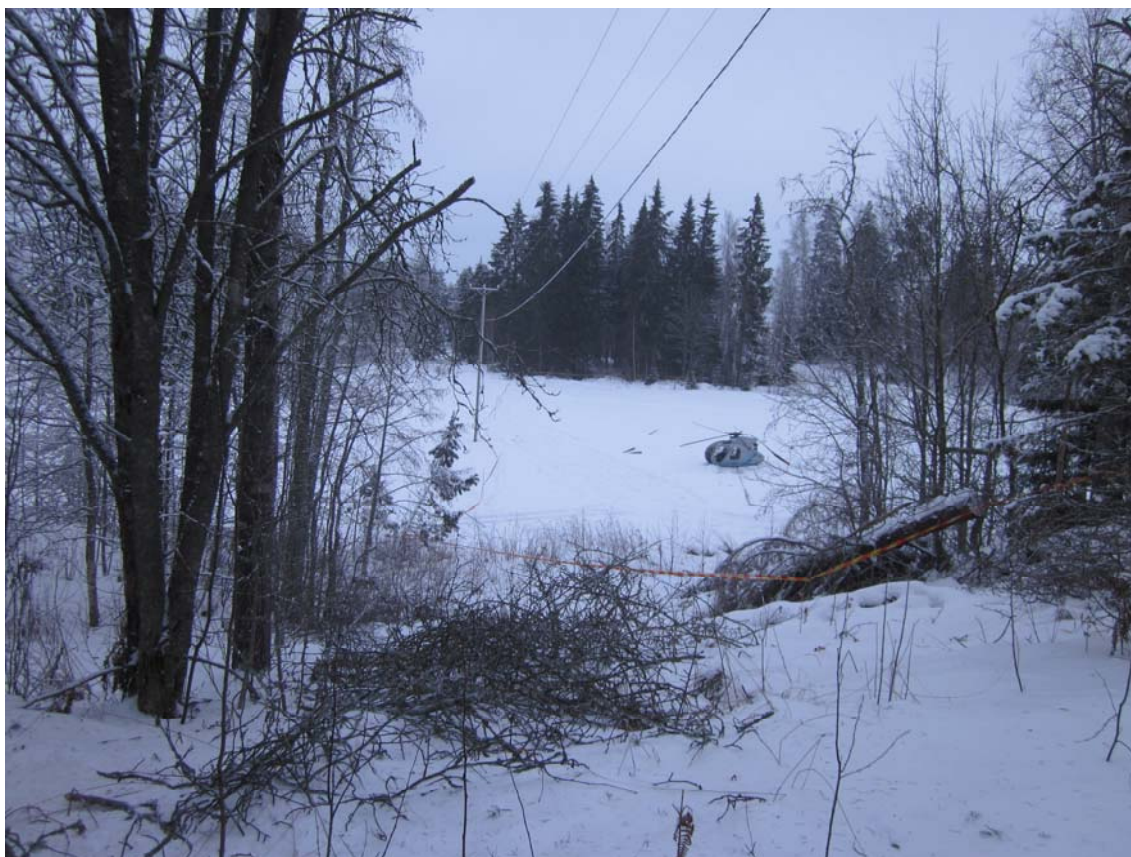
Figure 2. The accident site photographed from the top of the knoll.

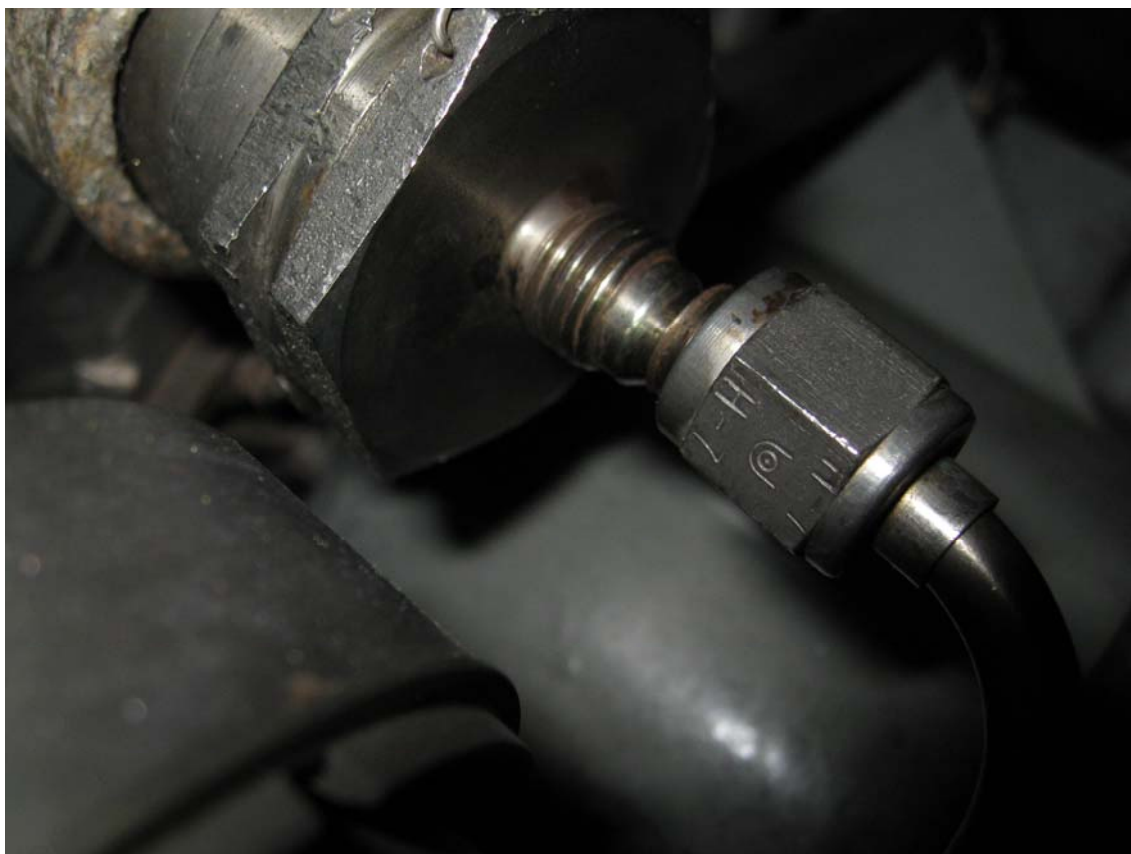
Figure 5. A B-nut downstream of the Pc filter on the compressor delivery air pressure sensing line, photographed after the accident.

The helicopter's technical inspection revealed that a B-nut downstream of the Pc filter on the compressor delivery air pressure sensing line and the coupling had become loose (Fig.

5). The line loosening results in an air pressure drop in the engine's power control system and, consequently, the loss of engine power or a flameout.

Once the line's nuts are tightened to the correct torque the couplings are marked with torque paint so as to make it possible to monitor any slippage. Whereas some paint markings had blackened because of heat, some nuts showed no paint markings at all. When the loosening and tightening torques of the B-nuts were tested for the purpose of general estimation, their loosening torques varied quite a lot, from 25 to 125 lb in. The B-nut at the other end of the Pc filter, upstream of the loosened coupling, was remarkably tight. It loosened at 125 lb in. The B-nut on the Pr line loosened at 25 lb in and tightened to its original position at less than 80 lb in.

The investigation determined that the slippage of the B-nut and the consequent opening of the coupling caused the loss of engine power. Since the control air pressure sensing lines, the filter and the B-nut were intact and there were no signs of abnormal engine vibration, Safety Investigation Authority deems it possible that

The immediate cause of the accident was a B-nut downstream of the Pc filter on the compressor delivery air pressure sensing line becoming completely unscrewed. The air pressure sensing line came loose, which resulted in a loss of pressure in the engine's power control system at which time the engine lost its power and probably flamed out.

Safety Investigation Authority, Finland recommends that MD Helicopters Inc review the MD 369D helicopter's compressor delivery air pressure sensing line section in the daily inspection manual in such a manner that it complies with the engine manufacturer's manual by including the paint markings on the B-nuts.

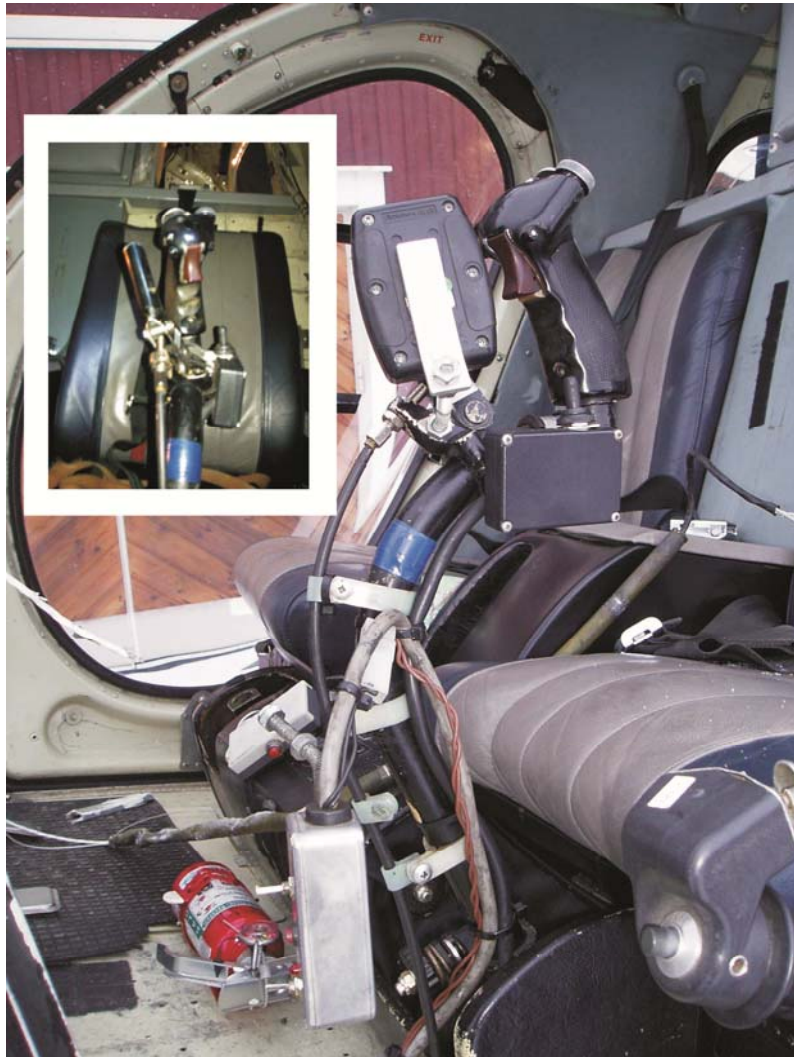
To allow for the heli-saw's controls, the external cargo release handle was installed a bit to the side and farther than normal from the cyclic control (Figure 6). The recording feature on the helicopter's GPS satnav had been turned off. Following the emergency landing the helicopter's ELT transmitter (ACK Model E-01) did not activate.

Figure 6. *The layout of the sawing unit's controls and the external cargo emergency release handle, photographed from the side and the front.*

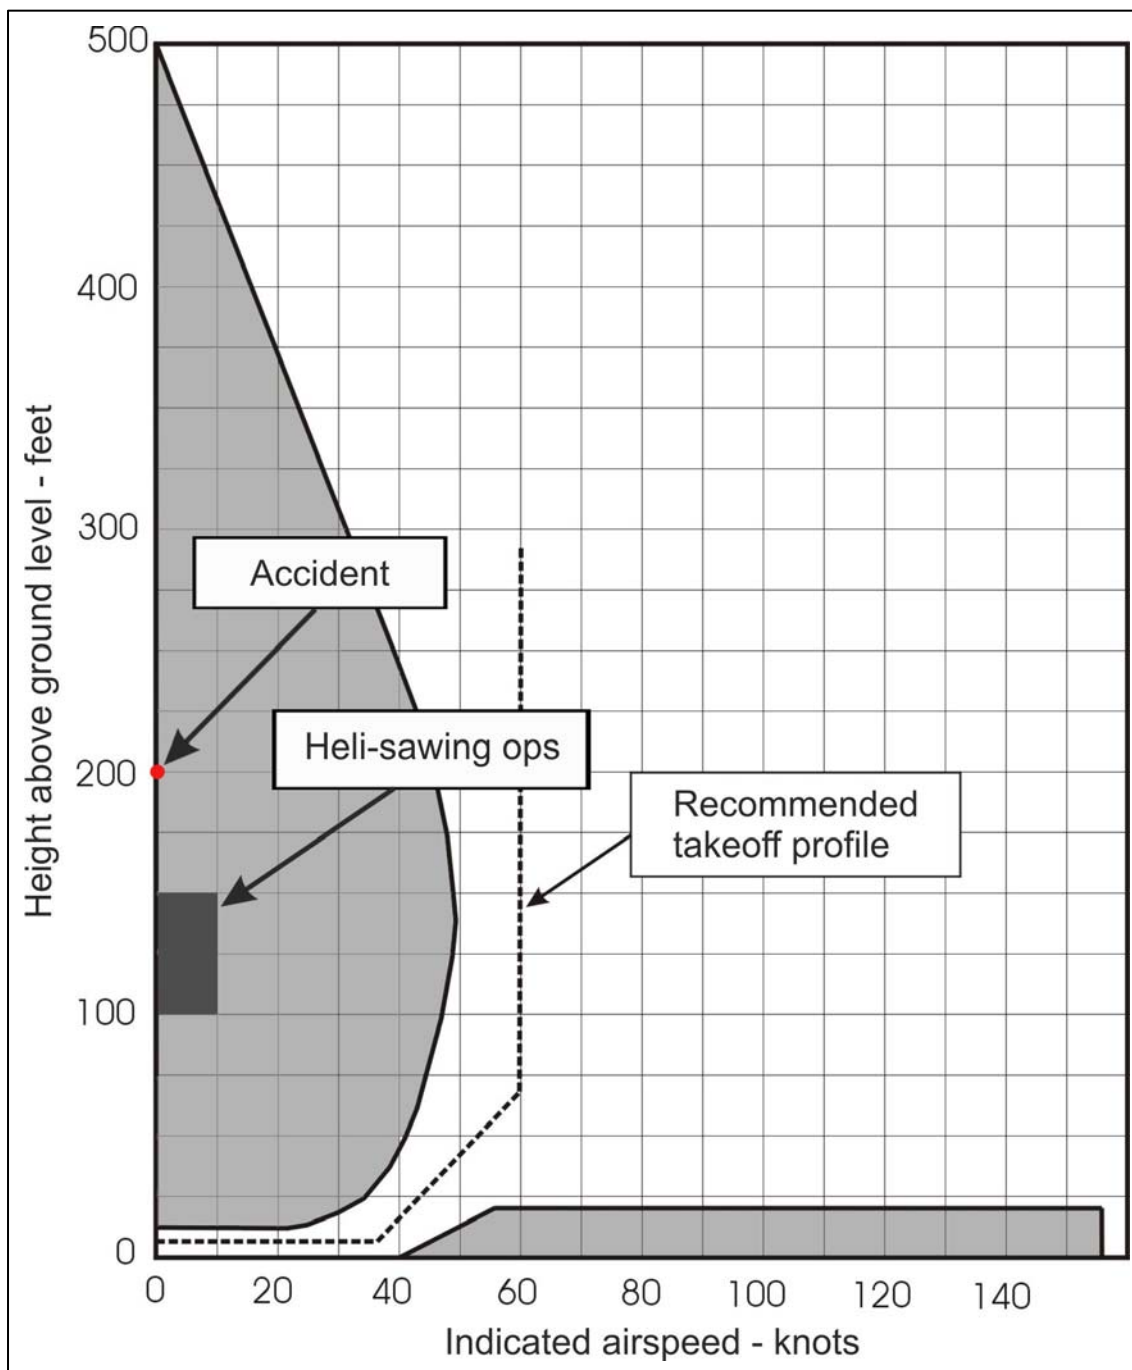
Figure 7. A helicopter's Height-Velocity Diagram. The grey-shaded zone is the so-called 'dead man's curve' which will likely prevent a successful autorotation. One should avoid operating in this height-velocity zone. Heli-sawing operations are normally flown at a very low airspeed and at the height of 30–40 metres or so (dark grey-shaded zone). The helicopter's engine failed as it was flying over a knoll. Therefore, it was flying at approximately 200 ft (red dot) in relation to the emergency landing site.
