Investigation report

B 5/2000 M

MV JANRA, capsizing in Northern Baltic 23.12.2000

Accident Investigation Board Finland

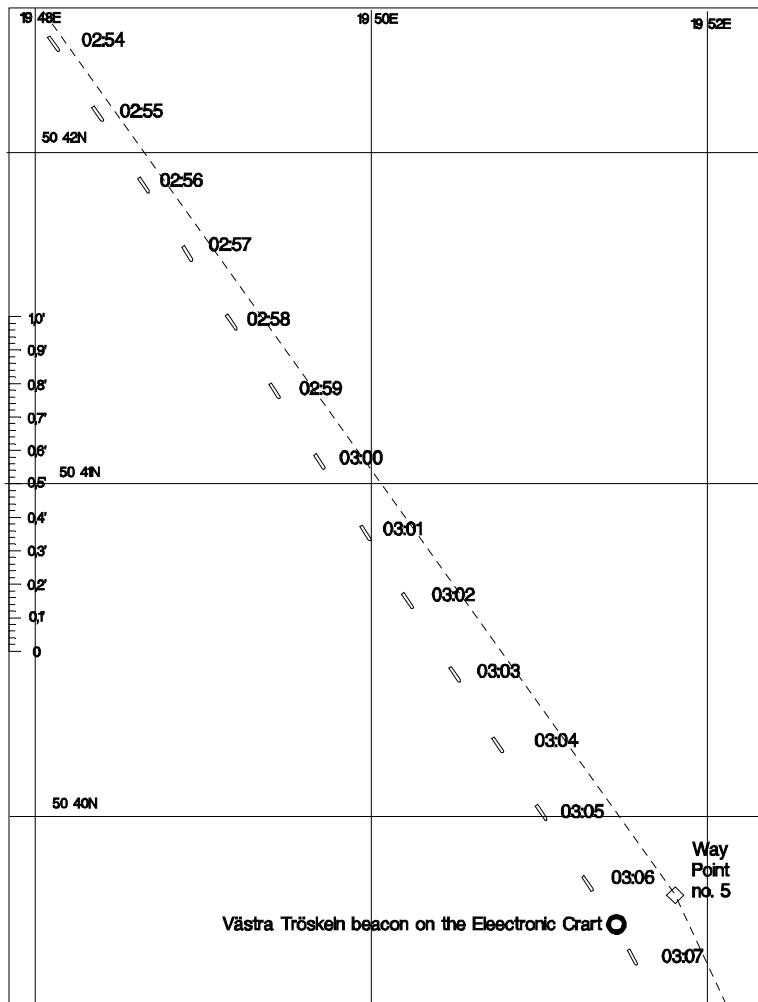
Figure 14. JANRA deviated from the passage plan at 02:54 by turning 2° to starboard.

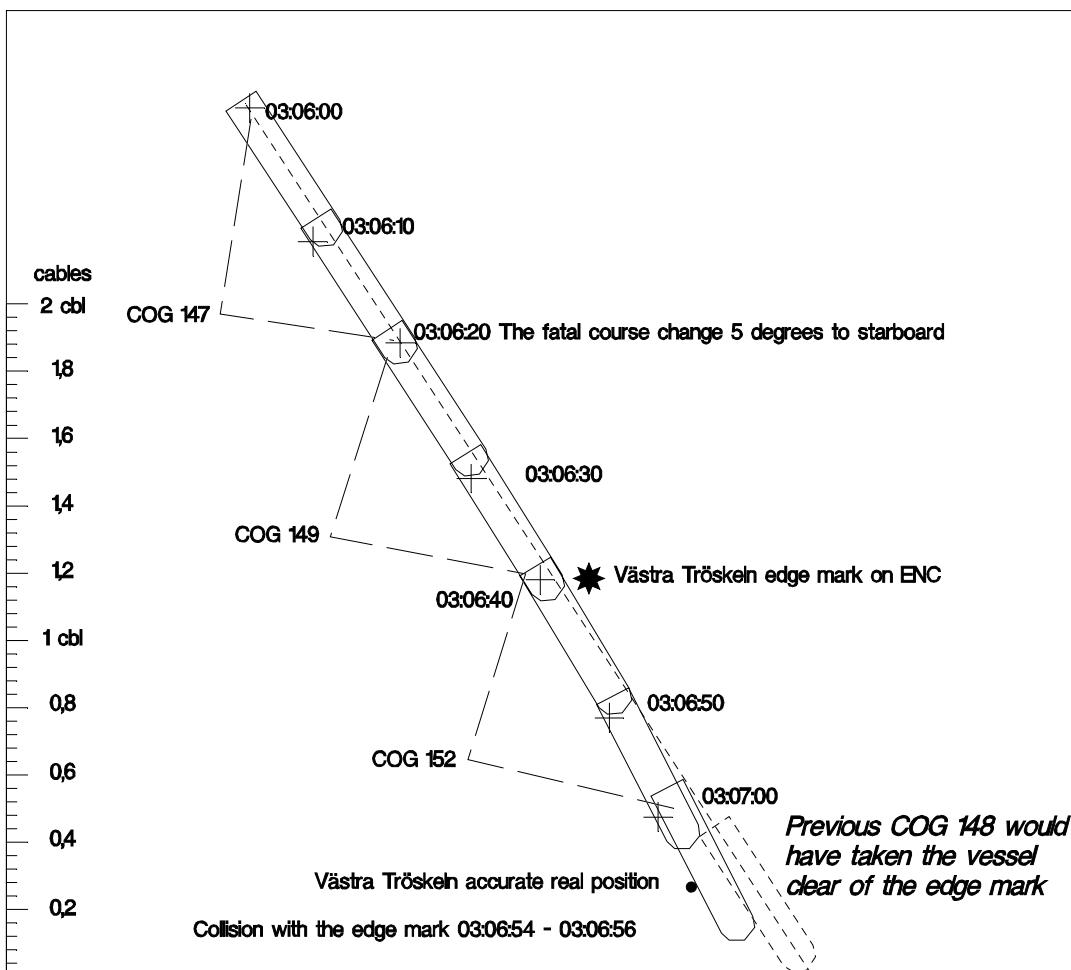
Figure 15. JANRA collides with Tröskeln Västra edge mark.

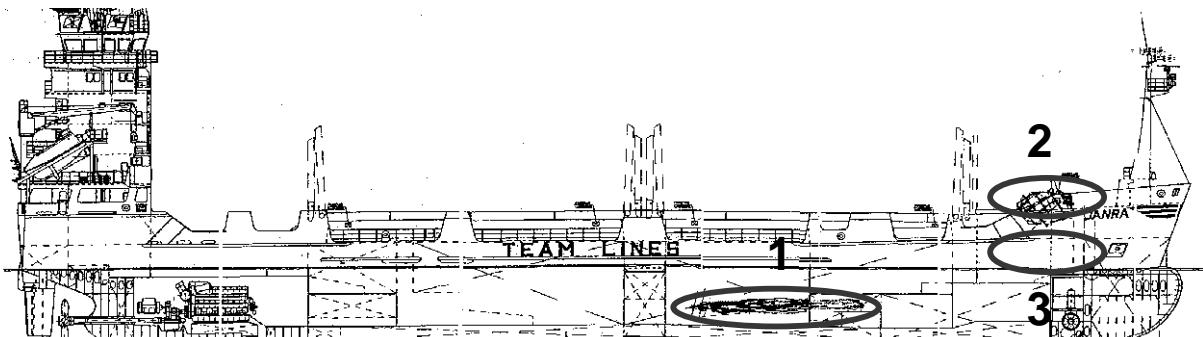
Figure 21. The damages on the starboard side of JANRA.

The damages were found in three main areas of the hull. One long hole was below the waterline on the side just forward of the midship (marked by number 1 in figure 21). This hole was a longitudinal rather narrow cut just above the bilge, see figure 22. As a result of this hole the side tank (SB wing tank nr. 1) was damaged. This cut also extended to an area where no double hull existed at hold no. 1.

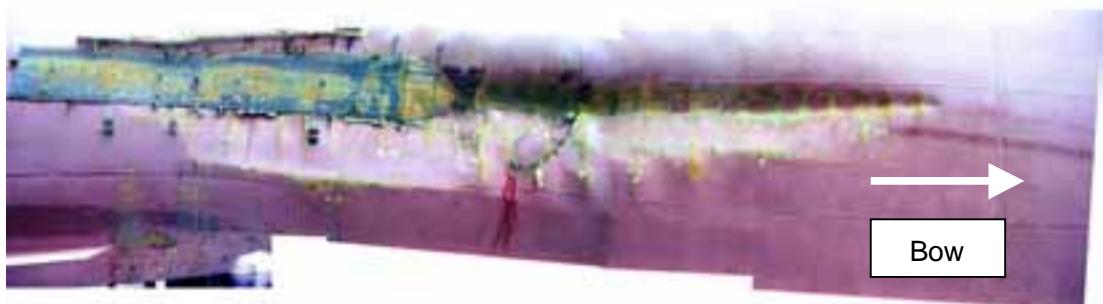
Figure 22. The damage on the side plating below waterline, damage no. 1 in figure 21. The cut is very sharp and the bow is to right. The hole is still temporarily repaired for the voyage from Turku to Germany. (Note that this picture is a composition and the perspective is not correct.)

The damage on the side plating forward of the midships which was below waterline is also a long cut and it was caused by the remaining part of the edge mark. It is supported by the fact that the height of the remaining edge mark part below water level corresponds to the damage of the ship, see figures 22 and 26.

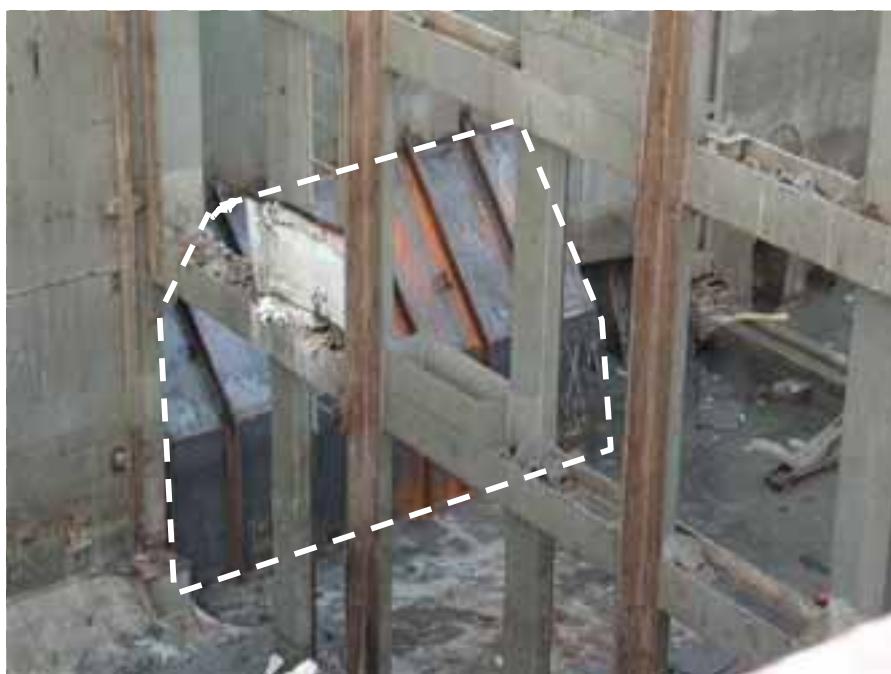
Figure 23. The temporarily repaired damage in hold no. 1.

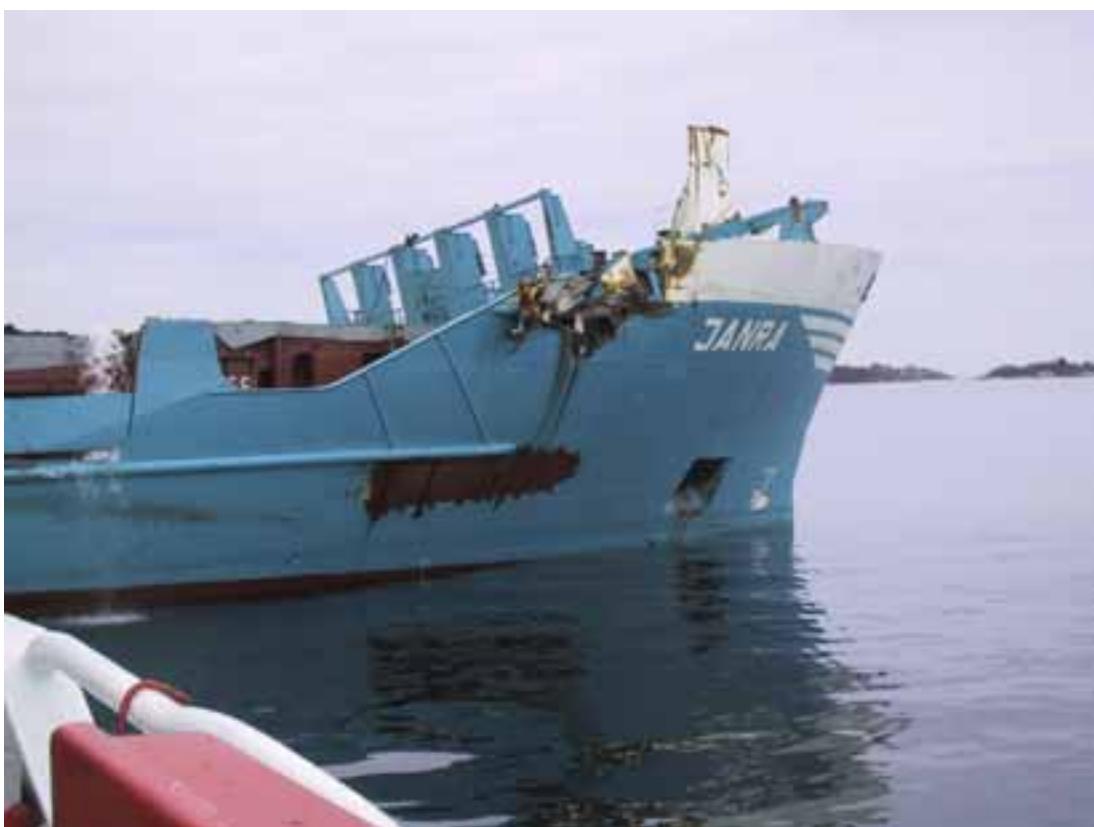
Another area of damage was on the starboard side of the forecastle, which had been damaged at two places. This area can be seen in figure 24. One damage was at the end of the reeling of the forecastle (number 2 in figure 21). This damage opened the forecastle to the sea. The other narrow cut was on the side of the bow above waterline (number 3 in figure 21 and figures 24 and 25). This hole damaged the starboard double bottom tank (SB DB tank nr. 1).

Figure 24. The two areas of damage on the bow of the JANRA. The photograph has been taken after the ship had been turned. (The lower hole had been temporarily repaired under water.)

The damage sequence. When JANRA hit the Tröskeln Västra the two damages in the starboard bow area occurred simultaneously. The one in the forecastle reeling was caused by the hit to the edge mark tube. The sharp cut on the bow side plating above water line was probably made by the ice cone upper edge. The cone was found to be slightly damaged and it was at the corresponding height, see figure 26.

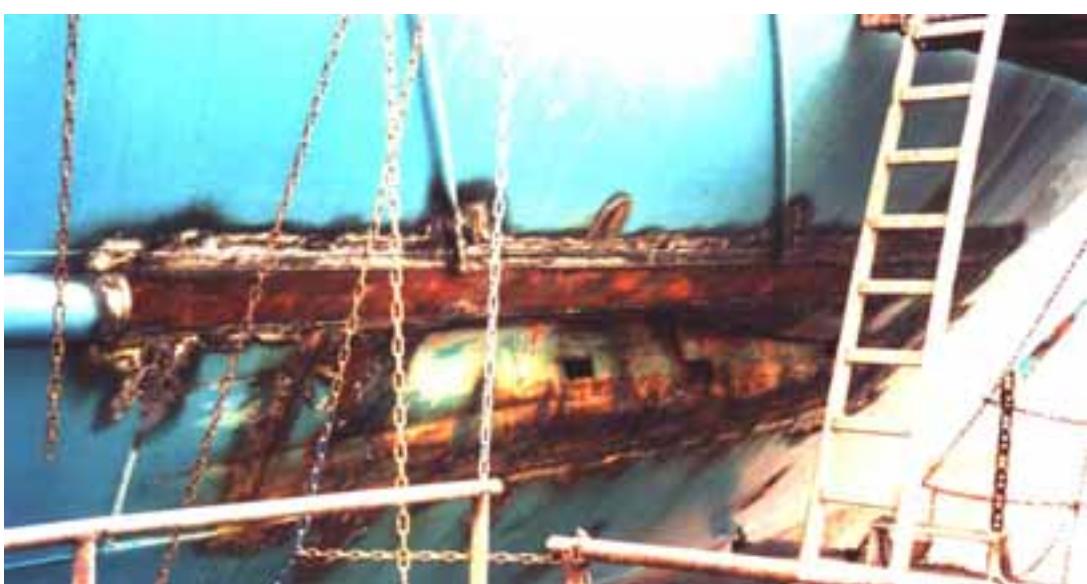
Figure 25. The damage on the side plating above waterline in bow, this is damage nr. 3 in figure 21.

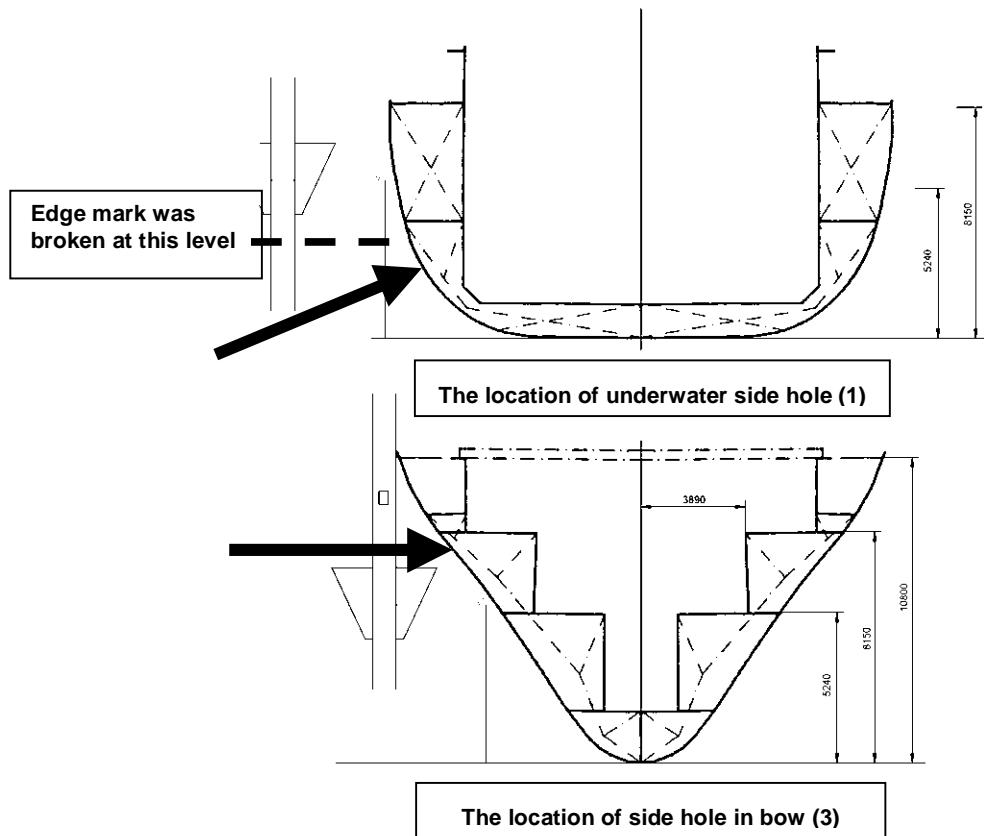
Figure 26. The Tröskeln Västra edge mark compared to the damaged cross sections of JANRA. Note the level where the edge mark had broken (dotted line) in the upper drawing and the level of the ice cone sharp edge in the lower drawing compared to the location of corresponding damage. The view is from bow to stern.

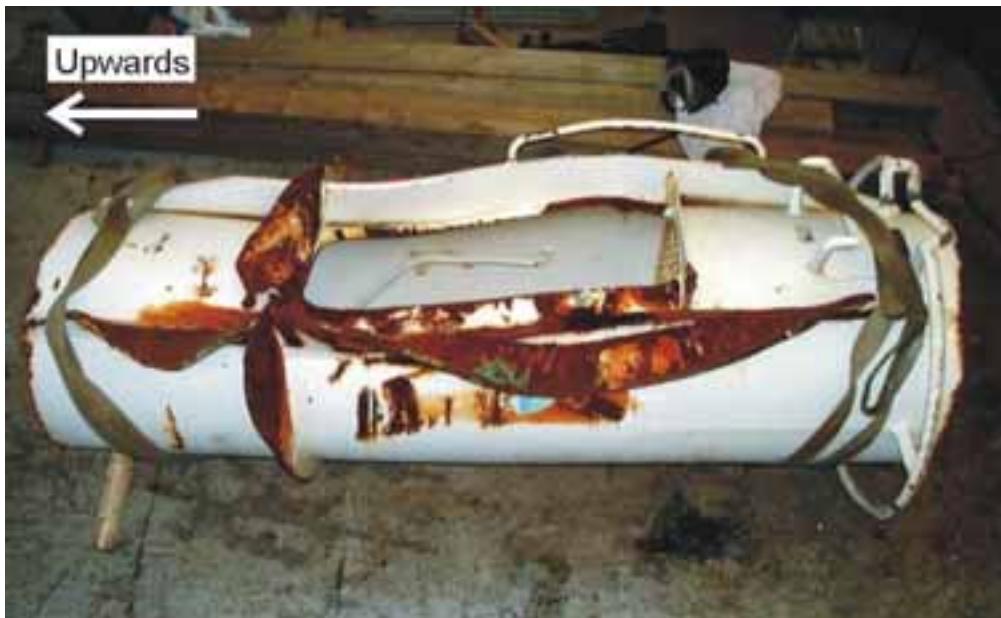
The Edge Mark was totally destroyed. It was cut off some metres below the surface. In the upper part there were traces of a hit in the area where the door to enter the mark had been. See the diver's sketch and photo of the point of impact on the recovered part of the edge mark in figures 24 and 25. According to the divers the fallen edge mark was near its original position and was not moved away by the ship.

Figure 27. Position of the impact on Tröskeln Västra. In the middle is the door opening.

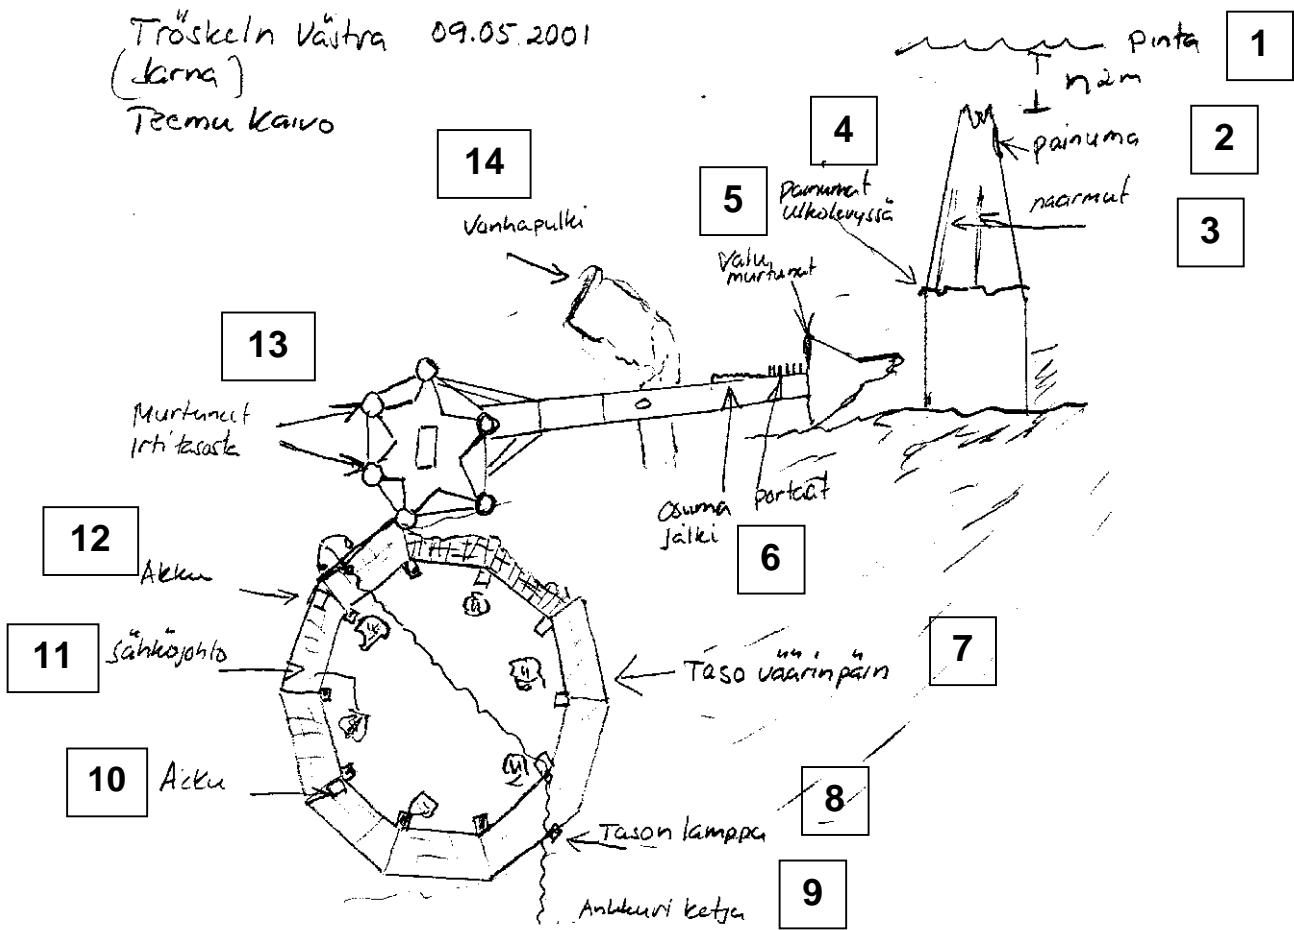
1. Water surface, distance mark = about 2 m
2. Dent
3. Scratches
4. Dents in the girder
5. Broken concrete
6. Impact and stairs (Figure 25)
7. Helicopter platform upside down
8. Platform light
9. Anchor chain
10. Battery
11. Electric wire
12. Battery
13. Broken from the platform
14. Old edge mark

Figure 28. Diver's sketch of the damaged Tröskeln Västra, the figure, north is approximately up.

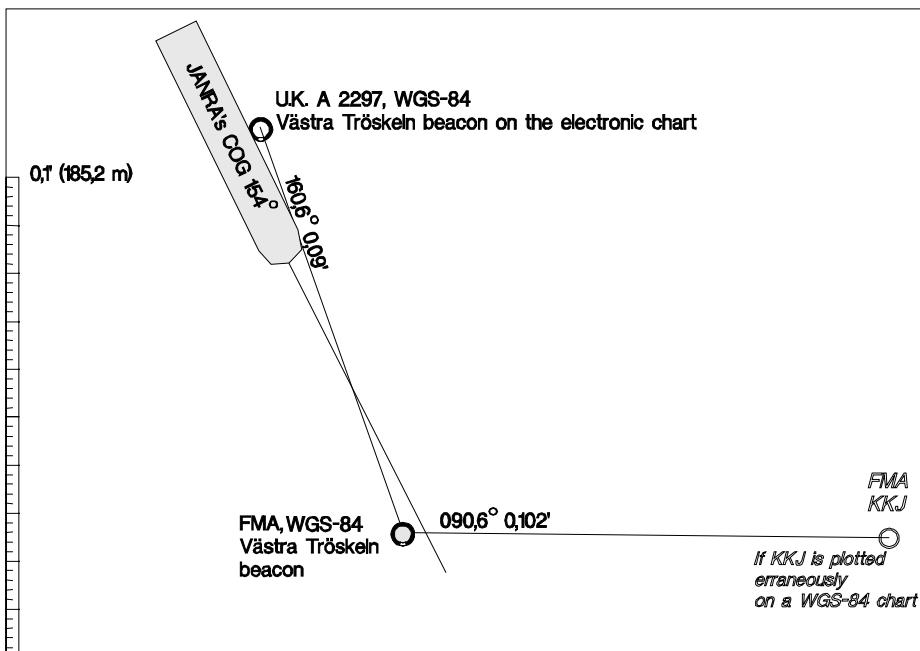
The electronic chart was digitised from the U.K. chart A 2297. On the electronic chart the beacon position deviated 168 metres from the real beacon given by Finnish Maritime Administration. The error cannot depend on confusion between Finnish and international co-ordinate systems because the Finnish KKJ (Finland Heyford) deviates mainly in longitude from WGS-84 (figure 27).

Figure 31. Different Tröskeln Västra beacon positions on a WGS-84 electronic chart.

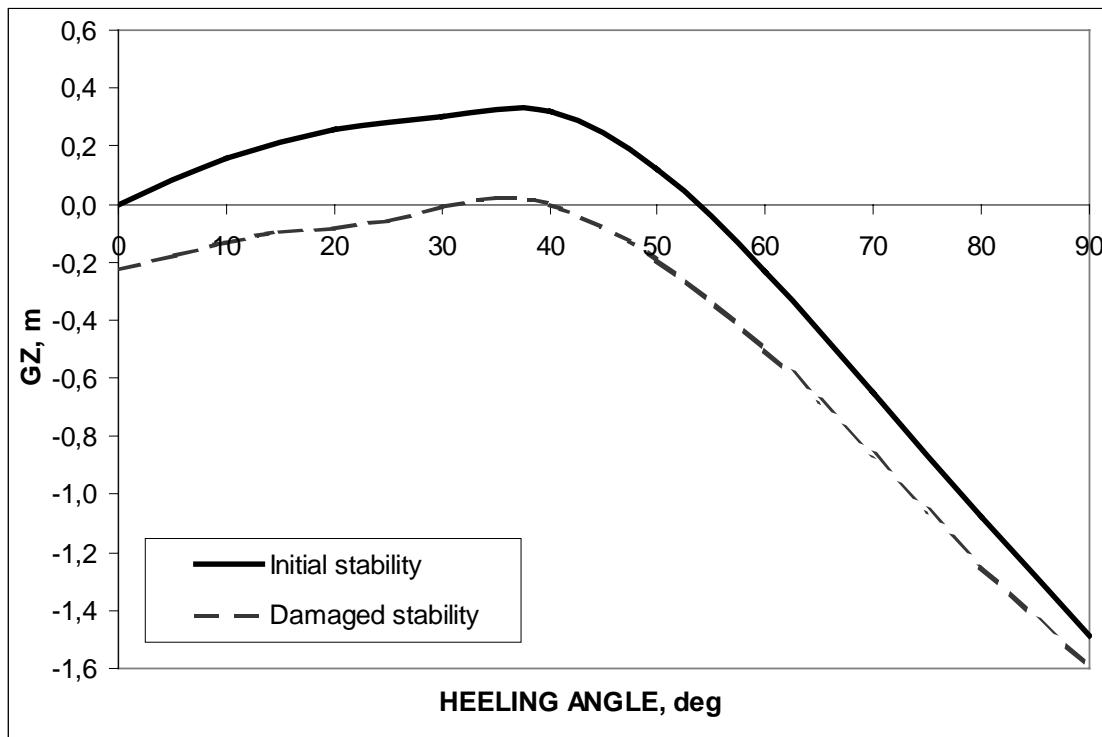
Figure 33. The GZ-curve of the JANRA's initial stability and the GZ-curve of the JANRA's damaged stability. Case 2 with damaged forecastle (no water in the hold no 1).

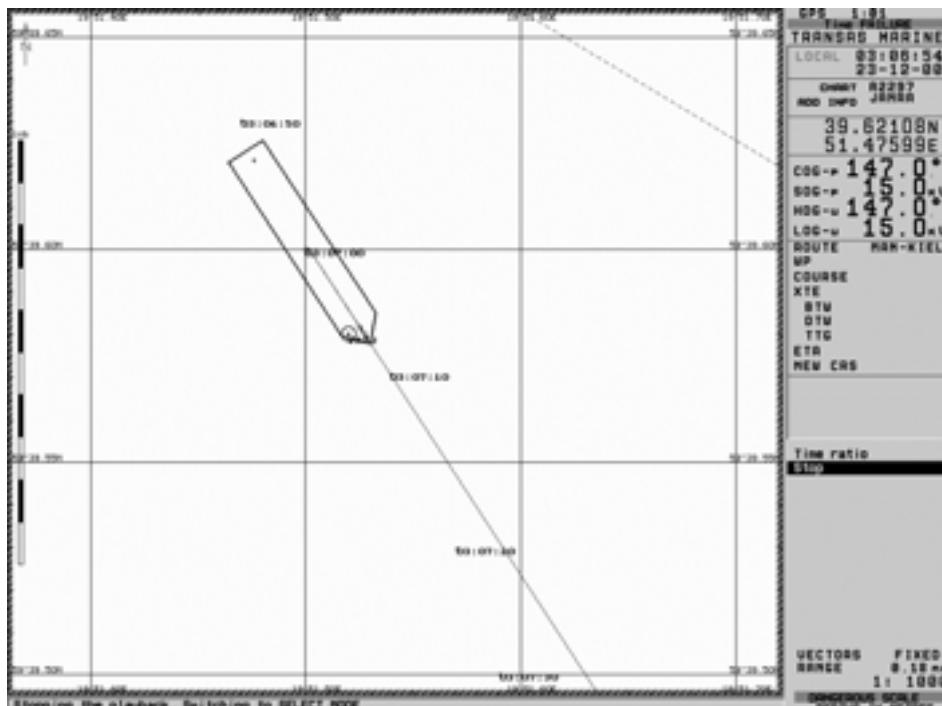
Figure 34. JANRA's collision with the edge mark illustrates clearly that the chart datum was correct and the accuracy was about 3 metres. See also damage in the bow in figure 24.
