Investigation report

C4/2006M

C5/2006M

M/S HOBURGEN on 7.10.2006 and M/T ARCTICA on 14.10.2006, ramming of edge mark Tröskeln Östra

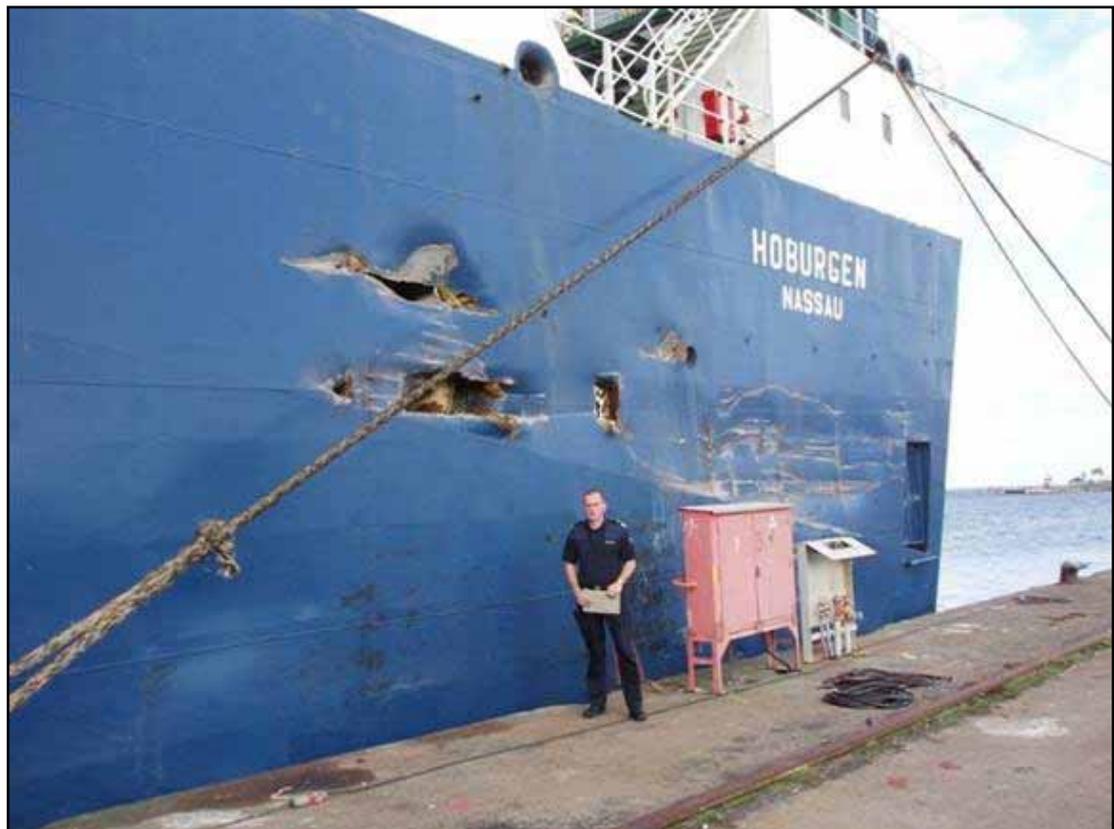
Damage to the vessel. The first damage detected was the life buoy's smoke signal, which had activated on the port wing of the bridge as a result of the collision. The port wing of the bridge was also damaged in the collision. The next damage was found approximately 10-15 metres aft from the first point of impact, where the railing of the rescue station was damaged. The vessel hit the edge mark the hardest at approximately 5-6 metres fore of stern (fig. 8). There, the vessel sustained dents and three holes in the side of the hull at different heights above the waterline. The hole closest to the waterline was an approximately 1.5 m long slash below the fender list, approximately one metre above the waterline. It was stopped up with rags and wooden wedges from the inside of the hull right after the collision.

Figure 8. The HOBURGEN in the port of Oskarshamn after the collision. The person in the photo is not one of the ship's crew.

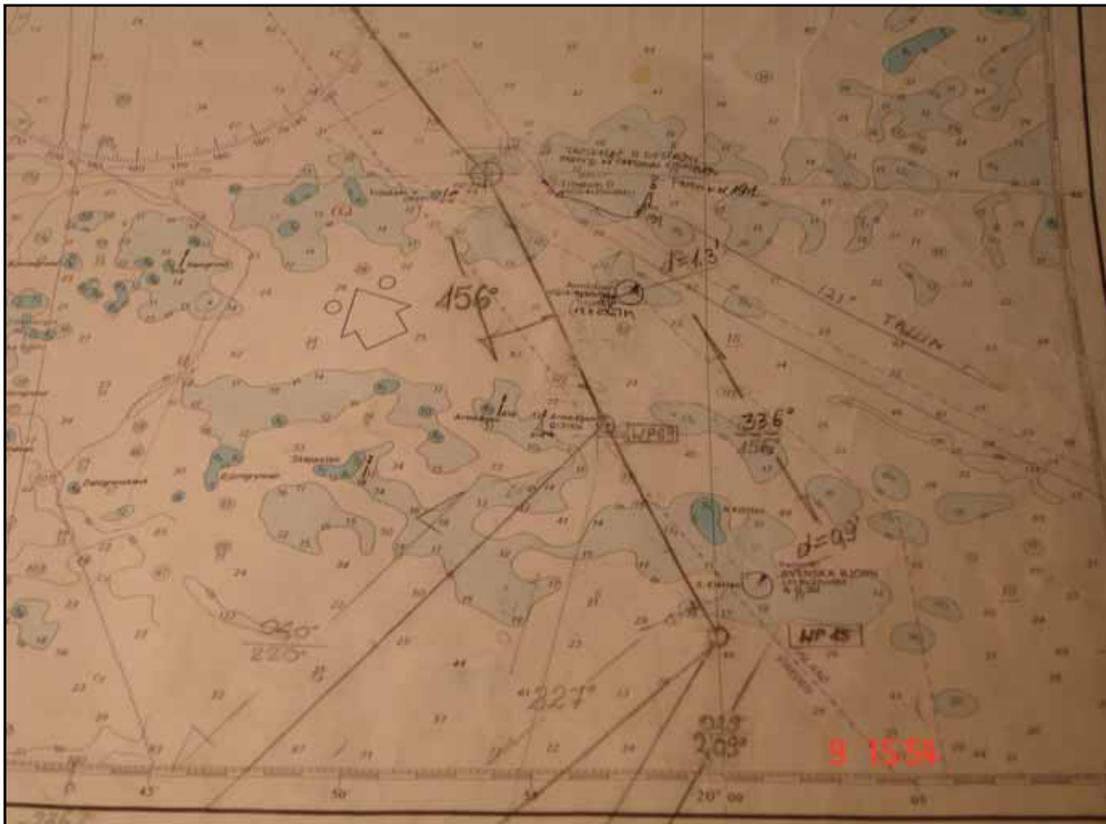
The ARCTICA had no electronic chart. Instead, she used the Admiralty's paper chart No. 2337 (Ålands Hav) with the scale of 1:120 000. Tracks were drawn by pen on the chart. The chart also had permanent markings for the Closest Points of Approach (CPA) and courses (fig. 9). The ARCTICA was not following the track marked on the chart.

Figure 9. A photo of the ARCTICA's navigation chart which was used at the time of the incident. The chart displays tracks, courses and the most important CPAs.

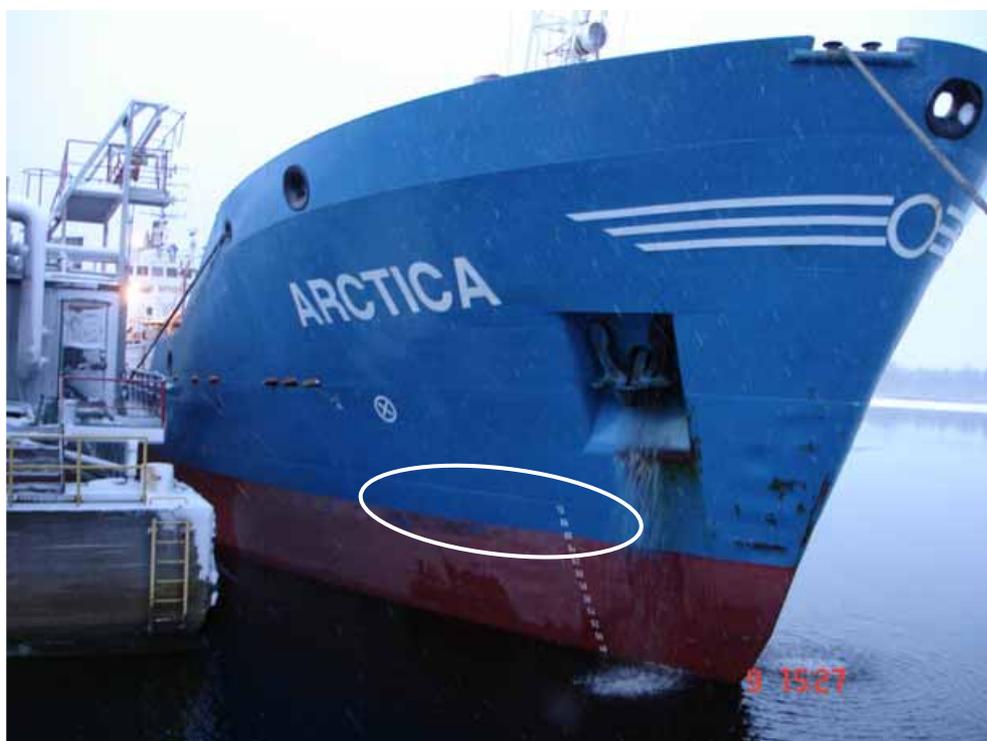
Damage to the vessel. The ARCTICA reported having sustained a 1 m x 2 m tear approximately 2 metres above the waterline and a 20 cm large hole on her starboard side where the ballast tank is located. The spot, with the now repaired damage, is shown in figure 11. When the damage was assessed, leaks were detected in the forepeak, the bow thruster compartment and the foremost starboard ballast tank. Because of the leaks they decided to put her in dock for repairs. There was no danger of sinking but the vessel turned towards a dry dock in Sweden a few hours after the collision.

Figure 11. The ARCTICA in Oulu after repairs. The white ellipse in the photo indicates the spot where she sustained the damage.

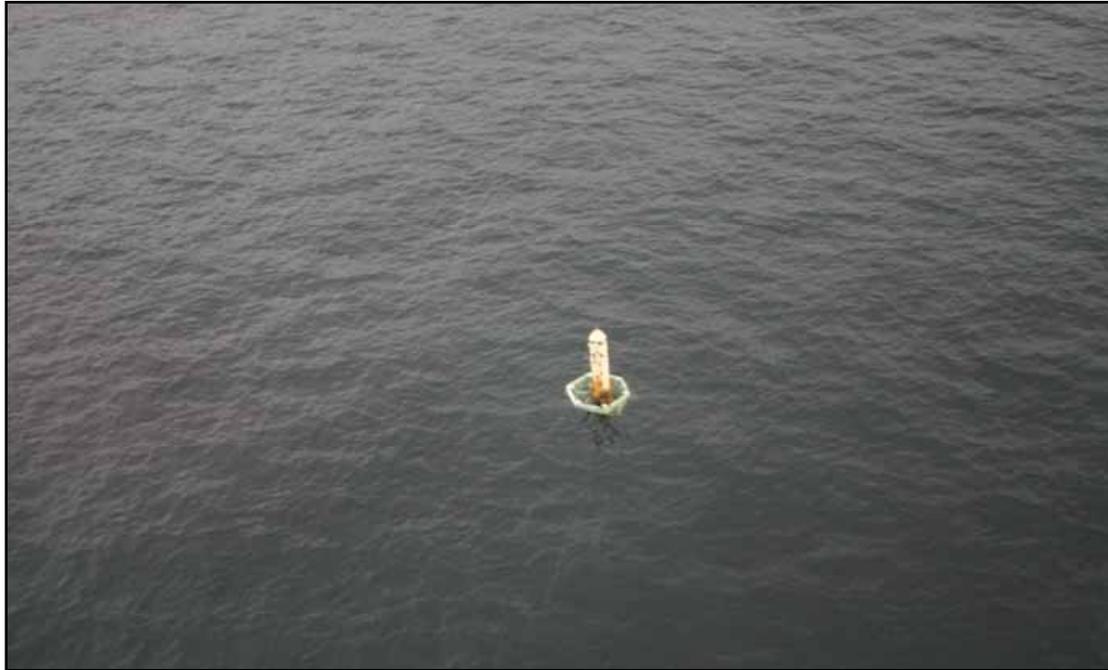
Damage to Tröskeln Östra. When the HOBURGEN rammed the edge mark it was bent just above the surface and the helideck fell to the sea. There was no lighting on the edge mark after the collision. Figure 12 shows Tröskeln Östra after the collision.

Figure 12. *Tröskeln Östra after the collision with the HOBURGEN. (Source: The Border Guard)*

Planned safety equipment repairs and traffic arrangements. According to the Finnish Maritime Administration at least the edge mark Tröskeln Östra is going to be rebuilt. After the JANRA rammed Tröskeln Västra it was replaced with a light buoy (a large ice buoy).

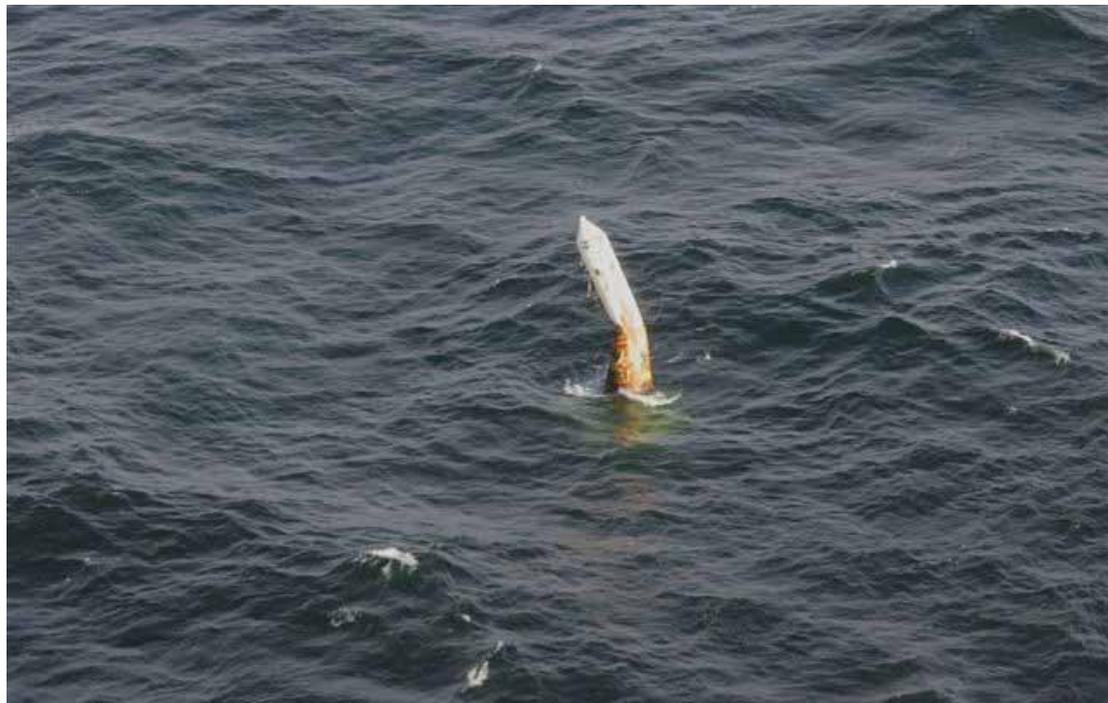
ther at the waterline and the previously fallen helideck disappeared from view. Figure 13 shows Tröskeln Östra after the collision with the ARCTICA.

Figure 13. *Tröskeln Östra after the collision with the ARCTICA. (Source: The Border Guard)*

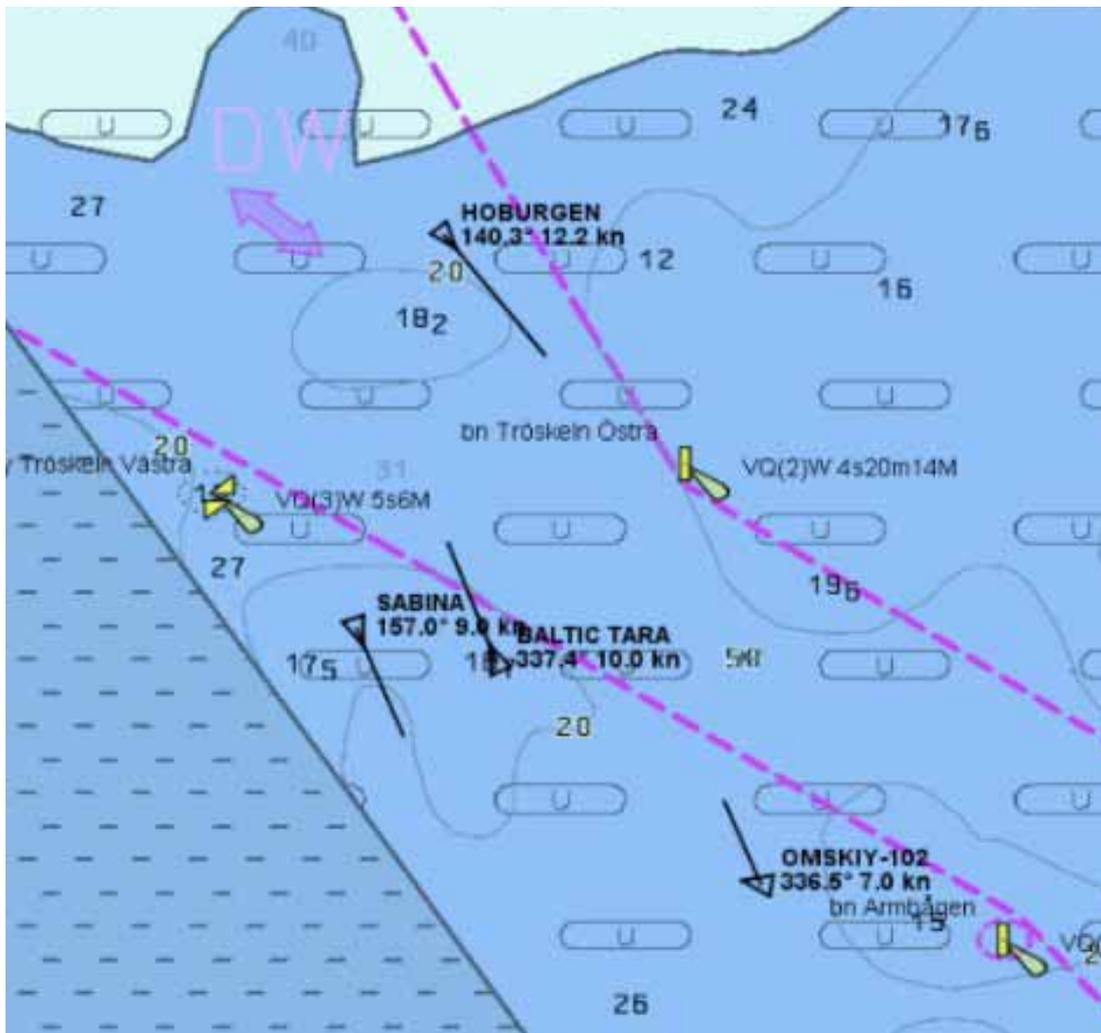
Figure 14 shows the AIS-recorded traffic situation in the vicinity of Tröskeln Östra on 7.10.2006 at 21:45. The HOBURGEN changed course 10 degrees to port (from course 142 degrees to course 132 degrees) at that time.

The AIS symbol of the OMSKIY-102 (figure 14) drew the attention of the investigators. The symbol shows that her heading and her Course Over Ground (COG) diverged by approximately 60 degrees. Her speed was approximately 7.0 knots which means that a drift angle of this magnitude was hydrodynamically impossible. Therefore the AIS transmitter of the OMSKIY-102 broadcast an incorrect heading.

Figure 14. Image of the FMA's AIS picture on 7.10.2006 at 21:45 when the HOBURGEN altered its course 10 degrees to port. The information content in the image corresponds to the situation picture at Archipelago VTS (Source: Finnish Maritime Administration, VTS records, Archipelago VTS)

Judging by VTS records of these accidents virtually all vessels in the area either failed to prepare a voyage plan as per these principles or ignored the prepared plan. The HOBURGEN was seemingly in the “oncoming lane” (fig.14). If she indeed followed a voyage plan, it was a risky one. The ARCTICA did not follow the track marked on the map. She overtook the ALTA MAR, which was sailing in the sea lane, from the starboard side and took a course which led her directly into Tröskeln Östra (figures 9 and 10b). By preparing and observing a voyage plan which takes the special conditions of the deep-water route into account one can improve the safety of traffic in the zone.

Furthermore, the HOBURGEN, evidently in an attempt to yield to oncoming traffic, changed course to port. This was in violation of the spirit of the rules of manoeuvring and navigation. As regards the HOBURGEN accident, the BALTIC TARA also used the “oncoming lane” as she entered the deep-water route zone (figure 14).

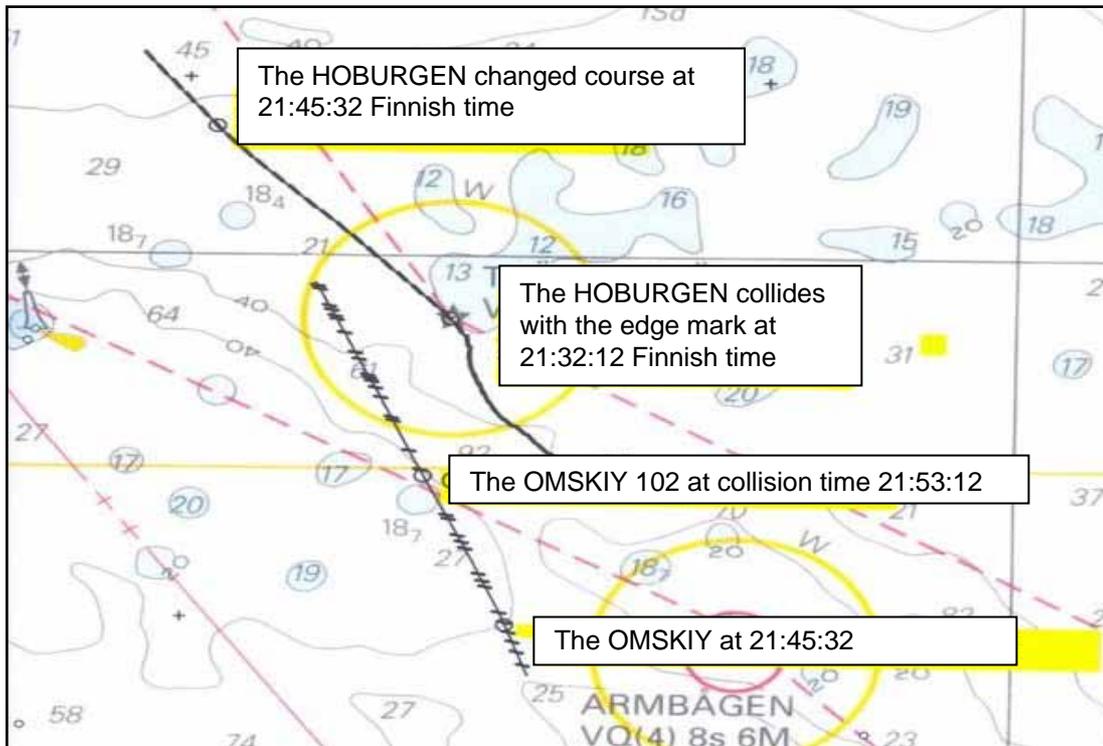
Detecting the edge mark, its remains and other traffic. The OOW on the HOBURGEN altered course 10° to port approximately 1.5 nm, i.e. seven minutes, before entering the passage delineated by the deep-water route edge marks (fig. 15). This can be understood as an action to avoid collision. The HOBURGEN and M/S OMSKIY-102, heading toward each other, would have ended up in a near head-on situation in which the Closest Point of Approach would have been less than 0.3 nm (CPA<0.3). The situation was even more hazardous because the HOBURGEN kept to the port edge of the deep-water route. A change of course to port, considering the oncoming traffic, was easier than collision avoidance to starboard, as prescribed by the Rules of the Road.

Figure 15. The HOBURGEN's Advento-recorded tracks (HOBURGEN / OMSKIY 102), superimposed on a chart.

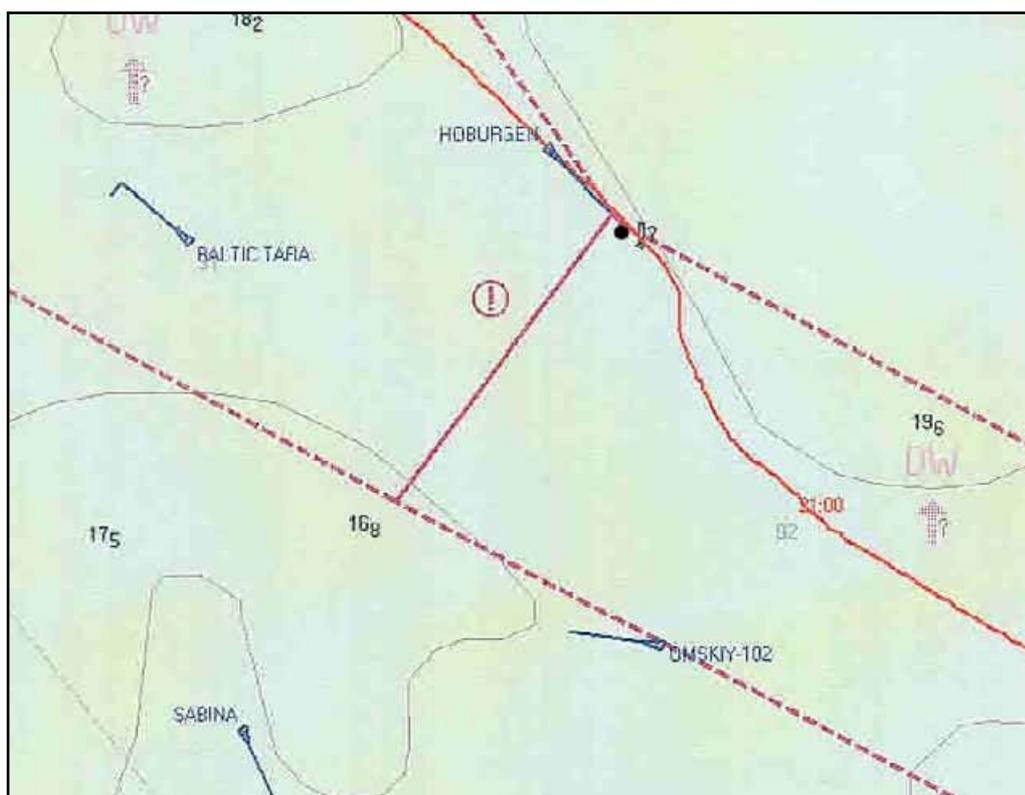
Figure 16 shows how the OMSKIY-102, according to the selected AIS display mode, seems to be maintaining a heading of 275-280°, and so clearly passes the track of the HOBURGEN from the port in the head-on situation. In reality the COG of the OMSKIY-102 was 335°, as shown in figure 17. The attitude of the vessel symbol also shows the ships heading in figure 17.

Figure 16. The electronic chart ADVETO's image of the situation; Sjöfartsverket's AIS-display. The OMSKIY-102 is on the bottom right. (Source: Sjöfartsverket).

2. *The Finnish Maritime Administration warn Finnish shipping of the hazardous possibility of AIS messages possibly displaying incorrect heading information.*

The Finnish Maritime Administration inform the IMO of the hazardous AIS message display possibility.

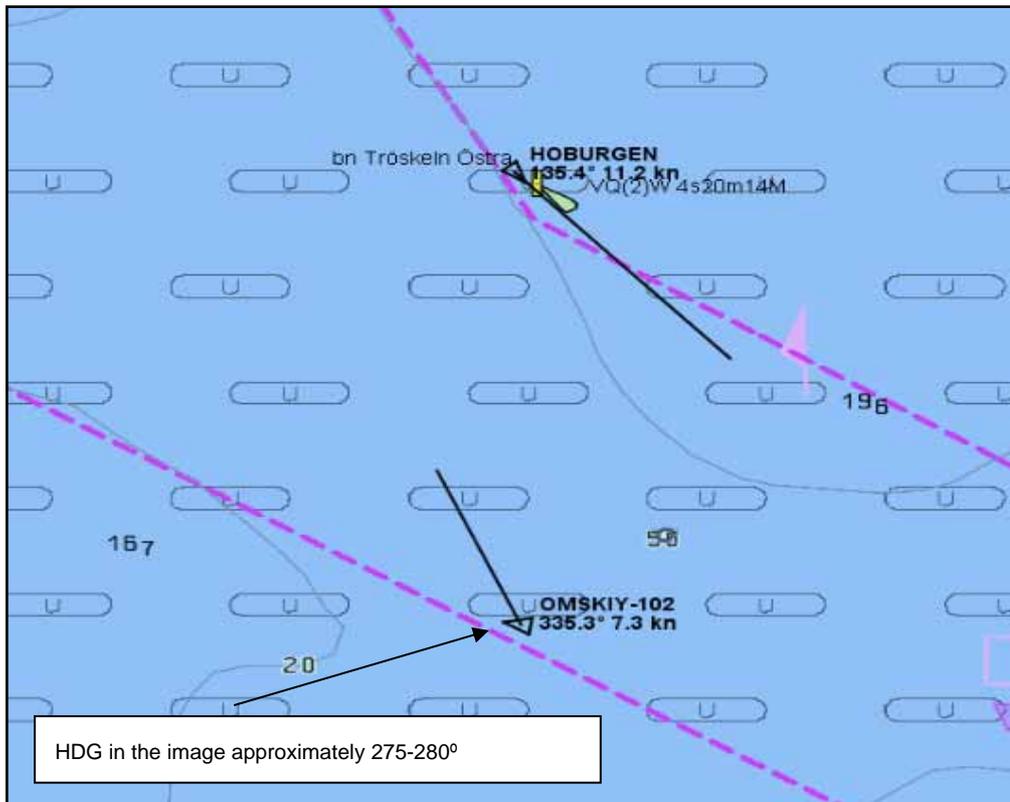
Figure 17. The image of the AIS recording of the Finnish Maritime Administration. (Note the heading of the tip of the symbol triangle; ca. 275–280°)
