Statens haverikommission
Swedish Accident Investigation Board

Report RS 2008:03e

**Loss of M/S FINNBIRCH
between Öland and Gotland,
1 november 2006**

Case S-130/06

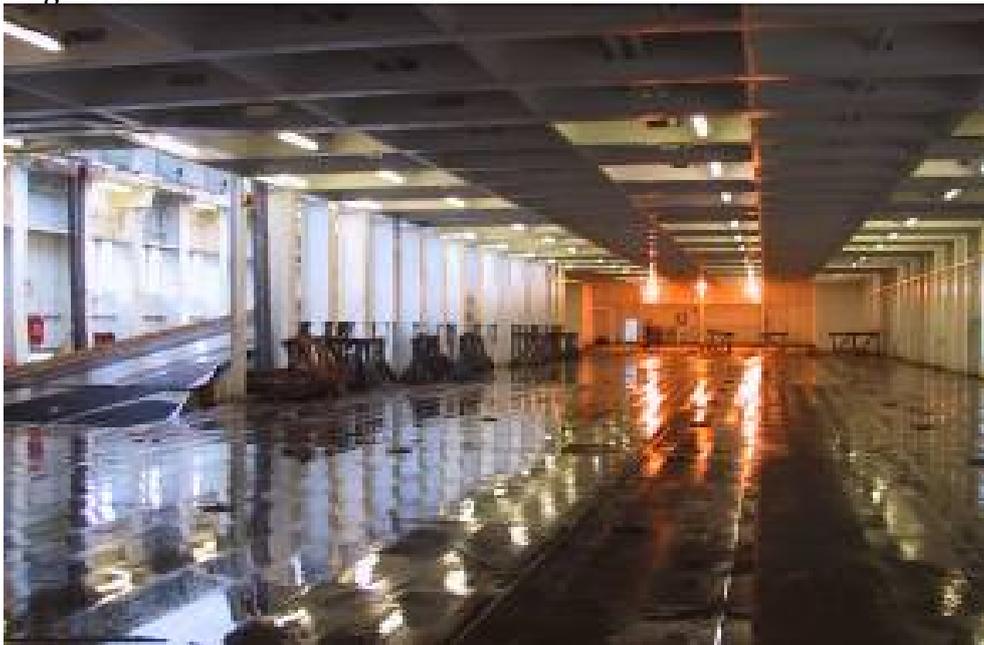
The wet weather during the loading probably lead to that an amount of water mixed with gravel and dirt arriving with the trailers, accumulated on the cargo decks.

Fig. 3 The above photo taken on board the sister ship M/V Finnforest in Helsingfors in December 2006 shows the collection of water on the Upper Deck following rain.

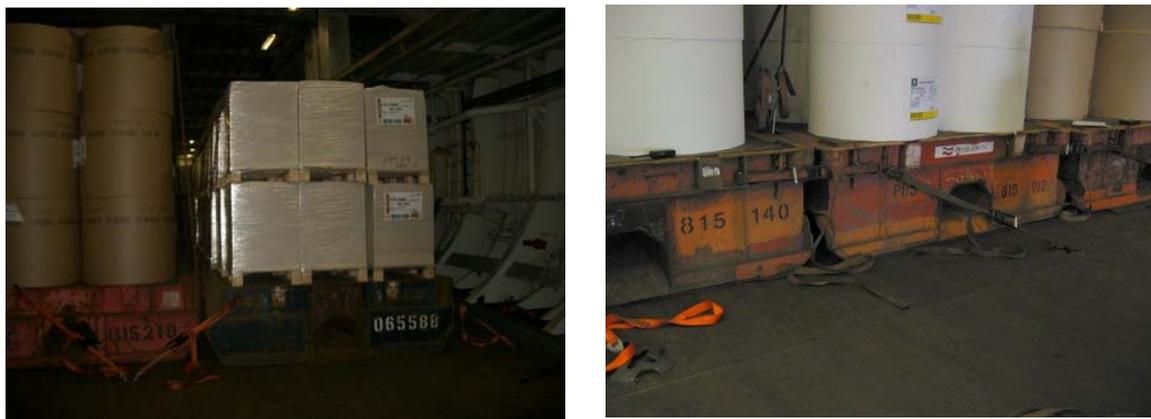
The left-hand photo in Fig. 6 shows that in some cases, the securing was only applied in the form as a half cross as shown in Fig. 7 and there was no horizontal lashing holding the roll-trailers together. There were other examples in which block-stowed units were only secured to the adjacent unit, the outside unit being secured to the ship's side with one lashing.

Fig. 6 The photo at the left shows roll-trailer 625 219 stowed on the Tank Top on board Finnforest and only secured with a half cross at the front of the unit. The Photo at the right shows roll-trailers on the Main Deck secured with a half cross plus one horizontal lashing.

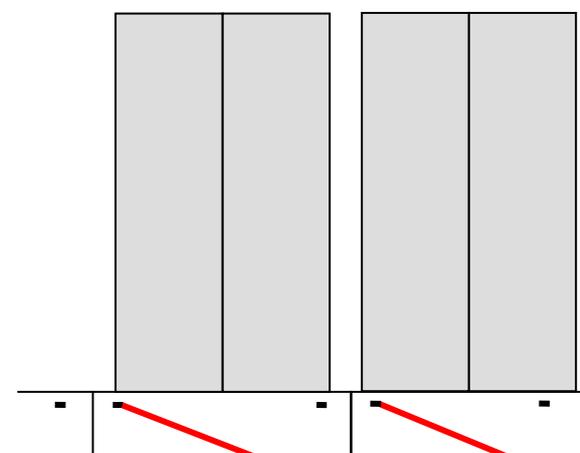
Fig. 7 Sketch showing how block-stowed roll-trailers in certain positions on board Finnforest in September 2007 were secured.

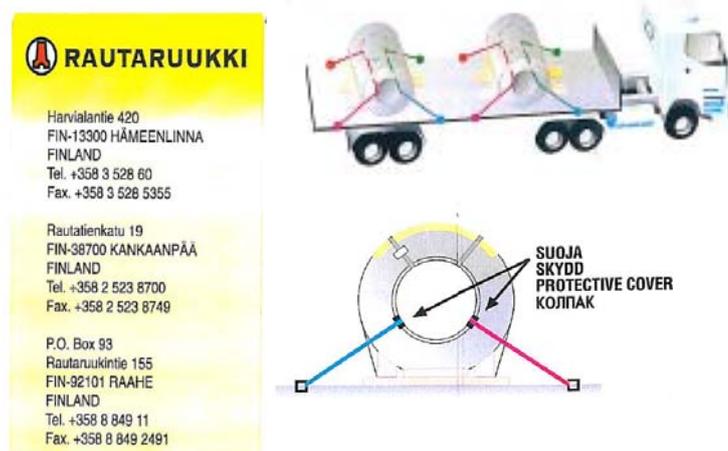
Fig. 11 Sketch showing the Rautaruukki securing instructions.

The Rautaruukki cargo-securing method is considered by SHK to be ineffective in preventing transverse movement and is radically different from recommendations for securing sheet steel coils in the European Best Practice Guidelines on Cargo Securing for Road Transport published by the EU Commission 2006 and Swedish guidelines on securing cargo published at the beginning of the 1990's. See the sketch below.

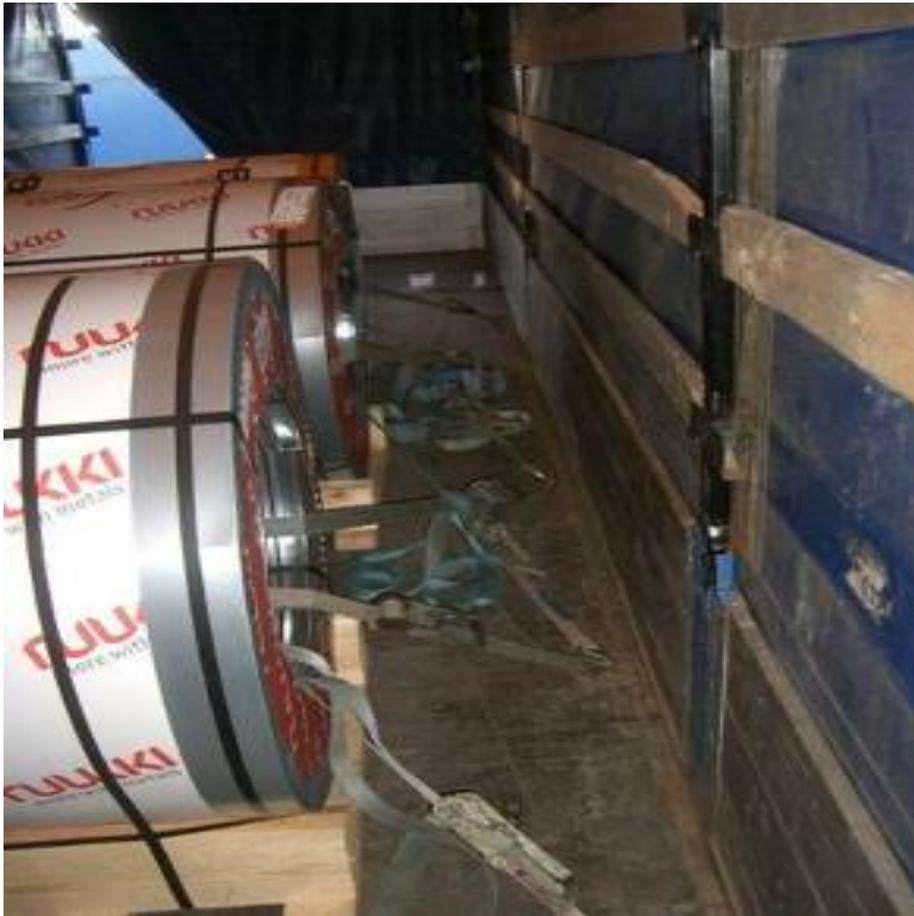
Fig 14 6-tonnes steel coils from Rautaruukki loaded on semi-trailer in Finnforest. These are secured in accordance with the company's instructions.

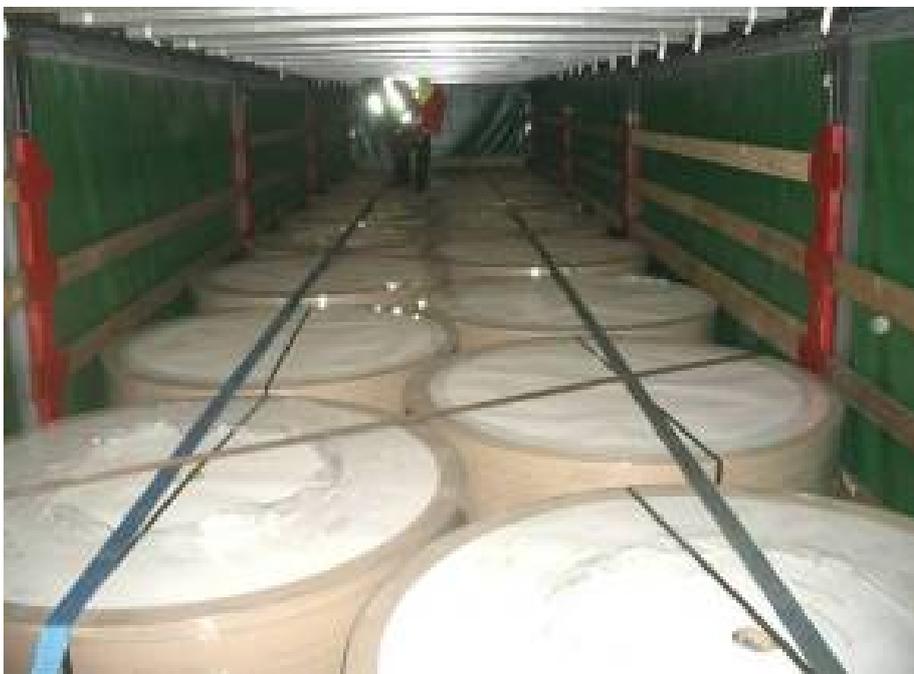
Paper reels with a diameter of 1.30 m were seen in another semi-trailer, standing on end. These were secured with very long, longitudinal lashings. A number of transverse lashings over the top had been applied but because there was no long retaining angle, many of the lashings had fallen off. Some of the web lashings were in very poor condition and some were tangled. (Fig. 15)

Fig. 15 Paper reels in semi-trailer on board Finnforest in September 2007.

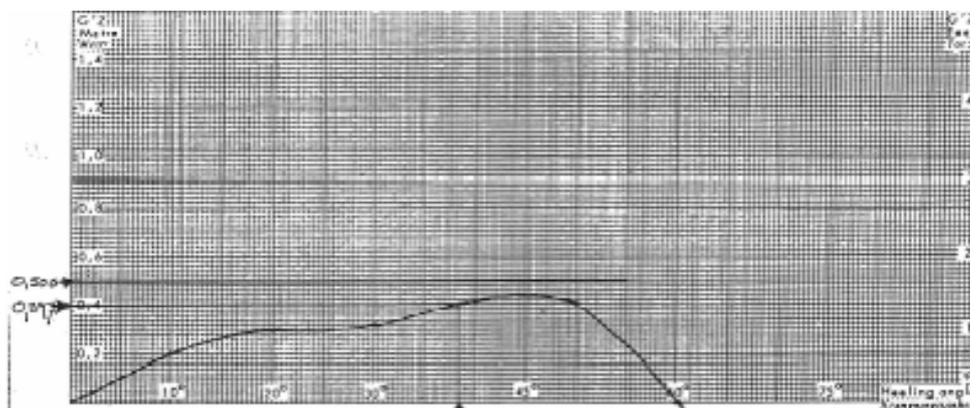
Fig. 18 The calculated righting and heeling lever at a total cargo shift. The larger heeling moment applies for the loading case with completely free-standing units.

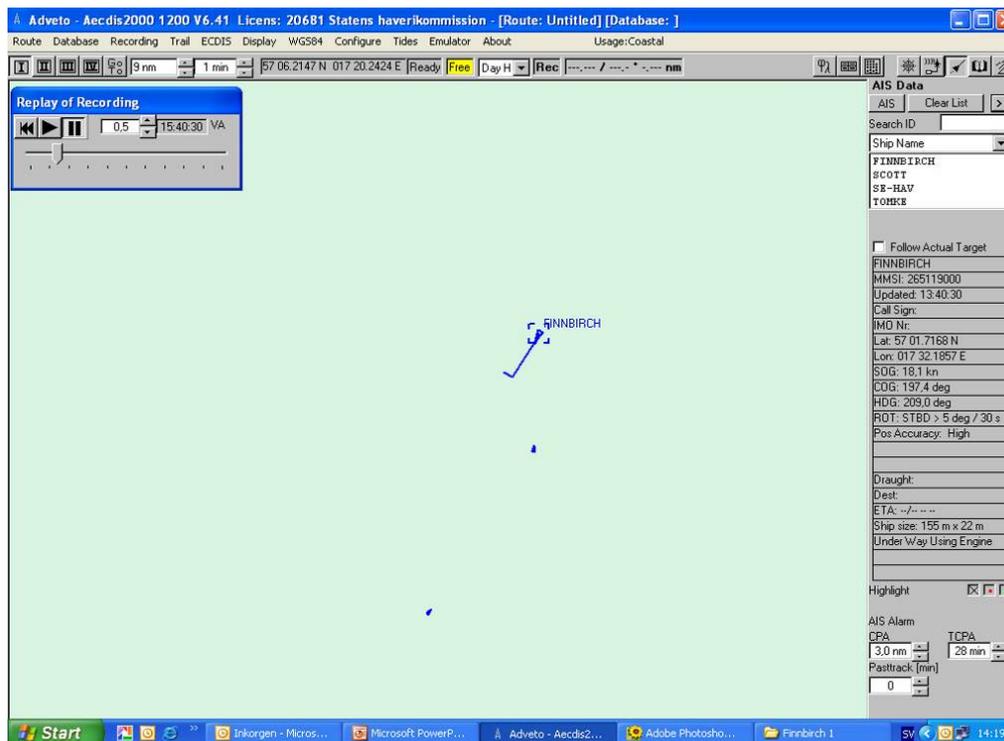
Fig. 28 Finnbirch at 1540 hours, at the time of the cargo shifting. The vector shows the beginning of the tendency to sheer to starboard. The speed remains unchanged. Marneborg is at a distance of approximately 2.3 M.

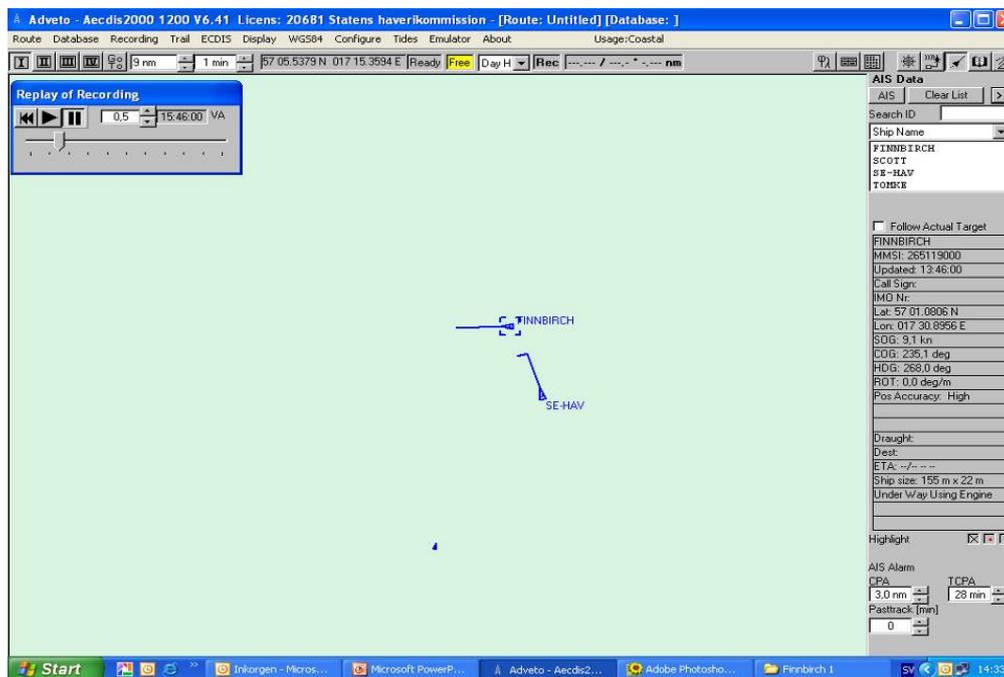
Fig. 29 Finnbirch at 1546 hours. The ship has changed course and the speed has dropped to 9.1 knots. The ship Marneborg (SE-HAV) has begun to alter course to head toward Finnbirch.

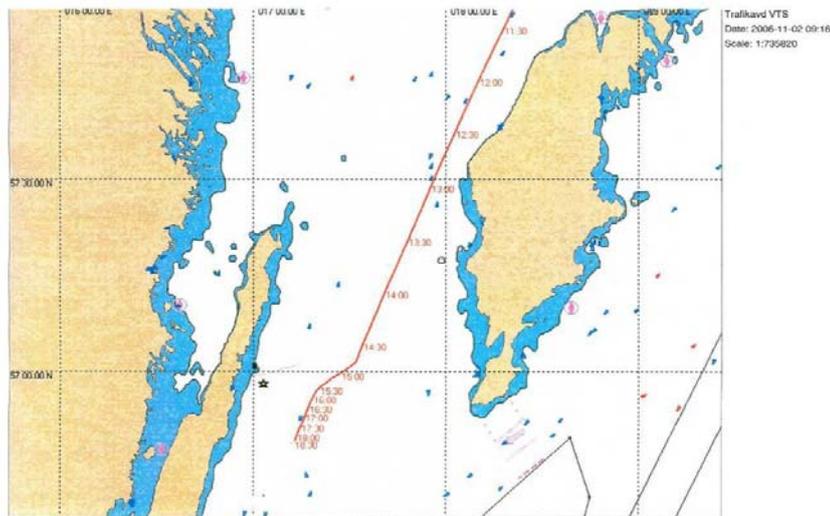
Fig. 30 The picture shows the track of the ship before and at the time of the shifting of the cargo. The first abrupt change of course between 1530 and 1600 hours (in the picture, between 1430 and 1500 hours GMT) indicates the location of the sudden heeling of the ship and the shifting of the cargo. The second and less abrupt change of course occurs when the engine has stopped after a further half hour. The last stage of the track shows how the ship drifted at approximately 2.5 knots to the position where the ship sunk at which the track ended.

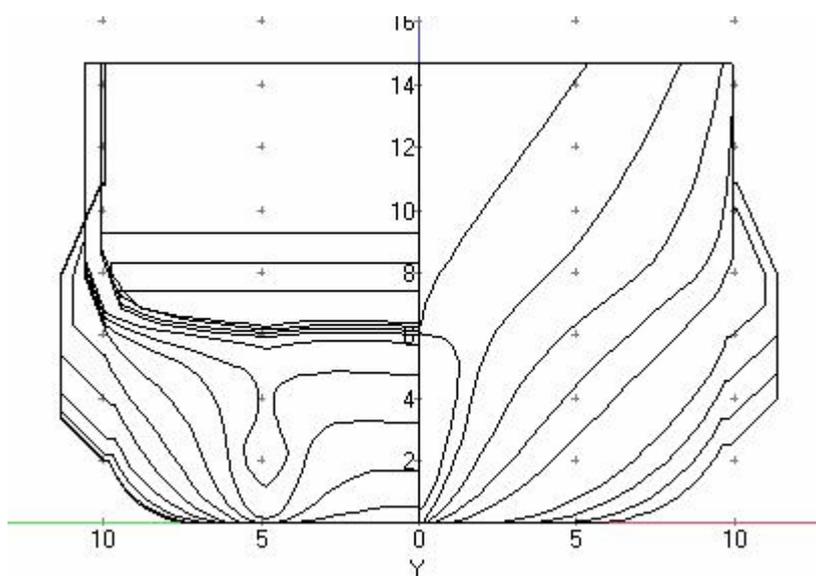
The addition of sponsons which increase the beam of the ship at the waterline gave the ship a different hull form (Fig. 32). With small heeling angles, the increased waterline beam gives the ship increased stability. With larger heeling angles, this positive effect is reduced as the water line rises over the sponsons on the one side and under on the other. This gives a GZ curve characterized by a dip at certain heeling angles, in this case, between approximately 20 and 40 degrees.

Fig. 32 Form of the ship's hull with sponsons.

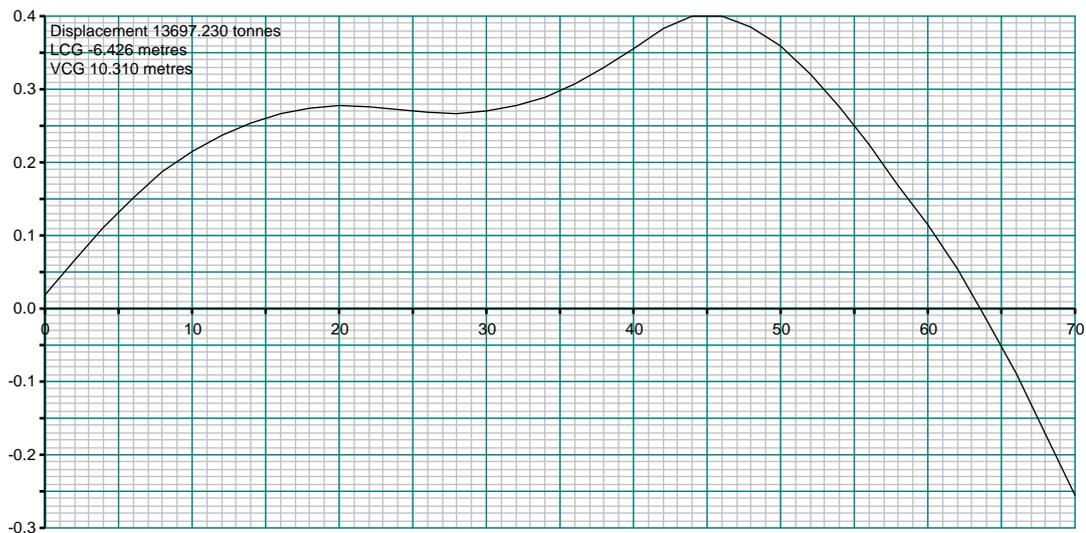
The figure below shows the calculated GZ curve at departure from Helsingfors with a shifting of approximately 13700 tonnes and a GM of approximately 1.36 m.

Figur 33 Calculated GZ-curve for Finnbirch at departure from Helsingfors.

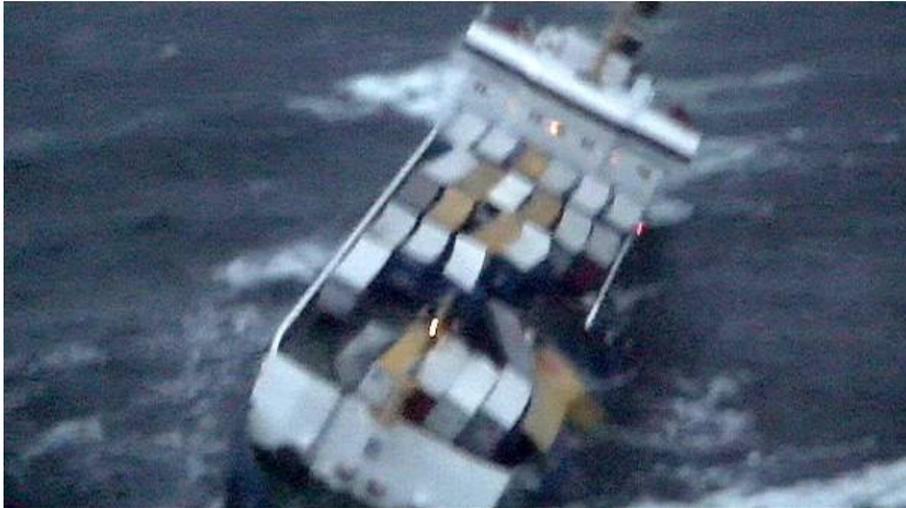
Fig. 38 Photograph of the Weather Deck after cargo shifting (Swedish Maritime Administration).

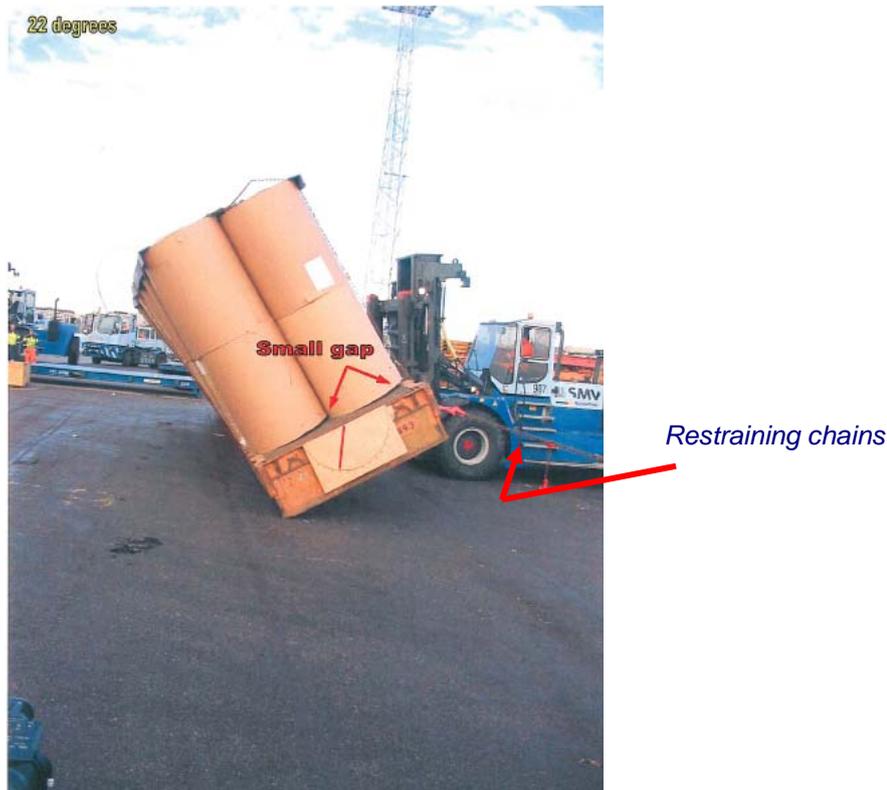
Fig. 43 Heeling tests showing that roll-trailers with high load are very likely to tip.

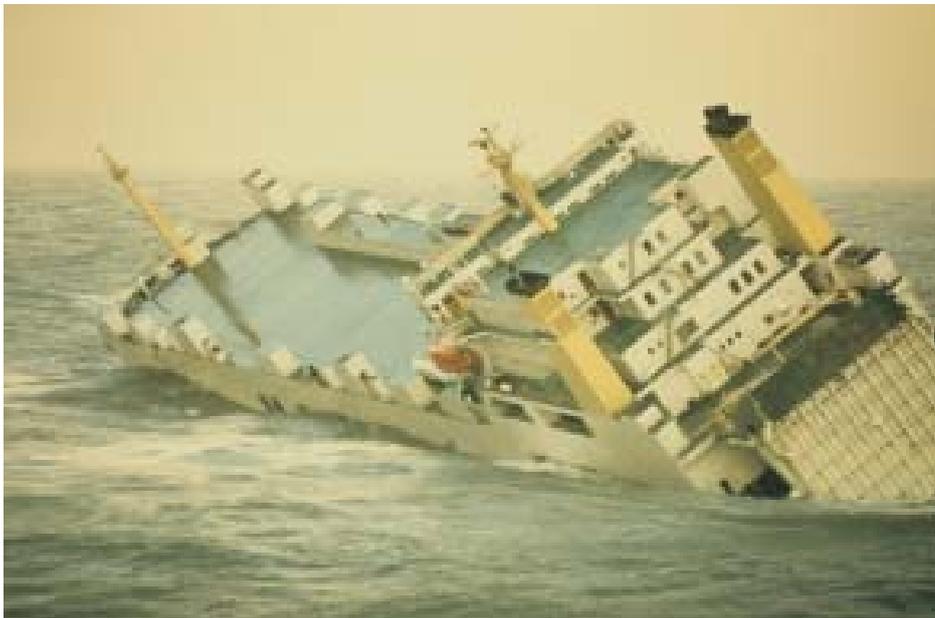
Fig. 53 Vinca Gorthon with large list following shifting of forest products cargo loaded on roll-trailers.

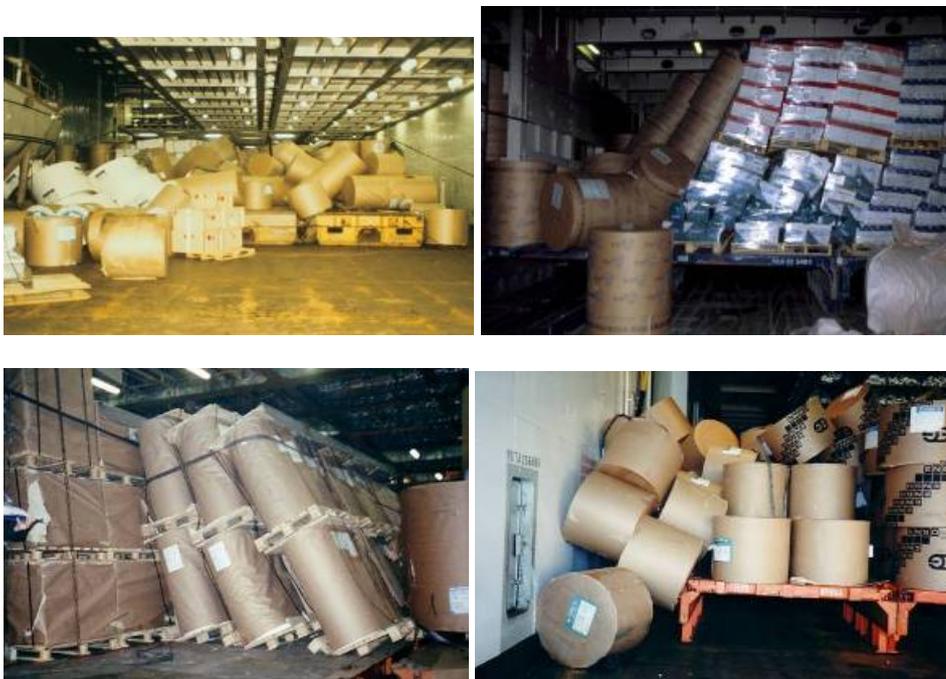
Fig. 54 Examples of shifted forest products cargo loaded on roll-trailers and cassettes.
