Aviation Accident at Selänpää Aerodrome on July 16, 2023

L2023-02

SYNOPSIS

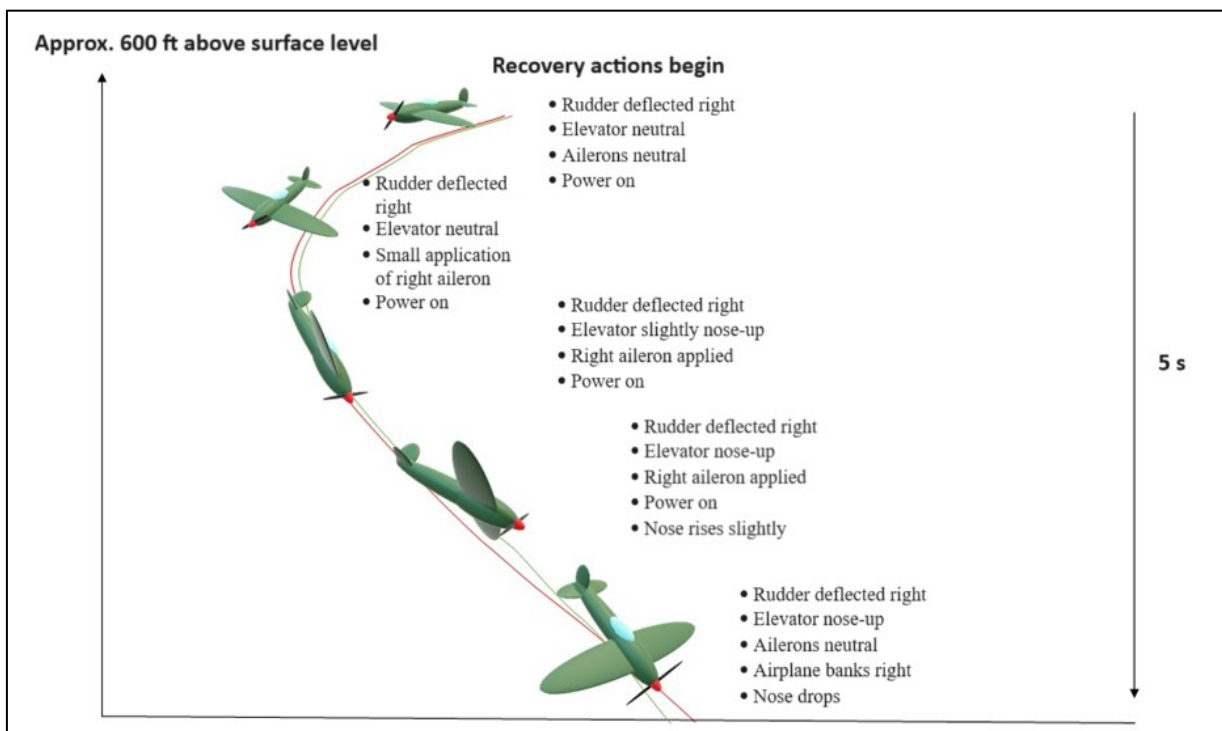
Figure 2. Sequence of attempted spin recovery. (Figure: SIAF)

Approximately 40 s prior to ground impact the pilot initiated a climbing 270° turn. Halfway through the turn the airplane began to descend, and in the final phase of the turn the altitude was approximately 300 ft above aerodrome level. On completion of the turn the pilot pulled up into a pure vertical climb. By this time the elevator had remained in the nose-up position for 13 s, which had bled the airplane's kinetic energy. During the climb, the pilot performed two 360° aileron rolls⁶ to the right. These rolls were not "clean" in that the airplane's nose oscillated in a circular motion about the longitudinal axis. In the end of the second roll, airspeed decayed to near zero. The pilot then put the airplane into a left-hand flat spin at an altitude of 1,200 to 1,300 ft. The airplane made approximately four and a half rotations about

the vertical axis⁷ while the nose continued to pitch⁸ up and down. It is possible that nose position alternated between above and significantly below the level of the horizon. The duration of each full 360° rotation was about 2.5 to 3 s. The pilot began recovery after approximately four rotations at about 600 ft above surface level by applying the rudder in the opposite direction of rotation, i.e., to the right, and by neutralizing the elevator and ailerons. A moment later, he applied right aileron while the elevator remained in neutral and the rudder remained deflected to the right. These actions were initiated 5 s prior to ground impact. The airplane continued to rotate about the vertical axis approximately 120° to 150° after the initiation of recovery. Once the rotation stopped, it continued to roll approximately 10° to 20° to the left into the direction of the rotation, and simultaneously the nose dropped. Just before ground impact, the airplane banked in the opposite direction, i.e., to the right. It struck the ground in almost vertical nose-down attitude right wing first, with the elevator in fully nose-up position and the rudder deflected slightly to the right. The pilot reduced power to idle about 1 s before impact.

The maneuver that preceded the entry into the flat spin was commenced at an excessively low and therefore unsafe height. Recovery was initiated too low, which resulted in the ground
