Serious Incident on Norwegian Flight on August 11, 2024

L2024-01

SYNOPSIS

Investigation designator: L2024-01
Investigation report 5/2025
ISBN: 978-951-836-682-2 (PDF)
ISSN: 2341-5991

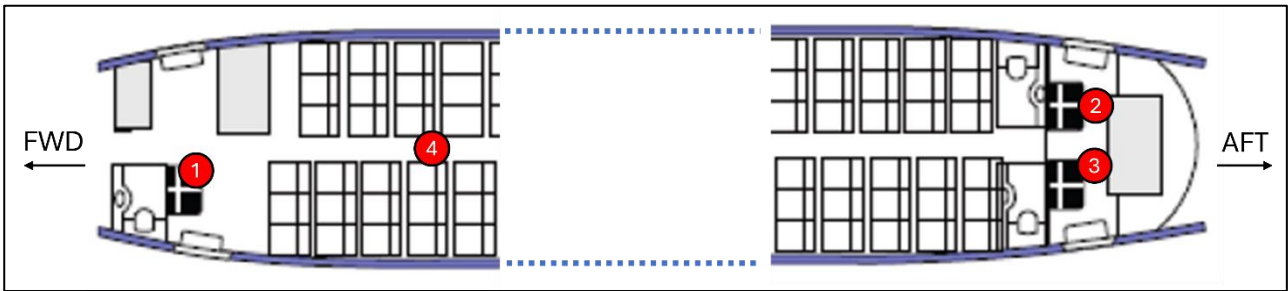
Figure 1. Cabin layout of occurrence airplane. Red circles indicate cabin crew positions at turbulence onset: 1 = SCCM, 2 = CCM2, 3 = CCM3, 4 = CCM4. (Source: Norwegian, annotations: SIAF)

At the onset of the event, CCM2 was in the aft galley switching off payment devices, and CCM3 was about to move into the cabin with a waste trolley. The first indication of the encounter was a series of bumps, which soon increased in intensity. CCM2 and CCM3 elected to stow the trolley, which took longer than anticipated due to airplane motion. They tried to take their seats for self-preservation but were unsuccessful before turbulence intensified.

They repeatedly became weightless. During the first event, the legs of CCM3 were trapped in the airplane structure, while CCM2 impacted the galley ceiling. Then both crew members slammed on the galley floor. Significant vertical motions caused by the unanticipated intensification of turbulence lifted CCM2 and CCM3 up several times until they ended up on the floor and eventually managed to regain their seats and strap in.

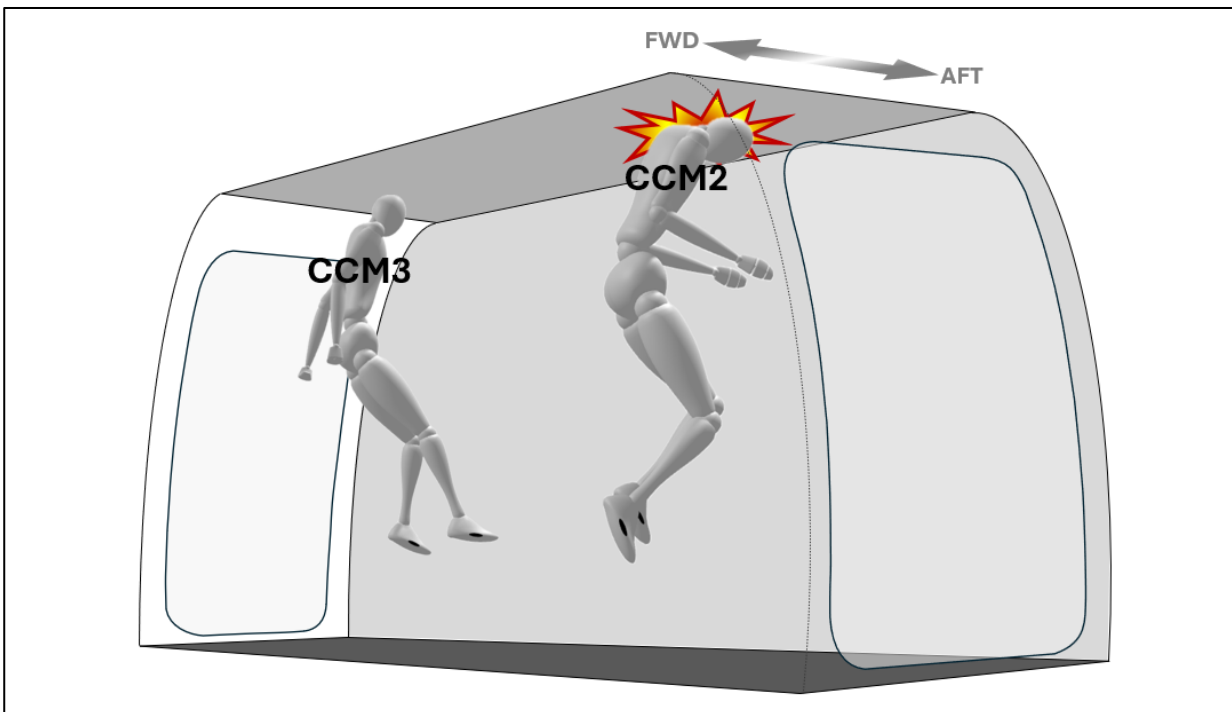
Figure 2. Rendition of aft galley cabin crew members in weightless condition during turbulence encounter. (Figure: SIAF)

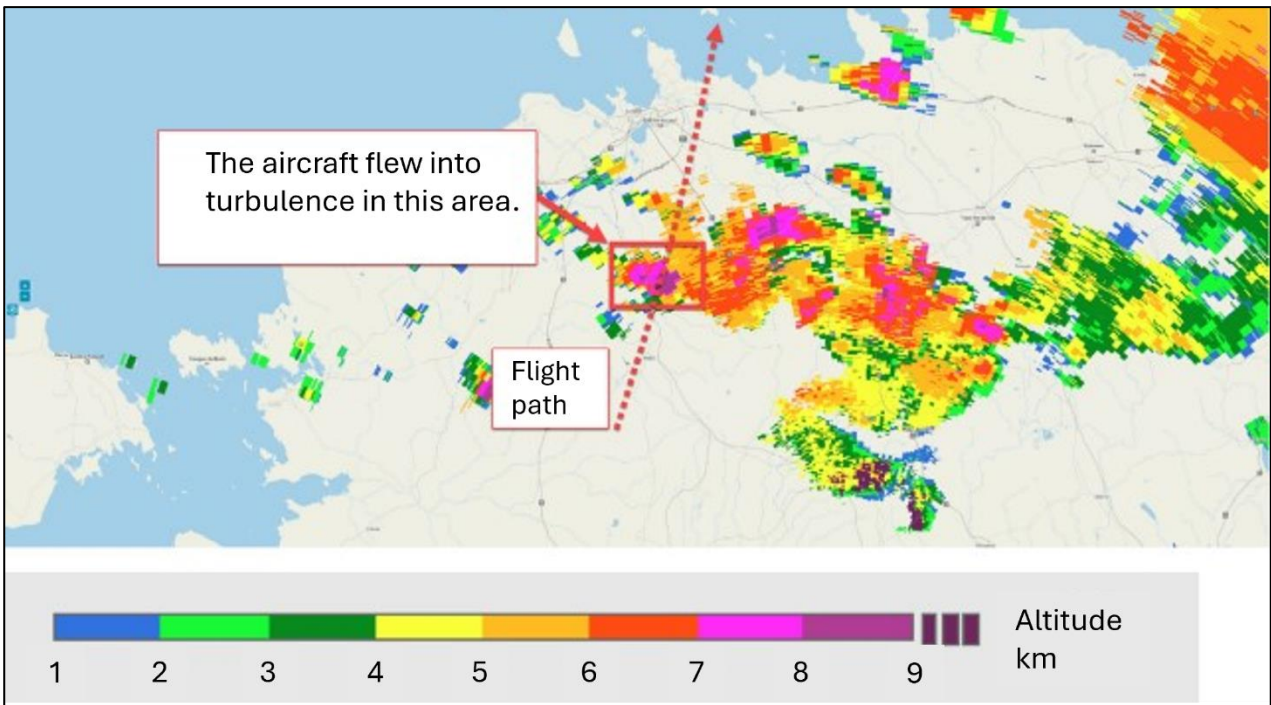
Figure 5. Airplane's route across thunderstorm area. (Figure: Norwegian, annotations SIAF)

developing and intensifying along the airplane's track. Its most intense part was very close to the airplane's track between 02.45 and 02.50 h UTC. Lightning was observed within the cloud.

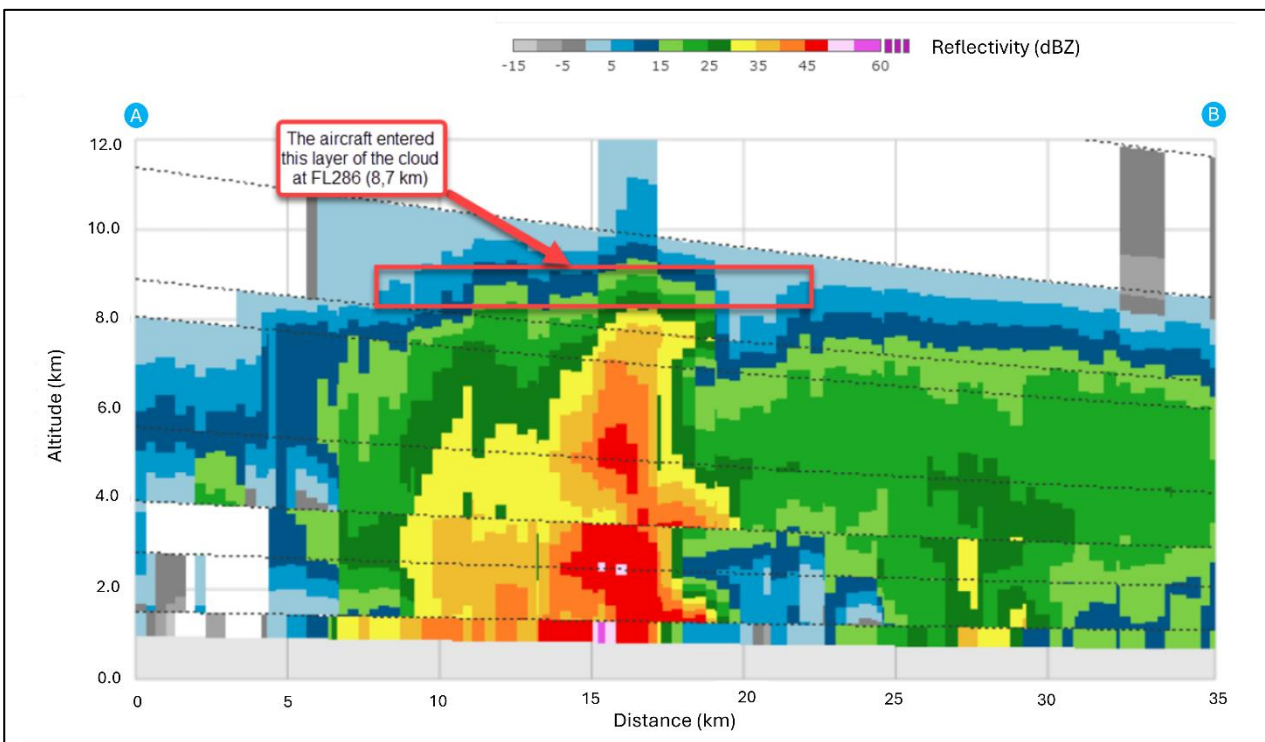
Figure 6. Cross-section of thunderstorm on airplane's estimated track. (Figure: Norwegian, annotations SIAF)

Single thunderstorm cells were moving toward the south-southeast at approximately 24 kt¹⁶ (approximately 12 m/s). Lightning was noted within these clouds. Although it was not particularly heavy, lightning is usually an indication of strong vertical air currents inside the cloud, and these create severe turbulence both within and in the vicinity of the cloud.

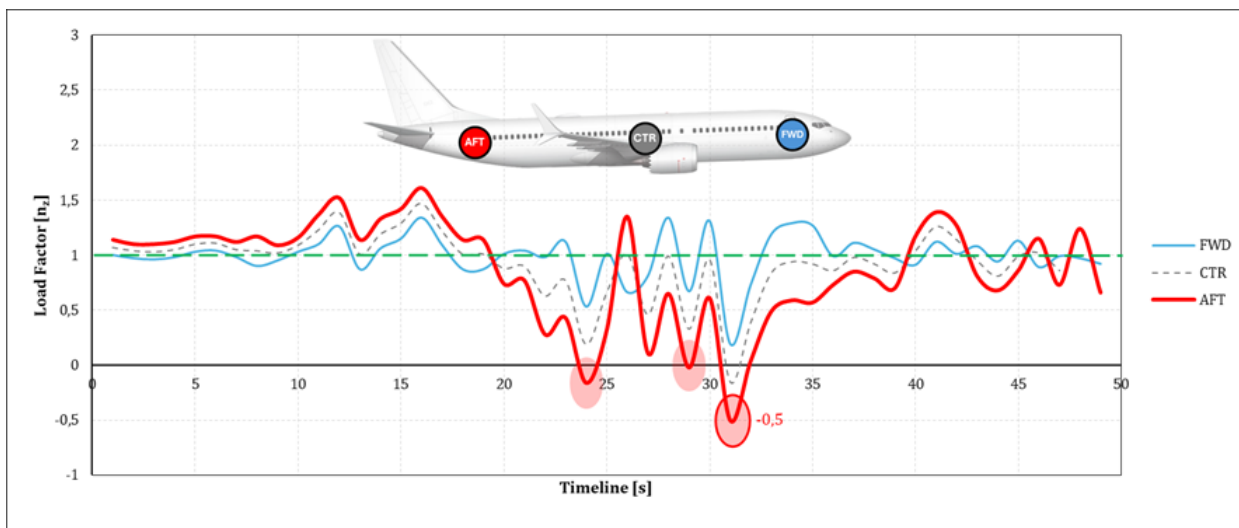
Figure 10. Load factor variations in airplane during turbulence encounter. (Figure: SIAF)

Load factors (G-forces) shown in the figure represent forces to which the crew and passengers were subjected in the three sections of the airplane. The gray dashed line describes load factor around the airplane's center of gravity, while the blue and red lines indicate load factor at the forward and aft galley, respectively. The figure shows that attitude excursions in the aft section exceeded those experienced in the center and forward sections.

Turbulence causes an extremely high risk of injury and may in the worst case be fatal. Unrestrained passengers may be injured, and loose items may cause injuries. The airplane was subjected to three negative load factor spikes. During the most severe of them, CCM2 impacted galley ceiling with a force that equals the dropping of a 10 kg weight from approximately 1.2 m height under static conditions.

In addition to atmospheric conditions, the behavior of an airplane is affected by the airplane type, weight and center of gravity, and by altitude and airspeed. Still, in general terms, the response of an airplane to disturbances in situations comparable to those experienced on board the occurrence airplane is more pronounced in the rear than in the front.

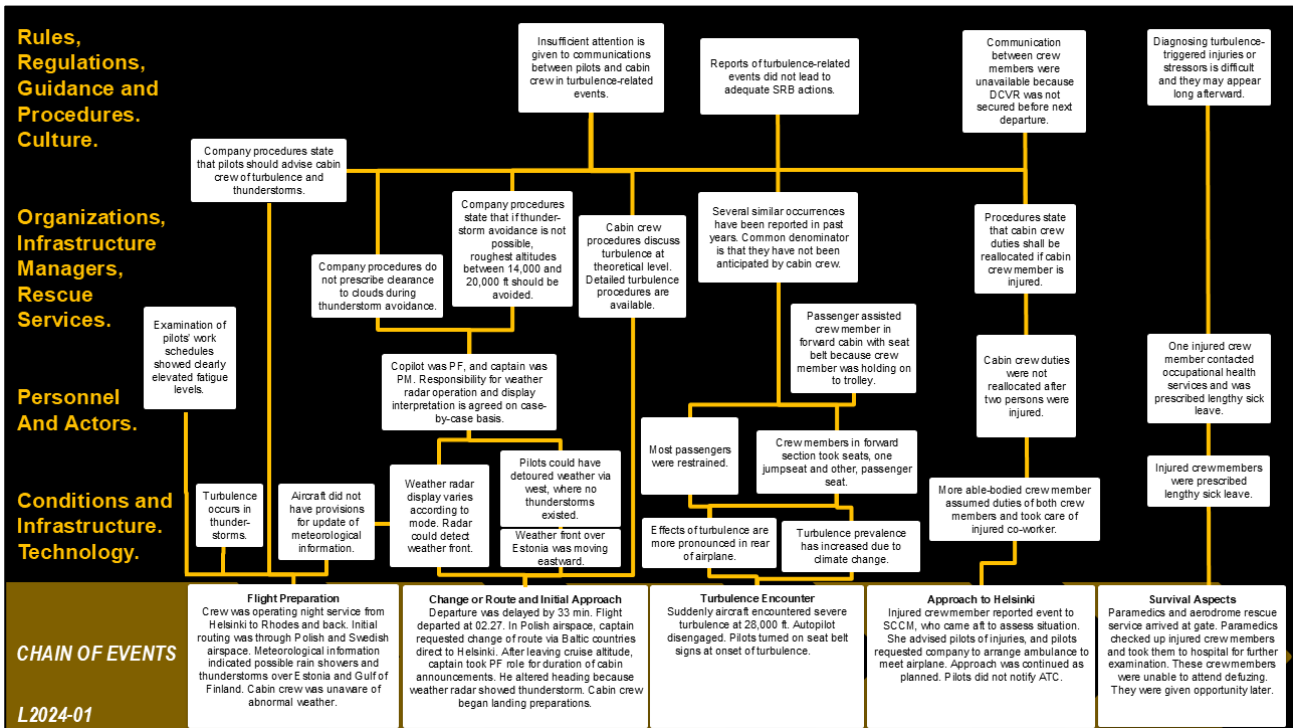
A SIAF-developed format of the AcciMap approach³⁰ was used to support the analysis of the occurrence. The following text is arranged in accordance with an AcciMap diagram created during the investigation. The occurrence is depicted as a chain of events along the bottom of the diagram. Contributing factors at various levels can be examined by moving up and down the diagram.

Figure 13. AcciMap diagram, investigation L2024-01. (Figure: SIAF)
