## Hostel fire leading to three fatalities in Äkäslompolo, Kolari on 13 February 2024

Y2024-01

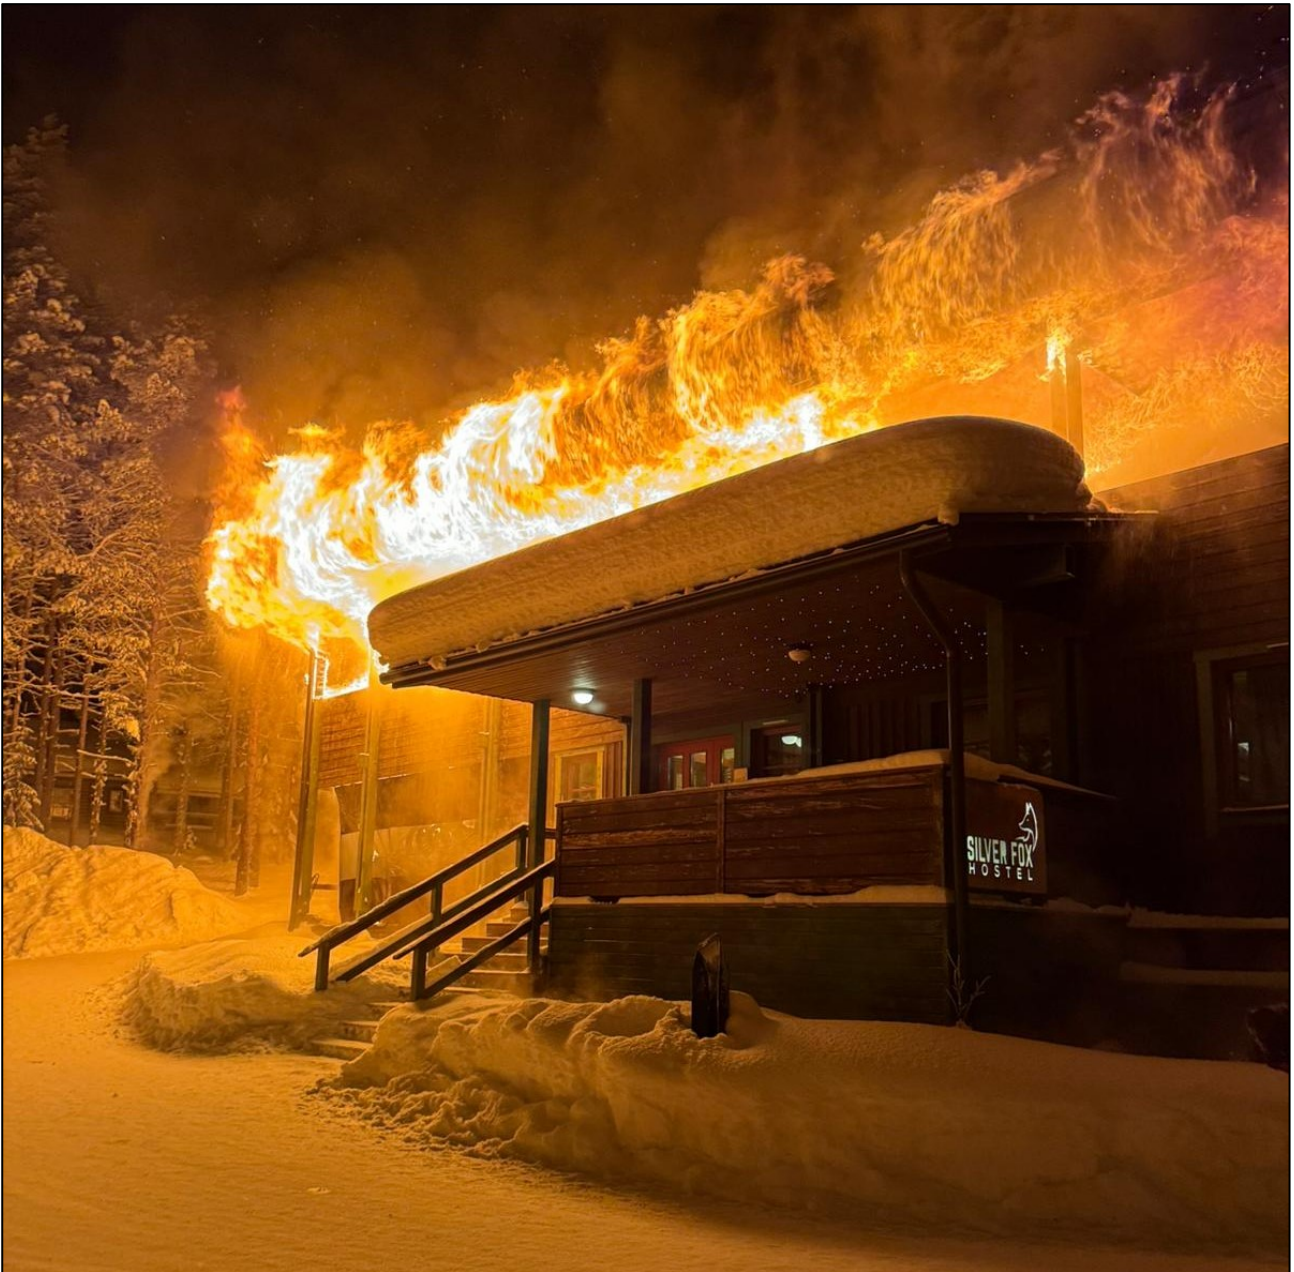
The blaze spread rapidly from the seat of the fire along the outer surfaces and ventilation gaps of the building to the balcony access corridor and roof structures. The only escape route from three first-floor rooms was through the balcony access corridor and external staircase to the ground level. The guests staying in one of these rooms crossed the balcony access corridor while it was already on fire and jumped down from a porch roof. Three people in the other two rooms died as the fire prevented their escape.

**Figure 2.** One of the earliest photographs of the fire. The fire spread quickly to the first floor balcony access corridor. At this stage, some of the persons who escaped were still inside the building. (Photo: private person)

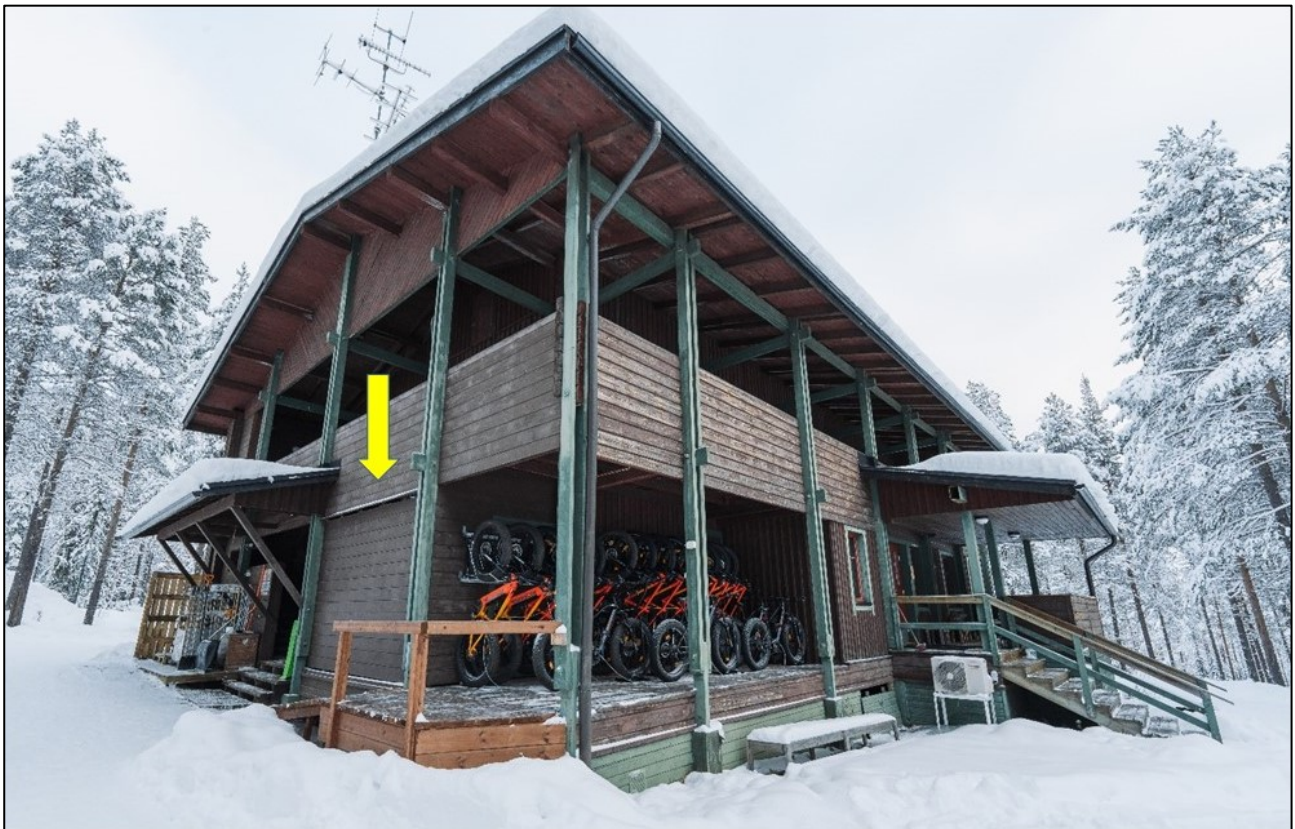
The storage area where, based on the fire investigation, the fire started was built at the northwest end of the building on the deck attached to the ground floor in 2002. The external walls of the storage area were enclosed with boards. The boards of the deck and the balcony above it served as its floor and ceiling.

**Figure 3.** Hostel building from the west. The arrow points to the unheated outdoor storage area. The stairs leading to the balcony access corridor are on the left. (Photo: private person)

The ashes from the campfire ignited in the outdoor storage area on the ground floor. The conditions for the spread of the fire were good, as the ash container was made from a combustible material and the structure of the storage area enabled the unobstructed spread of the fire along the building's outer cladding to the roof structures and the balcony access corridor. The fire was only detected when it had already spread widely across the external surfaces of the building.

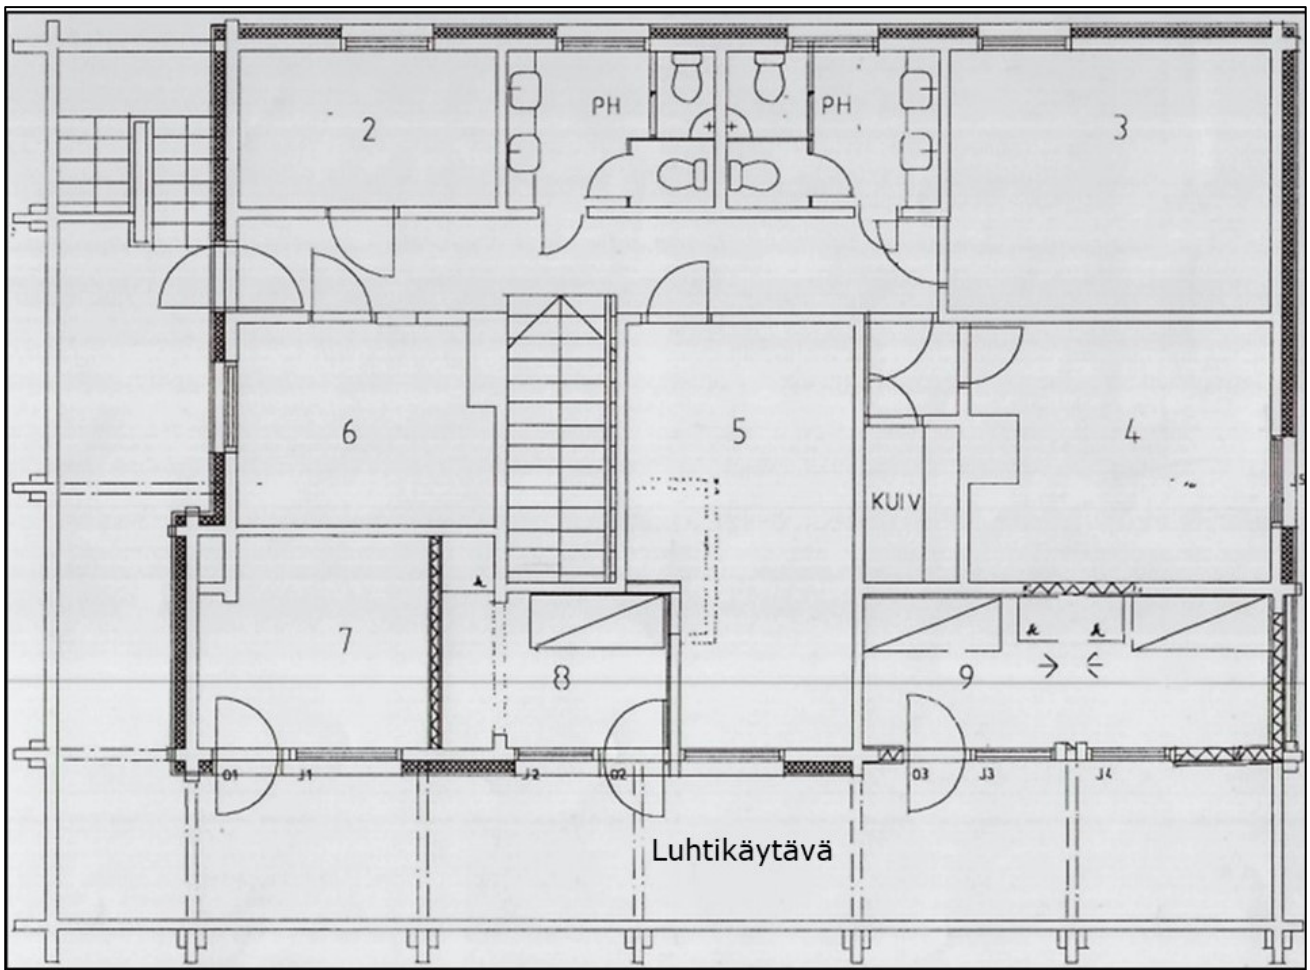
**Figure 5.** First floor of the main building. The guests who lost their lives were staying in rooms 7 and 8. (Image: Kolari building control services, balcony access corridor ('Luhtikäytävä') marked by the Safety Investigation Authority)

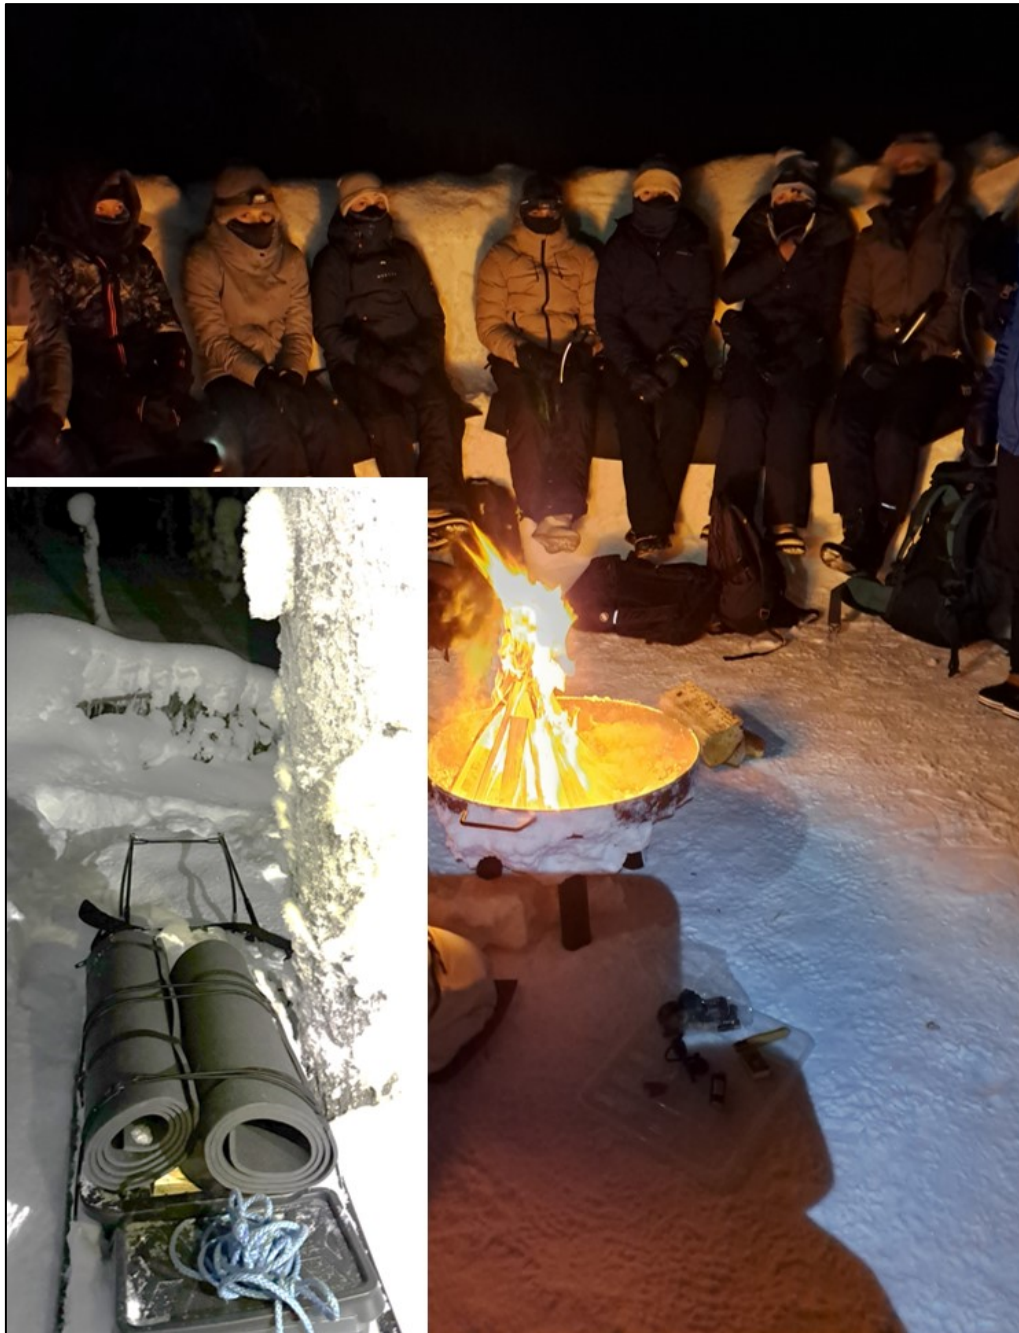
**Figure 6.** At the campfire site used during the northern lights excursions, the fire was lit in a firepit, and the supplies were transported to the site in a sled. (Photos: private person)

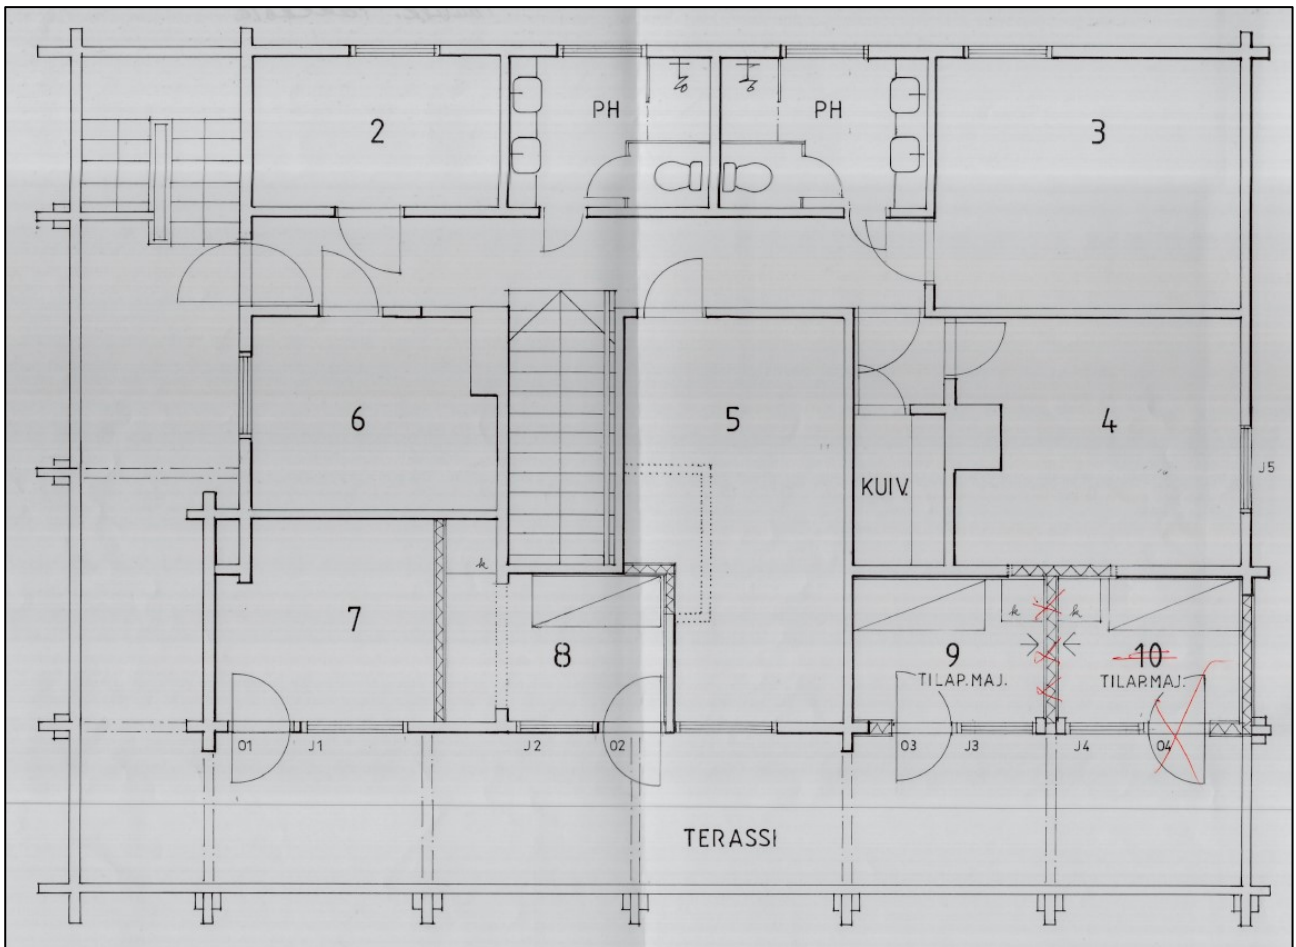
**Figure 8.** First floor in the drawings of the building permit issued in 1987. The rooms on the balcony side only had a single exit route into the balcony access corridor. Rooms 9 and 10 were combined into one. (Image: Kolari building control services)

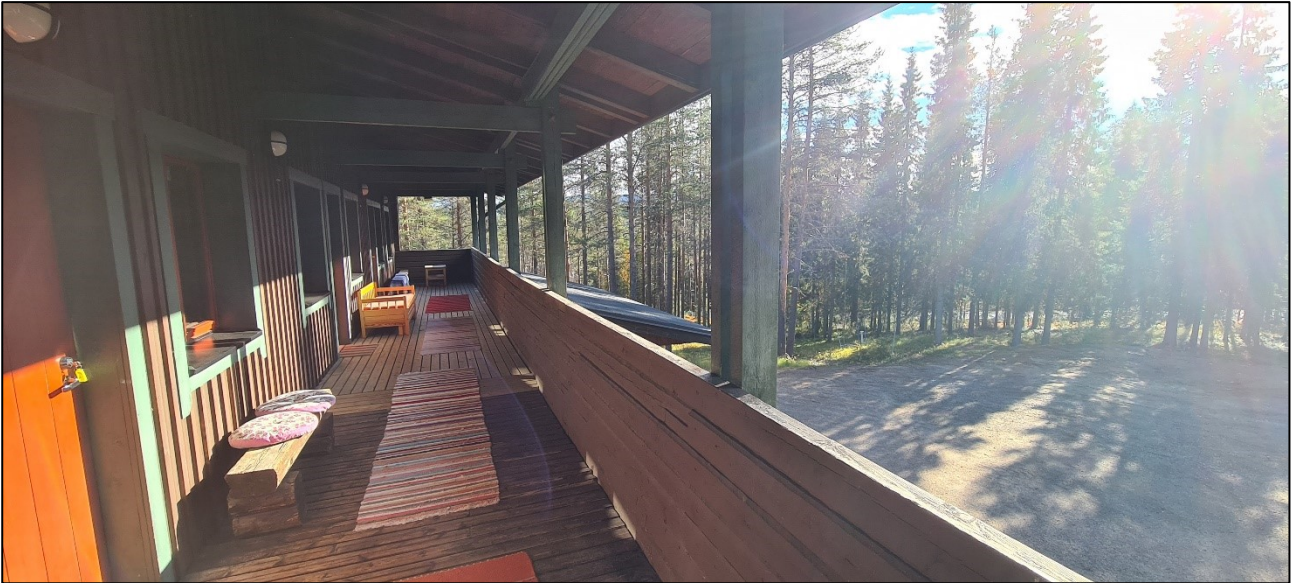
**Figure 9.** Doors in the first floor the corridor with balcony access looking to the southeast. (Photo: private person)
