LIITTEET

RAPORTTI R2604001

SELVITYS M/S FINNFELLOWN LIIKETILASTA

ENNEN POHJAKOSKETUSTA 02.04.2000

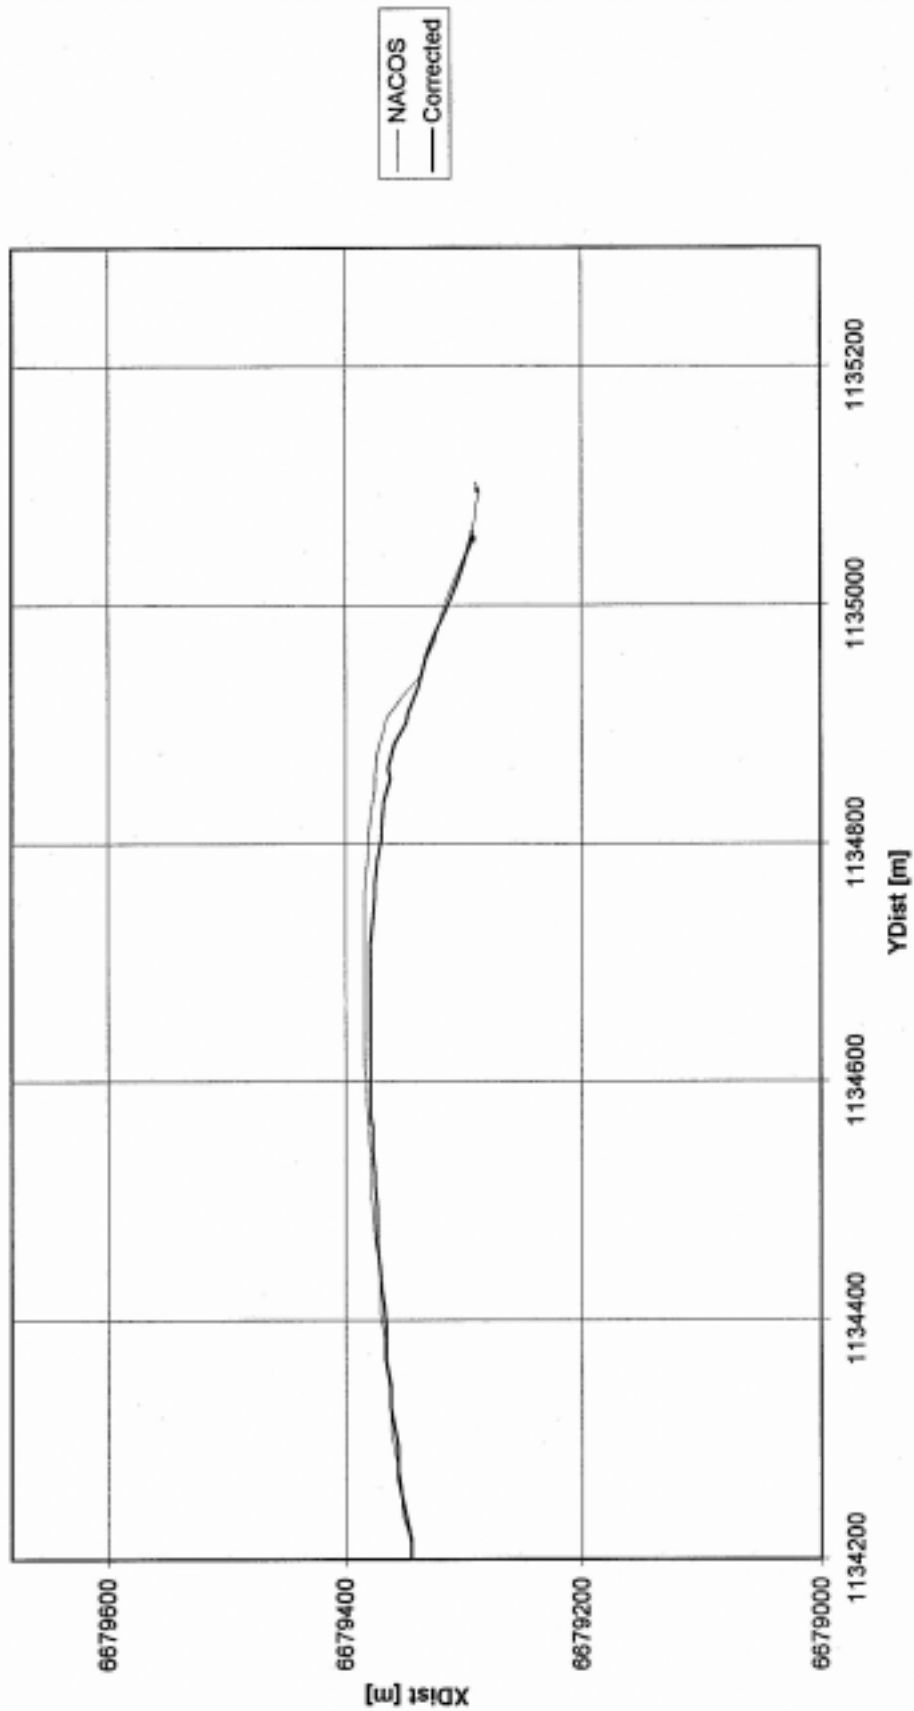
Position

"ANS Blackbox"-ohjelman tallettamien tietojen avulla on laskettu aluksen keskipisteen liikerata (sivu 4) ja sen avulla edelleen keskipisteen suunta sekä nopeus pohjan suhteen (sivut 5 ja 6).

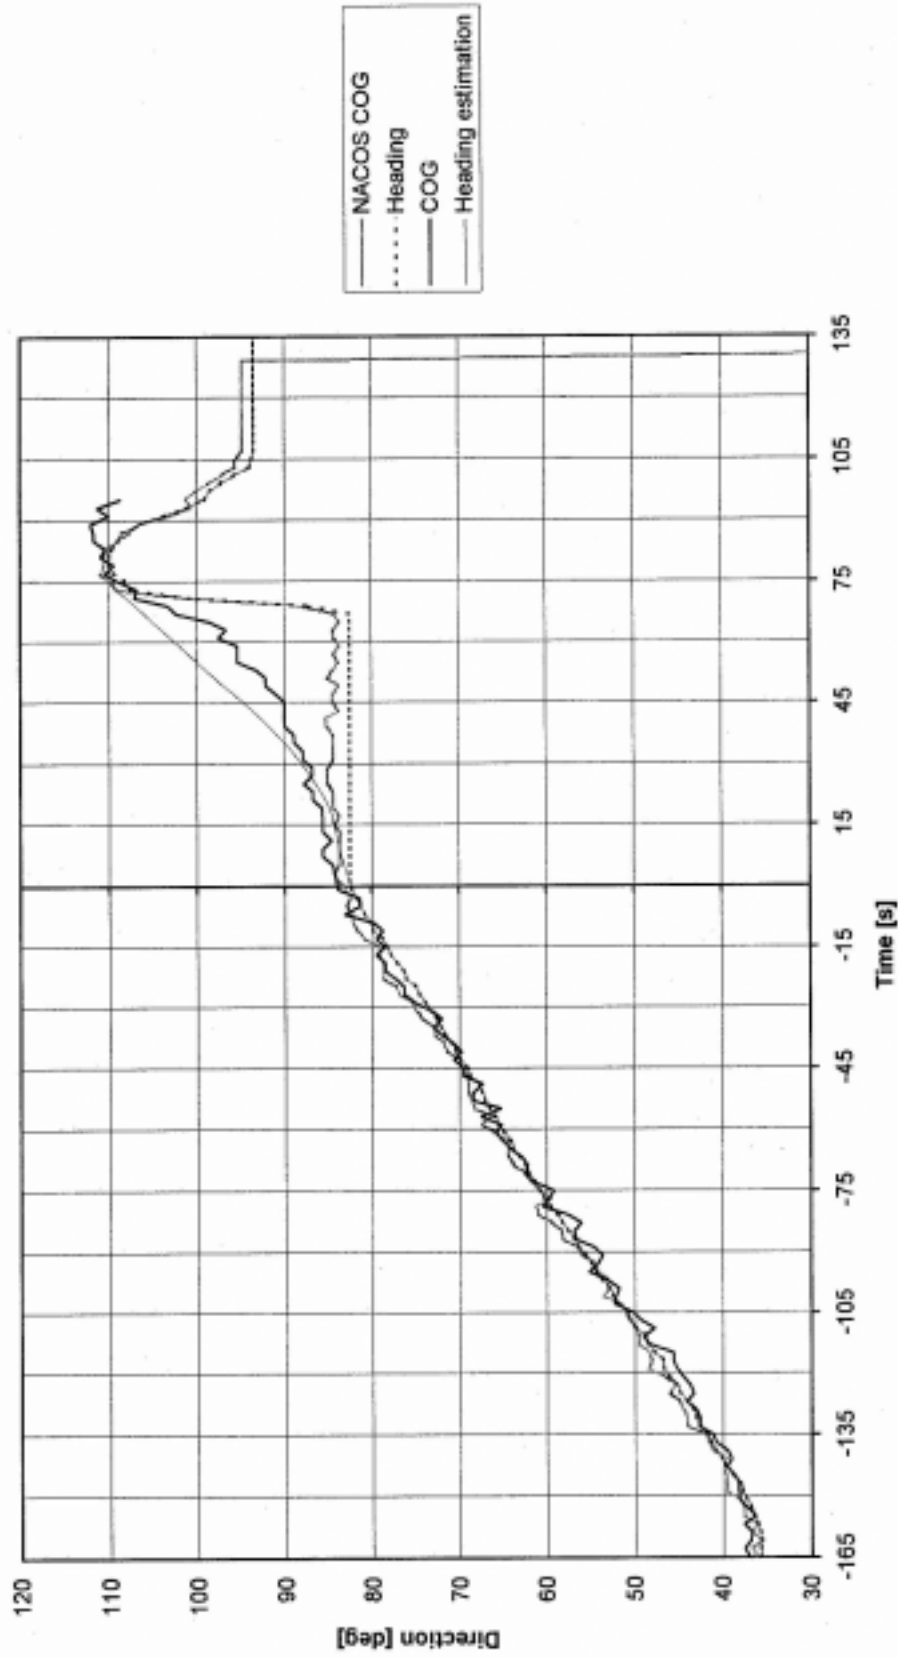
Heading and COG

Usean simuloinnin pohjalta arvioitu aluksen todennäköinen keulan suunta kompassivian ajalta on esitetty sivulla 5.

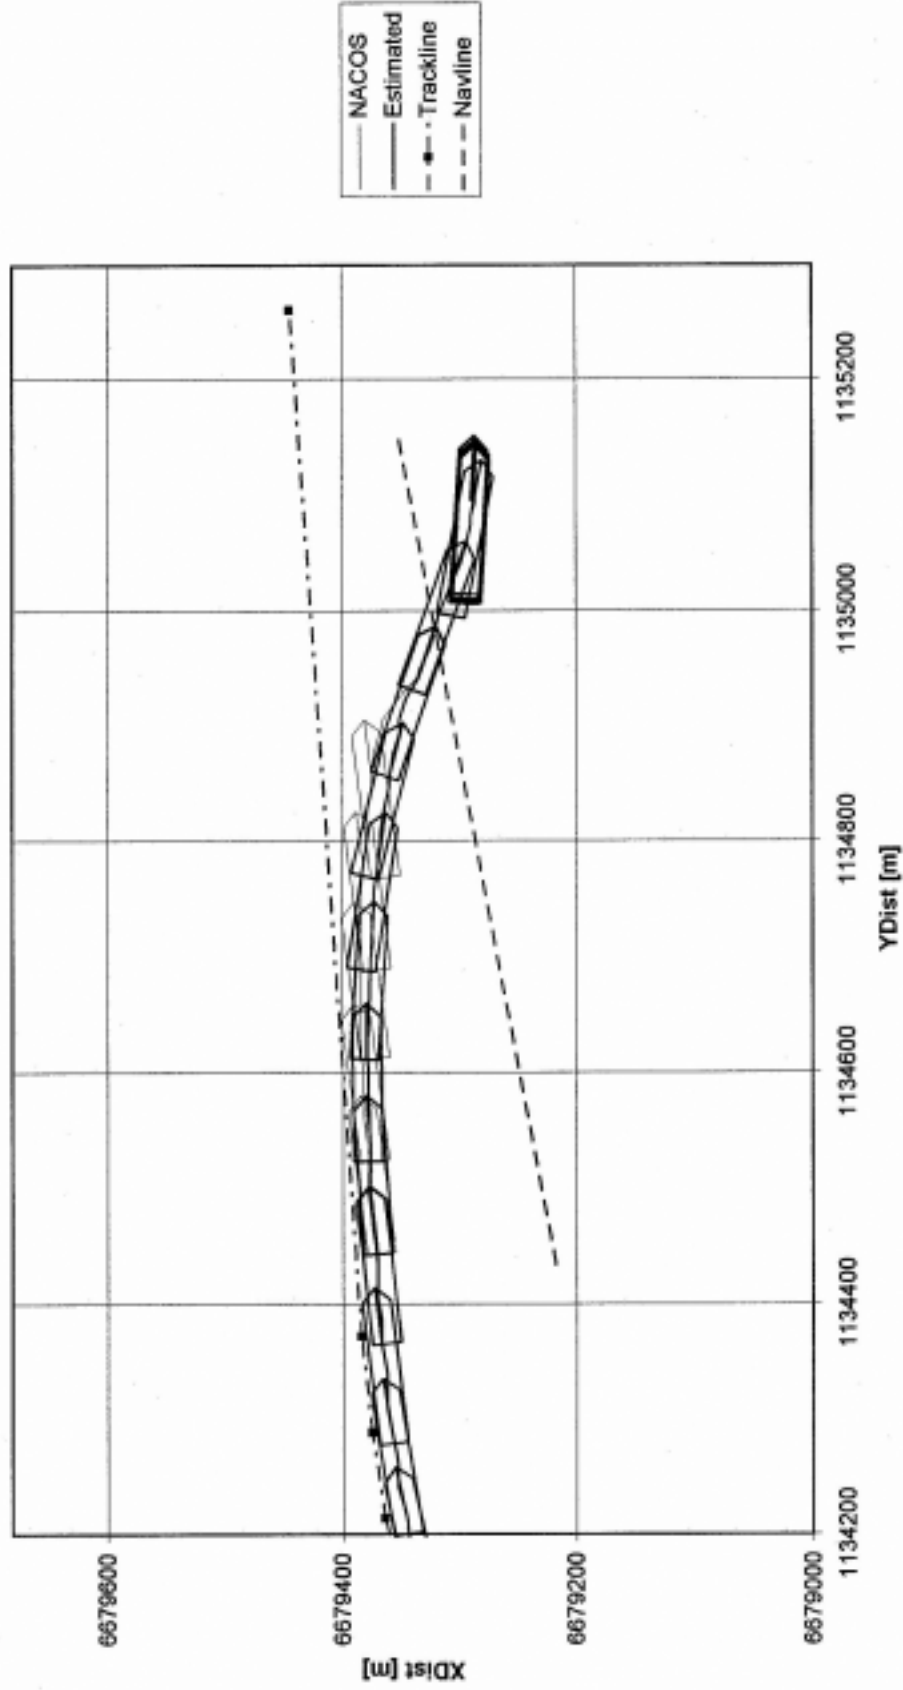
Track

Korjattu liikerata on esitetty sivulla 7 yhdessä "ANS Blackbox"-ohjelman tallettaman liikeradan kanssa. Tämän lisäksi lasketuista tiedoista on luotu SimBox-nauhoitustietokanta. Sen avulla onnettomuustilanteen uudelleenarviointi simulaattorissa on mahdollinen.

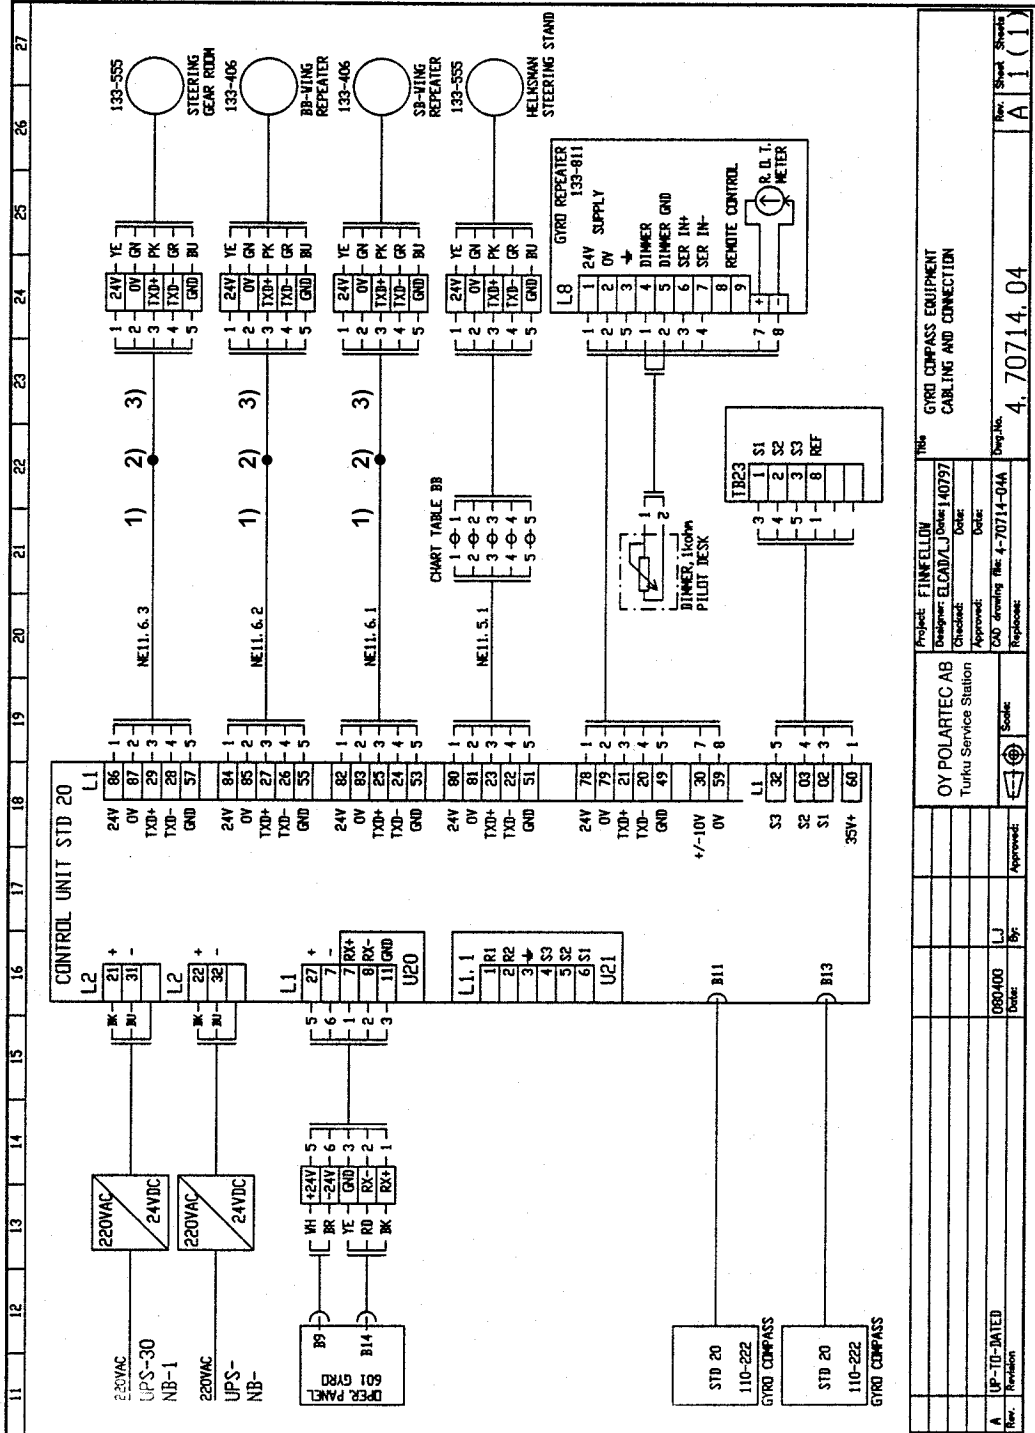
- 1) Häiriösuojattu kaapeli
 - 2) Liitos
 - 3) Häiriösuojaamaton kaapeli
-
- 1) Cable with disturbance protection
 - 2) Joint
 - 3) Cable without disturbance protection
