Investigation report

B 3/2000 M

M/T CRYSTAL RUBINO, environmental accident during loading, Port of Hamina, July 20, 2000

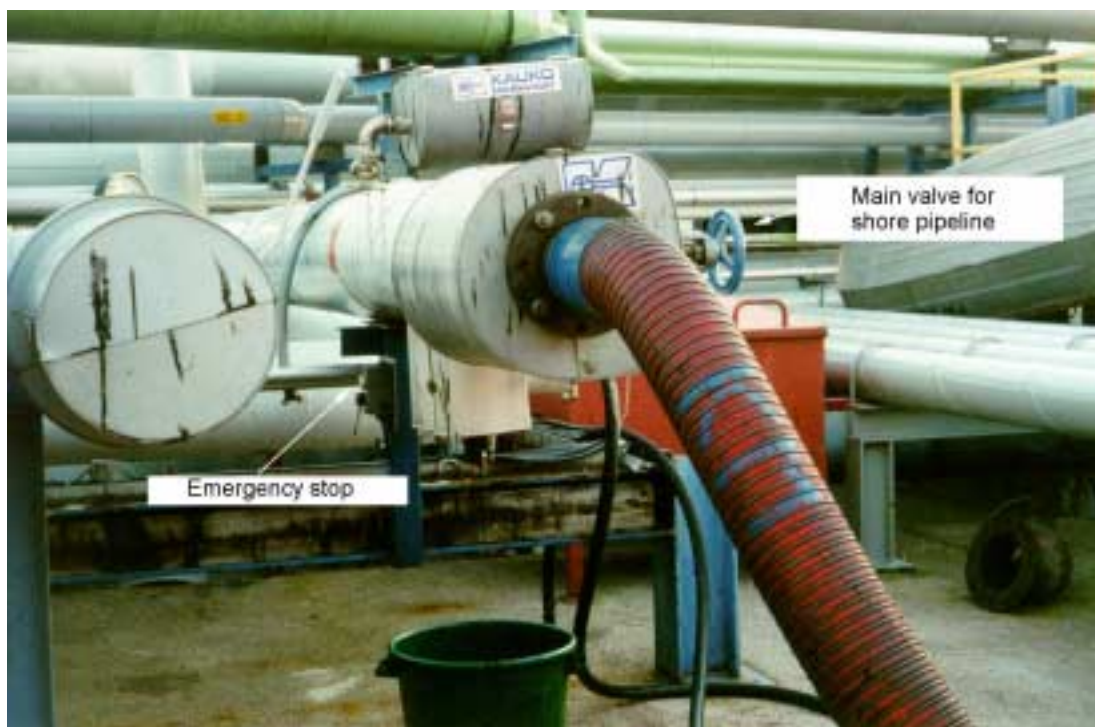
Figure 2 The loading hose, attachment on the pier, main valve and emergency stop button. Note incomplete attachment of the flange.

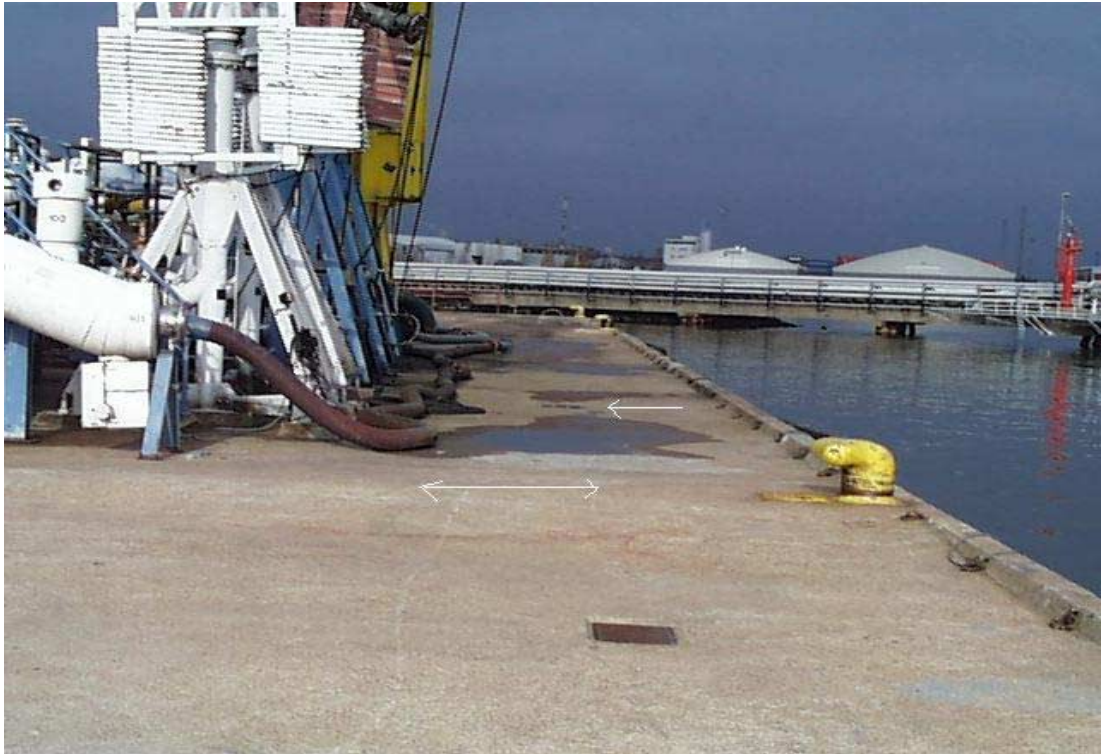
There are three drains in the cargo-handling area on Pier 2 (under the arms). The drains conduct rain water and other possible products into a rain well which has an automatic draining system (float pump). Any liquids which might leak from the hose joints will be further conducted into an underground tank. There are two drains at each end of the pier behind the platform outside of the cargo handling area. These drains lead directly into the sea. During the overload of the vessel spilled cargo drained directly into the sea from these two drains.

Figure 5 Upper one-way arrow points at the drain at the actual loading area leading to the pier well. The two-way arrow points at the platform that separates the loading area from the rest of the pier.

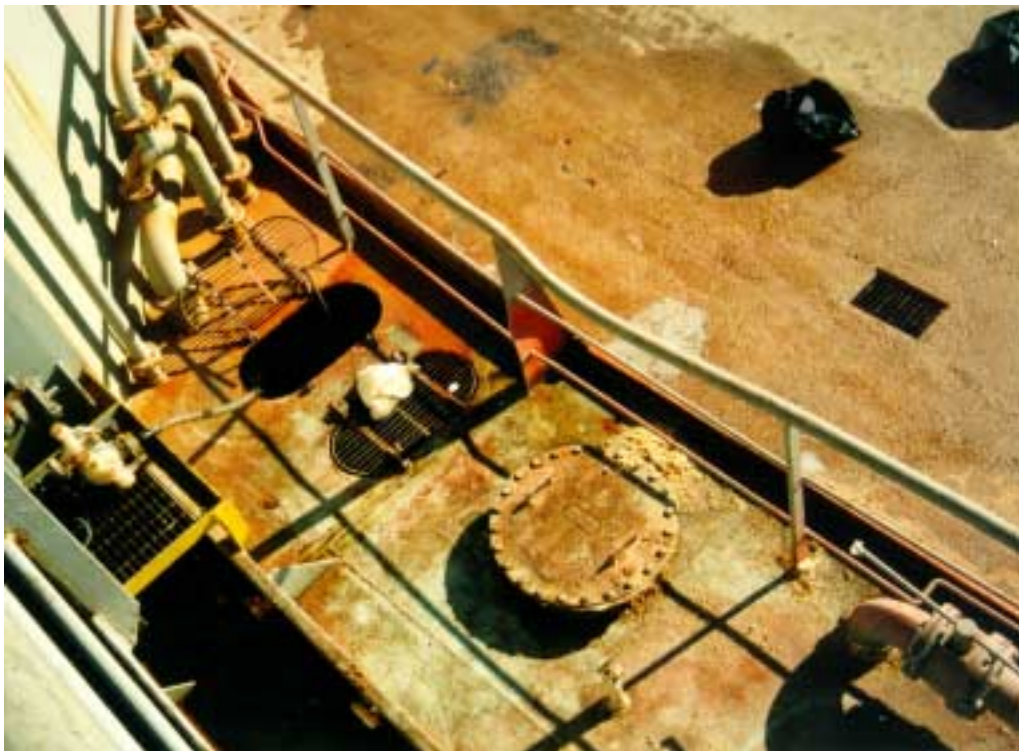
The seaman on deck was the first person to spot the overfill on board and he took action to stop the loading. His actions were prompt but took place in a disadvantageous order with regard to the extent of the environmental damage. The loading should have been stopped before he reported to the mate. The deckhand did not know that it is possible to shut off the neck valve without causing damage to the shore pipeline. The pump operator in the loading control room heard what was happening and came down onto the pier where he saw liquid spilling onto the deck towards the vessel's stern. He went to shut off the ullage drain valve.

Figure 7 Ullage drain at the stern of the vessel

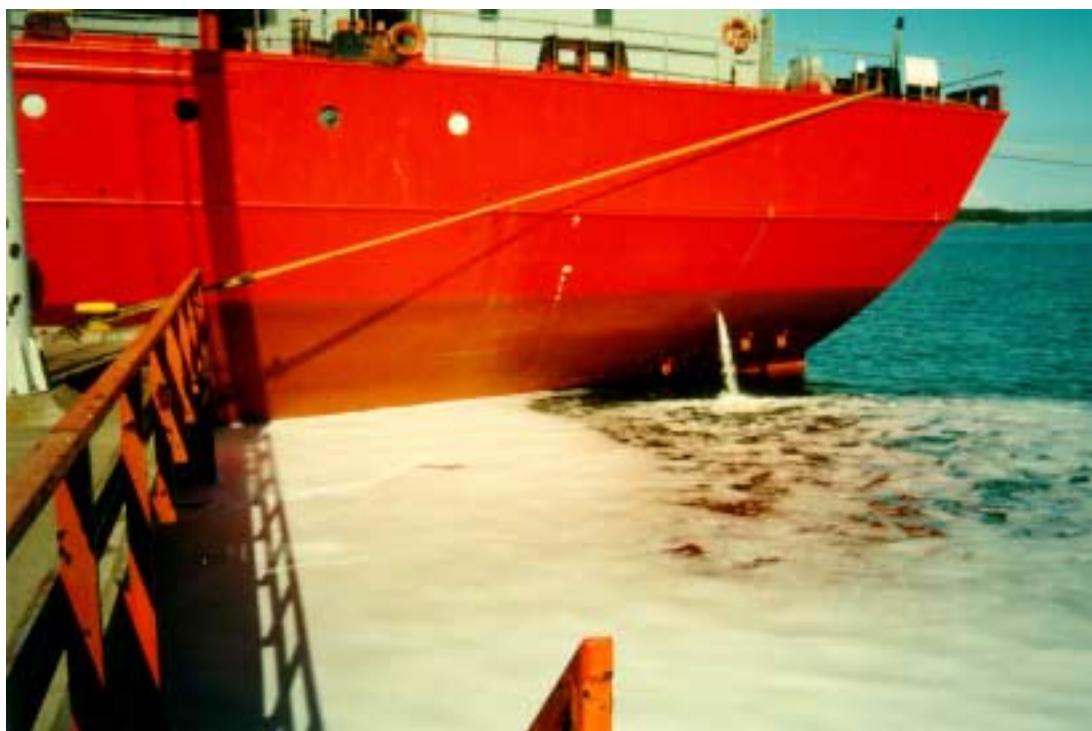
Figure 8 Foam in the sea after the leak. The substance coming out of the hole at the stern is cooling water for auxiliary machine and not related to the accident.

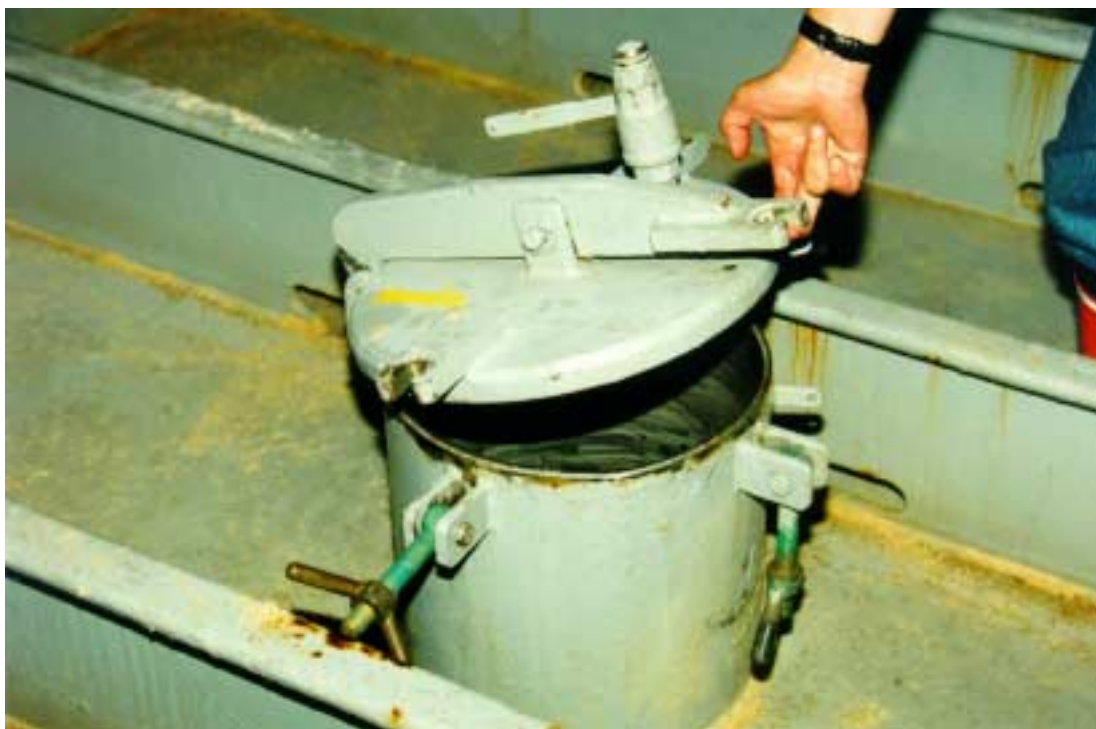
According to the mate (interrogation on 26 July 2000) the main cause of the accident can be found in the valves, (the investigators have only discovered a malfunction in the discharge valve, which would not cause an overflow situation in this type of operation provided that the main valve was functional). The other reason was the computer. According to the mate's report, the computer did not show what it was supposed to show. Since both computers are connected to one another, both machines showed false information. The mate said in his statement that this had occurred again the same night when loading the other tanks. The surface gauges had functioned normally.

Figure 10 Ullage hatch of tank 1P

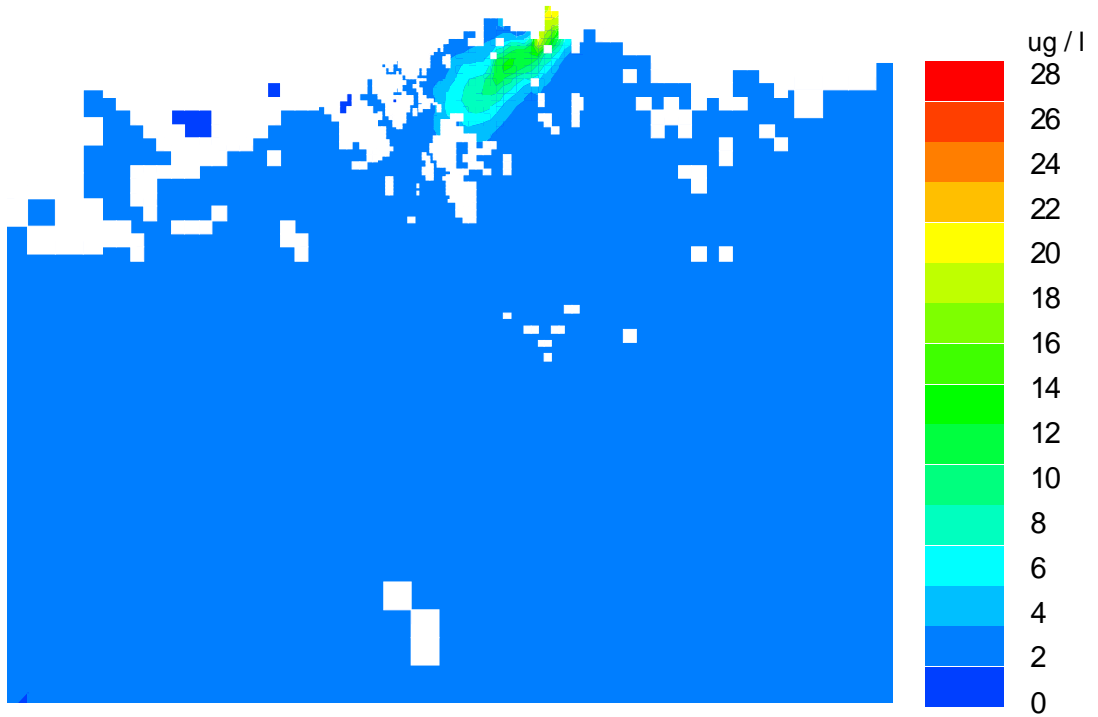
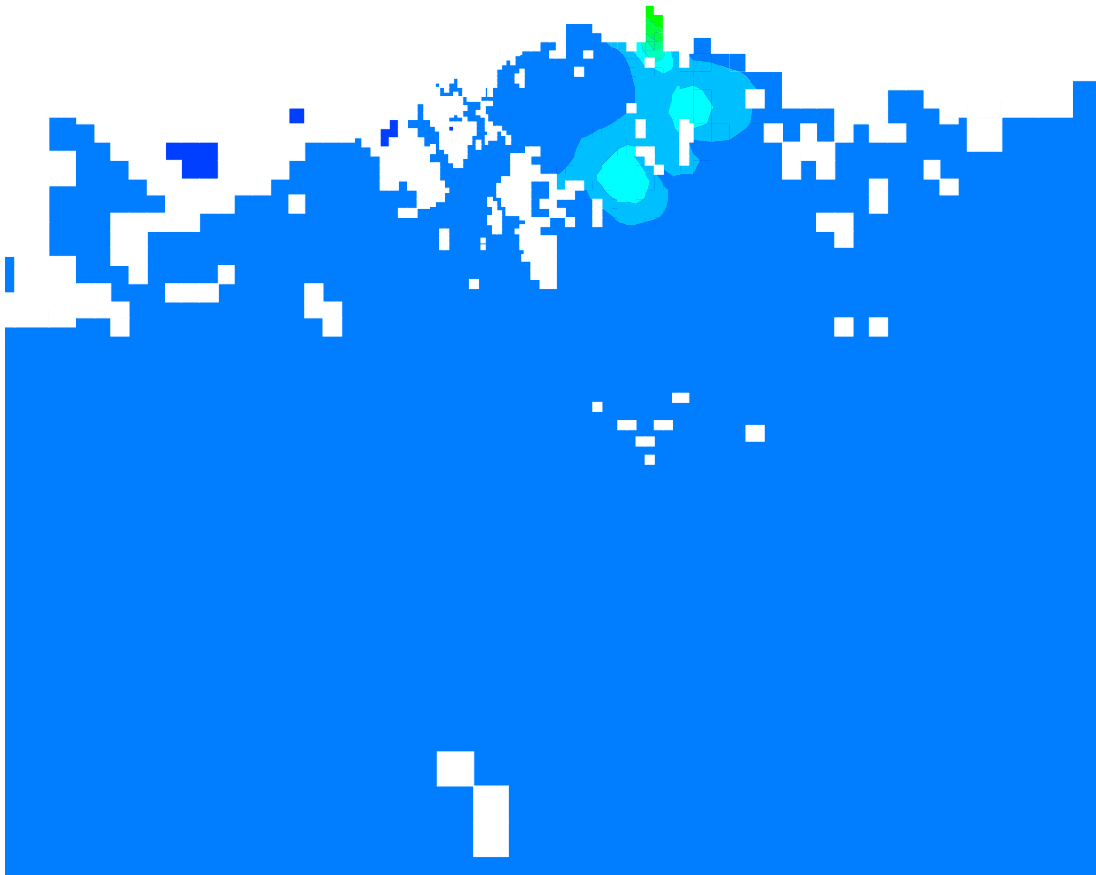
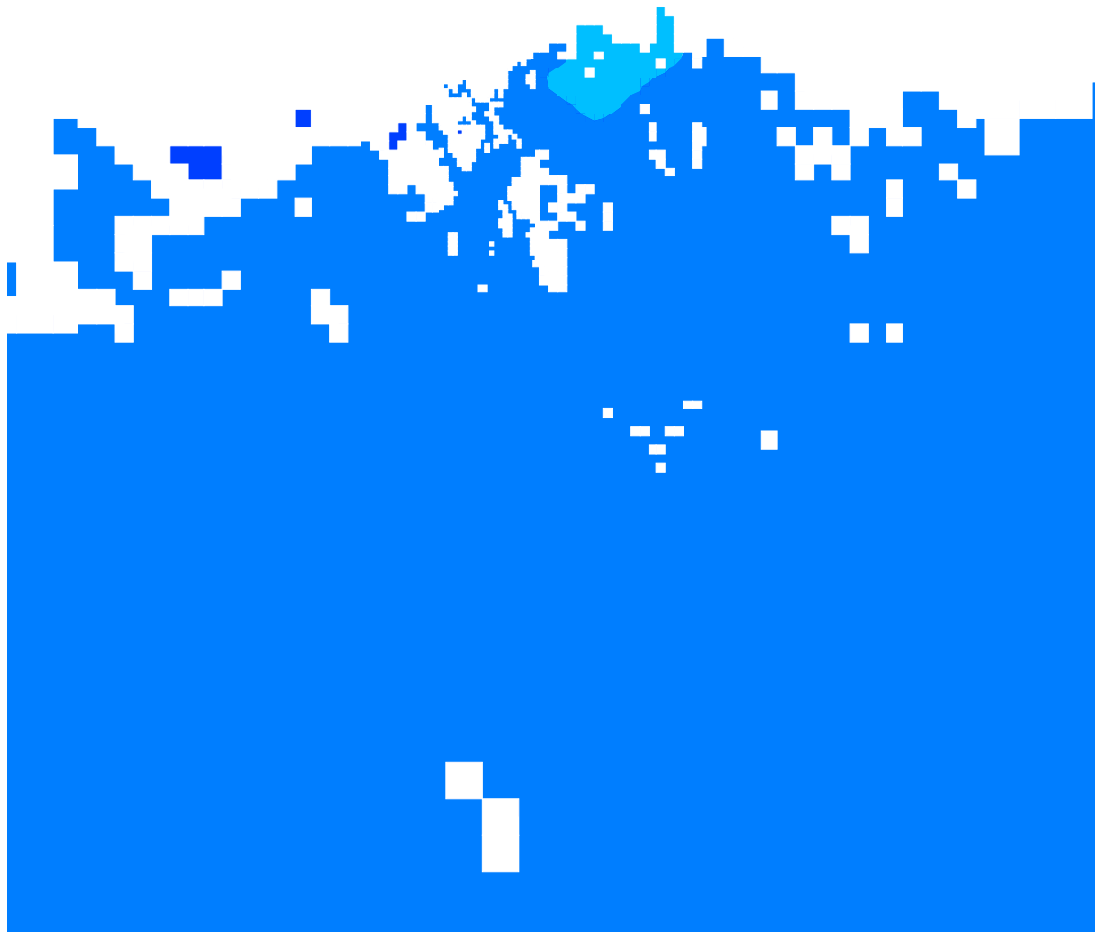
Estimated amount of substance leaked into the sea 2 tons.

Discharge 2 tonnes off Hamina on 20 July 2000.
Spreading 1 week after the accident (27 July 2000).
Minimum detectable concentration 2 µg/l.

Discharge 2 tonnes off Hamina on 20 July 2000.
Spreading 2 weeks after the accident (3 August 2000).
Minimum detectable concentration 2 µg/l.

Discharge 2 tonnes off Hamina on 20 July 2000.
Spreading 4 weeks after the accident (17 August 2000).
Minimum detectable concentration 2 µg/l.

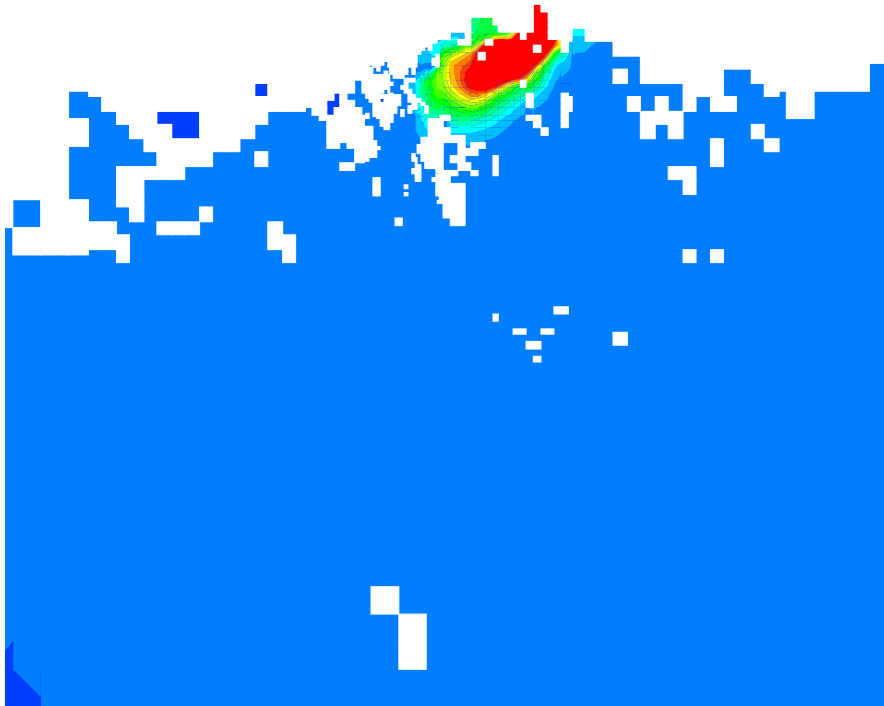
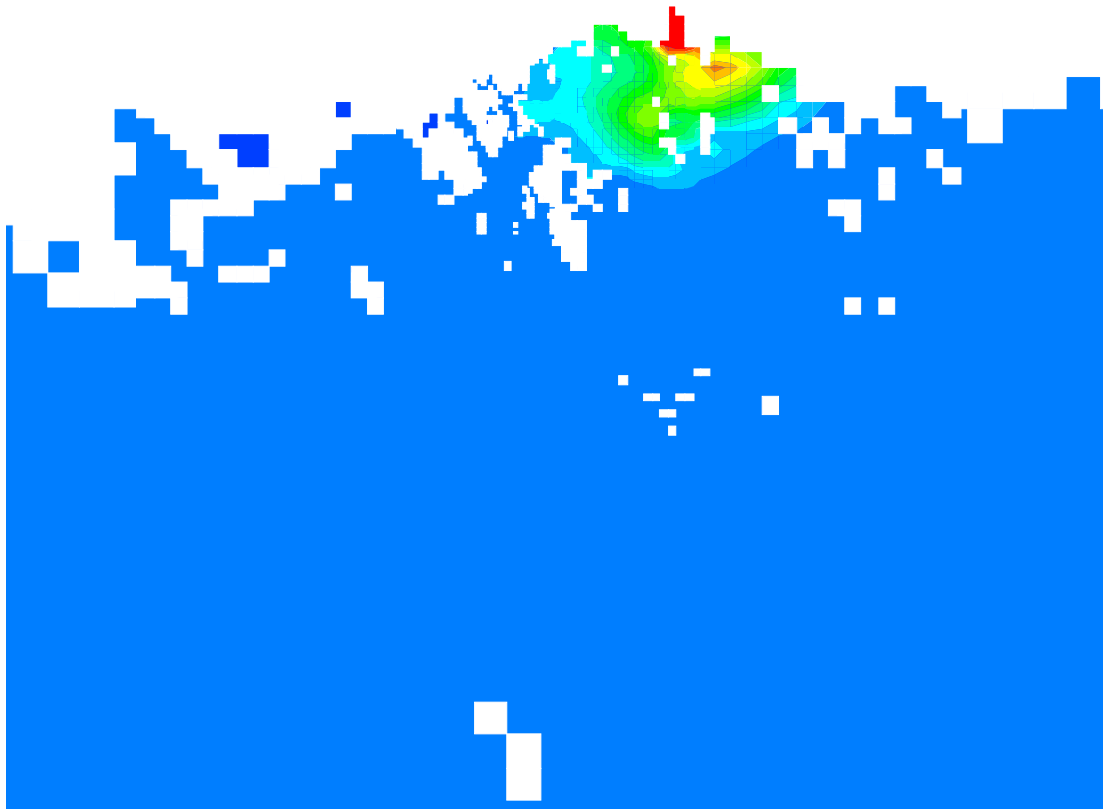
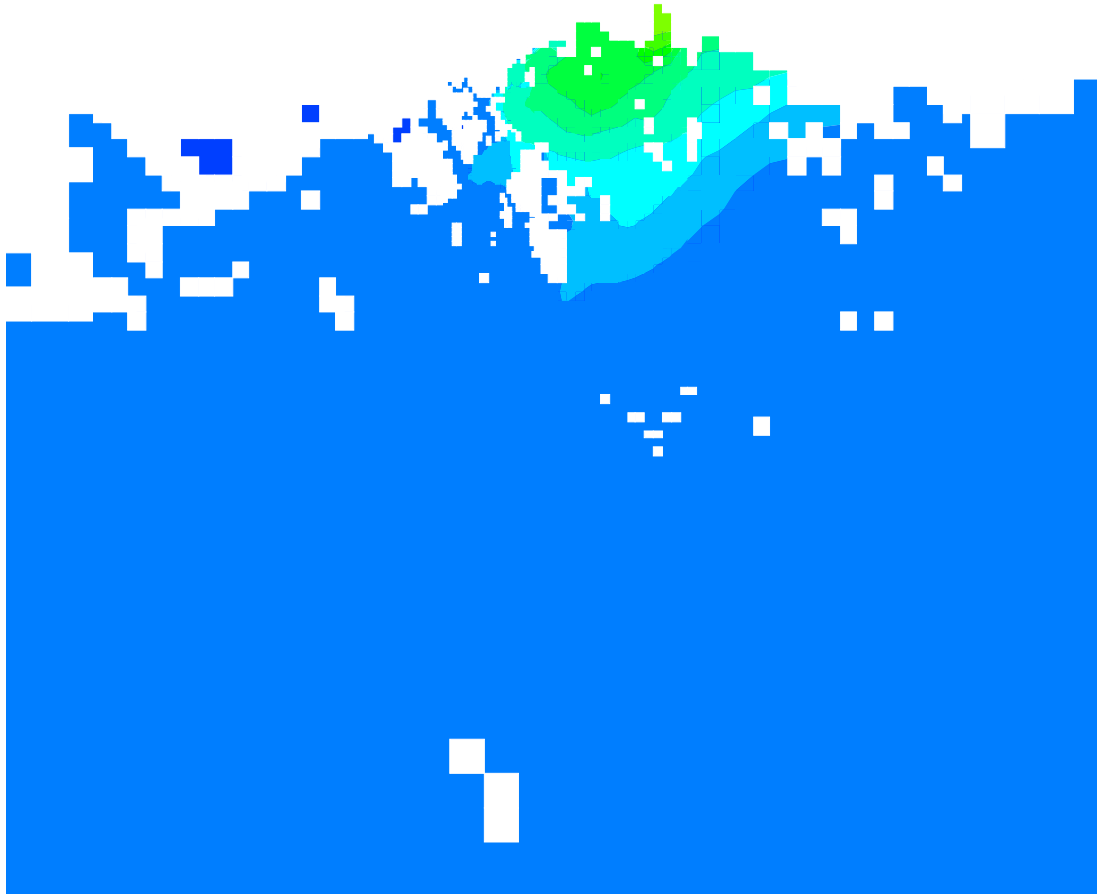
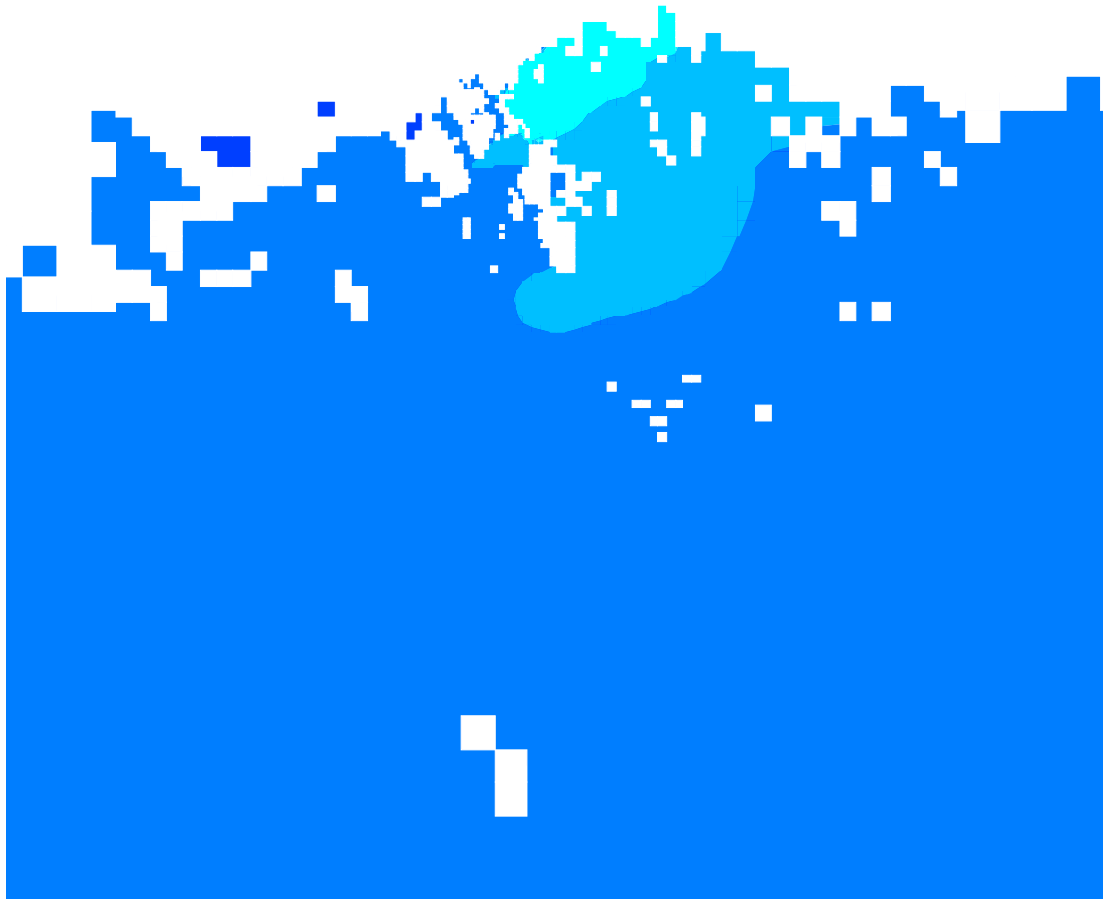
Estimated amount of substance leaked into the sea 10 tons. Scenario if the pier watch had been in the pier house and it would have taken 4 minutes to shut the valve after the overfill started

Discharge 10 tonnes off Hamina on 20 July 2000.
Spreading 1 week after the accident (27 July 2000).
Minimum detectable concentration 2 µg/l.

Discharge 10 tonnes off Hamina on 20 July 2000.
Spreading 2 weeks after the accident (3 August 2000).
Minimum detectable concentration 2 µg/l.

Discharge 10 tonnes off Hamina on 20 July 2000.
Spreading 4 weeks after the accident (17 August 2000).
Minimum detectable concentration 2 µg/l.

Discharge 10 tonnes off Hamina on 20 July 2000.
Spreading 8 weeks after the accident (14 September 2000).
Minimum detectable concentration 2 µg/l.

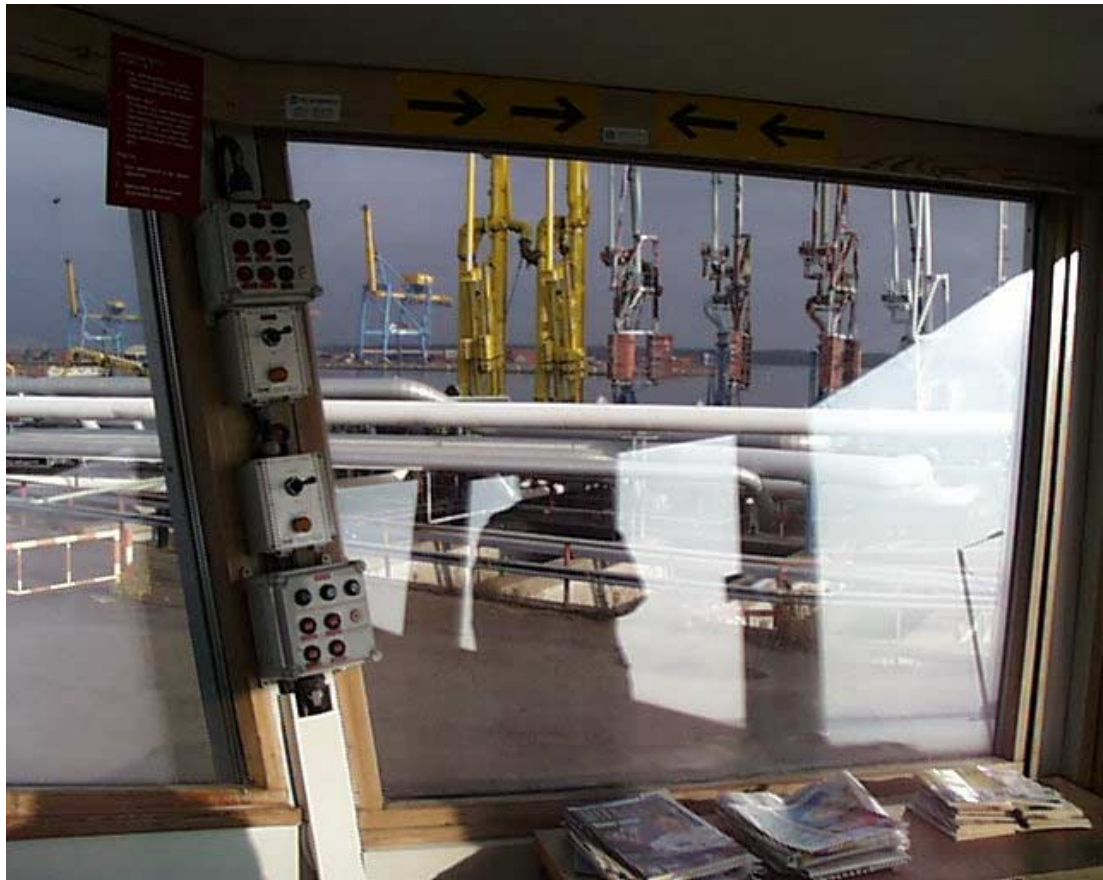
The pier watch is not always on the pier but he may also be in the pier house. The control room is on the second floor. If shouting is agreed as the method of communication, it cannot be heard in the control room. The control room offers limited visibility of the ship because the pipelines obstruct the view. In the control room there are emergency stops for the loading pumps of Transkem Oy, Kaukomarkkinat Oy and Suomen Petrooli Oy. However, the pipeline valves can be shut manually on the pier.

Figure 13 Limited view from the pier control room to the ship. Left in the picture the remote start for fire pumps and controls for fire cannons

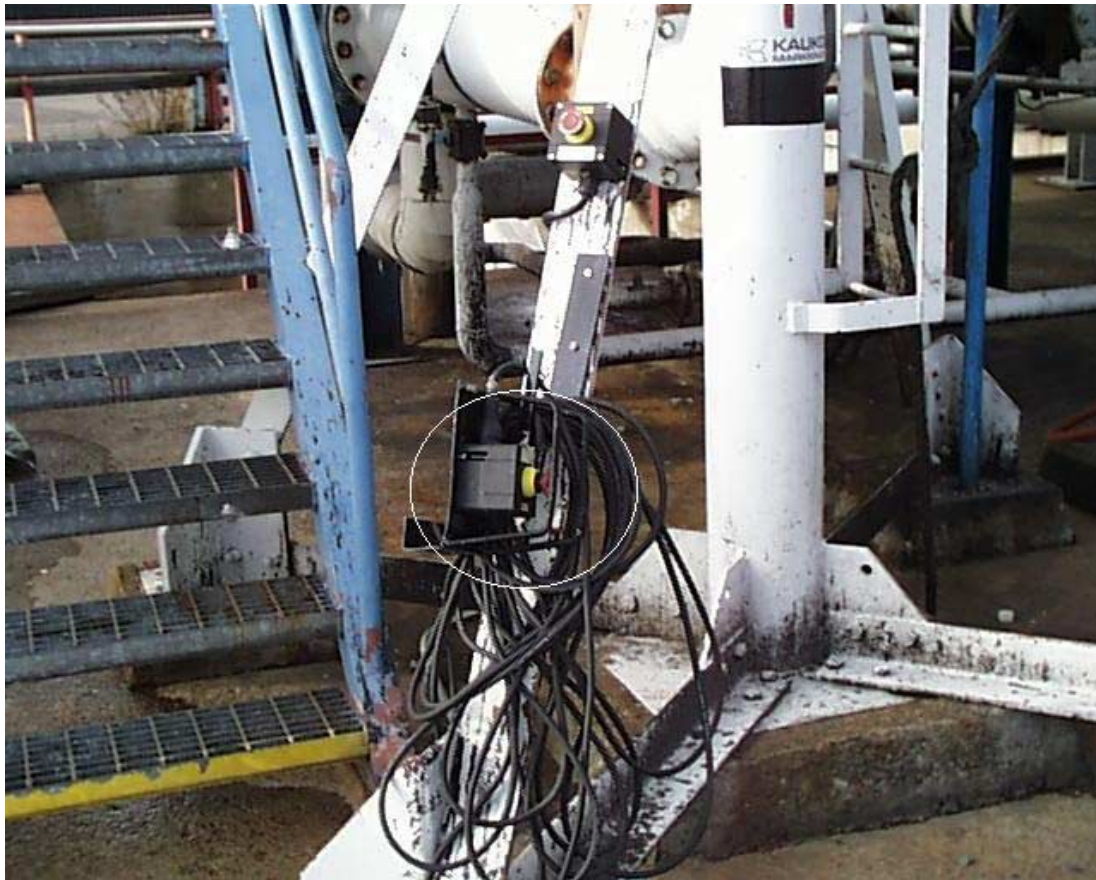
Figure 14 Cabled emergency stop button of Kaukomarkkinat for loading pump (circled). Can be attached on the railing of the vessel. Installed after the overload of the CRYSTAL RUBINO.

The companies operating on Pier 2, excepting Kaukomarkkinat Oy, had a cabled, portable emergency stop for the loading pumps. The device is initially hoisted onto the vessel's railing so that the crew on board can stop the pumping. After the accident, Kaukomarkkinat installed a similar device.

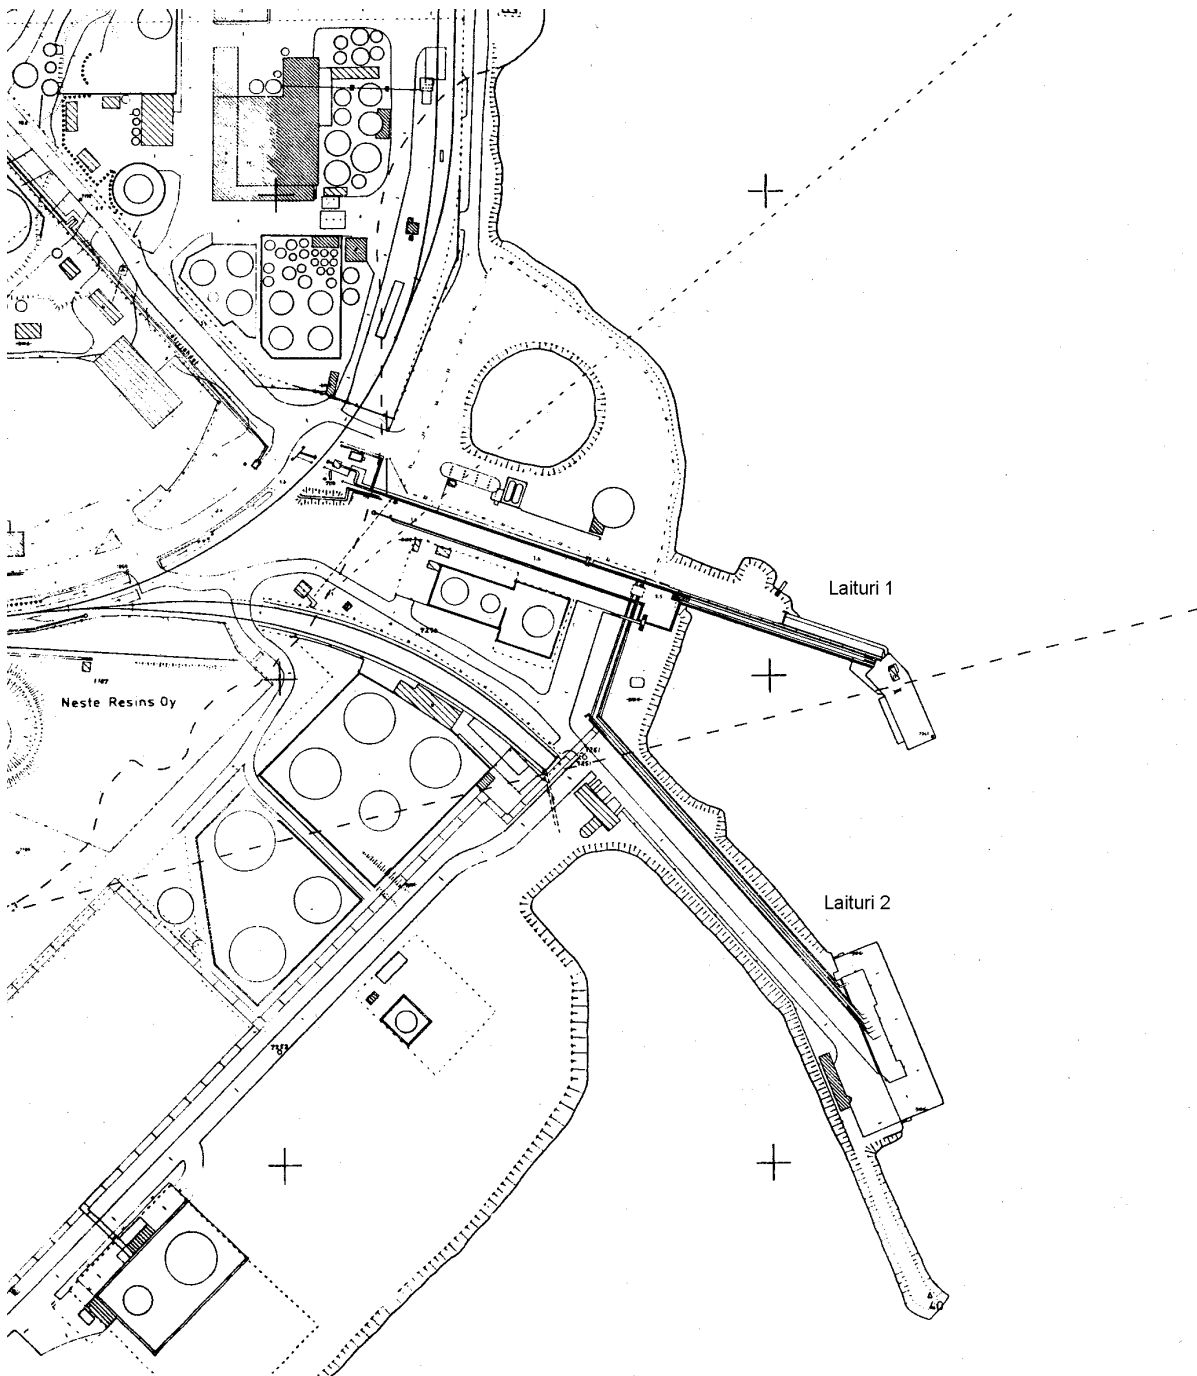
The piers in chemical ports are traditionally rather short without an immediate background area. A bridge or a narrow isthmus usually leads to the actual tank/production area. The arrangement in the Port of Hamina on piers 1 and 2 is similar to this. Over the years, new operators have established themselves on these piers with new pipelines. The isthmus has been filled and trafficking to the ship at the pier has become more difficult. The accident on the CRYSTAL RUBINO took place at Pier 2, which is not yet completely blocked like Pier 1. This pier cannot be reached by vehicles. Even going to the ship on foot often requires climbing over pressurised loading hoses.

The conditions on Pier 1 would make it difficult to mount an evacuation and rescue effort if an accident requiring this kind of activity were to happen.

Figure 16 Piers 1 and 2 of the chemical port
