Investigation report

C 1/2000 M

ms OCEAN PRIDE, grounding at Orregrund, March 6, 2000

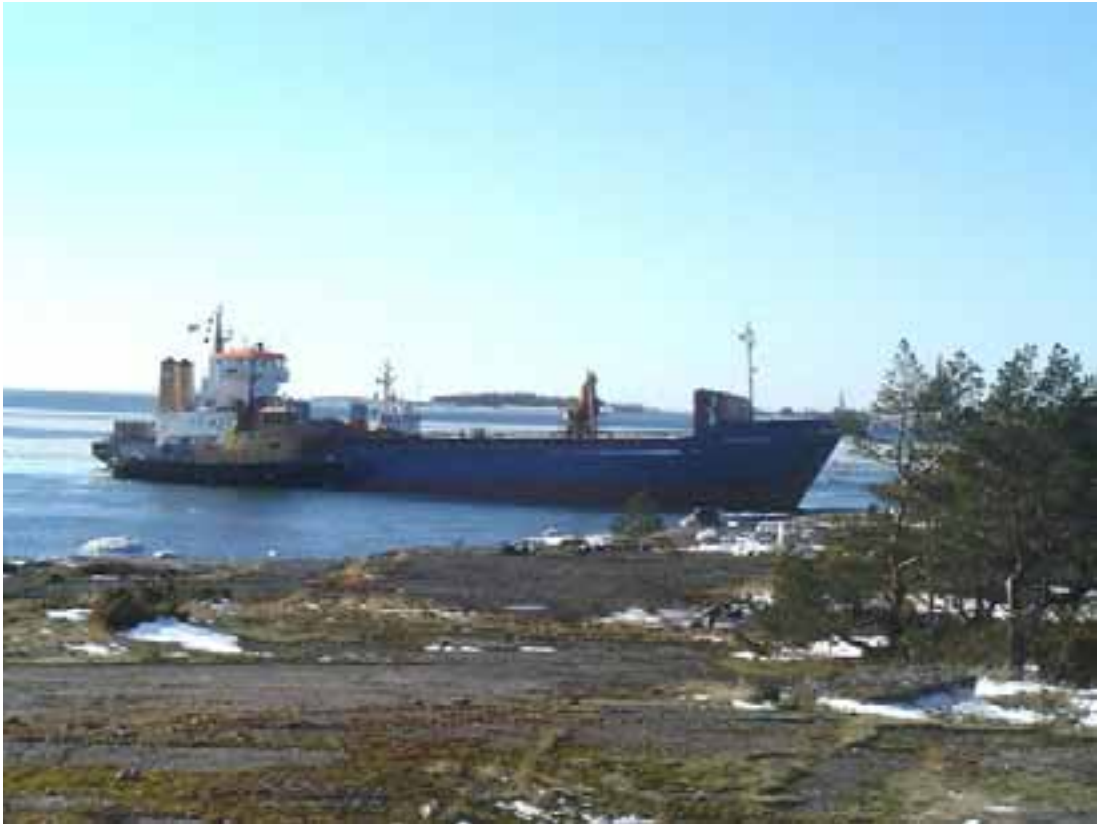
OCEAN PRIDE's damages were inspected in Sunila and the following description of the damaged compartments is based on maritime accident report made by the Master. The fore peak and double bottom tank number DB 1 S (right side) were damaged in the grounding. While grounded because of the waves the vessel was hitting into the rock and additionally to the original damage damage to the double bottom tanks DB number 1 P (left side) and DB number 3 and 4 and 5 on both sides and to double bottom fuel tanks number 3 and 4 in the midship were holedsprang. The leakage to the hold's fore part bilge was sprang due to the damage in the de-ballasting pipe.

According to the diver's inspection in Sunila there were several 0,5 m deep dents in the stern of the vessel but rudder and propeller were undamaged. The whole bottom of the vessel from from midship to bow was damaged. On the right side almost the entire bottom was open at 3-4 m width and it had risen about a meter. On the left side the bottom had risen from 3 m width and it had tears. In the midship there were dents and small cracks. The bow propeller was in order but there were cracks in the stem.

Figure 4. OCEAN PRIDE at the shore of Orregrund.

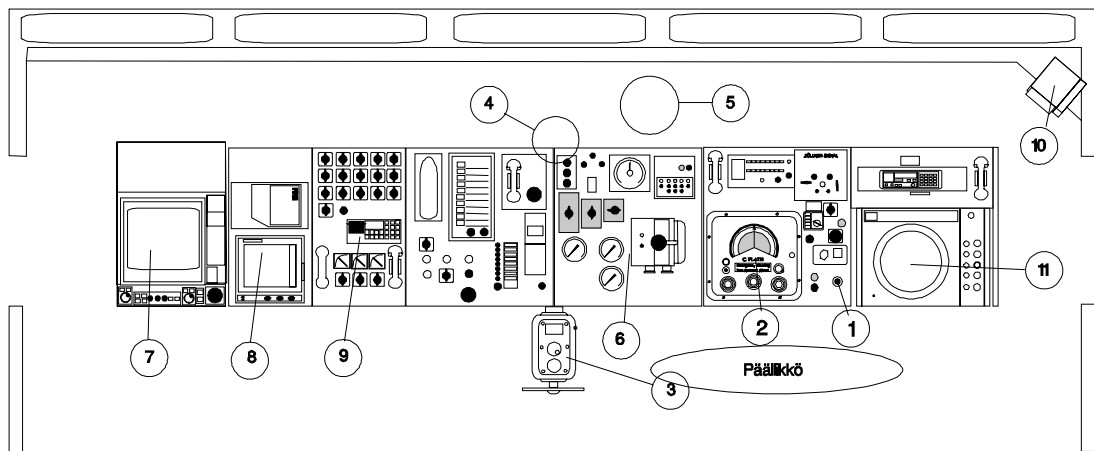
Figure 9. General cockpit arrangement of the OCEAN PRIDE. The Master's work point is drawn based on the Maritime Declaration.

- There was no navigation and steering point for one person. The old inoperative radar had been left next to the autopilot and had not been replaced by a new one. There was no operative radar next to the steering systems. This made it impossible to concentrate the steering and positioning on one person. The Master had to move back and forth between the radar and the autopilot.

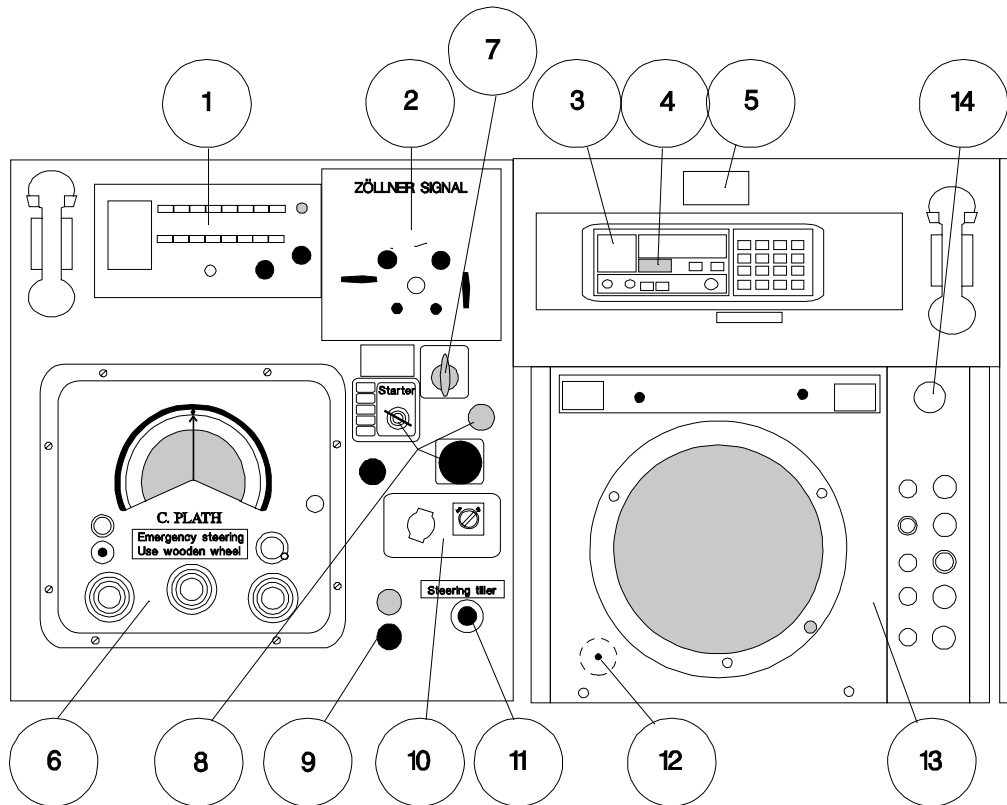
The navigation and steering point at the right end of the console was correctly designed. Since the DECCA radar had not been replaced the work point was reduced to a mere steering point.

Figure 10. There was a navigation and steering point on the right side of the console.

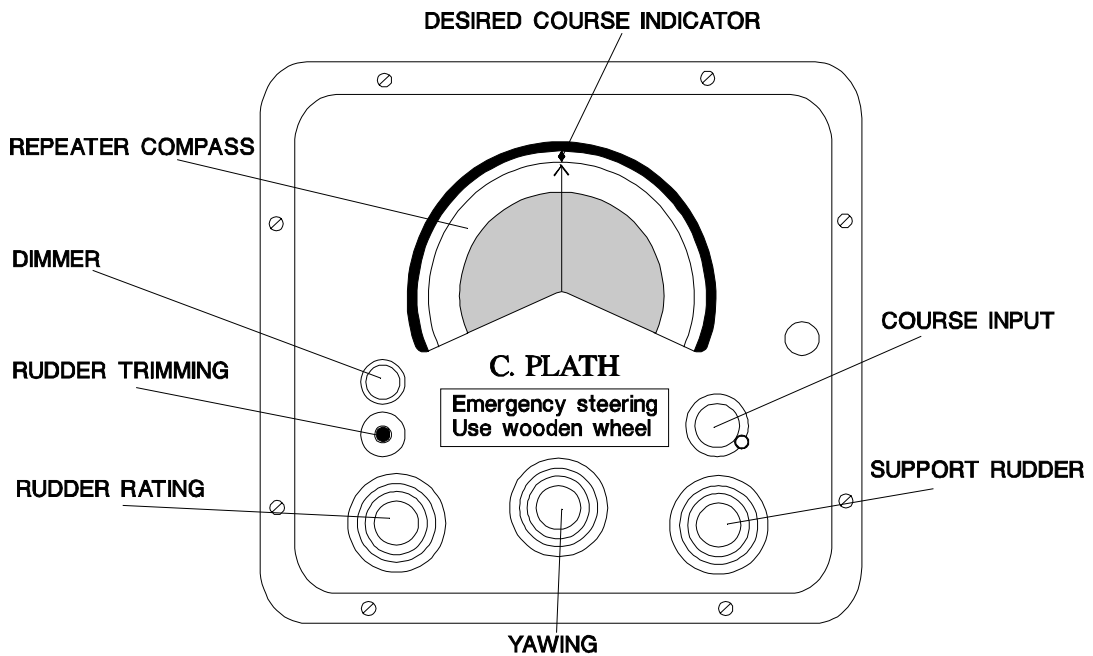
Figure 13. Operating panel of the C.PLATH NAVIPILOT autopilot of the OCEAN PRIDE.

RUDDER RATING (settings 1 - 4). At setting 1 the rudder reacts to course changes mildly and at setting 4 strongly. The normal setting is 2. The setting must be increased at slow speeds. The setting of the OCEAN PRIDE was 2 in the photograph taken on March 14, 2000.

The manual of the autopilot states that 'if the rudder machine operates at two different speeds, the slower speed should be used'. The sign for the 'emergency rudder' mentioned the rudder pumps, so the vessel apparently had two rudder pumps. If the manual of the autopilot was observed, only one pump was active. This would explain why the 'emergency rudder' turned slowly when the Master attempted to turn to port.

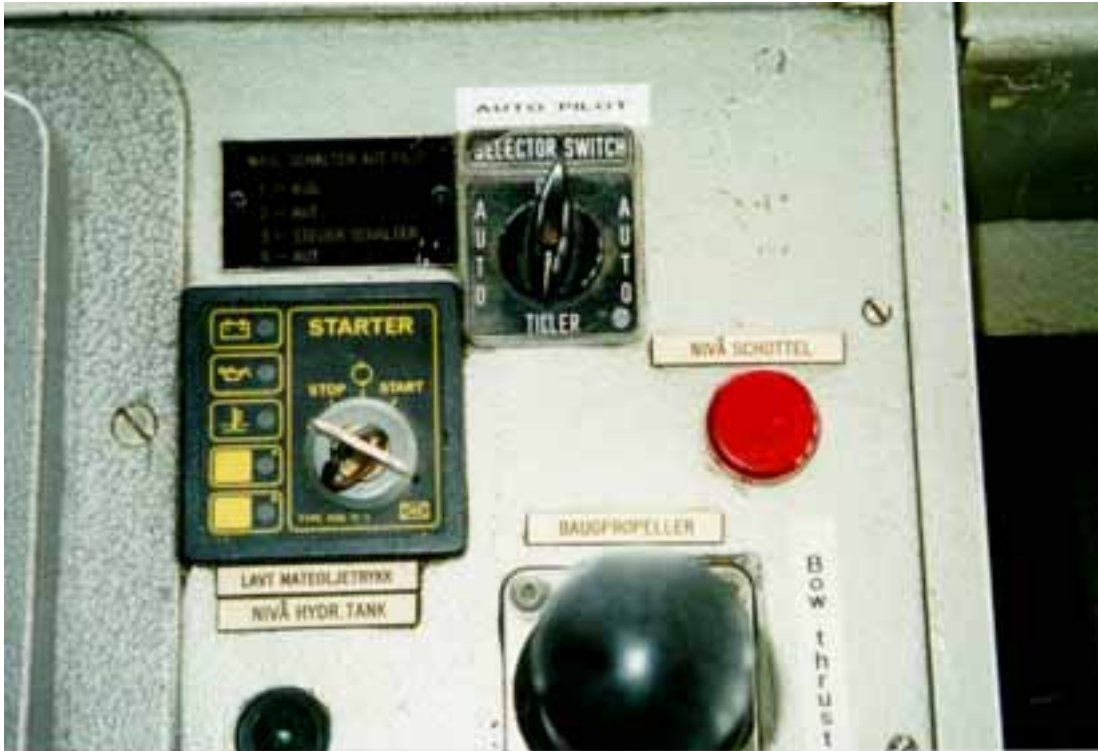
Figure 14. Selector switch for autopilot and manual steering.

- The mode switch for the steering system included a hazardous choice that switched all the systems off.
- The directions concerning the emergency steering system were not sufficient.

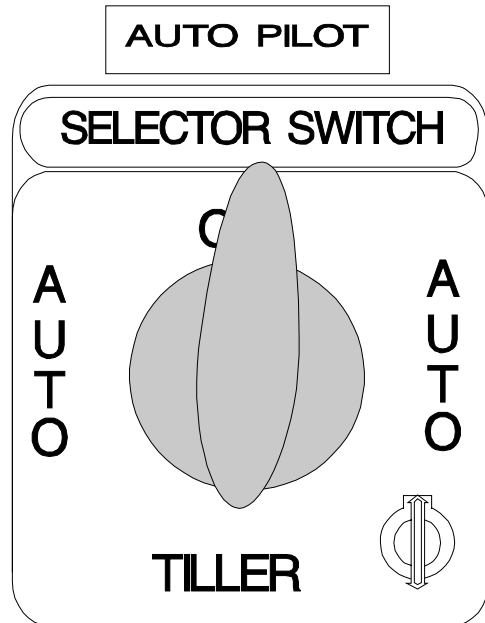
Figure 15. The Selector switch for autopilot and manual steering and the operating instructions for the switch to the left of it. The blunt end of the switch points to the selected function. In the picture, the TILLER mode is selected.

The TILLER position of the switch could have been installed similarly to the AUTO option, which would have replaced the OFF position by TILLER. This would have left only two choices without the possibility of an error. The ergonomic design of the selector switch was misleading. There should be no OFF option, since it is possible to encounter a situation where the OFF position is switched on unintentionally. This is a possibility also in the accident of the OCEAN PRIDE, since the Master reported having switched between the autopilot and manual steering modes twice using the switch, but none of the modes functioned. (Section 1.2.2).
