Investigation report

C 1/2002 M

M/S FJORD PEARL, Shifting of Cargo and Danger Situation, January 2, 2002

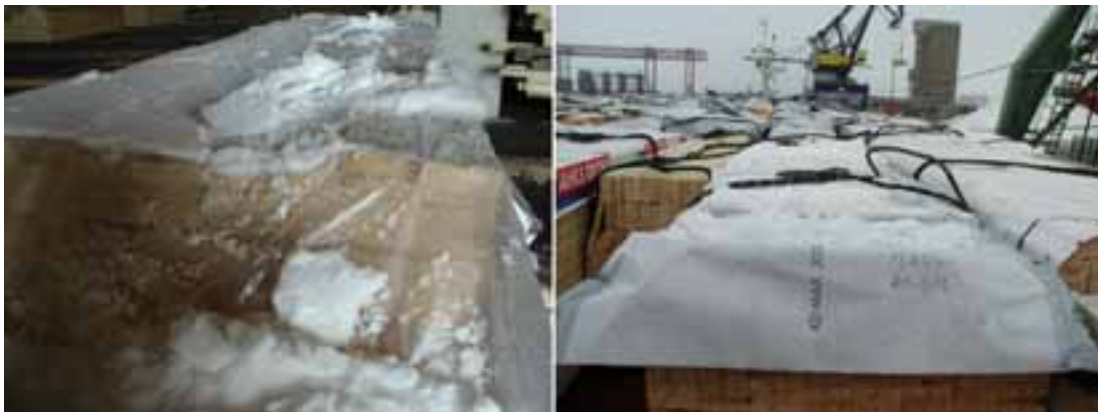
Figure 7. *In winter, the packages are snowy and icy (photos by the Finnish Institute of Occupational Health)*

The sawn timber packages were in part covered with snow and ice. The stevedore removed snow and ice by blasting air and by chiselling. The ice and the snow could not be fully removed. The load was packed as tightly as possible under the supervision of the ship officers. The second tier of deck cargo was placed across. Due to the varying lengths, gaps of half a metre remained here and there.

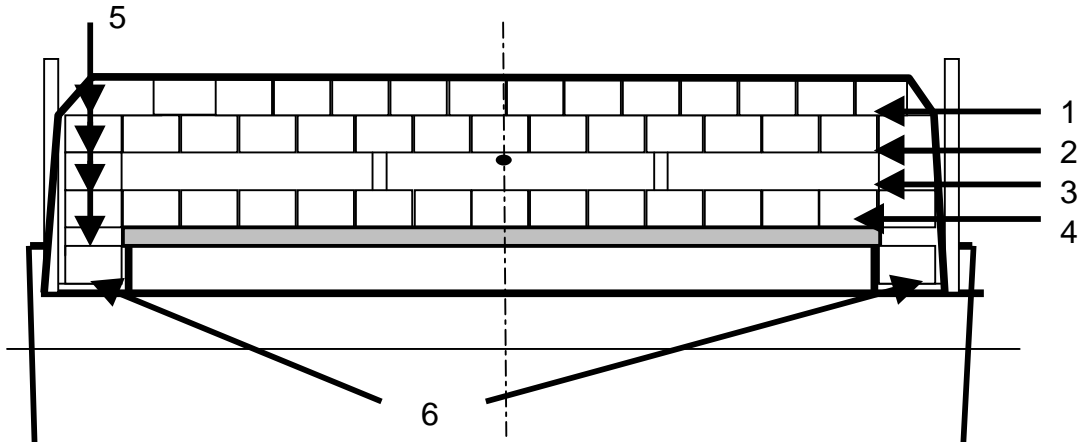
The lifting ropes of the cargo, two per package or pair of packages were left slack on top of the sawn timber packages. This resulted in the following combinations of two horizontal surfaces (the numbers refer to figure 10):

1. Two packages lengthwise stacked staggered on top of one another.
2. Packages stowed lengthwise on top of packages stowed across.
3. Packages stowed across on top of packages stowed lengthwise.
4. Packages lengthwise on top of a cargo hatch.
5. At the sides lengthwise packages stowed evenly on top of one another.
6. At the sides the lowermost lengthwise packages dunnage was placed.

Figure 10. Cross-section of the secured deck cargo, bow end of hold 4 and the location of the various friction surfaces

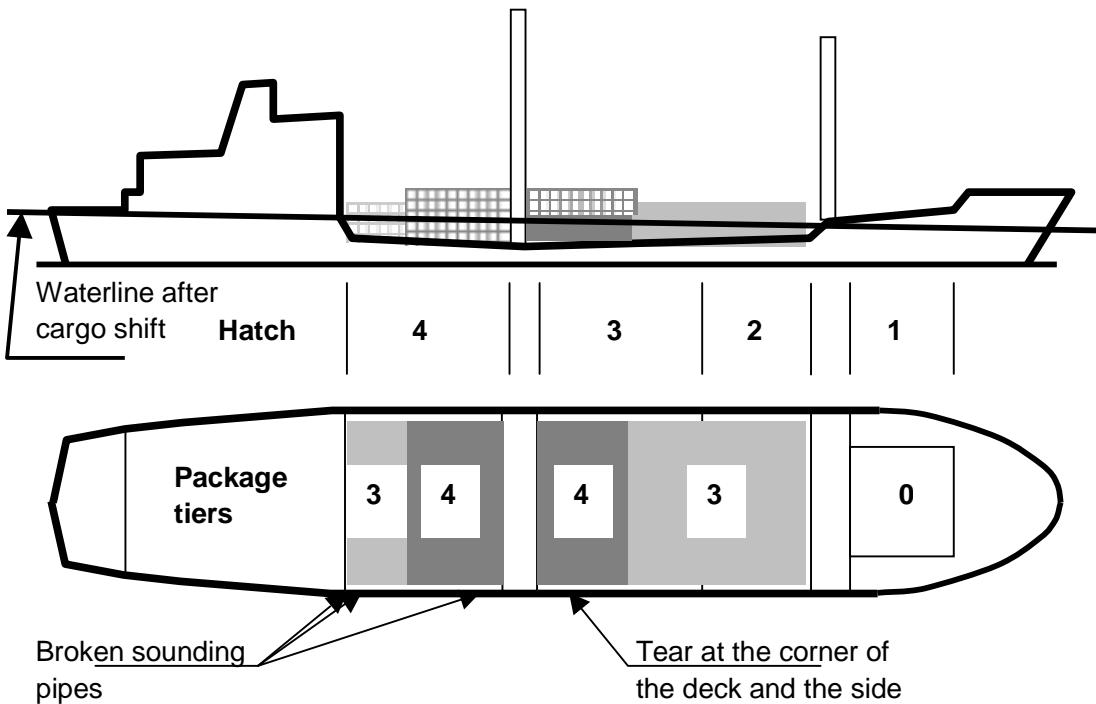
The deck cargo consisted of sawn timber packages from various sawmills with different protective hoods. Figure 11 shows the supposed distribution of the various hoods, based on the stowage plan of the vessel. The placement is significant since the friction coefficient of the various hoods differ greatly.

Figure 11. On-deck location of timber packages with the various hoods, the damaged sections are also marked

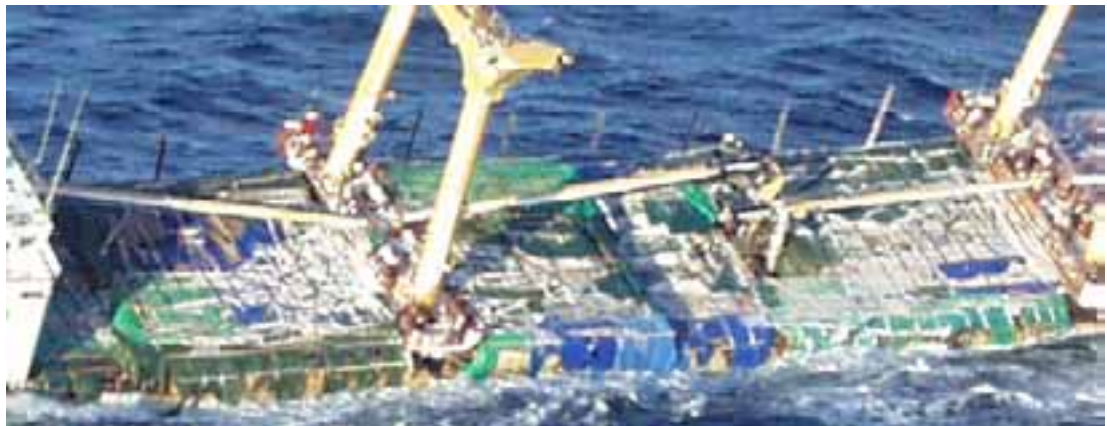
Figure 14. Shifted deck cargo, close-up of figure 2

According to the statement of the officers of the ship, the vessel listed first 15° to port, then 30° to starboard, then righted to 22° and within a few hours stabilised at 26-27°.

All uprights at the starboard railing snapped but the wires kept the cargo on board.

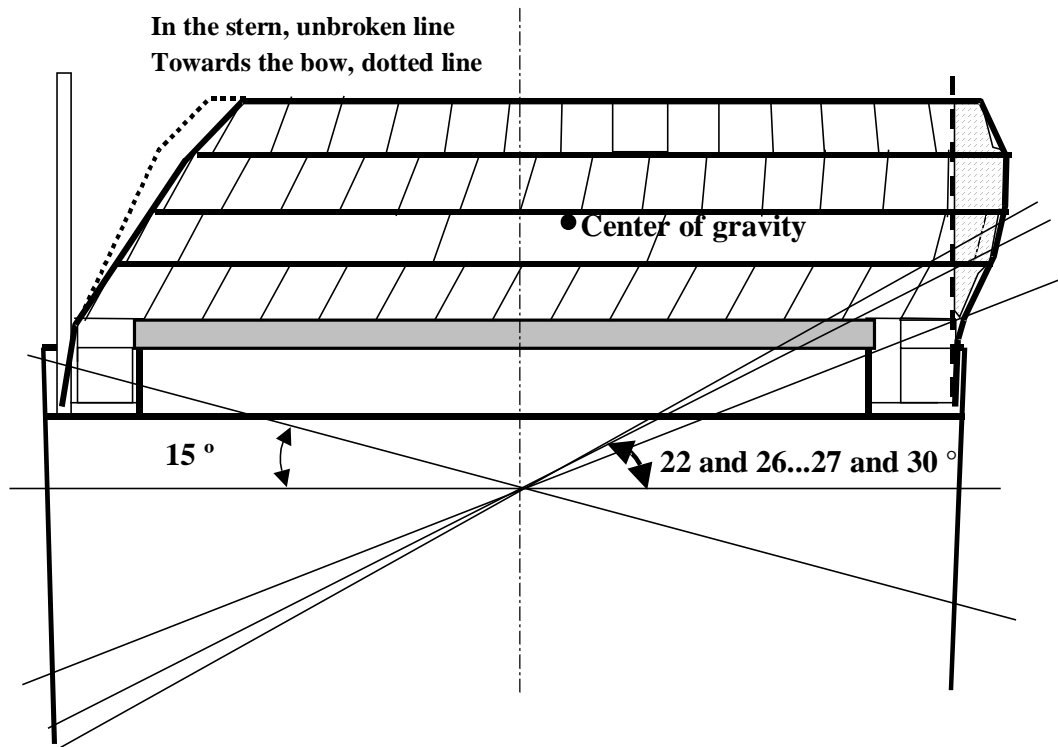
Figure 15. Shifted deck cargo in the area of four package tiers, shaded area gives extra righting volume compared to stability calculations

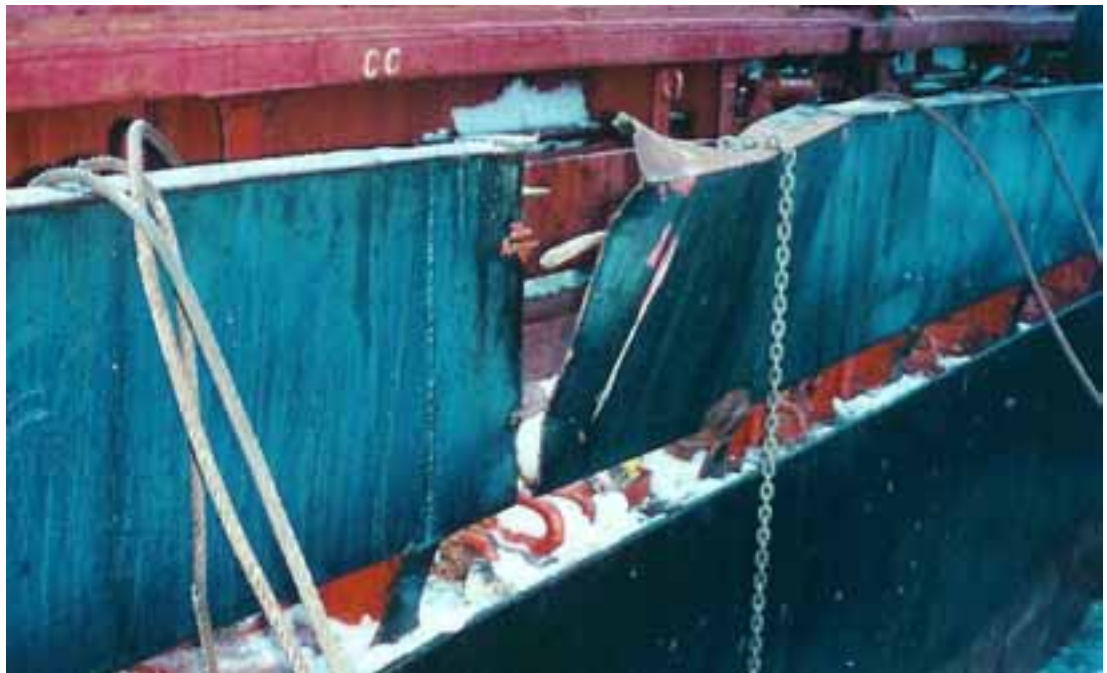
Figure 18. Damage to the railing

The shifting deck cargo caused damage to the starboard railing and caused a small tear at the corner seam of the deck and the side. In addition, air pipes and sounding pipes

were damaged in this area. In consequence of the damages, water leaked into the dry tank on the starboard side in the area of hold 3, into fuel tank TT N 2 and into diesel tank N 2. In addition water leaked into hold 3 either from the broken pipes and/or the hatch seals. Ballast tank 9, which was full, could not be emptied to reduce the list.

All uprights on the starboard side splintered. The securing wires of the deck cargo held. The tarpaulins of the deck cargo were partially torn. There is no information of the damage inside the ship. Figure 11 shows the location of the damages.

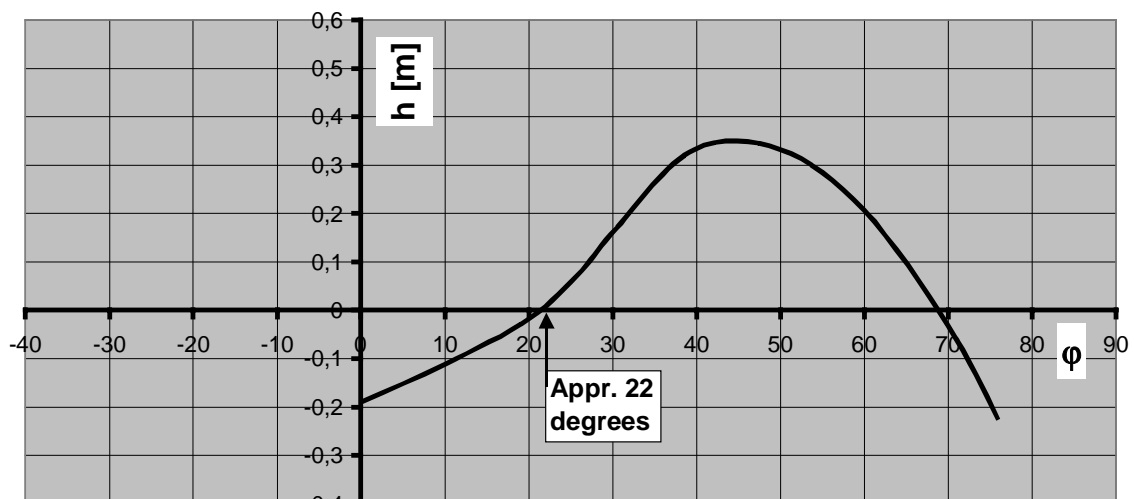
The listing moments total is $1512 + 510 = 2022 \text{ tm}$. The difference, $2070 - 2022 \text{ tm}$, can be attributed to the inaccuracies in the estimate and the initial data. Figure 20 presents the static stability curve for a list of 22°.

Figure 20. Static stability curve for a list of 22°

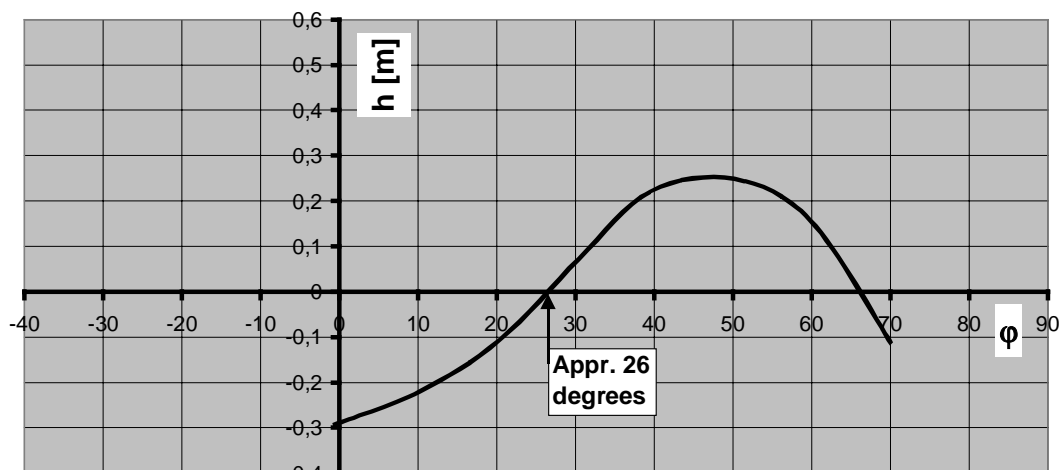
Total increase of the listing moments = $(600 + 240 - 400 + 180 + 200 + 150 + 100 + 70 - 75)\cos 26^\circ = 958 \text{ tm}$. The difference $958 - 930$ can be explained as in the above. Figure 21 presents the stability curve corresponding to this situation.

Figure 21. Static stability curve for a list of 26°
