2 ANALYSIS

2.1 Timber cargoes exported from Finland, general

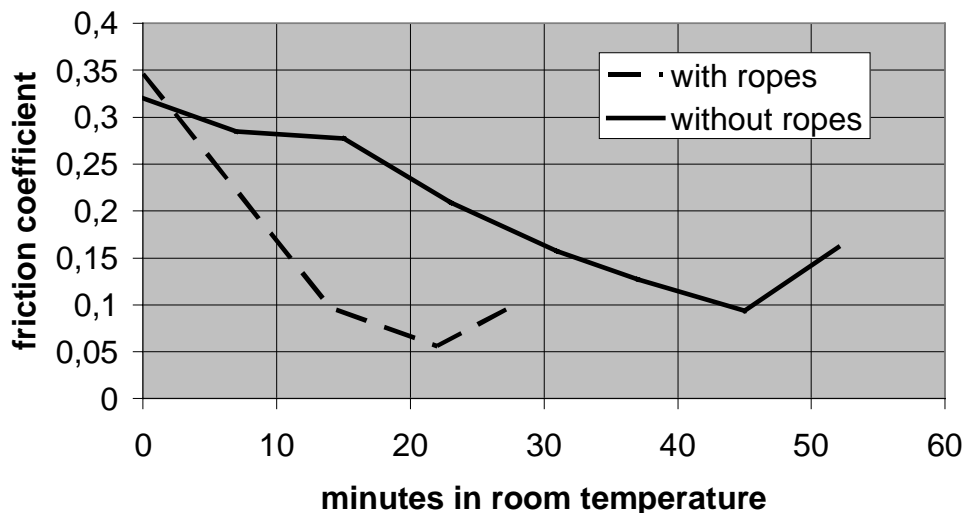
Figure 22. Effect of warming on the friction coefficient in the friction tests performed at the Technical Research Centre of Finland

Enclosure 4 includes the results of this test series. The friction coefficient diminishes radically when the thaw progresses and begins to grow when the ice has completely melted away.

Based on the observation and studies on the behaviour of the friction it can be concluded: FJORD PEARL sailed in conditions resulting in significantly lower friction coefficients and angles of static stability of the package stack than the initial values used as the basis when securing the deck cargo.

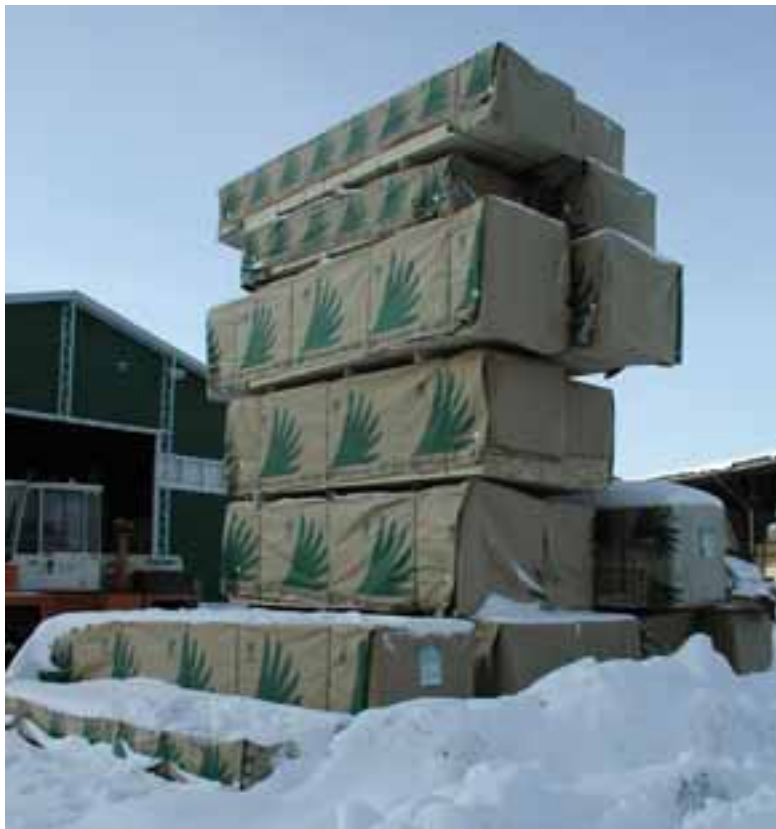
Figure 23. Timber packages stored in open air, work safety should be considered in the storage (photo by the Finnish Institute of Occupational Health)

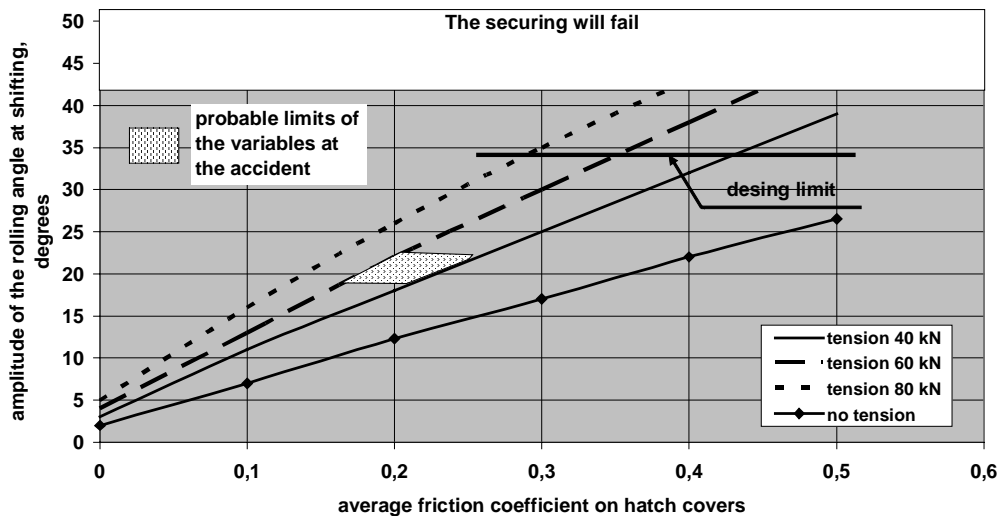
Figure 24. Critical friction coefficient-rolling angle-tightening force combinations

The results of the calculation are presented in figure 24. The tightening force at the time of the accident is estimated to have been between 40-60 kN. There were about 6 hours between the last tightening and the accident. During this time, the weather conditions were at their worst, which is why the cargo evidently packed further. This resulted in a decrease of the tightening force.

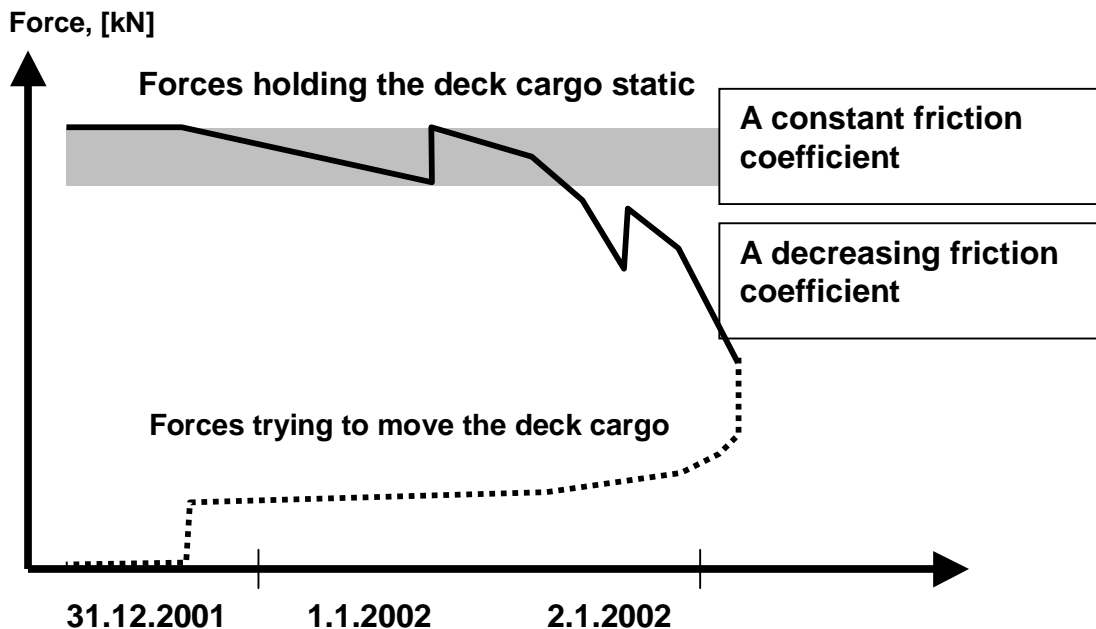
The forces created during the turn contributing to the shifting of the cargo exceeded the securing forces because of the reduction in the friction coefficient. Figure 25 shows one possible scenario of the development of forces.

Figure 25. One possible scenario of the history of the forces during the voyage of FJORD PEARL, abrupt changes in the securing force show the moment of tightening

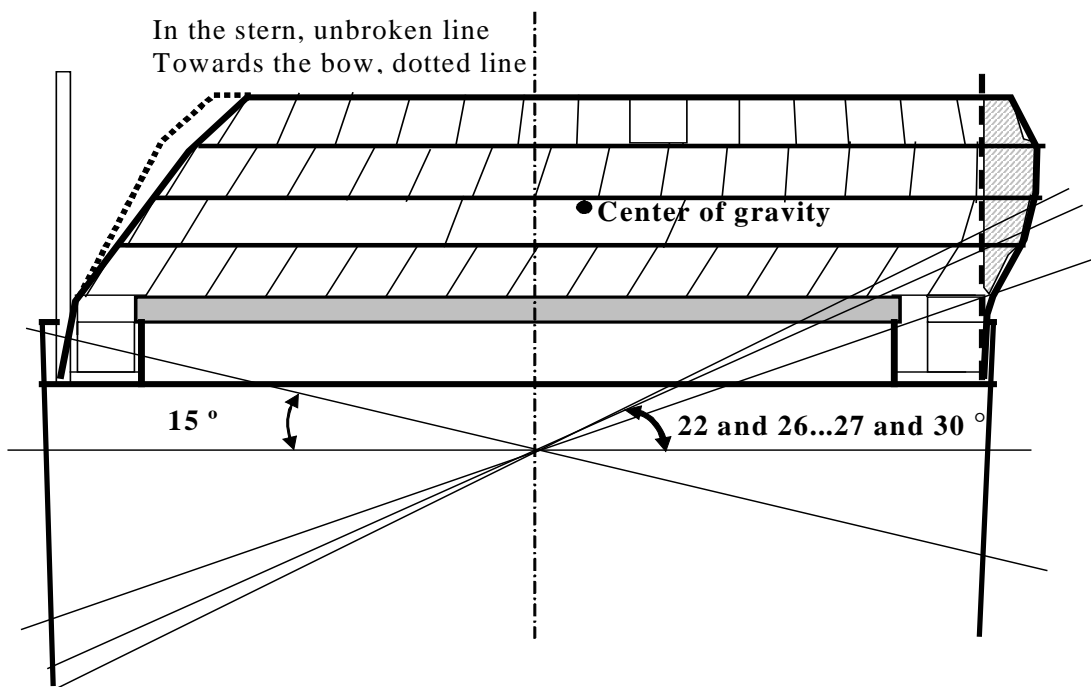
Figure 2. Shifted deck cargo, the shaded area is the extra volume of the deck cargo compared to the cross curve calculations, the change in the shape of the sawn timber packages may be exaggerated

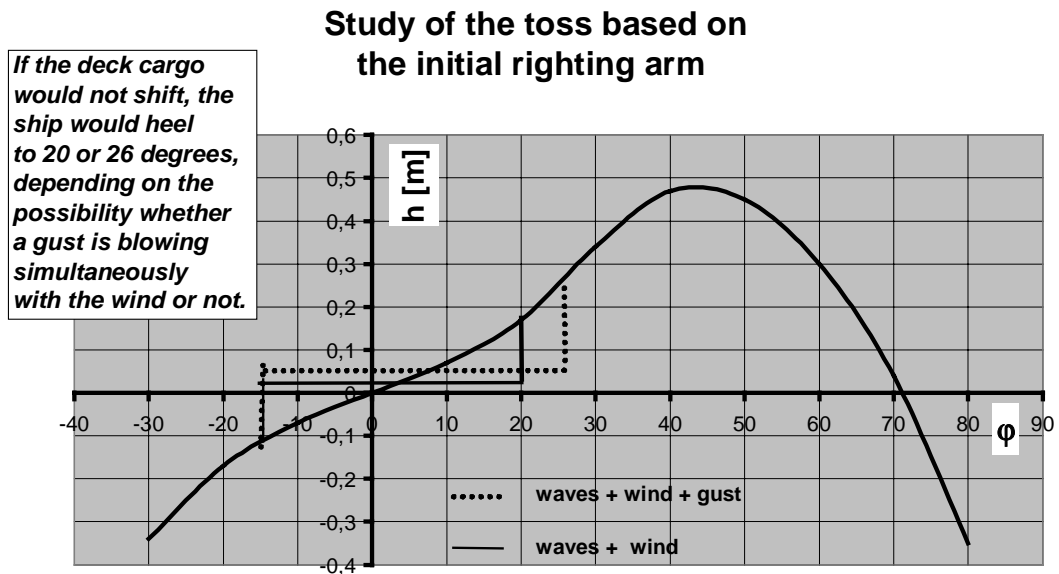
It can be concluded, that the shift of the deck cargo started at an angle between 16° and 25°, probably at 19-22°. Dynamic effects of the shift tossed the ship over this limit to 30°.

Figure 4. Maximum roll angle to starboard after the rolling 15° to port if the deck cargo had not shifted

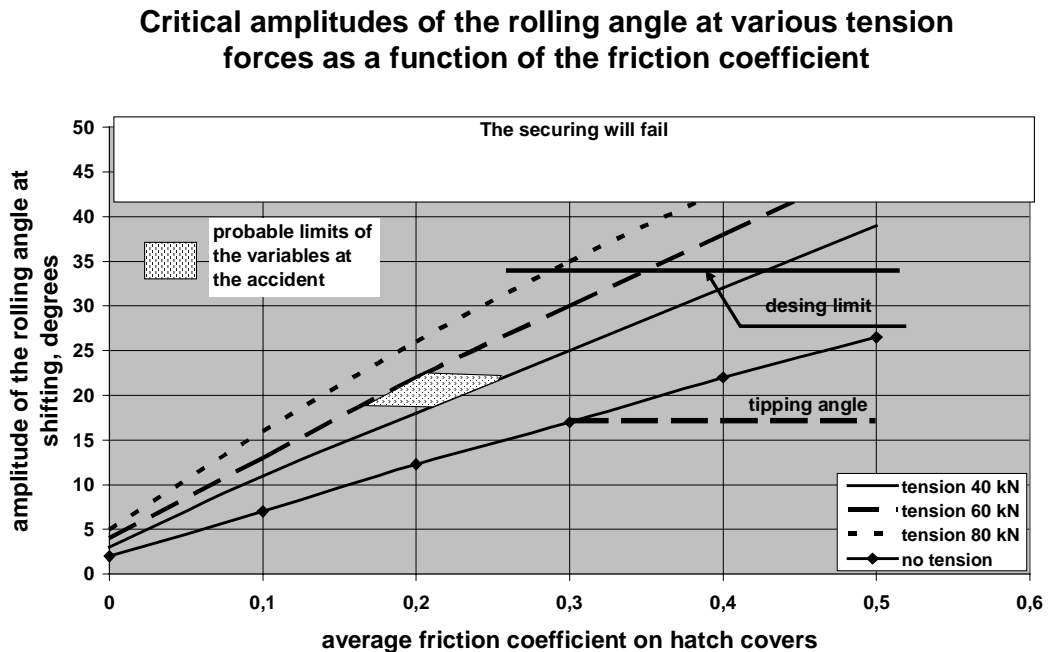
Figure 5. Critical friction coefficient/rolling angle combinations

The deck cargo remains stable below the curves. There were 52 securing wires including two thirds of the diagonal wires. The tension is the vertical force created in the wire when the tightening is done on top of the cargo. The vertical force in the wire at both sides is smaller due to the wire friction against the corners of the cargo. The differences level out as the cargo packs. The calculations assume that the friction coefficient for the packages furthest to the side is the friction coefficient on the hatch covers +0.15. Thus, if the friction coefficient on the hatch covers is zero, a small rolling angle is yet allowed. When the wire has no tension, it is not slack, but begins to resist the shift if the heel angle exceeds the stability angle of the stack.

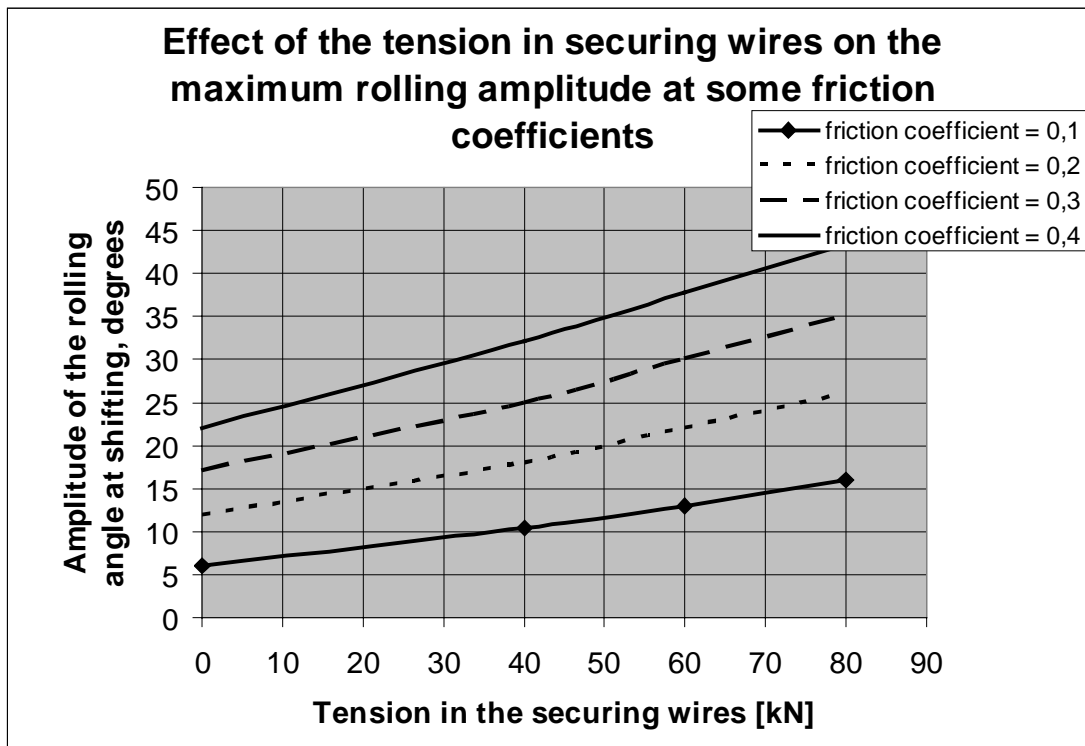
It can be seen that the tension of the securing wires has a strong effect on the maximum allowable rolling amplitude. Figure 6 shows the effect of tension in more detail as calculated by the investigator team. For example, if the friction coefficient is 0.2 the cargo will shift at an angle of 12° with no tension and at an angle of 26° when the tension wire is very taut.

Figure 6. Effect of tension in the securing wires on the critical listing angle at various friction coefficients on the hatch covers

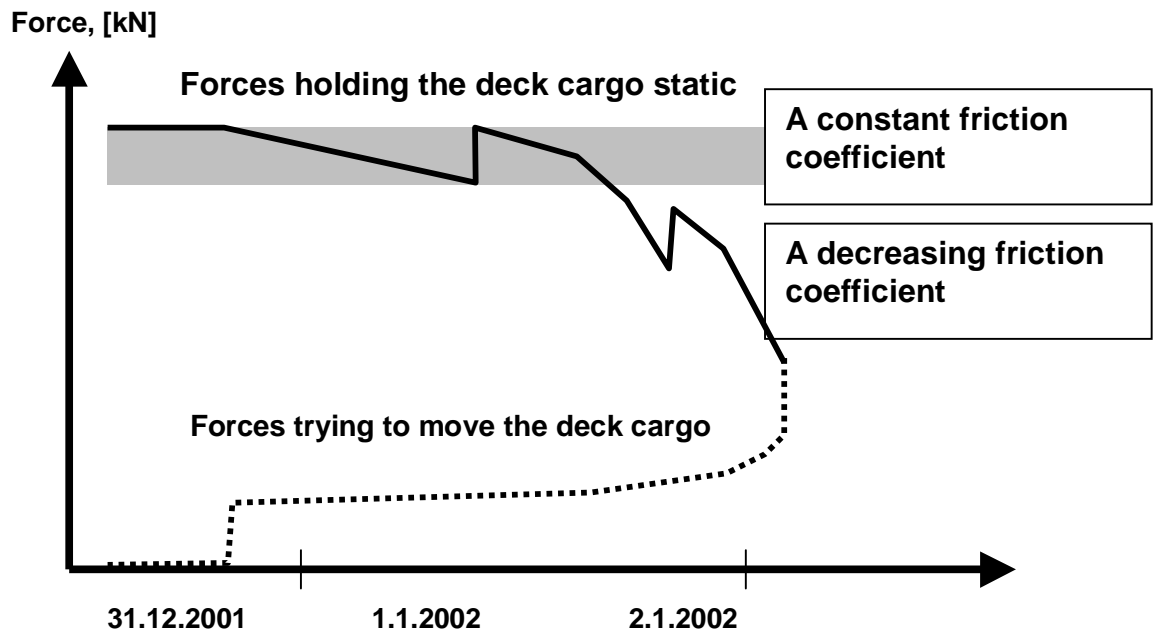
Figure 7. A possible scenario of the development of forces during the voyage of FJORD PEARL
