Investigation report

C 3/2002 M

**DOURO CHEMIST, grounding at Lövskär junction area,
February 19, 2002**

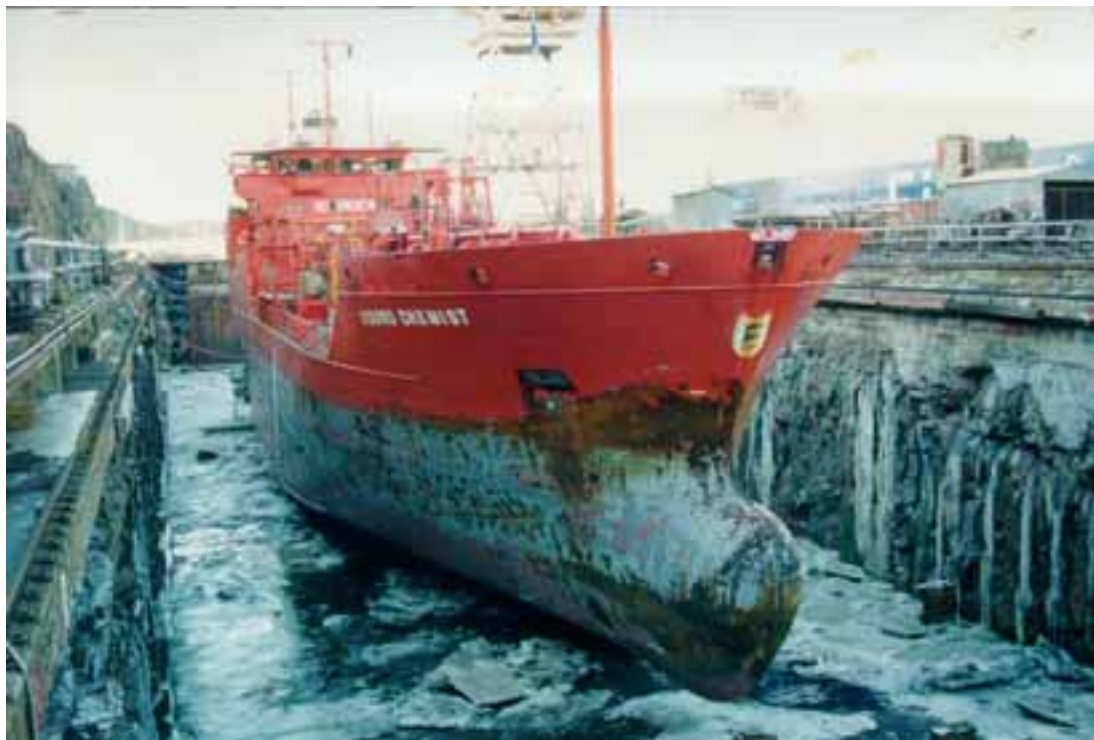
Figure 1. M/T DOURO CHEMIST in the basin of Turku repair dock

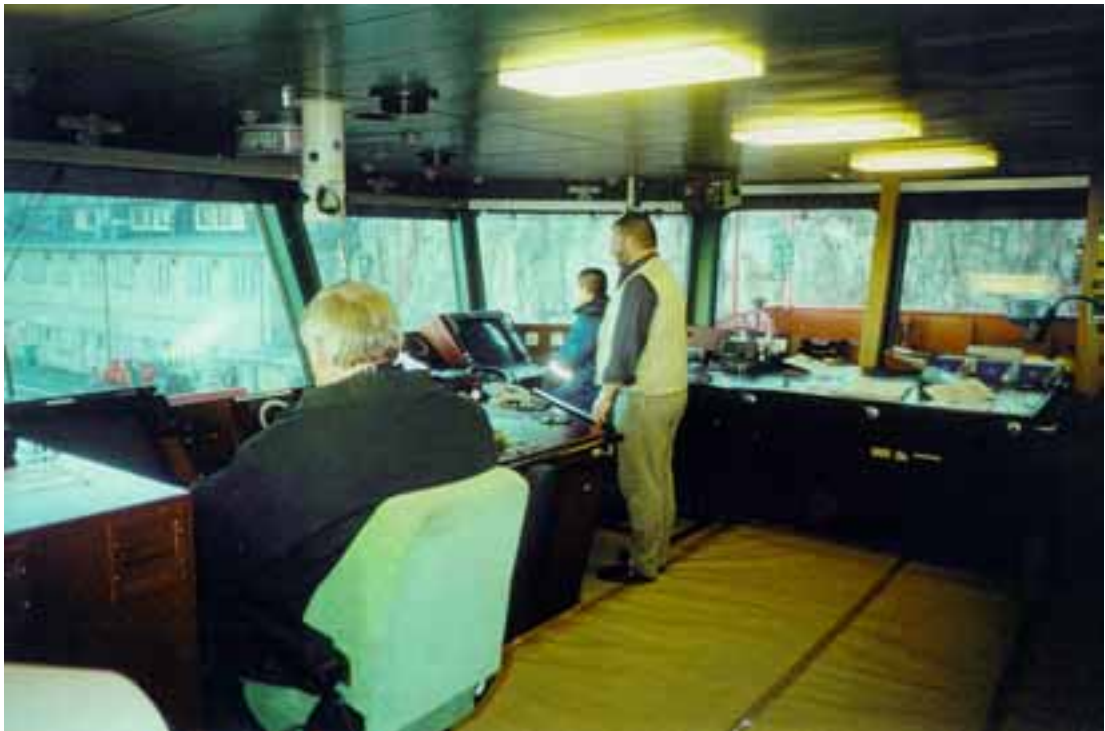
Figure 2. Cockpit: The persons in the picture are situated as at the time of the accident. Pilot on the left, Master standing and mate sitting on the right.

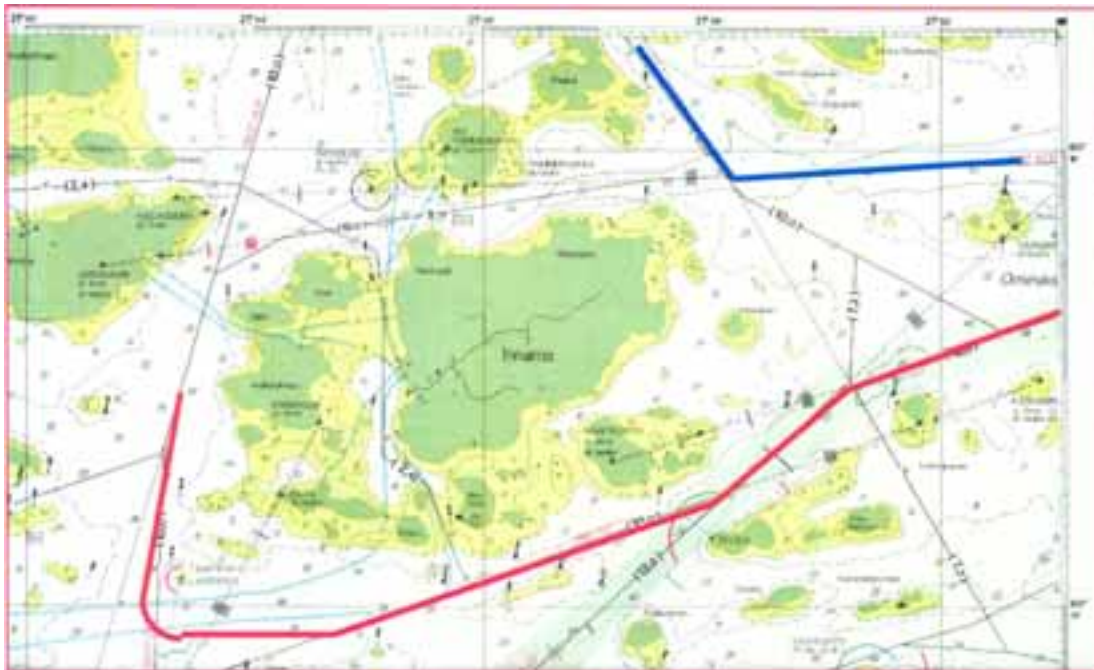
The Master and the pilot went over to the chart desk to study the chart together and the pilot explained the situation but apparently did not emphasise that the Kaitkivi turn would be driven based only on a single radar target. It is the impression of the investigators that it was intended to rely on optical observation in the final stages of the turn. The Master studied the route proposed by the pilot. It is a marked deep channel and the Master did not doubt the choice of the new passage and trusted the pilot in the situation in question. The Master familiarised himself with the new passage by taking the accurate position, the following heading and the distance. When a new course was adopted the Master went back to the chart to study the next leg of the passage.

Figure 4. Blue line depicts the passage plan made by the Master and the red line the passage selected by the pilot.

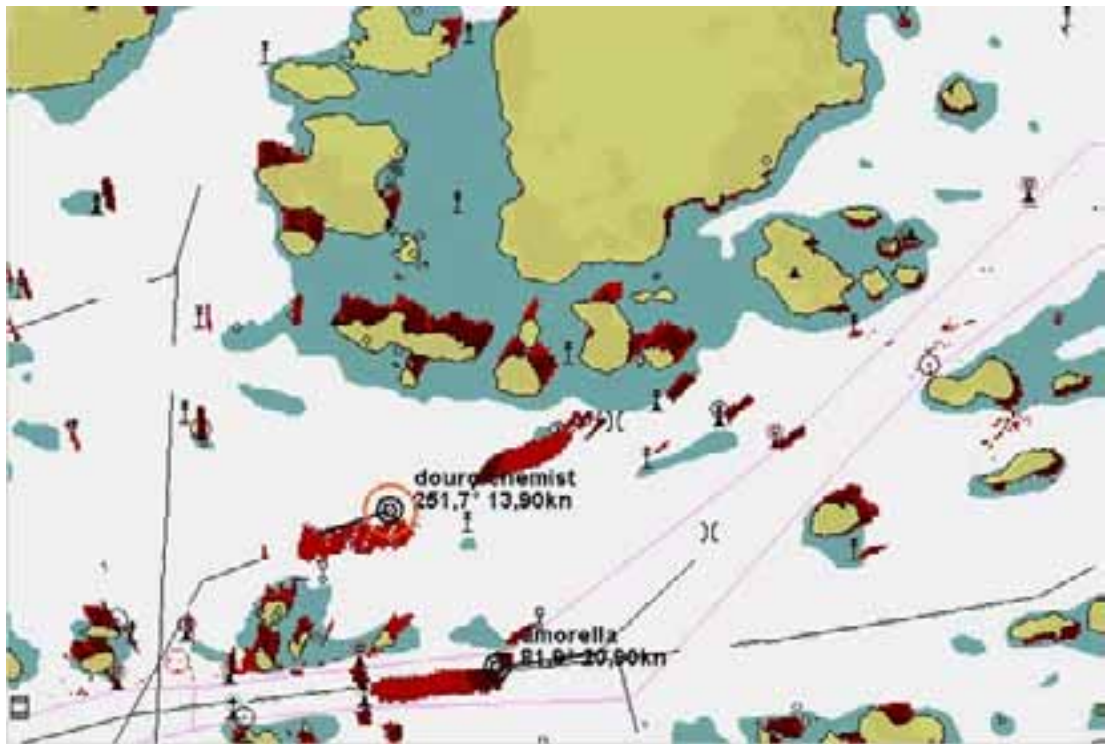
The vessel was driving along the Kaskisgrundet stern lead. The lead was slightly open to the south. The pilot was driving an open lead in order to control the drift caused by the south-west wind. At 05.49 the vessel passed the south buoy VQ(6)+LF 10 s. The Kaitkivi light was visible on both radars. The Master went over to the chart desk to study the situation. The pilot continued along the Kaskisgrundet lead until the Grangrundet edge marker lay 4 cables off, at which point he turned to heading 270°. In this turn the Master was still convinced about safe navigation of the ship and of the pilot's chances to execute the sharp turn that was approaching.

Figure 5. VTS registration display as the ship was driving on the Kaskisgrundet line before the turn to west.

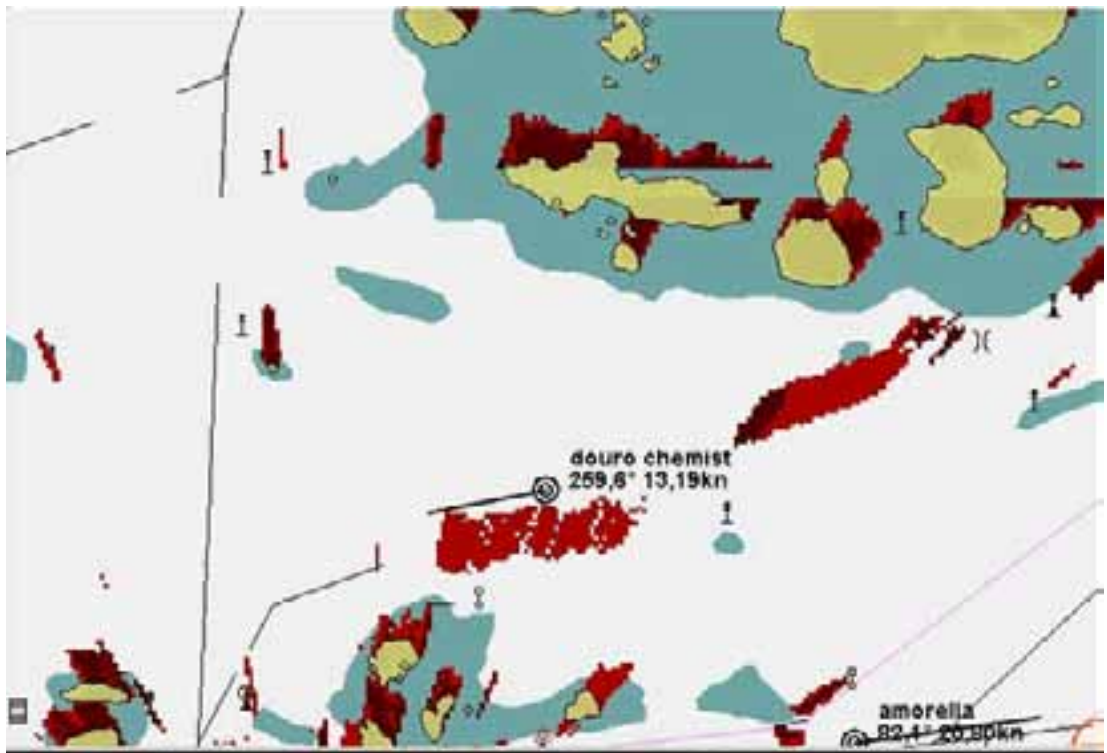
Figure 6. Vessel turning to heading 270°. Grangrundet and Kaitkivi are still visible on the radar of the vessel.

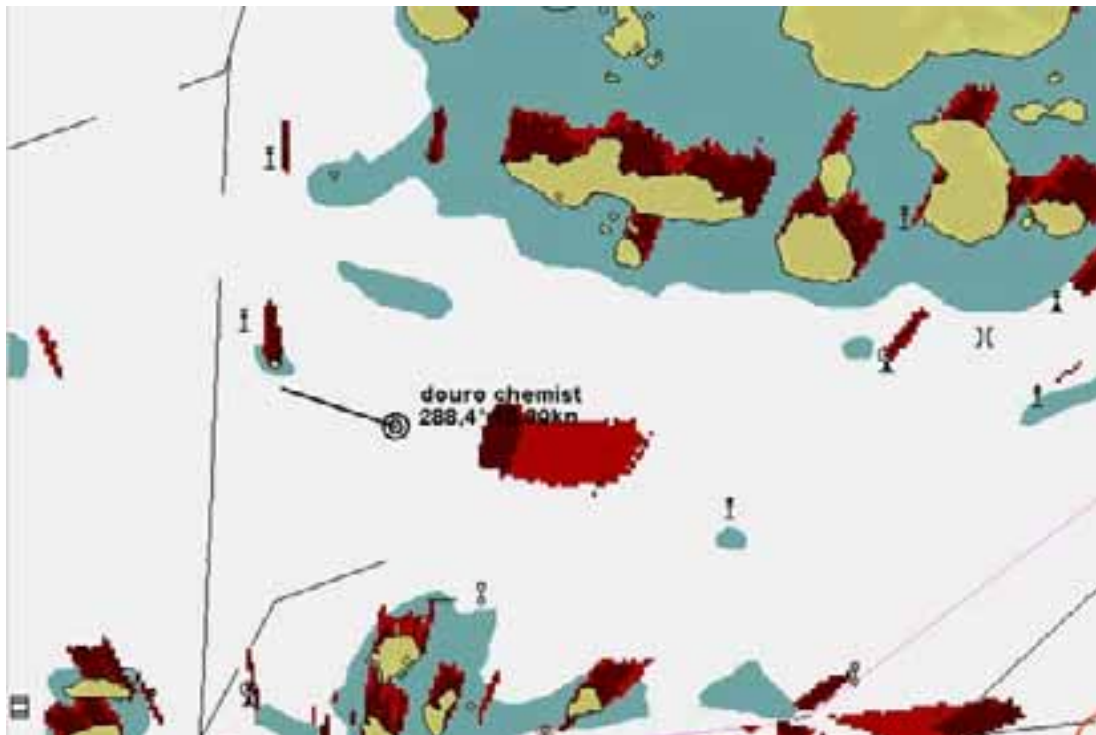
Figure 7. Last chance to avoid the accident if the positioning had been successful.

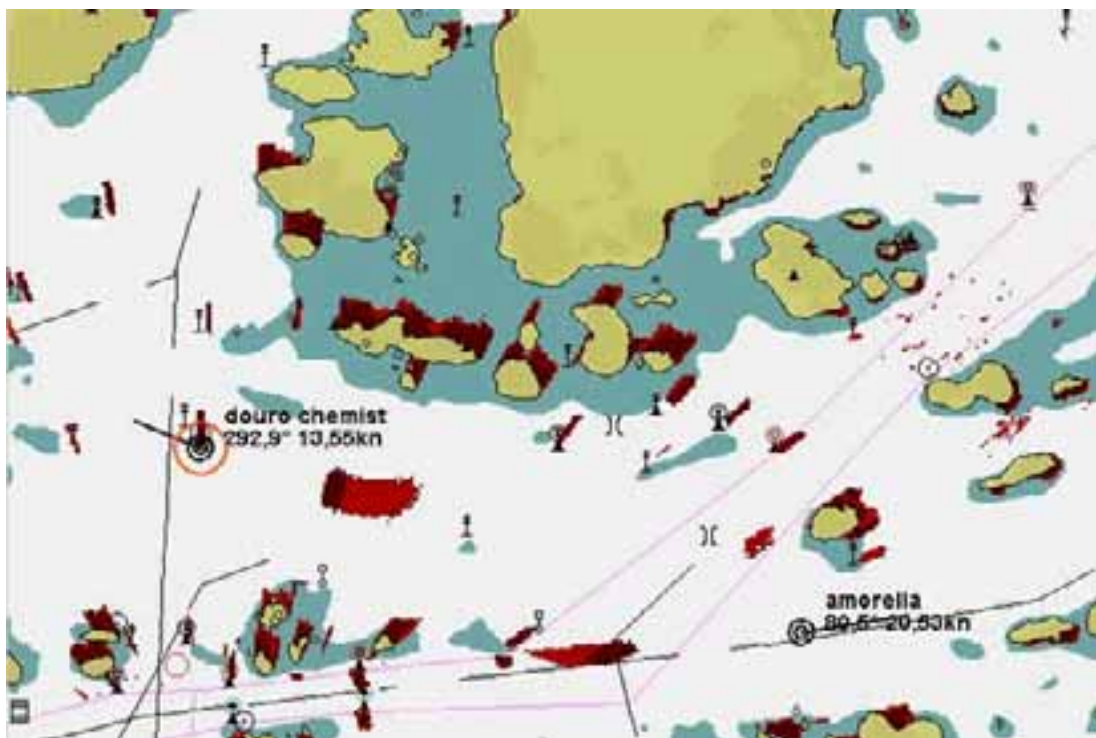
Figure 8. Vessel and Kaitkivi shallow meet

Grounding. When the searchlight was switched on, Kaitkivi was detected at 05.54 about 10 metres starboard of the bow in the light and at the same moment the vessel grounded during the turn to port. At the time of the grounding the pilot, III mate and the Master all observed that Kaitkivi was unlit. According to the investigation, the vessel was not in the lit sector of Kaitkivi at this time.

According to the survey of the seabed performed by a diver on March 5, 2002, the first grounding took place in the south-east, about 20 metres from Kaitkivi where the depth is about 4,2 metres. This place is in the dark sector of Kaitkivi.

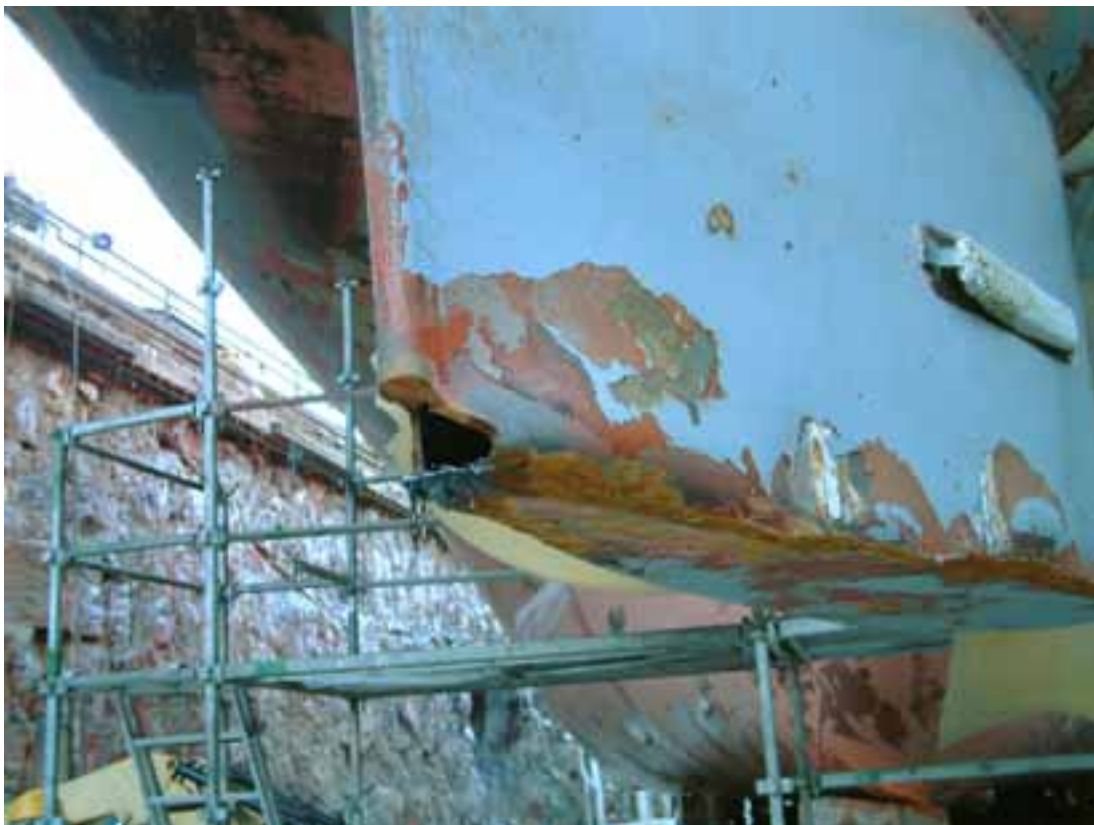
The rudder, rudder butt and the rudder machine had been damaged. All four propeller blades, the propeller shaft and the coupling machine had also sustained damage. All these had to be dismantled, repaired and remounted. Ballast tanks 4 C, 5 SB, 6 C and 7 SB had sustained damage in an area of about 150 m². 11 metres of the bilge keel had been damaged. A total of 7458 kg of steel was used for the repairs.

Figure 9. Damage to the rudder

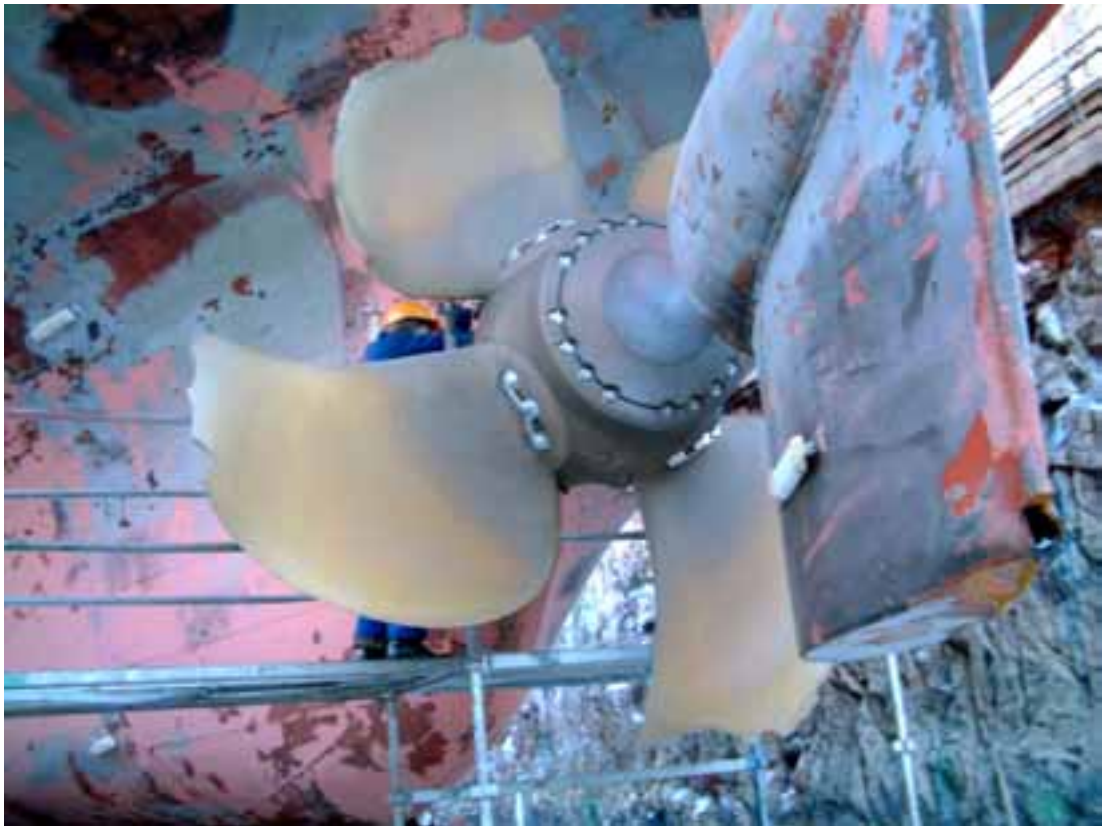
Figure 10. Damage to the propeller, all blades damaged

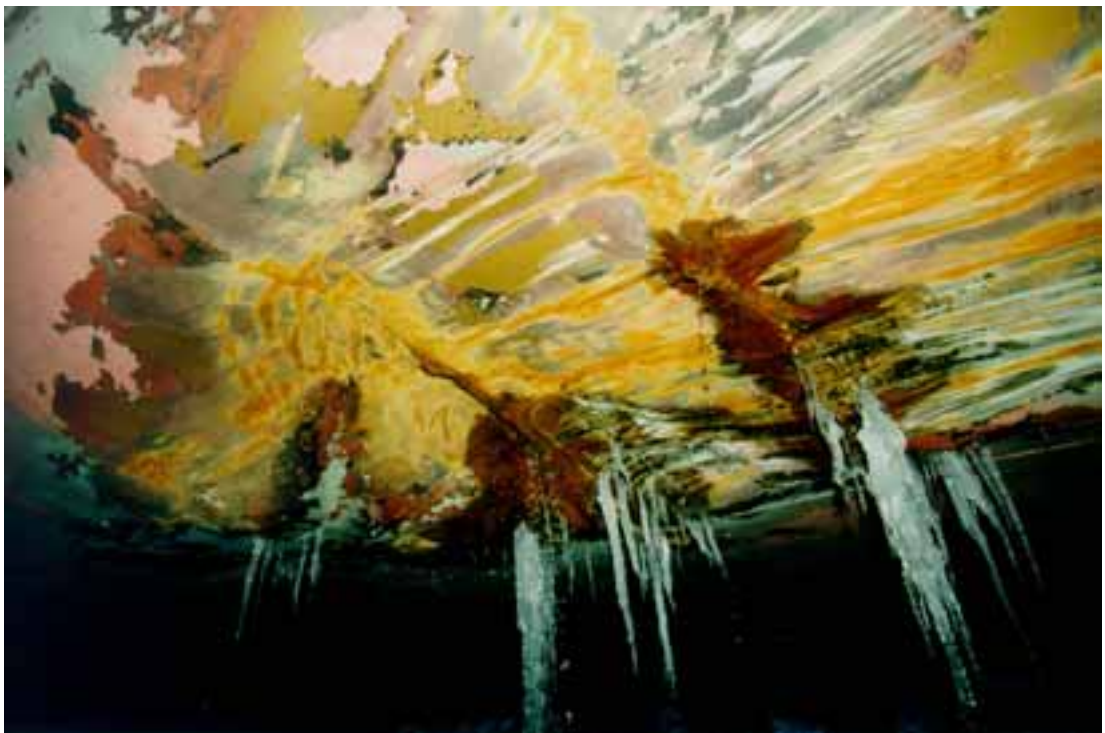
The vessel had sustained damage to three ballast tanks in the double bottom, 4 C, 6 C and 7 S, to the double bottom of the engine room, to the propeller and to the rudder.

Figure 11. Hull damage on outer bottom of vessel. Water dripping out of a ballast tank

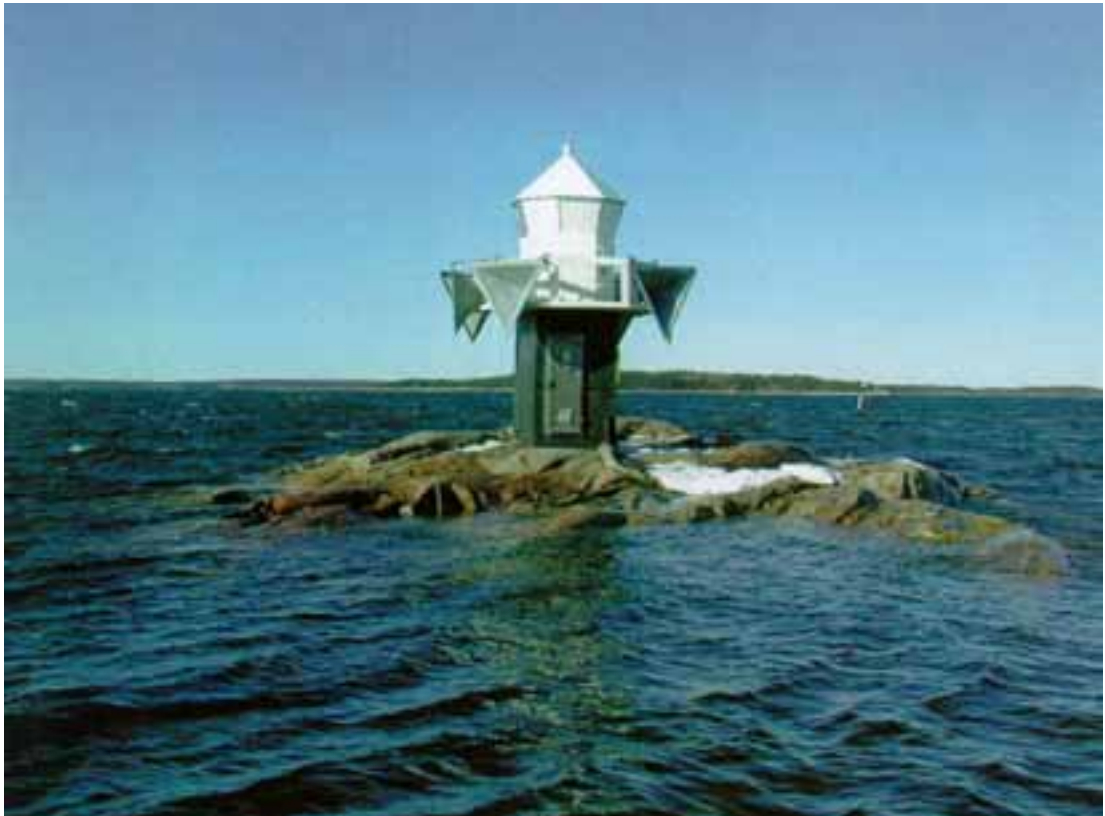
Visibility in the accident area was good, wind was from the south-west at 6 m/s and open water. Kaitkivi is low (5,2 m from sea level) and there were stacks of ice around it which could have made it more difficult to get a good radar echo of Kaitkivi even though it is equipped with efficient but low-mounted radar transponders.

Figure 13. Kaitkivi light

The obvious reason for the loss of the Kaitkivi target from the radar screen is its low height (5,2 m), and alternative echoes were not used. Observing the target weakens its unlit trunk and the lack of the sector light in the direction used for the approach. However the vessel was not stopped when the situation became uncertain.

4. *The Kaitkivi turn be marked more clearly by using leads and a radar transponder higher up. The sector of the Kaitkivi light should be extended to the approach direction used in this case and also the trunk of the light should be lit.*
