Investigation report

C3/2007L

Emergency water landing off Helsinki on 27 May 2007

Aircraft type and model: Diamond DA40D

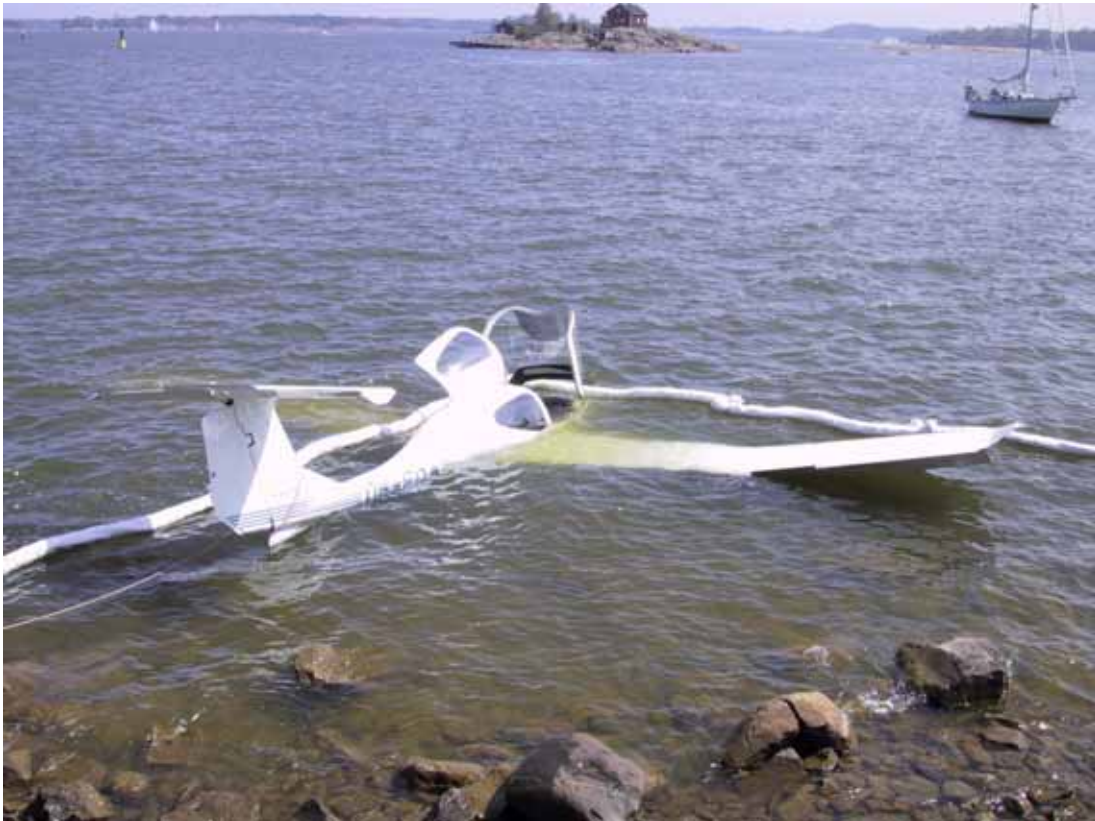
The nose gear was damaged and the engine cowlings came off during the landing. The upper cowling was never found. The leading edge of the right wing was torn. All propeller blades snapped approximately in half. Once the aircraft was towed to shore, it sank so deep that it was completely submerged.

There were traces of black oil leaks on the front inner surface of the lower engine cowling. Oil could also be detected on the nose gear and the belly of the fuselage.

Figure 1. The aircraft at the shore

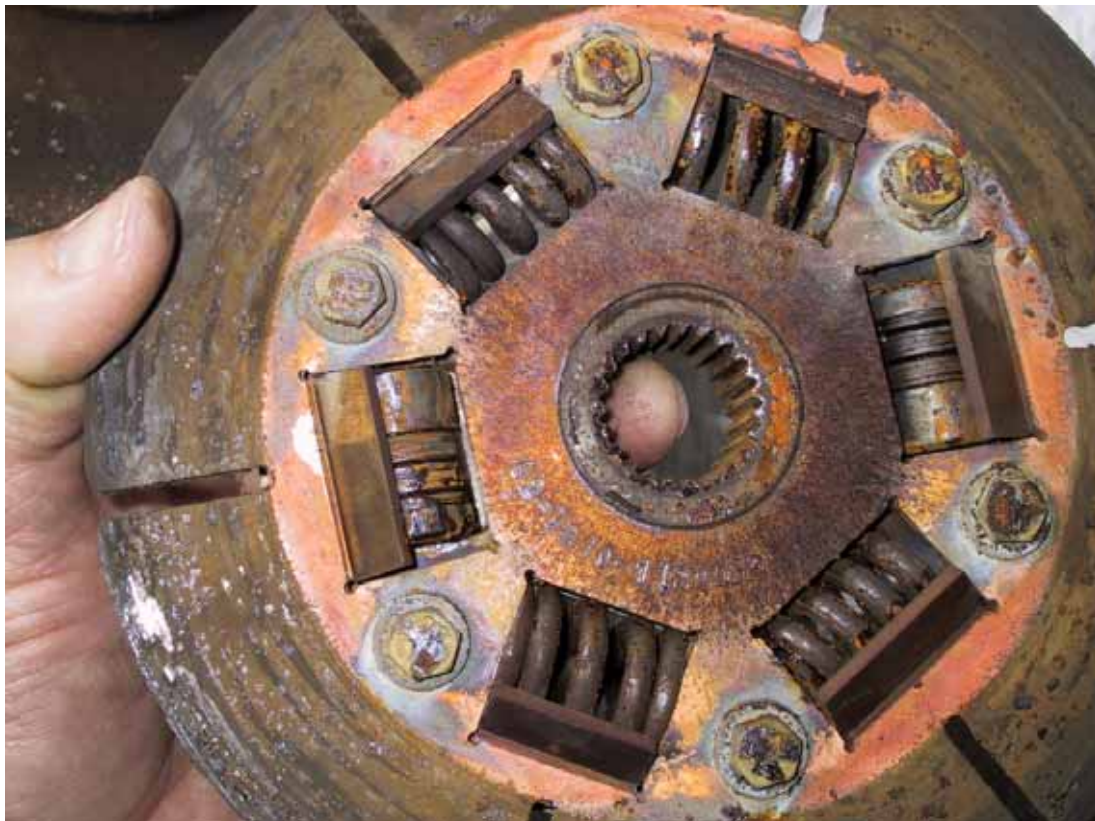
Figure 2. The badly damaged clutch plate

The clutch friction plates were almost totally worn off. Clutch plate shavings were found on the bottom of the clutch housing. The clutch assembly was corroded by sea water. When the assembly was dismantled, bolt tightness was measured at only 4 Nm, when it should have been 25 Nm. It is probable that this was caused by clutch slippage generated by heat, followed by rapid cooling. The Belleville assembly was correctly assembled.

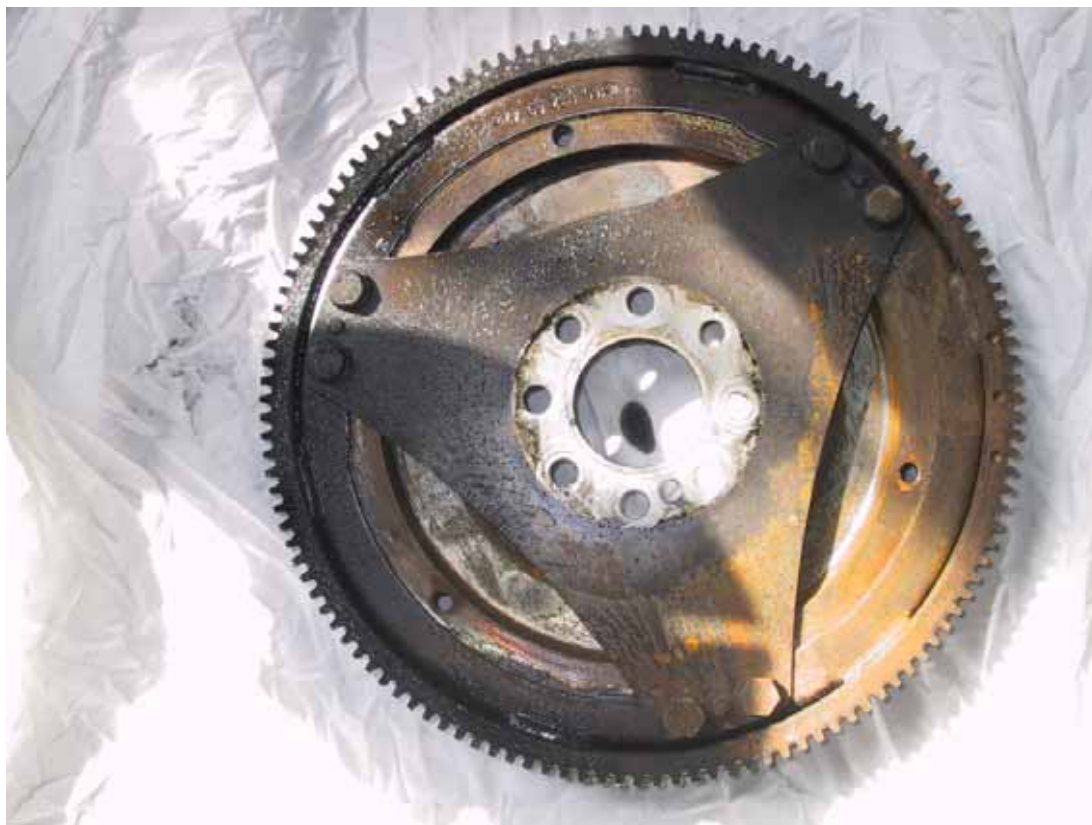
When the gearbox was removed it was detected that the gearbox housing was oily. There was also oil on the rear surface of the flywheel. In addition, there was oil on the seal between the crankshaft flange and the flywheel mating surfaces.

Figure 3. The oily rear surface of the flywheel

When the crankshaft lip seal is defective, engine oil makes it to the rear surface of the flywheel from where the oil vapour is slung into the clutch housing, contaminating the clutch. The clutch housing and the rear surface of the flywheel were oily in this case.

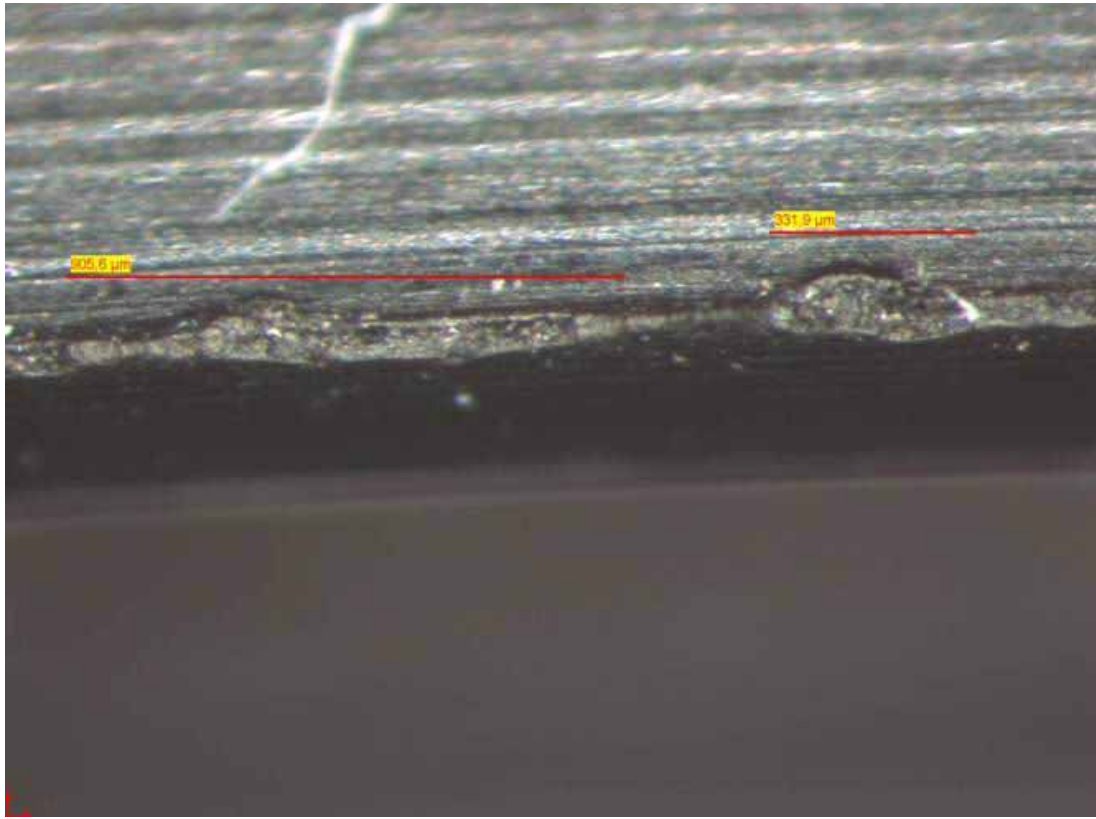
The flywheel-side crankshaft seal was microscopically examined at the manufacturer's plant. Normal wear was detected around the edges. However, at the very edge of the seal there were two fractures. The first was 332 μm long and about 100 μm wide. The second was 906 μm long and approximately 100 μm at its widest.

Figure 4. Crankshaft seal damage

Under a microscope the engine manufacturer detected fissures on the crankshaft lip seal surface. These could have caused the leak. According to the manufacturer these kinds of seal defects have not been detected earlier, but manufacturer assumes they are due to high internal crankcase pressure.

Another interesting point of observation of the fractures was that they were located 180° in opposite to each other. This let us assume that one half of the sealing lip flipped over due to high internal crankcase pressure and created these fractures.

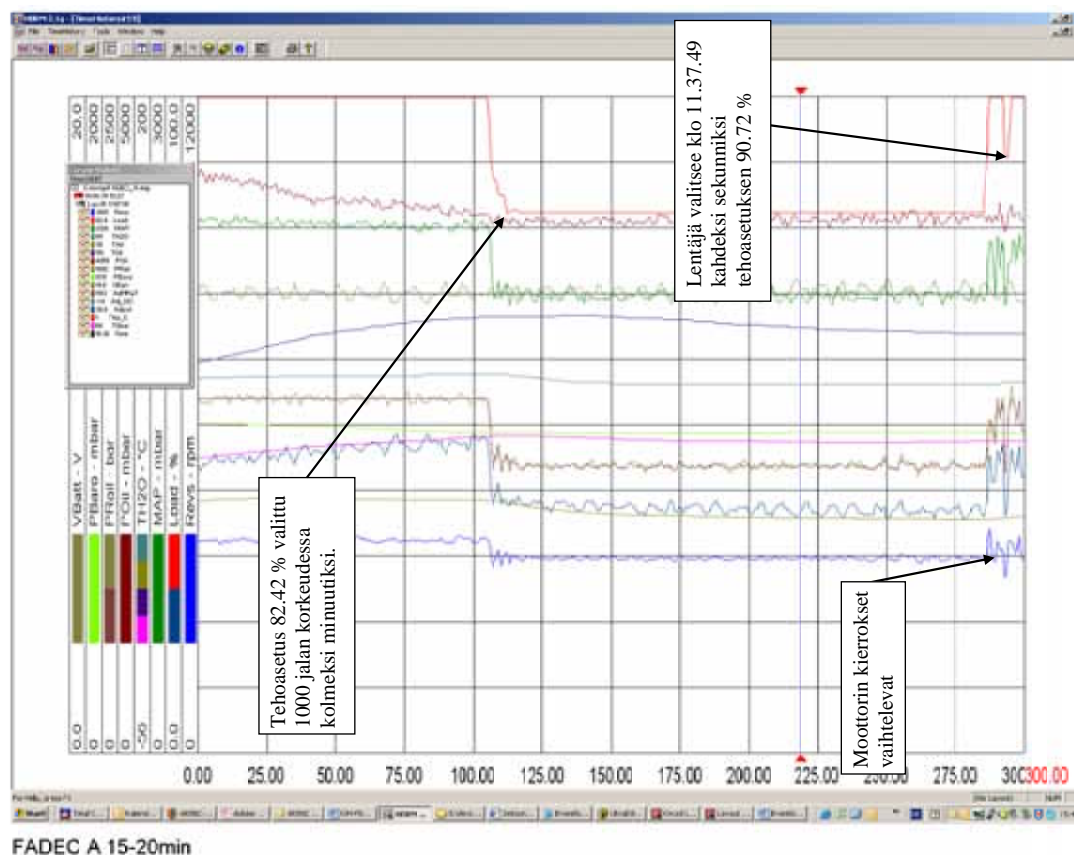
At 1000 ft power was set to 82.4 % for three minutes. Power was set to 99.99 % at 11:37, (clearance to climb to 4000 ft). Engine parameters fluctuated for six seconds as follows: engine speed 4136–3494 RPM (2447–2067 propeller rpm), manifold pressure 2364–2078 mbar, fuel pressure 1358–1172 bar. Power was set to 90.72 % for two seconds at 11:37, after which it was set to 99.99 %.

Figure 5. FADEC parameters at 15–20 min into the flight

The clutch torque limit was exceeded for the first time when the aircraft commenced the climb to its clearance altitude. As the clutch slipped, the engine rpm-limiter (FADEC) automatically reduced fuel feed for six seconds. Had the pilot become aware that the malfunction was caused by clutch slippage, he could have continued the flight at a lower power setting (see figure 5).

The investigation commission recommends that the engine manufacturer design a system indicating changes in the rotational ratio between the crankshaft and propeller, i.e. clutch slippage. Clutch slippage indication should also be recorded in the FADEC's On-Board Diagnostics system.

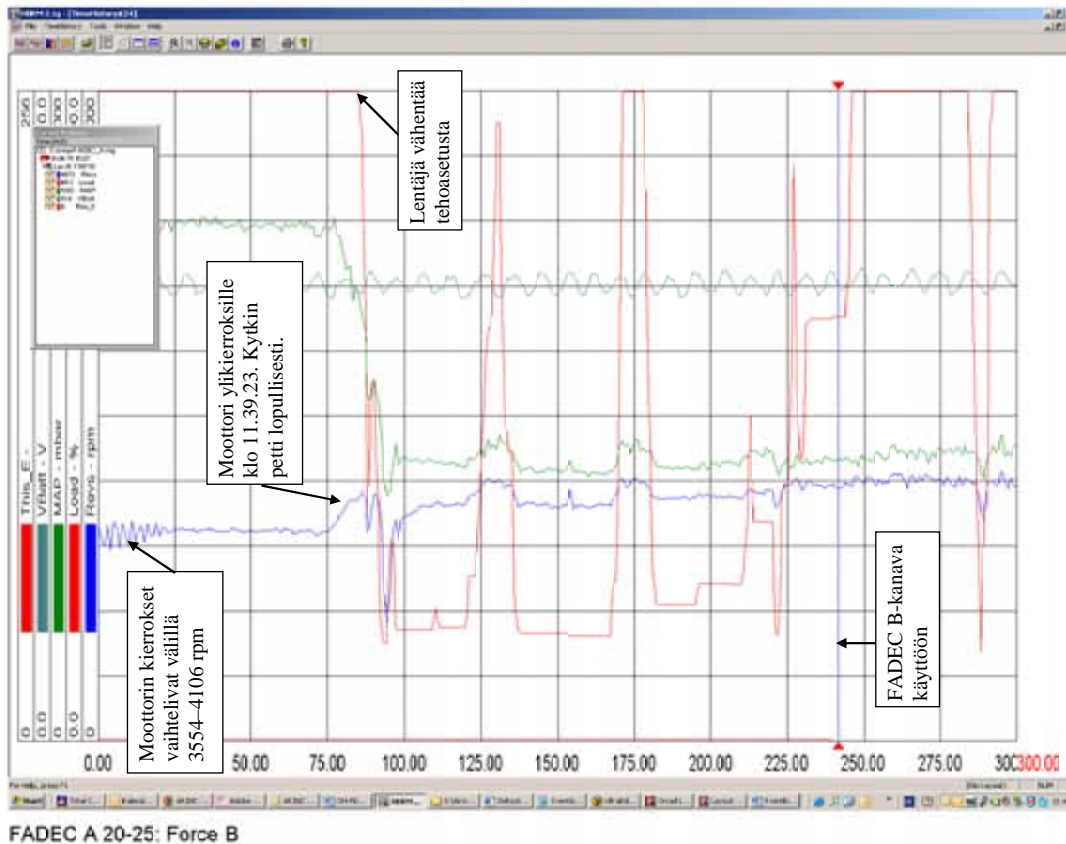
Engine speed varied between 3554–4106 rpm. (maximum engine speed is 4225 rpm, maximum propeller speed is 2500 rpm). The engine oversped (overrevved) at 11:39 (4608 rpm), which was recorded by the FADEC's diagnostic unit. When power was set to 15% engine speed decreased to 2144 rpm for one second. Hereafter, the engine was overspeeding until landing, even though the power lever position varied from 16.21–99.99 %. The FADEC's B channel was selected at 11:41.

Figure 6. FADEC parameters at 20–25 min into the flight

When the clutch finally failed, propeller speed was no longer appropriate for the corresponding engine speed. Fuel feed constituted only 20–25 % of the normal full power fuel requirement (figure 6).

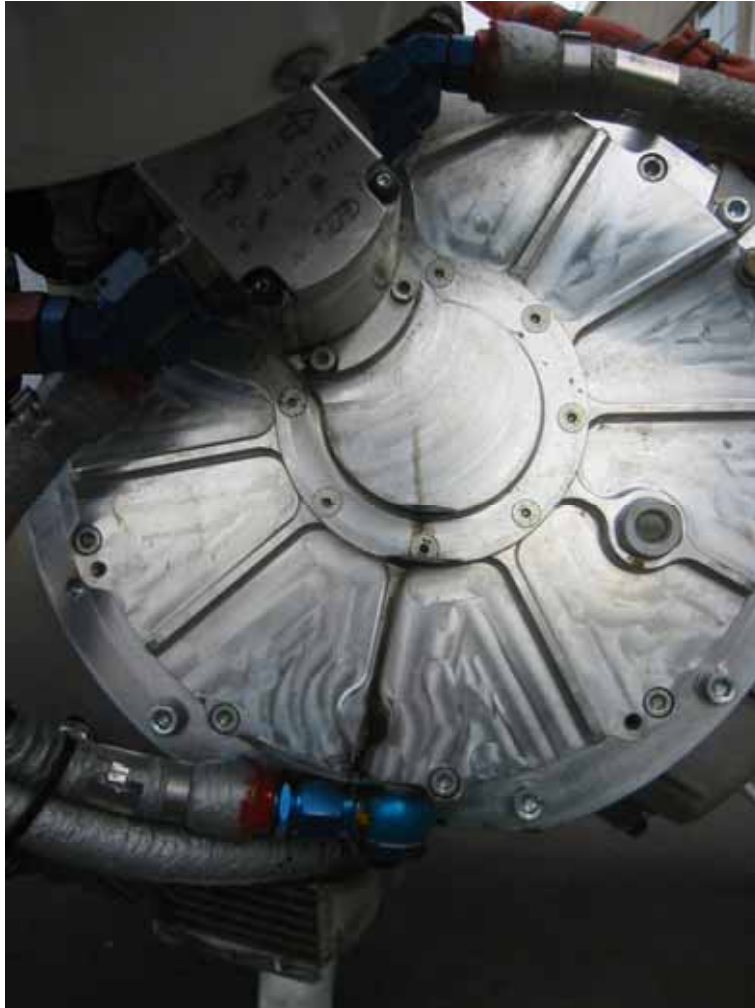
Approximately one and a half months prior to the emergency landing the aviation club's maintenance manager had continually detected engine oil on the front surface of the gearbox. The leak was monitored and it was then noticed that engine oil was seeping from the seal between the dual Combi pump (oil pump) on the front of the gearbox and the turbocharger oil line. Oil was still leaking even after the oil line was replaced. Approximately two weeks later it was noticed that the leak did not involve the seal after all. Rather, it came from the space between the Combi pumps where there was a case drain aperture. The leaking oil ran down the front of the gearbox onto its lower edge from where it dripped into the inside front of the lower engine cowling. Airflow then sprayed the oil onto the nose gear and the belly of the fuselage, all the way back to the empennage.

The maintenance manager had noticed that there were traces of oil leaks in two separate places inside the engine cowling. They also differed in colour. The front oil leak was lighter whereas the one behind it was darker.

Figure 7. The oil leak from the Combi pump ran down the front of the gearbox onto its lower edge, from where it dripped into the inside front of the lower engine cowling.

The plan was to replace the leaking Combi pump during the next maintenance in May–June.

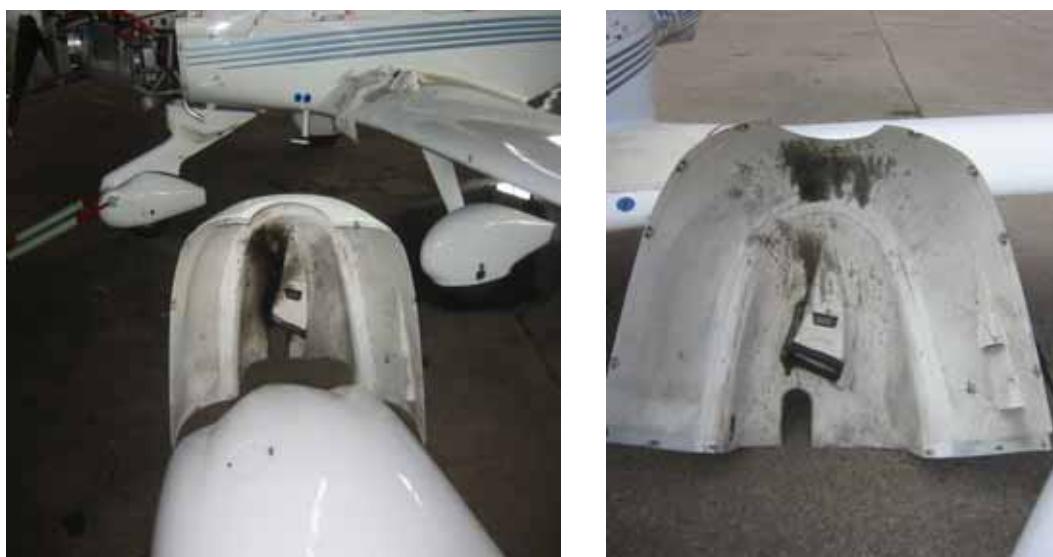
The maintenance manager had taken photographs of the oil leaks on the inner surface of the lower engine cowling. The first photos were taken on 16 April and 17 April, i.e. approximately one and a half months before the emergency landing. The photos reveal quite extensive oil leaks from the Combi pump as well as traces of leaked oil on the lower cowling at the pump location as well as where the clutch housing breather aperture is located. The pictures show that the oil leak at the aperture is lighter in colour compared to the colour of the leak in front of it. The leaked oil had also made it to the nose gear and, possibly, to the belly of the fuselage. At that time the oil leak traces were cleaned off.

Figure 8. Oil leak traces on the lower engine cowling. Left photo taken on 17 April 2007. Right photo taken on 26 April 2007.

The second photo, taken on April 26, also shows oil leaks at two spots. The biggest leak is situated in front of the breather aperture. However, there are also traces at the aperture itself. This oil is lighter in colour compared to the previous time and no oil had leaked onto the nose gear. This time, too, the oil leak traces were cleaned off.

The investigation commission recommends that the engine manufacturer redesign the clutch breather orifice or its shape so that oil leaks internal to the clutch housing could be reliably distinguished from other, external, oil leaks.

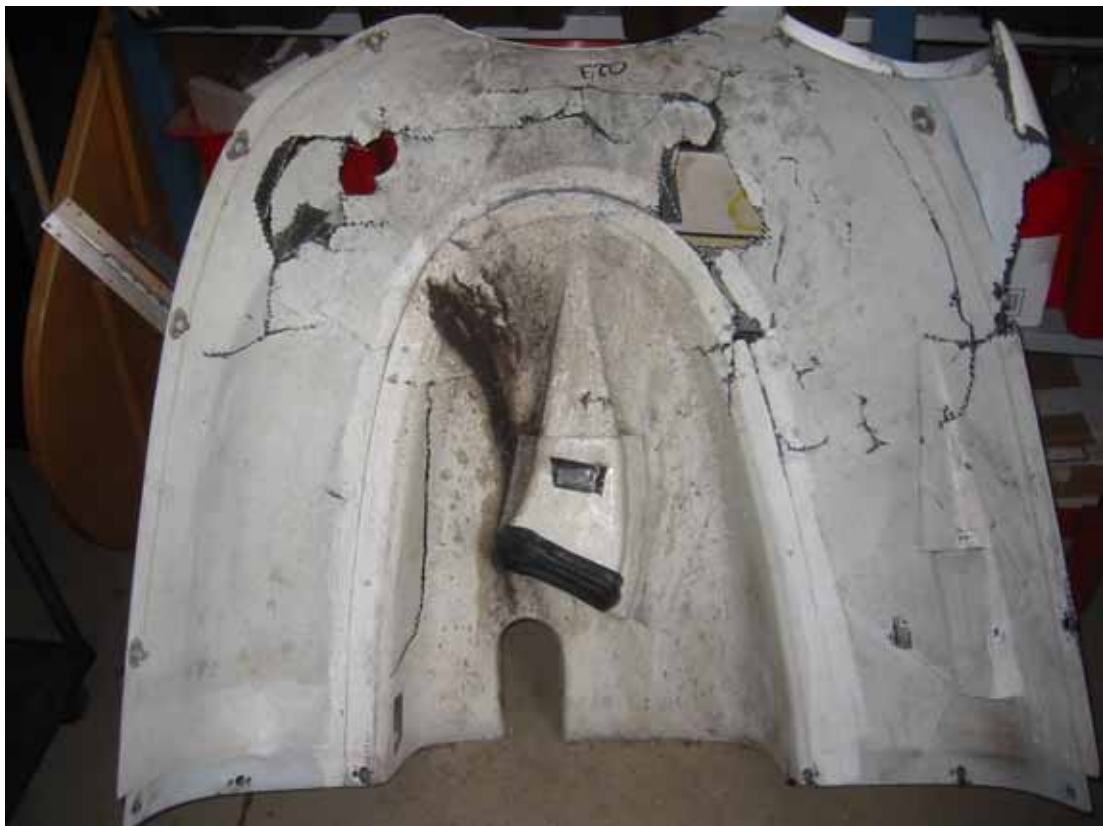
Traces of oil leaks were mostly found in two places on the inside of the engine cowling. The front trace was caused by a leak in the Combi pump on the gearbox. Some of the oil from this leak had dripped directly onto the cowling. The rest of it ran down the front wall of the gearbox and dripped behind the previous spot, at the clutch housing breather aperture. The oil from inside the clutch housing also dripped onto the same spot. It was darker in colour because it was contaminated by the friction material from the clutch.

Figure 9. Oil leak traces after the emergency landing

The external oil leak dripped onto the inner surface of the lower engine cowling at the edge of the clutch housing breather orifice. In other words, at the very same place from where the oil leak inside the clutch housing was coming out. Checks during flight operations had focused on the external oil leak from the oil pump. Therefore, the internal leak was only discovered after the emergency landing. Combined, these leaks were quite significant, as oil was detected under the fuselage all the way to the tail section and had required a need to top up the oil reservoir.
