## **Investigation report**

C 4/1998 M

**ms GERDA, grounding outside port of Kotka, April 7, 1998**

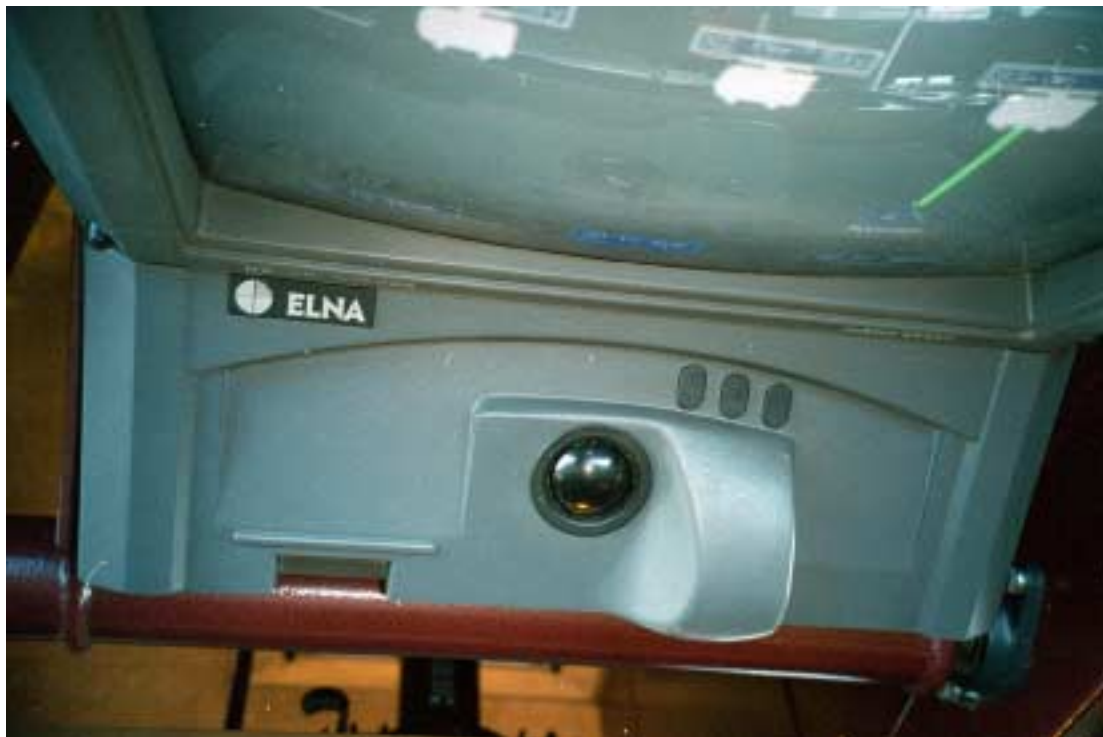
**User interface of the Kelvin & Hughes radar.** The Kelvin & Hughes monitor is generally considered to be a fairly good piece of equipment for open sea navigation in Europe. All functions are handled through menus with one rollerball and three buttons, which perform different functions according to the selected menu. The user interface of the radar is presented in Figure 9. The advantage of this system is the absence of all buttons and controls, but for the user this means multiple functions. The system is not functional for pilots, as it differs from other radars. The radars and steering equipment of a vessel the GERDA's type are analysed in accordance with the accident investigation of ms BALTIC MERCHANT (Investigation C 5/1998 M) based on piloting and the Rhein river traffic regulations. According to these regulations, the user interface of the Kelvin & Hughes radar is not acceptable. In the investigation of the BALTIC MERCHANT, the pilot clearly indicated that the user interface of the Kelvin & Hughes marine radar was slow to operate.

Figure 9. Keyboard of Kelvin & Hughes radar.

**Summary of radars.** The user interface of the Kelvin & Hughes radar on the GERDA differs considerably from radar sets of other manufacturers. This causes problems, especially for pilots, because they do not get the same opportunity to practice using the radar as the ship's officers. With regard to piloting, the radar adjustments are too complex and too slow to use. Pilots navigating in archipelagos and in ice have criticised the user interface.

The Rhein river traffic regulations contain provisions for the user interface of the variable range marker and electronic bearing, which could be applied to piloting under Finnish conditions. If the user interface of a radar is deemed unsuitable for piloting then a visibility limit must be set for the piloting.

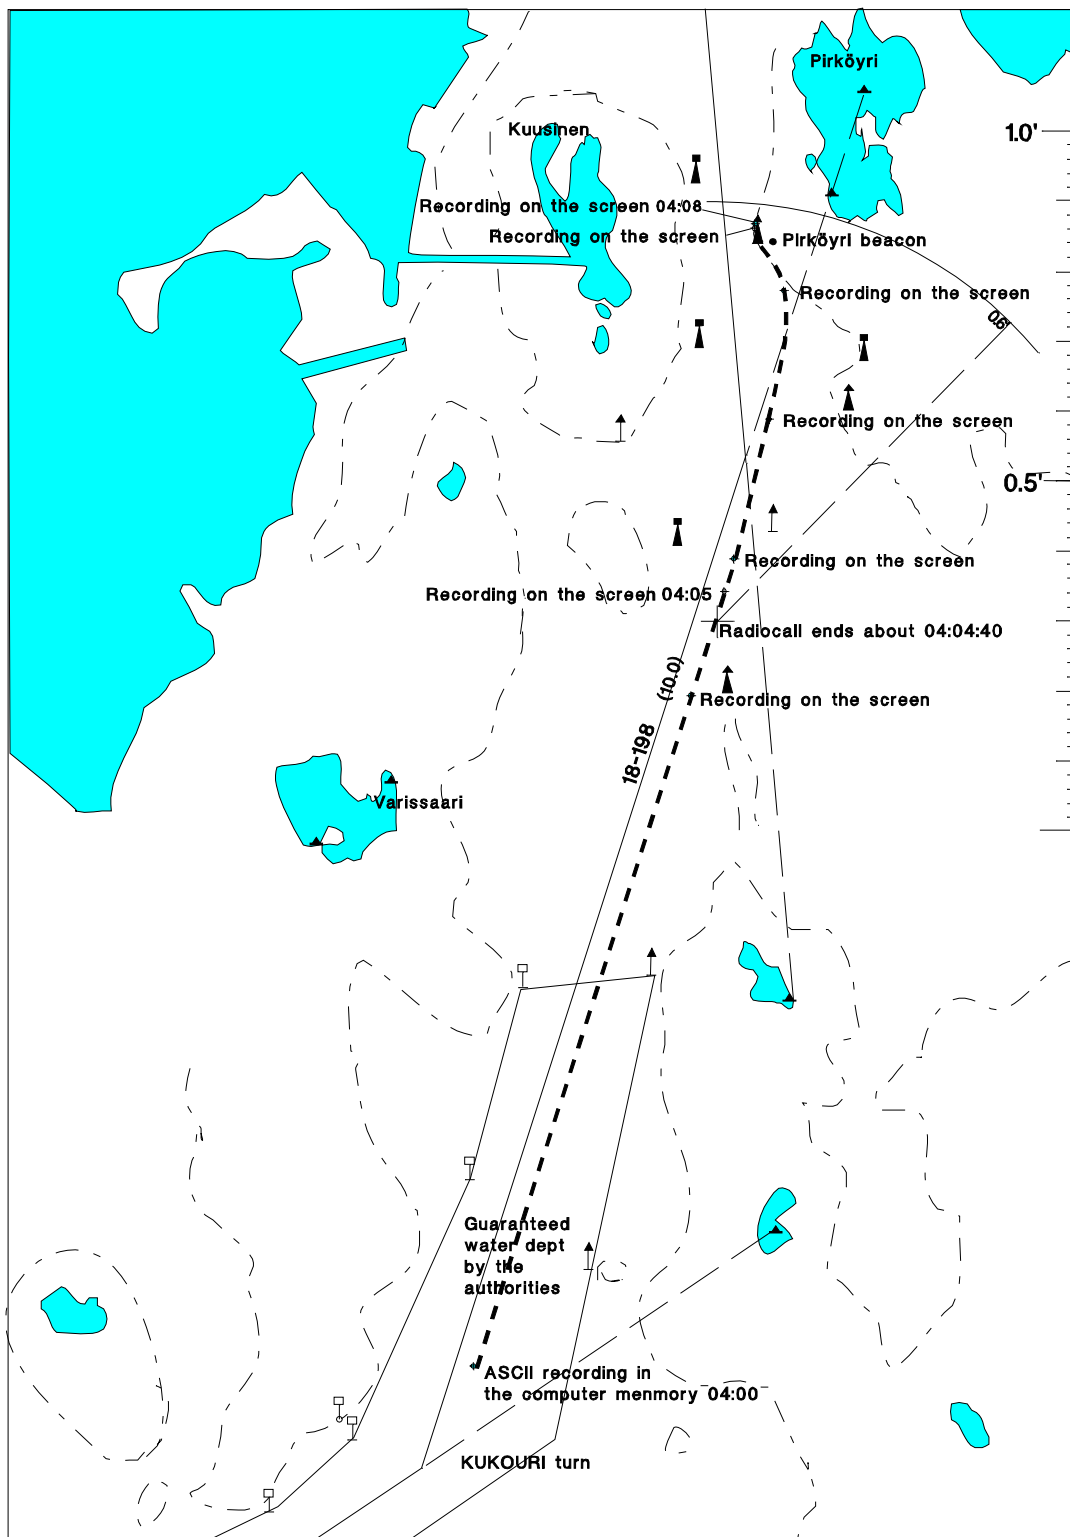
Figure 13. Passage of GERDA traced from electronic chart. Chart was photographed after grounding. Vessel position and times registered automatically on chart at 1 minute intervals. Grounding site next to Pirköyri beacon.

According to the GPS registration (position points recorded on the electronic chart), the GERDA had passed the Halla – Kukouri line (355°) at a speed of about 11–12 knots before the turn to heading 360° began (Figure 13).

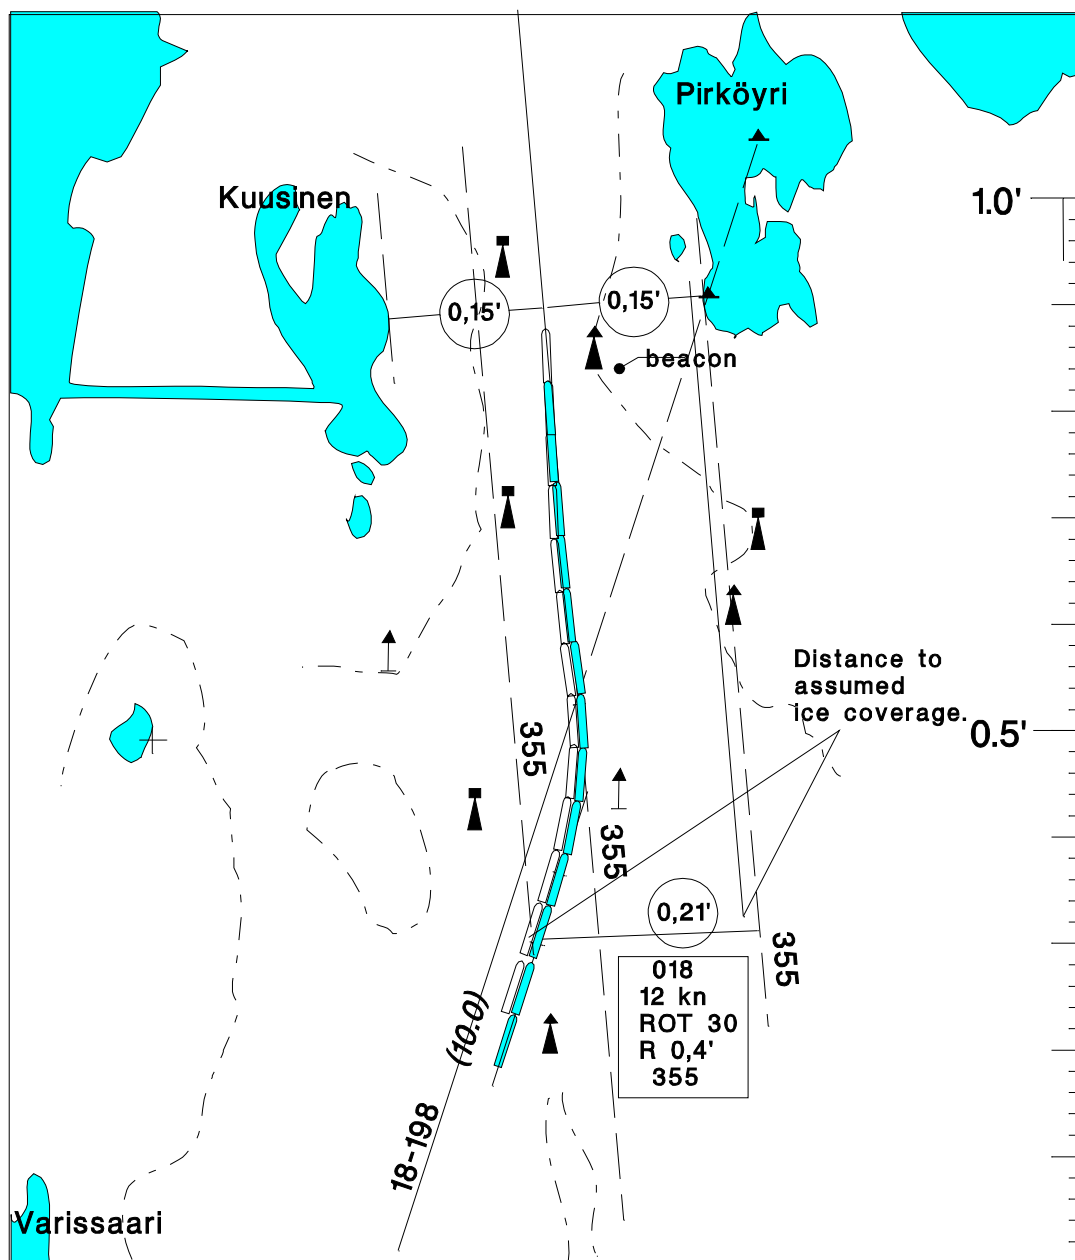
The radius of the turn is 0.4', and the starting point 0.06' before the start of an constant turn (Figure 16). Value 0.21' is set on the VRM ring and 355° is set for the EBL heading as tangent to the ring. The turn is started when the EBL touches the shore of Pirköyri. The pilot stated that there was packed ice at the Pirköyri shore interfering with the definition of the turning point. The assumption in Figure 16 is that the ice has shifted the shoreline 30–40 metres, which would have resulted in a similar shift to port in the trajectory of the vessel. The error could have been easily corrected with a heading of 355° before the Pirköyri Sound. The two parallel vessel trajectories depict the error caused by the ice on the shore.

In a written passage plan, the turn parameters are marked in a clearly visible box next to the turn (example in Figure 16). At the beginning of the turn, the rudder angles are 10°–20°. The rudder angle is adjusted so that the rate-of-turn indicator shows 30°/minute.

Figure 16 Example of Pirköyri turn plan.

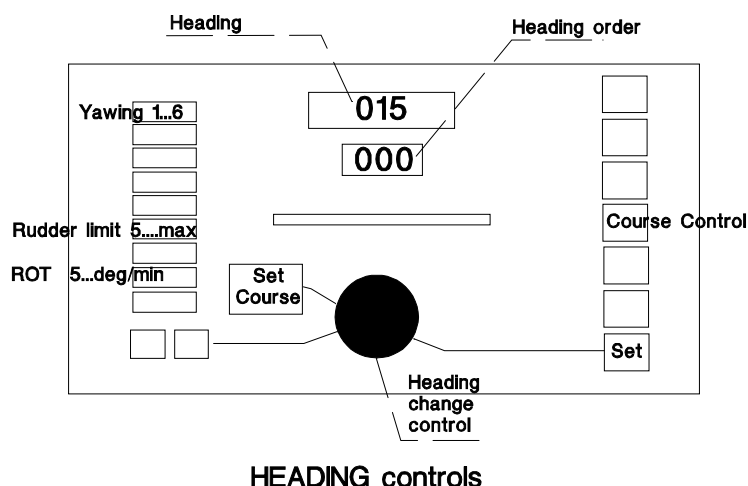
Figure 17. Main controls of COURSE CONTROL mode of Anschutz Nautopilot D in piloting:

The Course Control is thus susceptible to mistakes but it is not designed for navigation on winding fairways. The ROT Tiller is designed for that.

The user manuals of all commonly used radars and autopilots should also be made available to pilots. The autopilot modes should be summarised in a brief procedural manual for piloting. The ROT Tiller steering method should always be used during piloting. The course control mode is designed for cruising on open seas: it can be used on long straight lines but not on winding fairways. Training should be organised for pilots to explain the user modes of autopilots and the risk factors involved.

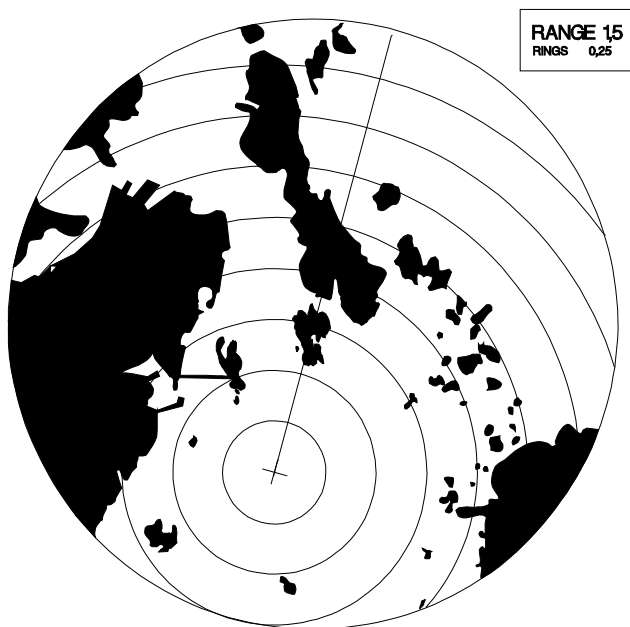
It is possible that the pilot made an error with the distances between the fixed rings on the radar when preparing for the turn. He could not use the variable range marker because the only user interface for the radar – the rollerball – was reserved for the adjustment of the radar image, which the pilot tried constantly to improve. If the southern tip of Pirköyri pierced the second range ring it is possible that the pilot erroneously thought that the first ring depicted a range of 0.5' instead of the actual range of 0.25'. This may

explain why he did not begin the turn at the location presented in Figure 18. The distance between the rings (RINGS) is expressed in the upper right-hand corner of the radar in smaller print than 'range' (RANGE).

*Figure 18. Range of radar 1,5', distance to Pirköyri 0,6'. Turn should have begun here.*

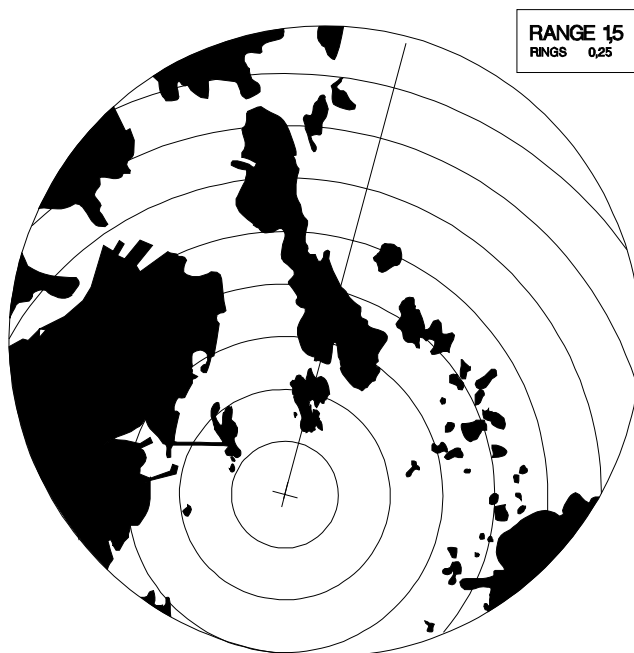
Figure 19a. Distance to Pirköyri about 0,3'. Range of radar still 1,5'. Turn to heading 360° begins.

Based on the above analysis, it can be assumed that the reason for the delay of the start of the Pirköyri turn has been a misinterpretation of the distance. This was caused by:

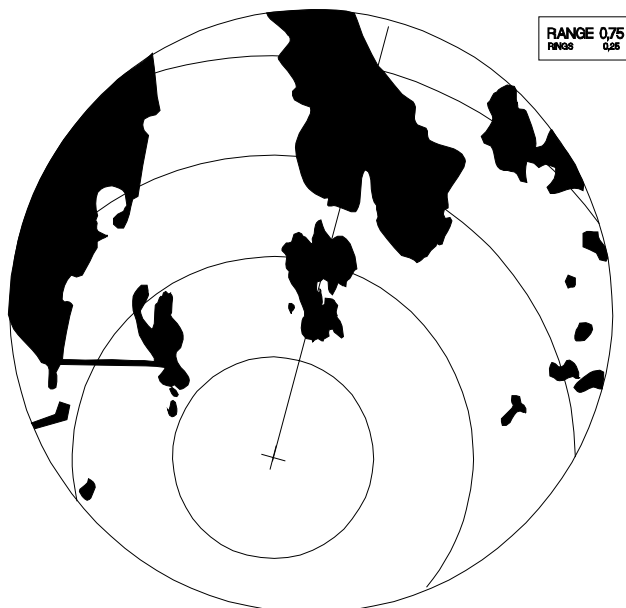
Unless there is time to verify the distance between the rings from the upper right-hand corner of the radar the distance can be misinterpreted.

Figure 19b. Distance to Pirköyri about 0,3'. Range of radar changed to 0,75'.
