Investigation report

C 5/1998 M

ms BALTIC MERCHANT, grounding in Puumala at Hätingvirta, April 21, 1998

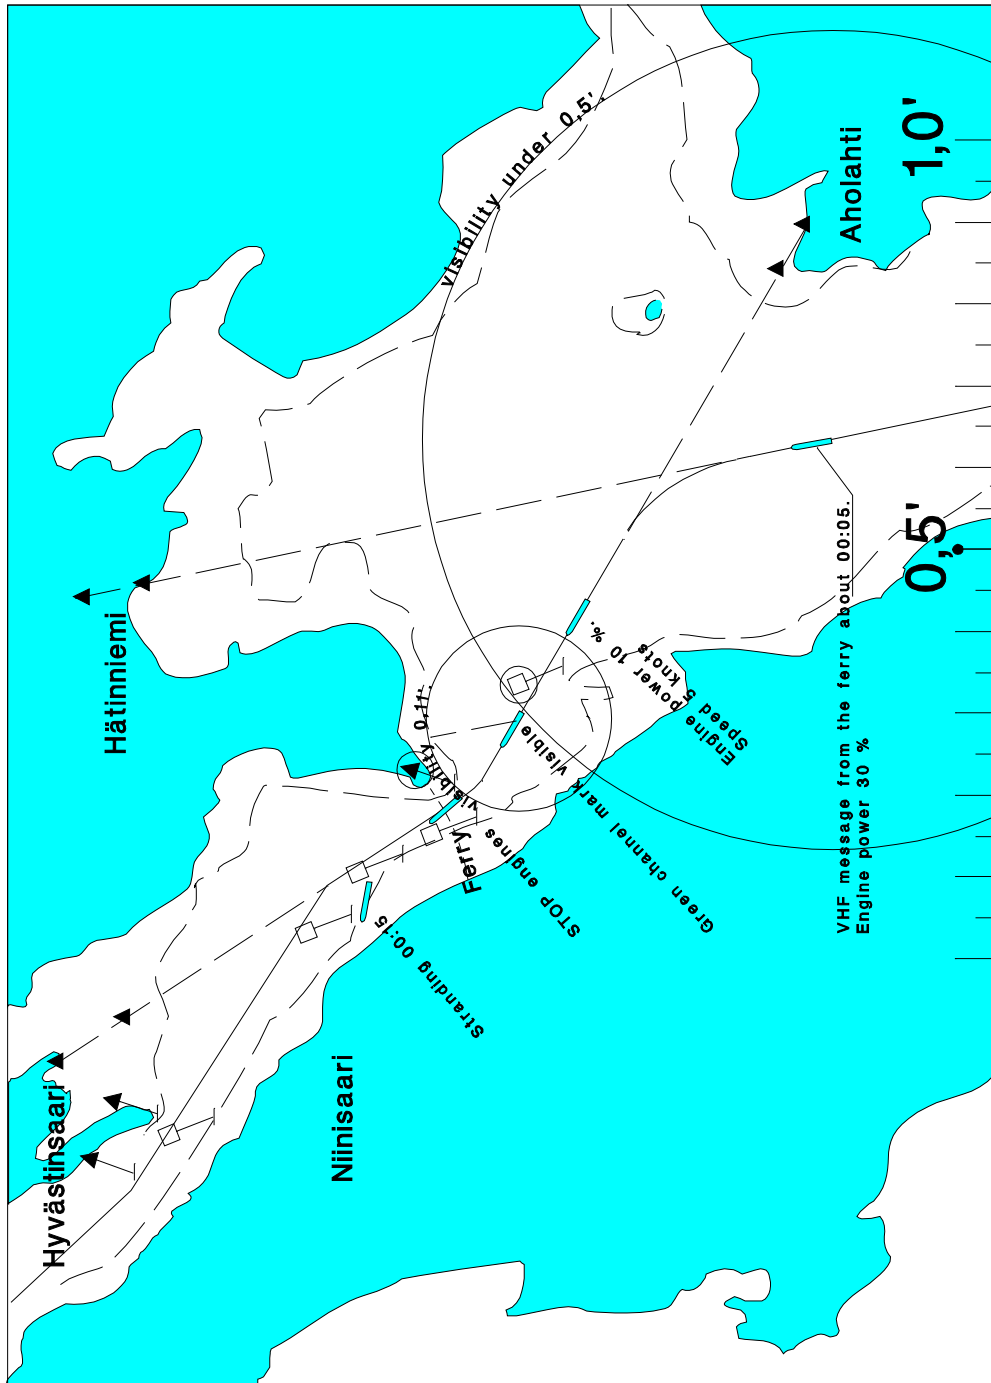
Figure 3. Events according to maritime declaration. Visibility deteriorated at crucial moment. Location of vessel at 00:15 and heading copied from chart based on unofficial soundings delivered by the maritime district to the Maritime Court in connection with the maritime declaration.

On arrival at the red lit buoy the pilot observed a visibility considerably less than half a mile. The speed was 5 knots and the engine power 30%. The pilot asked the mate to look for the next green lit buoy with binoculars and reduced the engine power to 10 per cent. The green buoy appeared at a distance of 200 metres. No leading lights were visible. The pilot asked the mate to search for the next red buoys with the searchlight. The pilot manned the helm. The mate used the searchlight on the port wing.

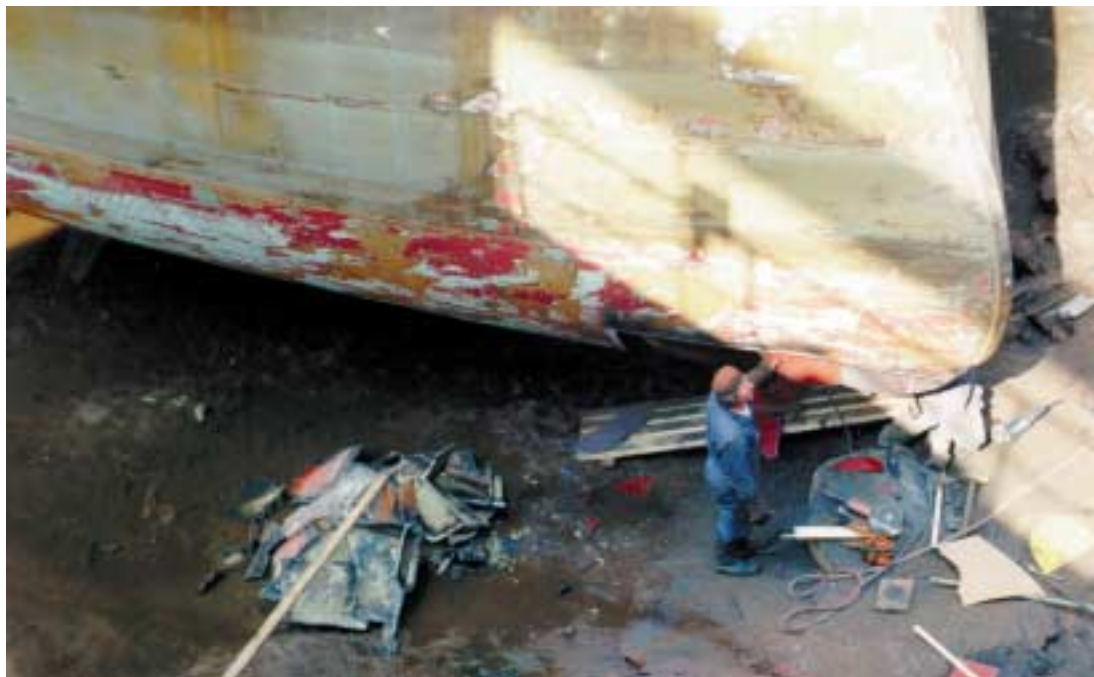
The forepeak had sustained a leak. The master began the pumping of ballast from the bow. The police, fire brigade and Puumala pilot arrived on the vessel. The engine was running slowly forward all night in order to keep the vessel grounded. Fairway maintenance vessel KUMMELI arrived in the early morning.

Figure 4. Damaged forepeak of ms BALTIC MERCHANT under repair at Savonlinna dock.

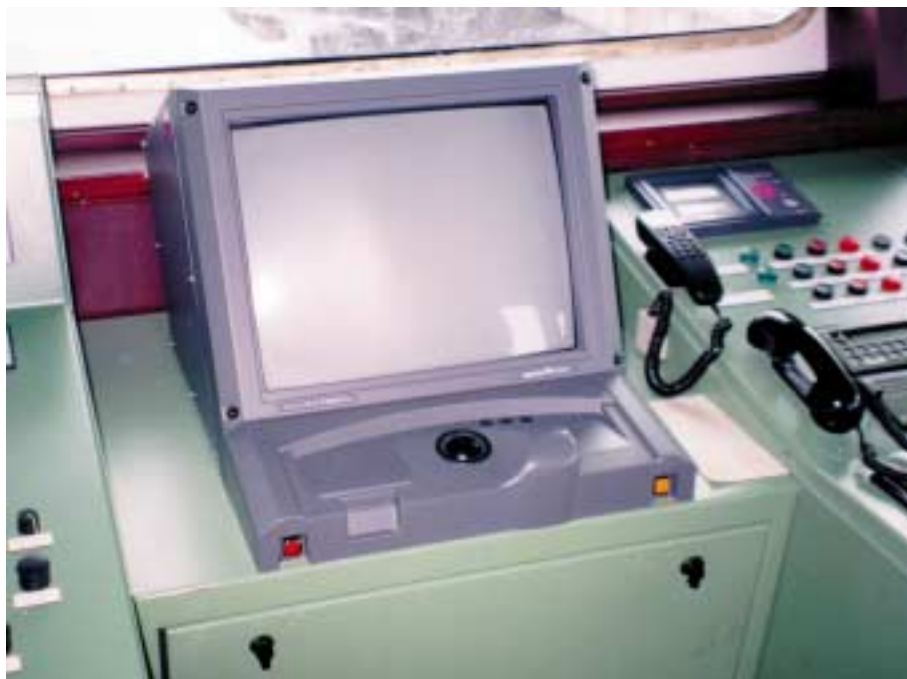
Figure 6. Kelvin & Hughes marine radar

Radars. The Kelvin & Hughes marine radar is not designed for piloting on archipelago fairways or inland waters. The user interface of this radar has been analysed in regard to piloting in the accident investigation of ms GERDA (Investigation C 4/1998 M). It could be determined that the user interface of the radar operated with a roller ball and menus is difficult for piloting. The problem is the complicated use of the electronic bearing line and variable range marker. During piloting, these controls are too complex and slow to use.

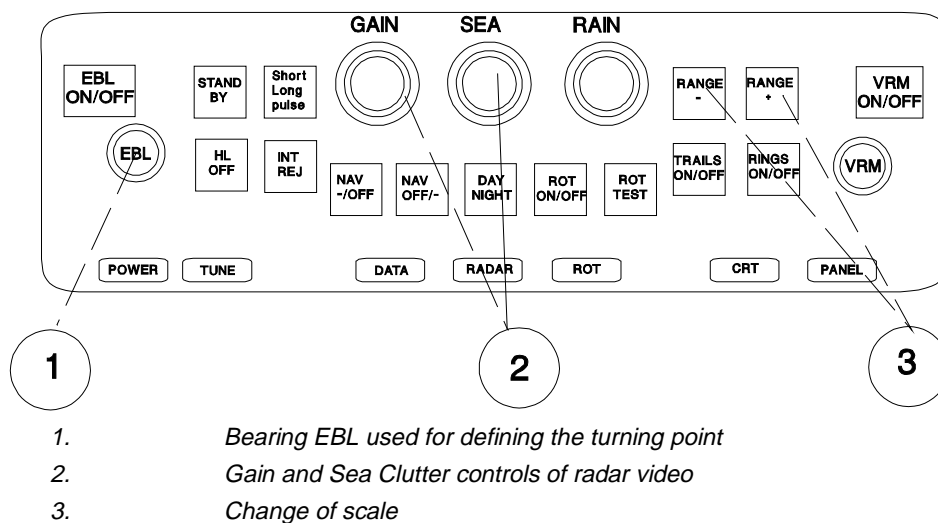
Figure 8. Keyboard of the ELNA 3300 radar was clear and user friendly. Controls 1, 2 and 3 would have been needed at Hätinvirta in the conditions during the grounding. Figure drawn from photograph.

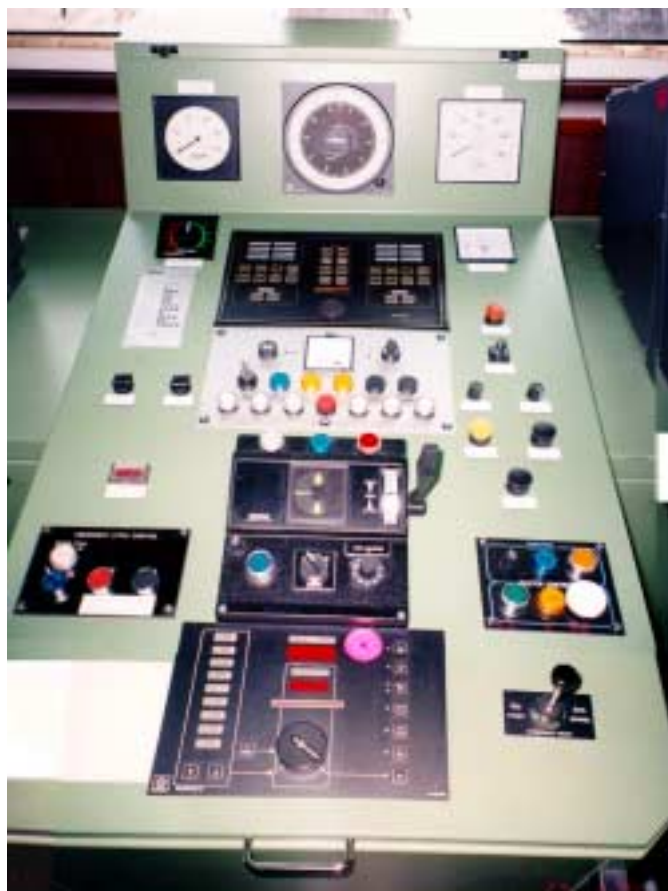
Steering equipment. The BALTIC MERCHANT had only the autopilot and NFU steering. The steering place was selected with press buttons from the top edge of the steering console in the control unit for the rudder machine. The Nautopilot D automatic steering was not suitable for piloting on narrow winding fairways, because the BALTIC MERCHANT was not equipped with the ROT Tiller steering mode for the Nautopilot D system. This mode would have been suitable for demanding steering on narrow fairways.

The NFU (Non Follow Up) steering is commonly used as emergency steering because it is very reliable. It is difficult to steer with the NFU lever, since the position of the rudder is determined by the length of time the lever is pressed which means that the rudder angle indicator must be monitored constantly. It is not possible for the same person to navigate with the radar and steer the vessel in this mode at the same time. Another commonly used method for manual steering is the FU, (follow Up) steering, which the BALTIC MERCHANT did not have, however. The magnitude of the rudder angle command is felt with the lever of the FU steering and the rudder angle indicator need not be constantly monitored. This is an advantage if the radar image requires concentration when steering. There was no time for radar adjustment in the piloting situation at Hätinvirta.

Figure 9. *Steering console of the BALTIC MERCHANT*

The limitations of the steering equipment should be considered when sharing the tasks on the bridge. The pilot may not use the NFU steering of the rudder himself if the navigation is performed solely with the radar (for example in a fog or in heavy rain). A separate helmsman may use the NFU steering in these conditions.

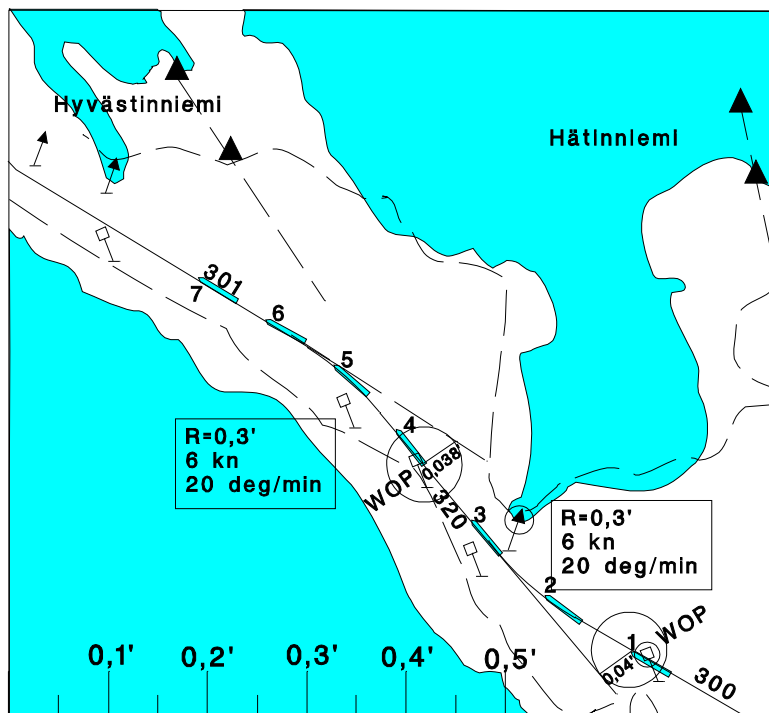
The recommendation on turns on fairways requires that the straight leg from the end of one turn to the start of the next turn should be at least five ship lengths if the heading change is between 20 and 30 degrees⁵. On the Hyvästinniemi line, this leg was only 220 metres. In the case of the BALTIC MERCHANT, this equals only 2,8 shiplengths. This is roughly the same as twice the advance required by the ship from the turning command to the even turn. The turning radius should be at least five shiplengths (0,22') according to the fairway recommendations. The geometry in the Hätingvirta bend does not comply with the fairway recommendations.

The new geometry based on the simulation is presented in Figure 11. This still does not comply with the fairway recommendations but steering is radically easier especially because of the longer turning radius.

Figure 11. The new course based on simulation. Course changed by shifting Hyvästinniemi line 7° to port, which shifted the second turn northward.

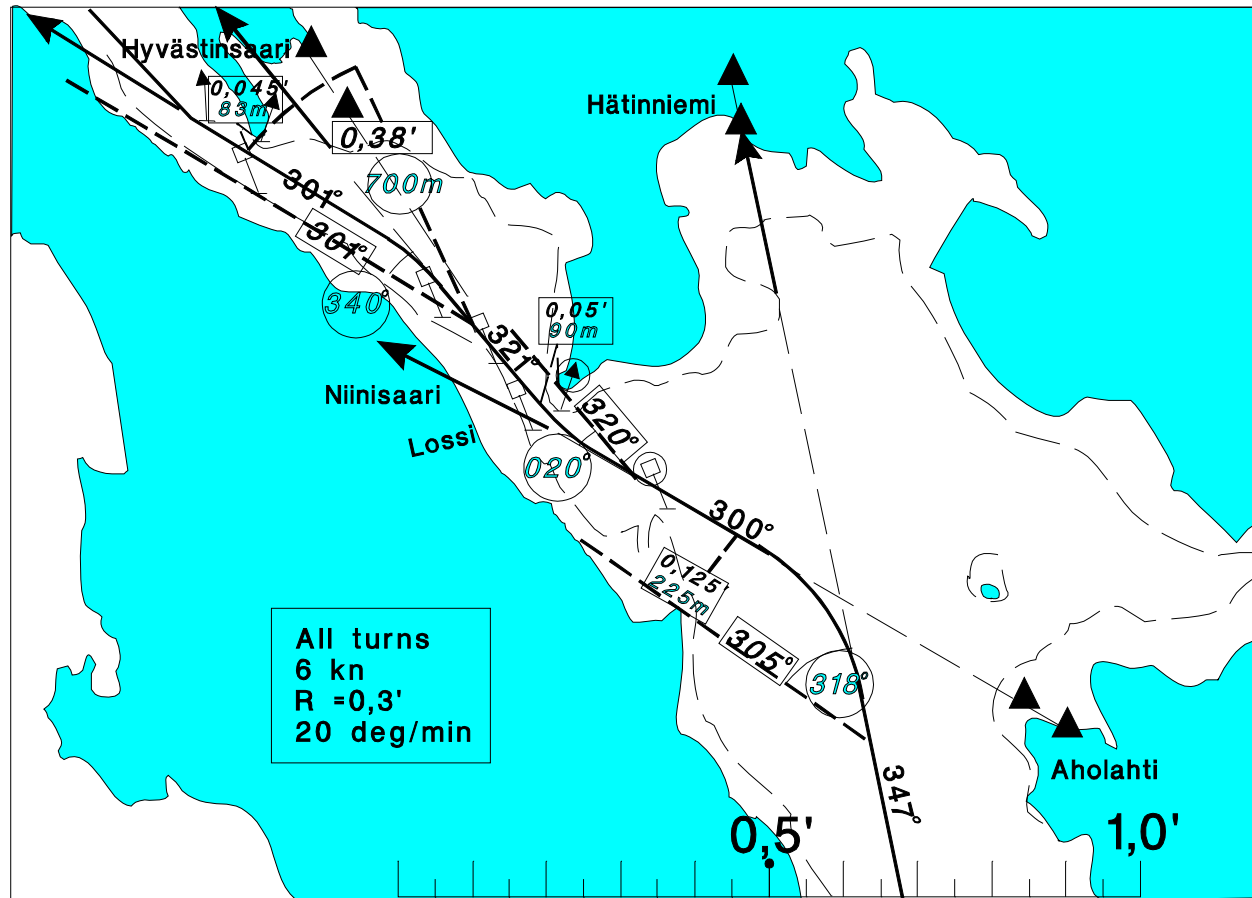
The Aholanti turn is initiated with the bearing 305° (marine radar) (Table 2). In the middle of the turn, steering is performed with the ROT indicator. If there is none, the vessel should be positioned on the new line by adjusting the rudder angle so that the lateral distance (225m) is realised (Figure 12).

Figure 12. Passage plan for marine and river radar for open water conditions.

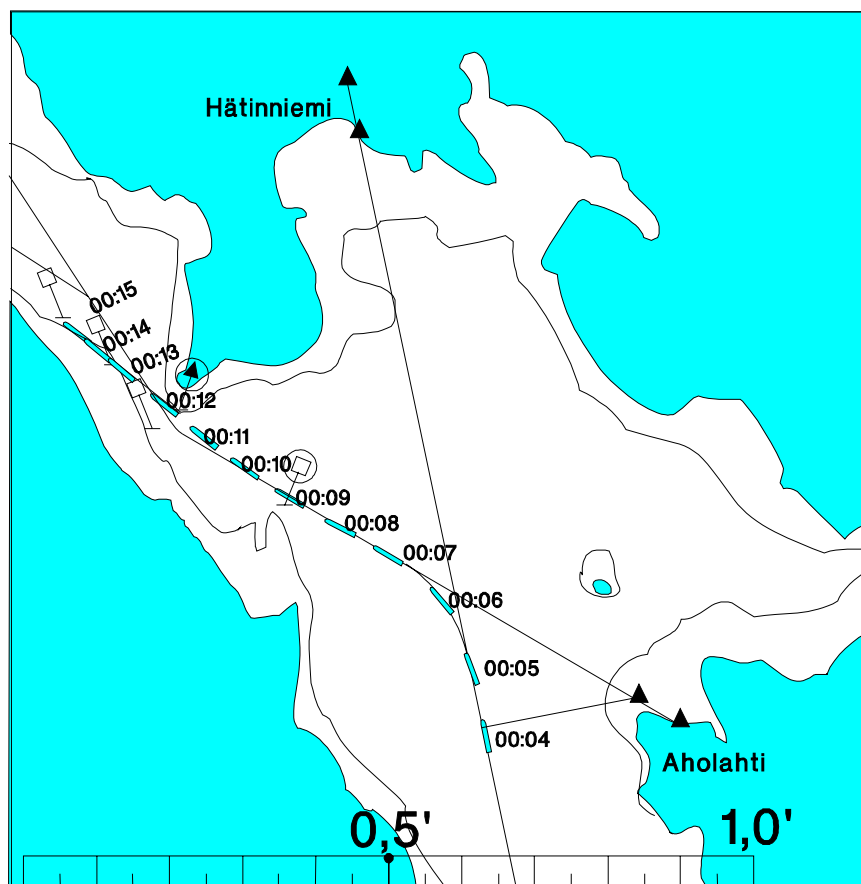
The vessel reached the Aholahiti line at about 00:08 (Figure 13). The visibility had deteriorated to less than half a mile based on the leading lights. The red lit buoy port of ship was passed at 00:09. The speed had dropped to 4,6 knots in the turn.

Figure 13. Piloting situation and grounding reconstructed by simulation.

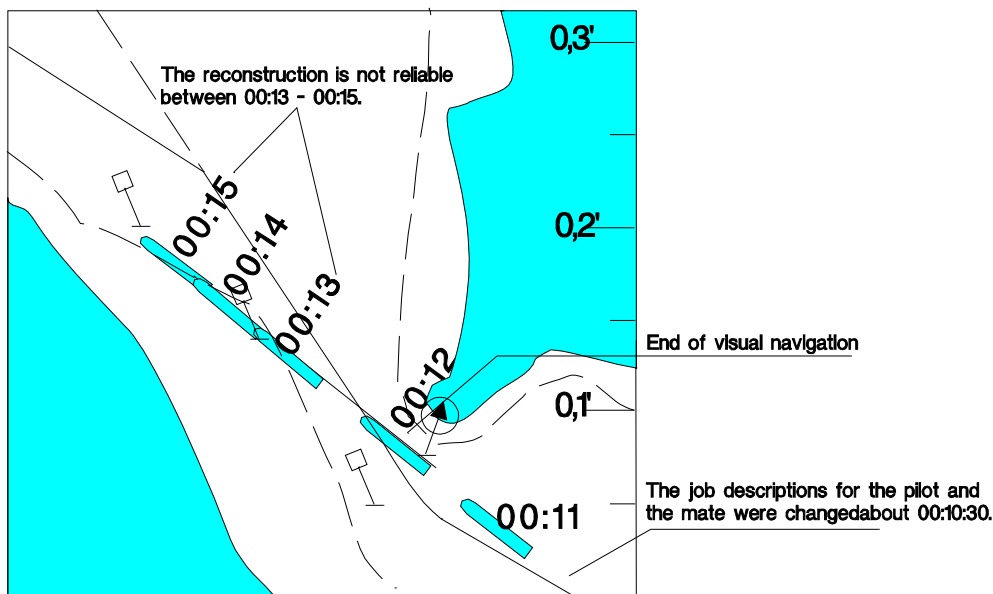
The reconstruction showed that the BALTIC MERCHANT had travelled almost straight during the last three minutes before the grounding.

Figure 14. Grounding of the BALTIC MERCHANT. The vessel has apparently headed almost straight during the last minute before grounding. Situation in the picture was reconstructed by simulation. In reality, the vessel has turned slightly to port during the last minute.

After the starboard green lit buoy of the buoy gate in the Hätinvirta sound had been passed (Figure 14) the only visual steering mark was lost. The mate could not find the portside left buoy of the buoy gate with the searchlight. The pilot presumed it had been covered by the ice. There was only a curtain of fog ahead. The situation had turned dangerous and the pilot set the propeller pitch to zero.

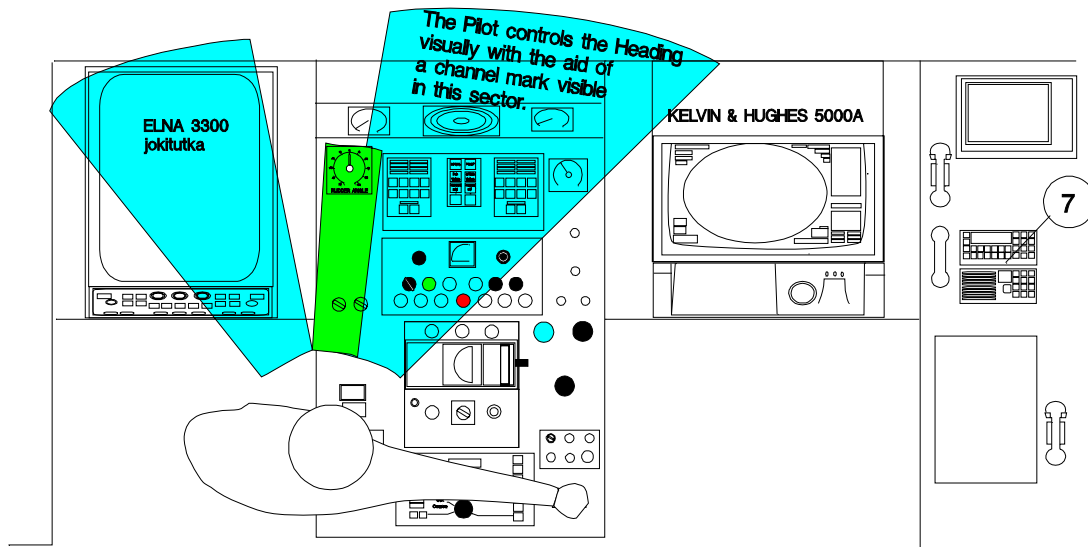
Figure 15. After the pilot had manned the river radar, he had to monitor three sectors while steering with the NFU lever, the radar, the rudder angle indicator and the green buoy ahead, diagonally to starboard. The pilot steered towards the green buoy using the NFU lever and monitored the rudder angle indicator. He relied on visual navigation because concentrating on the radar would have made the steering more difficult.

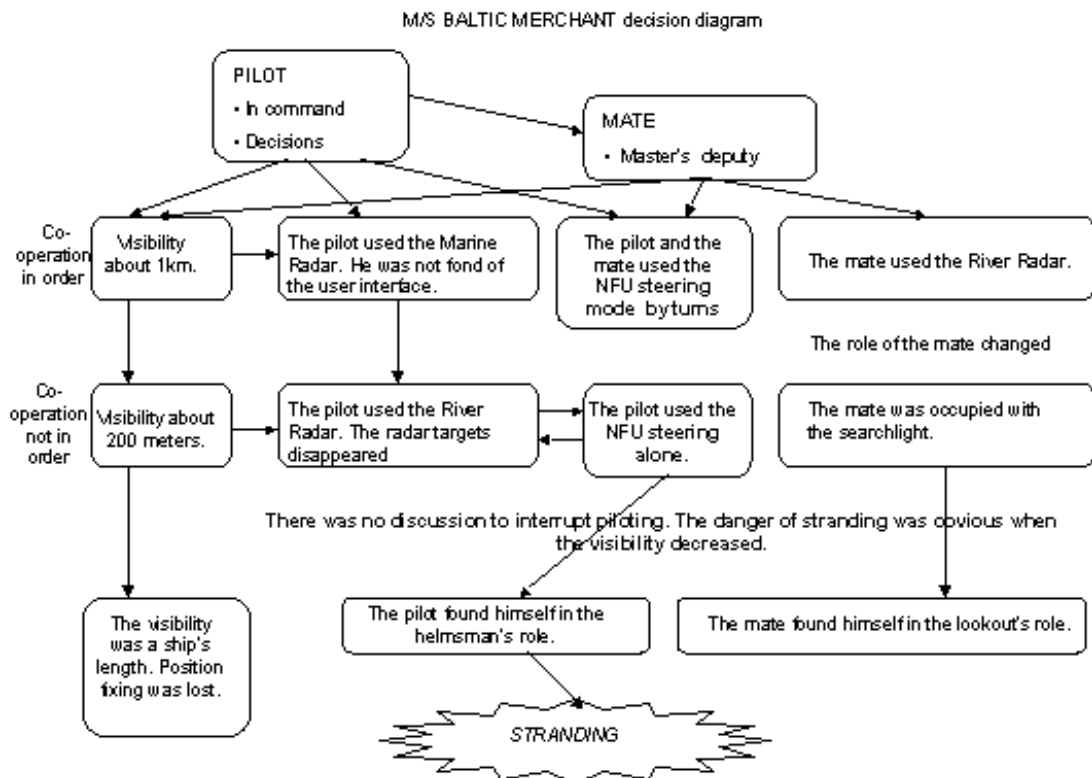
Figure 16. Activity and decision making chart of the grounding of the BALTIC MERCHANT.
