Investigation Report

C5/2010M

MS NAJADEN (FIN), Collision with the Caland Bridge in the Port of Rotterdam, Netherlands, on 2 June 2010

**Onnettomuustutkintakeskus
Olycksutredningscentralen
Safety Investigation Authority, Finland**

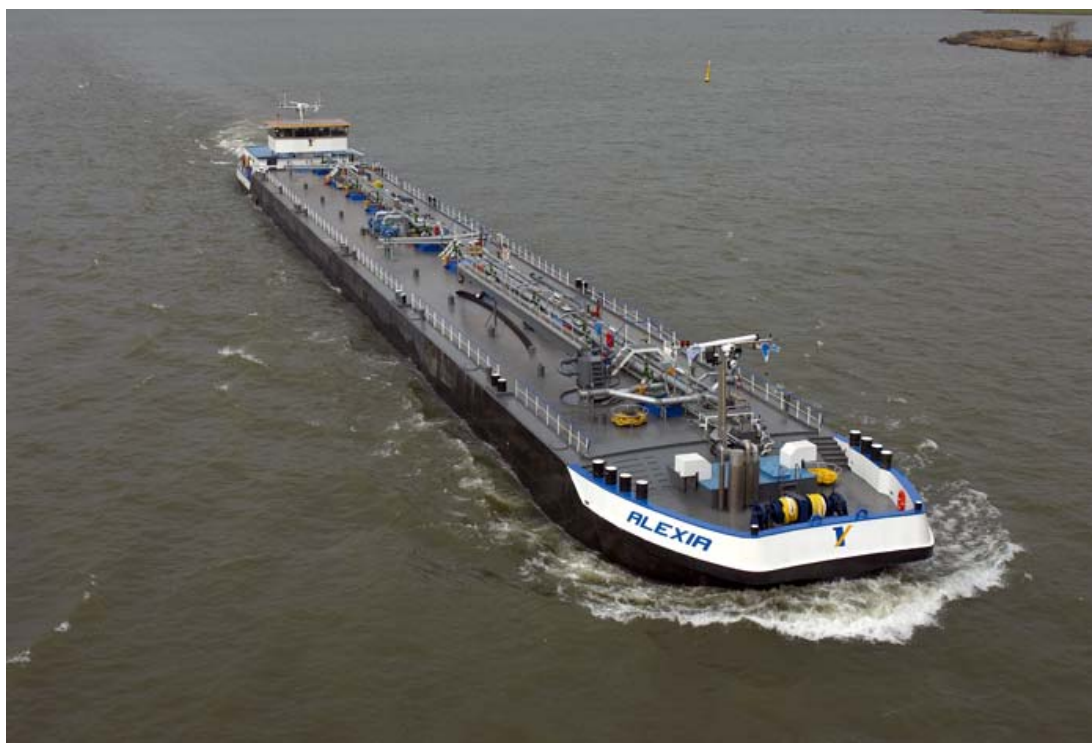
As it happened, this was not the case, as the vessel in question was the river tanker ALEXIA (see Figure 6), which passed beneath the fixed part of the Caland Bridge, right next to the bridge pier. The bridge operator trainee thought that the fairway going under the Caland Bridge was at that particular moment free of any vessels.

Figure 6. The river tanker ALEXIA, the deck hatches of which were in the Dutch investigation described to be similar with those of the NAJADEN. (© Arie Jonkman)

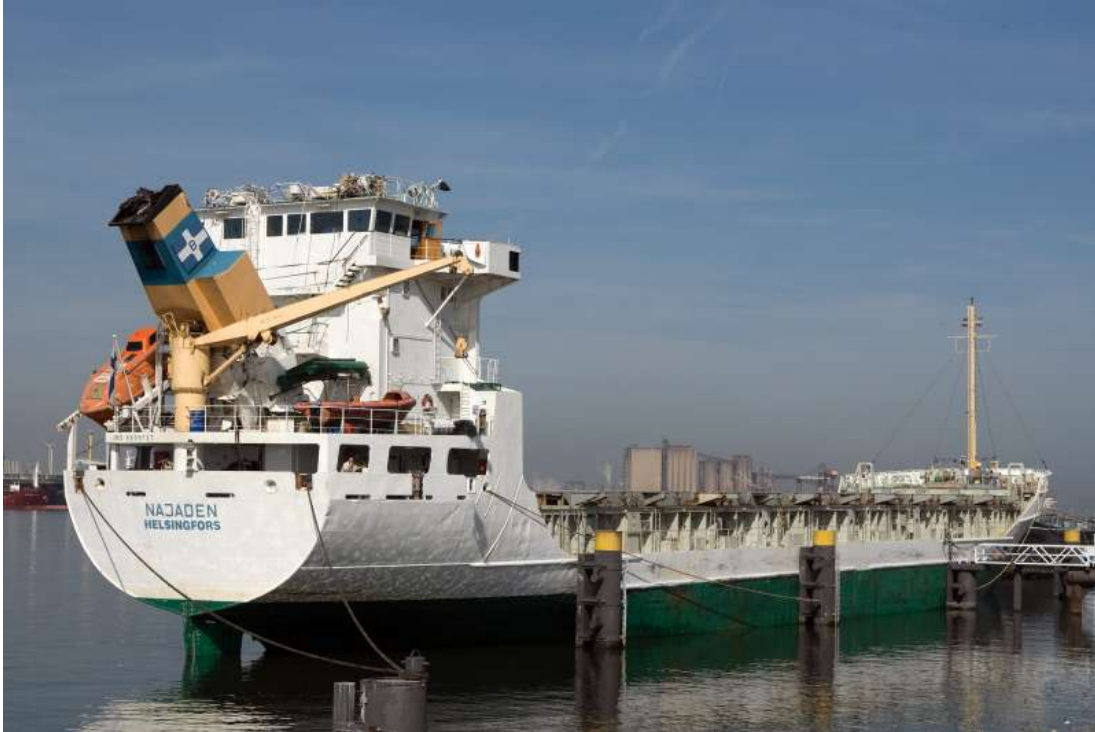
Figure 7. The NAJADEN moored to the Caland jetty number 3.

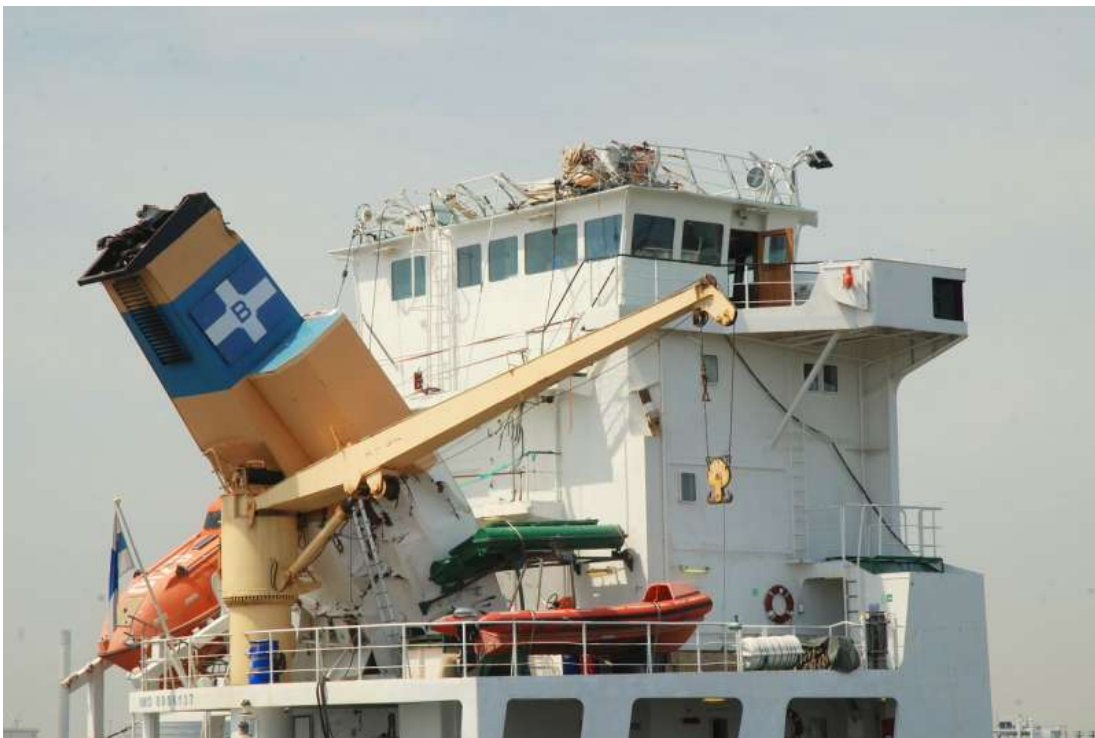
At 20.42 the NAJADEN reported that she had been hit by the bridge. The part of the bridge to be lifted/lowered hit the roof of the navigating bridge and destroyed almost all equipment on the roof of the navigating bridge and tore off the funnel of the vessel.

Figure 8. Damages to the vessel were rather extensive.

The lowering speed of the bridge is illustrated by the fact that the magnetic compass located in the fore part of the navigating bridge remained intact whereas the structures located more aft were swept away.

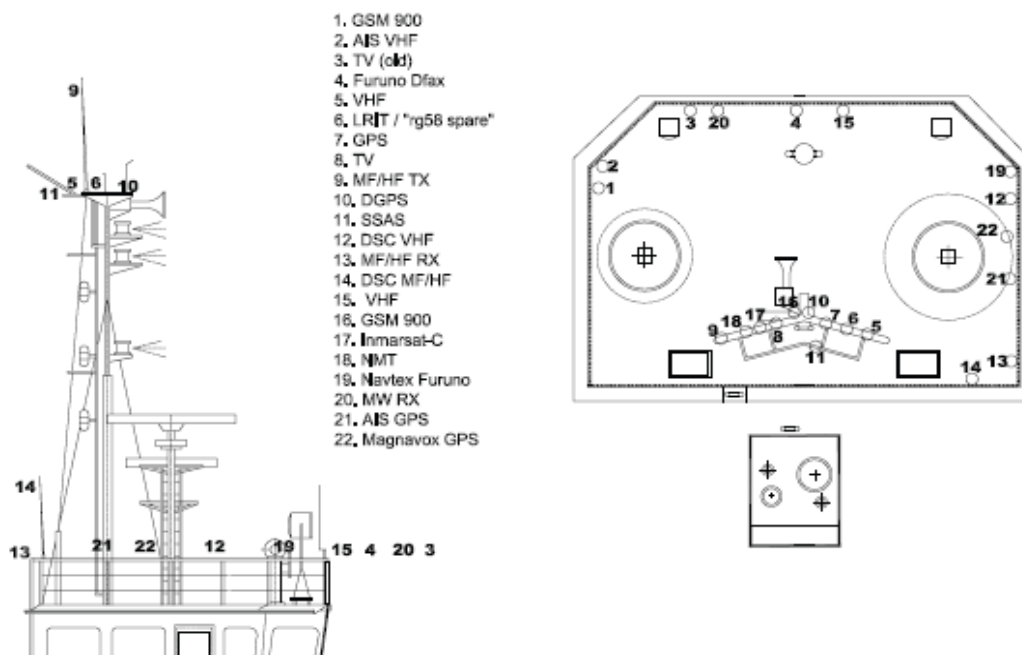
Figure 9. The equipment located on the roof of the navigating bridge.
