Investigation report

C7/2007L

Emergency landing on Porvoo motorway on 28 September 2007

Cessna 172N, diesel engine TAE 125-01

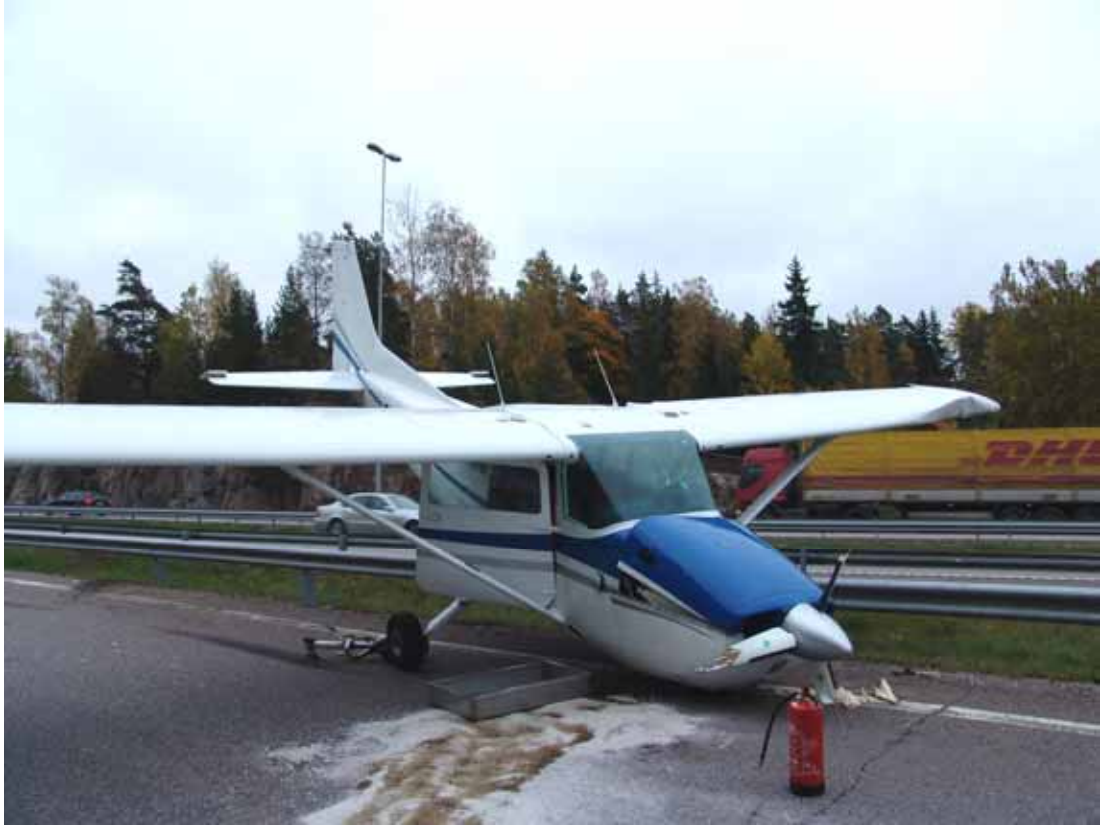
Figure 3 The aircraft resting on the crash barrier after the emergency landing.

Every blade of the wooden propeller was broken approximately in half and the broken pieces were lying on the ground next to the propeller. The lower engine cowling was dented and bent upwards. The nose wheel had broken off the firewall and the lower edge of the firewall was bent. The right wingtip was broken and there was a collision mark at the tip of the wing. The rear fuselage and the empennage were undamaged. Due to the damage to the wing the roof of the cabin was dented. The entire left wing root was bent and the trailing edge flap had broken the left back window of the cabin. The leading edge of the wingtip was dented inwards at a length of approximately two metres. The left main gear strut cowling was dented.

When the nose wheel broke off, the aircraft came to rest in a nose-down attitude. This caused fuel to leak onto the ground through the right fuel tank filler cap. No other leaks were detected. After the accident site was inspected and photographed the rescue personnel lashed the tail to the crash barrier, thereby lifting the nose and stopping the fuel leak.

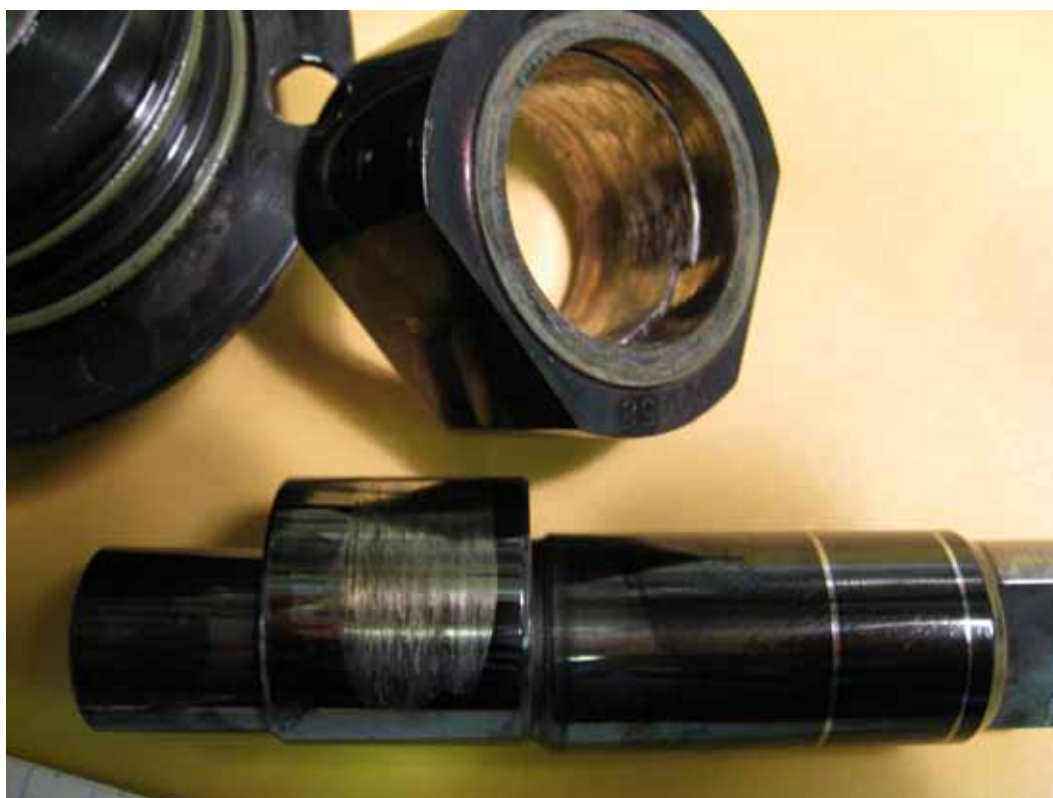
Figure 4 Damages of the eccentric cam and the driveshaft on the HP pump.

The pump cylinders and pistons were as good as new. When the cylinders were being detached, metal particles were discovered inside the pump. The surface of the drive-shaft and the eccentric cam bearing were badly scuffed. Particles had come loose from the bearing's steel surface. Early-stage corrosion was found on the three surfaces of the eccentric cam which come into contact with the pump pistons.

The investigation commission measured the wear on the driveshaft cam and the eccentric cam. The results showed that the diameter of the driveshaft cam at the unworn spot was 23.95 mm. Maximum wear was 0.08 mm. The eccentric cam bearing was worn out of round. The diameter of one end of the bearing was 24.49 mm and the corresponding reading at the other end was 25.01 mm. Measurements showed that driveshaft cam and eccentric cam clearances varied between 0.62–1.14 mm, averaging at 0.88 mm. The stroke length of an unworn pump piston is 6.92 mm. Therefore, due to wear, stroke was approximately 13% shorter than normal.

The engine manufacturer, when developing the engine, had modified the HP pump so as to allow for the lubricity of JET A1 fuel. With regard to this incident, the Teflon coating on the eccentric cam bearing, including the bronze surface underneath it, were almost completely worn off and even some parts of the bearing's steel frame had disintegrated. The surface of the driveshaft cam was worn. In addition, the two other bearing surfaces of driveshaft facing the eccentric cam, those receiving the highest loading, exhibited

wear scars. TAE specialist stated that this kind of late-stage bearing damage must have already begun several flight hours before it was detected.

When the pump was inspected rust was detected in a steel bushing that leads fuel into the eccentric cam chamber for the purpose of lubrication. According to TAE statement the rust indicated that free water had been in the fuel at some stage. As per the statement, water was the probable root cause for the HP pump bearing failure.

According to TAE statement the damage to the HP pump on the OH-CAU was caused by free water in the fuel. The investigation commission considers this plausible because water could have entered the fuel system through the tank filler cap, the seal of which was adjusted incorrectly. There was no water in the fuel samples taken prior and after to the accident flight. The damage of the HP pump had initiated earlier.

A metal shaving from the HP pump eccentric cam bearing surface probably caused the pressure-control valve ball to jam open.

The damage on the eccentric cam bearing surface had begun already earlier, when there has been free water in the fuel. Water has probably got into the fuel system through the incorrectly adjusted fuel filler cap. The fuel samples taken prior and after the occurrence flight there was no water in the fuel.

1. *The investigation commission recommends that the EASA take action to establish whether JET A1 can safely be used as fuel in diesel engine-equipped aircraft, and if it can, the required measures.*
2. *The investigation commission recommends that the EASA consider whether a new type certificate test be required for TAE engine high-pressure fuel pumps, using such JET A1 fuel which meets the lowest permissible lubricity value set for jet engine fuel.*
3. *The investigation commission recommends that EASA take action to ensure that required maintenance instructions will be published concerning the fuel tank filler caps adjustment on the aircraft equipped with TAE-engines.*

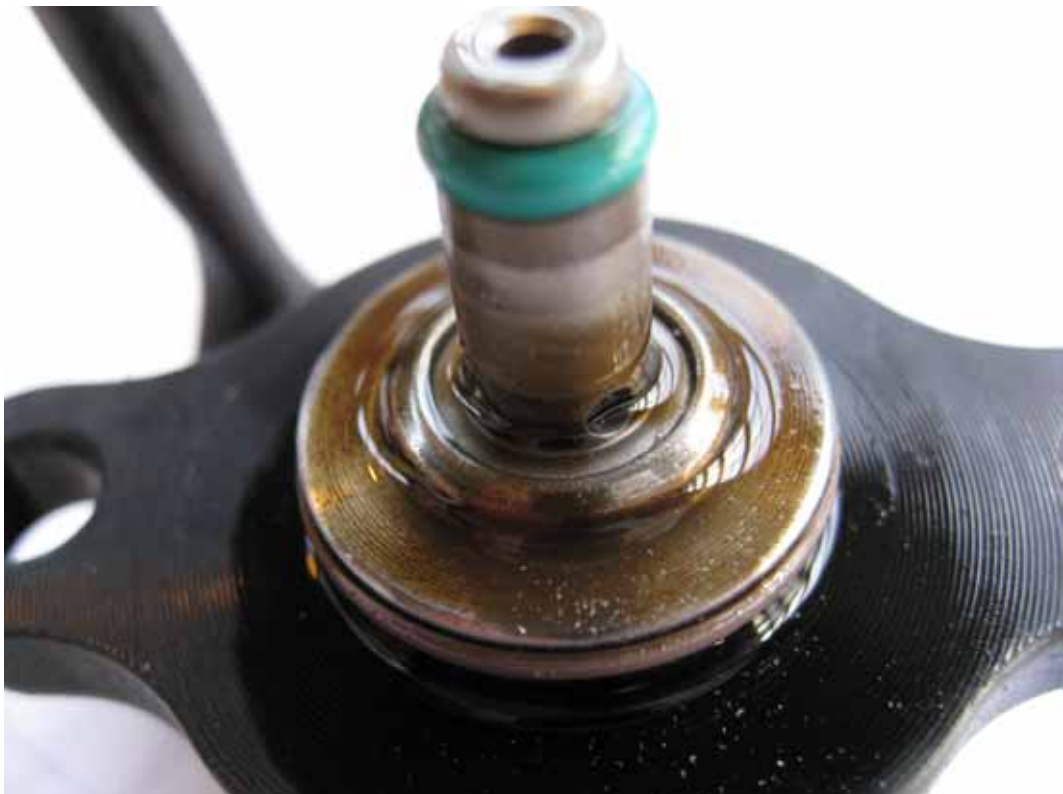
Figure 5 Metal particles in the pressure control valve

The pressure control valve at the rear of the common rail was detached. It contained metal particles. The HP pump, the nozzles and the pressure limiter were sent to BFU in

Germany who, in turn, forwarded them to the manufacturer for testing. Testing was conducted under the supervision of the authorities. During testing the injectors and the pressure control valve performed flawlessly. On 13.2.2008 the engine manufacturer sent an inspection report to AIB regarding the damage on the HP pump of the OH-CAU. The report stated that the damage was unique and that the manufacturer is not aware of any similar damage elsewhere. The manufacturer strongly assumes that there has been water in the fuel, probably on some other earlier flight, and it had initiated the damage.

The wear of many flight hours had shortened the pump piston stroke by approximately 13%. Although this decreased maximum performance, considering the pump's capacity it is unlikely that wear caused the rapid loss of pressure during the flight. Instead, the most likely explanation is that a metal shaving got caught in the pressure control valve, a computer-controlled solenoid ball valve located at the end of the rail, causing it to jam partly open and, thus, collapsed the fuel pressure.

The accident was caused by a chain of events in which the HP pump failure caused the common rail pressure-control valve to jam almost entirely open. This resulted in loss of engine power because the residual fuel pressure in the common rail could only sustain engine idle.

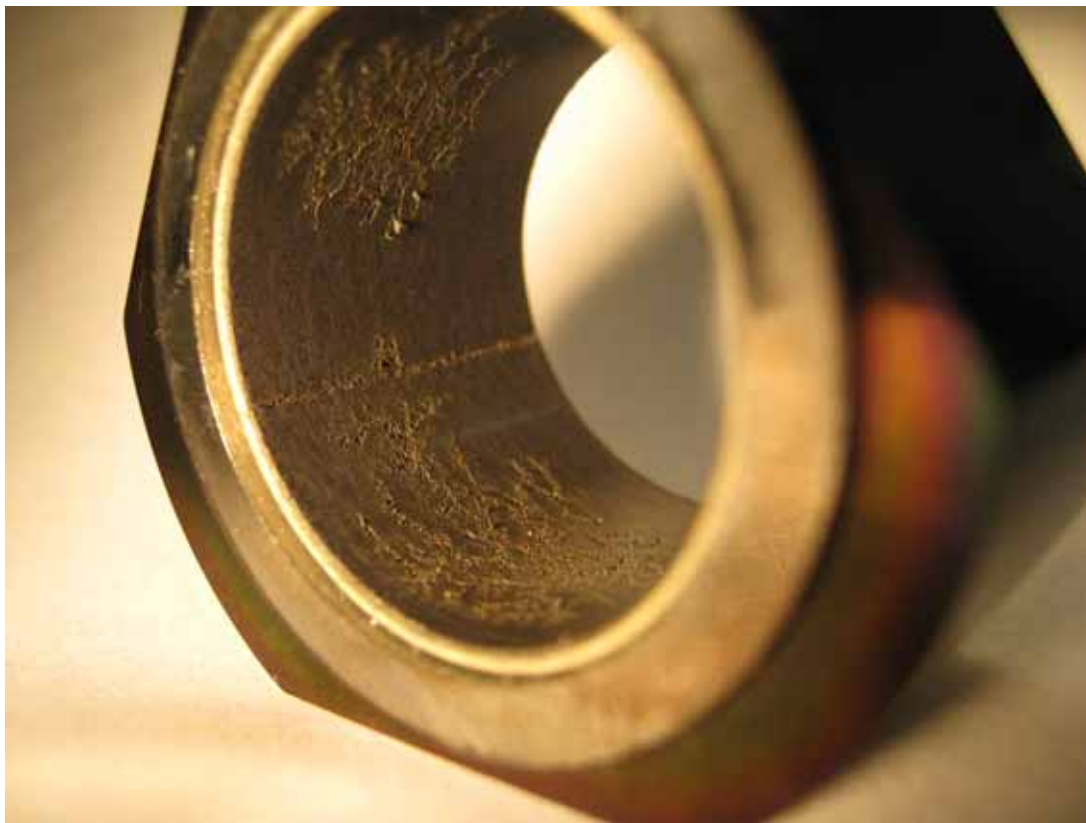
After receiving this report the investigation commission, for a point of reference, examined the HP pump on the OH-CAZ, p/n 02-7310-04005R5, s/n 11901. The running time on the pump was 332 h and the time between overhauls 300 h. After the pump was disassembled it was noted that the pump pistons and cylinders were in good condition and the driveshaft cam was pristine. The Teflon coating of the eccentric cam bearing had partly come off and it was uneven. This was most evident in three areas, at 120 degree angles to each other. However, the Teflon coating was also damaged in narrow streaks between these areas. The damaged area encompassed approximately one half of the area of the bearing.

Microscopic analysis revealed that the Teflon coating was so badly worn in three places that it revealed the copper-coloured coating under it. Part of the Teflon had worn off and some of it was partly loosened. The pump was sent via BFU to TAE, where it was tested. TAE report stated that while the pump was in worse than normal condition, it was still operable.

Figure 6 Wear marks on the OH-CAZ's HP pump eccentric cam bearing Teflon coating.

As per the statement of TAE, the wear on the pump on the OH-CAZ was within acceptable limits. Since the HP pump on the OH-CME was effectively as good as new, it was not sent to the manufacturer.
