Investigation report

S1/2005R-S

Safety Study on Level Crossing Accidents – A shortened version

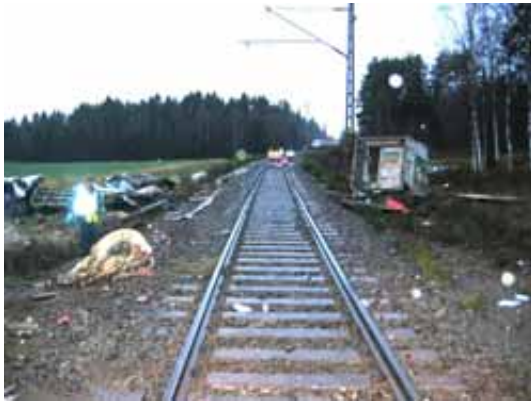
1.1 Collision of a Pendolino train with a lorry carrying livestock at an unprotected level crossing in Kälviä on 10 November 2005

On Thursday 10 November 2005 at 6.22 a.m., a Pendolino train en route from Oulu to Helsinki collided with a lorry carrying livestock at 132 km/h at an unprotected level crossing in Kälviä. As a result of the collision, the lorry crashed into a field next to the railway. The lorry's driver and co-driver were fatally injured. The engine driver and one passenger were slightly injured. Furthermore, the lorry was completely wrecked and the livestock

perished. The first coach (= power car with cabin) was badly damaged.

The accident was caused by the lorry driver driving past the STOP sign without stopping and continuing on to the crossing in front of the approaching train. On the basis of technical investigations on the lorry, as well as calculations and the engine driver's observations, it can be assumed that the lorry driver did not notice the approaching train at all.

The unprotected level crossing and the conditions created possibility to an accident caused by lack of observation and failure to act as indicated by the road signs in place.

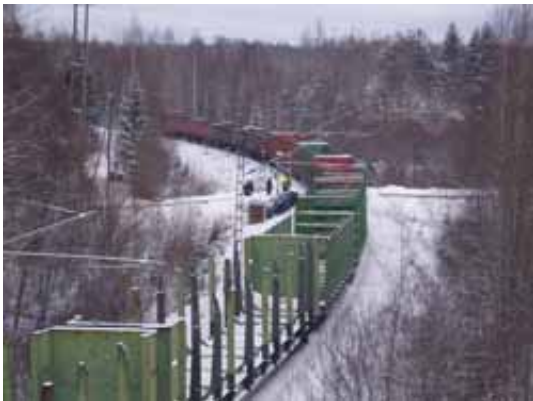
1.2 Collision of a freight train with a passenger car on a level crossing with light and sound warning signals in Kouvola on 14 February 2006

On Tuesday 14 February 2006 at 11.51 a.m., a freight train collided with the left front corner of a passenger car on Tanttari level crossing with light and sound warning system, along the Kouvola–Kuusankoski track. The train was travelling at 43 km/h. The car driver was slightly injured and the car wrecked beyond repair. Moreover, the equipment in the front of the locomotive incurred some damage.

The cause of the accident was the driver's lack of focus at the crucial moment, and too high approaching speed of the car. In addition, the rising slope ahead of the crossing may encourage motorists to make too early a decision on crossing the track. The fact that the location was familiar might also have contributed to the driver's lack of vigilance in approaching the crossing.

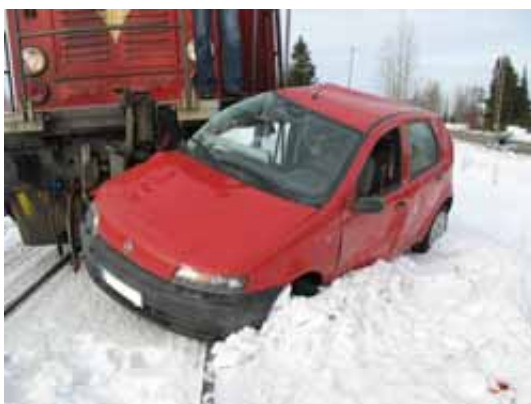
1.3 Collision of a train consisting of two locomotives with a passenger car at an unprotected level crossing in Tornio on 16 March 2006

On Thursday 16 March 2006 at 9.54 a.m., a train consisting of two diesel locomotives, en route to Kemi, collided with a passenger car at 44 km/h at an unprotected level crossing in Konu. The driver of the car was slightly injured. Moreover, the front corner of the first locomotive incurred some damage, and the car was damaged beyond repair.

The cause of the accident was the driver's faulty perception and actions. Other contributing factors were poor visibility and the STOP sign's poor location. The sharp angle formed by the road and the track, and blocked vision in the direction of the train in the angle of vision formed by the front seat's head support and the car's B pillar, also affected visibility.

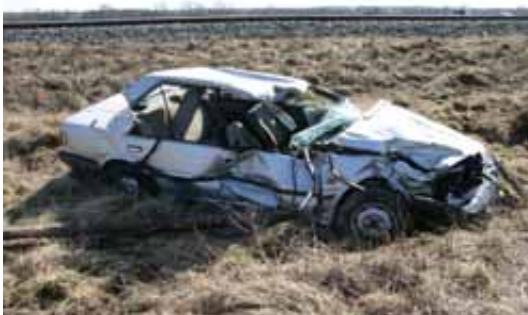
1.4 Collision of a freight train with a passenger car at an unprotected level crossing in Närpiö on 5 May 2006

On Friday 5 May 2006 at 11.57 a.m., a freight train en route from Kaskinen to Seinäjoki collided with a passenger car at an unprotected level crossing in Närpiö. The car driver was seriously injured and died later as a result of the injuries. In addition, the locomotive suffered slight damages to the nose and the car was damaged beyond repair.

The accident was caused by the driver of the car entering the level crossing without giving way to the train approaching from the right. Apparently, the driver completely failed to notice the train. The structure of the unprotected level crossing was also a contributing factor. The car driver's poor eyesight and state of intoxication, and the fact that the sun was in the driver's eyes from ahead, inhibited the driver's observational capabilities. In addition, the driver may have behaved negligently in terms of personal safety.

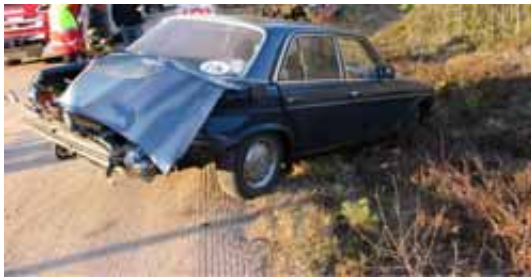
1.5 Collision of a freight train with a passenger car at an unprotected level crossing in Raahe on 5 May 2006

On Friday 5 May 2006 at 7.11 p.m., a freight train en route to Raahe collided with a passenger car at 66 km/h at an unprotected level crossing in Raahe. The rear of the car was badly damaged, and the locomotive incurred some damage.

The accident was caused by the driver of the car passing the STOP sign without stopping and not checking the track to ensure a safe crossing.

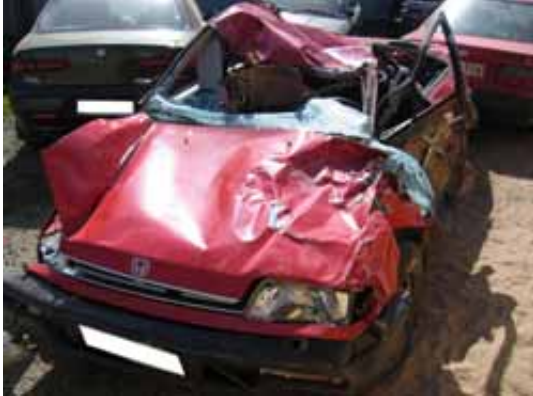
1.6 Collision of a museum train with a passenger car at a guarded half-barrier level crossing in Alavus on 17 June 2006

On Friday 17 June 2006, a museum train en route to Haapamäki collided with a passenger car at a guarded level crossing with a half-barrier in Alavus. The museum train consisted of two Dm7 diesel motor units and an additional car. While the driver of the passenger car was slightly injured, the car was completely wrecked and the first motor unit of the train incurred some damage.

The accident was caused by the driver of the car failing to observe that the light and sound warning signal was on before the crossing and that the barrier was down on the driver's side of the road. Thus, the car continued onto the crossing without slowing down, using the left lane. This was affected by the following:

The speed limit of 80 km/h on main road 18 is too high a speed before the crossing. Moreover, the recommended speed of 40 km/h does not signal strongly enough that slowing down is necessary, especially since it is possible to cut straight through the curves.

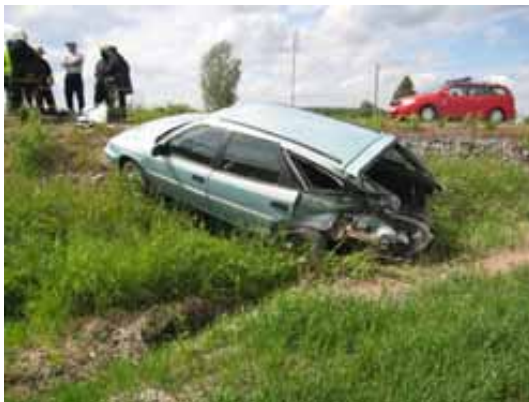
1.7 Collision of a freight train with a passenger car at an unprotected level crossing in Ylistaro on 21 June 2006

On Wednesday 21 June 2006, a freight train en route from Vaasa to Seinäjoki collided with a passenger car at an unprotected level crossing in Ylistaro. The car driver and passenger were unharmed. The car was badly damaged in the rear. The locomotive incurred some damage on its nose section.

The reason for the accident was that the car driver drove onto the level crossing without stopping. The driver also failed to notice the approaching train early enough, may have been focusing on issues other than making the crossing and may have been tired. In addition, the fact that the car radio was on, and that the driver was engaged in a conversation with the passenger, may have inhibited hearing the approaching train. The driver of the car acted inappropriately when making the crossing, with which the driver was familiar. Moreover, the driver had the habit to cross the level crossing without stopping.
