Historic Aircraft Accident at Räyskälä on October 16, 2024

L2024-02

SYNOPSIS

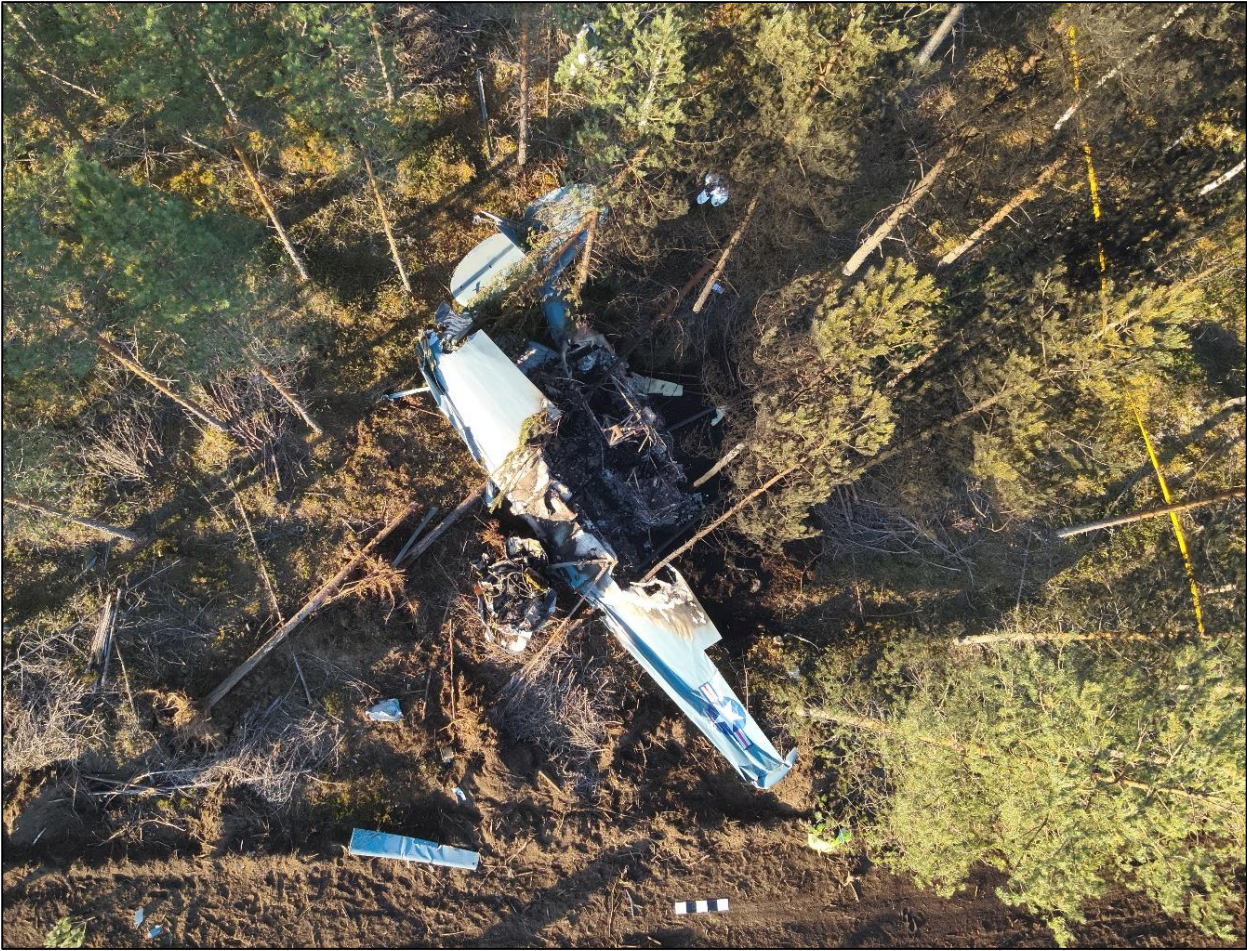
The airplane descended to ground in a steep angle. The initial impact was by the right wing tip and the engine. The airplane was substantially damaged by impact and fire. Scattered debris was located around the main wreckage. The wing assembly remained in one piece but had separated from the fuselage and rotated about 180° to the direction of arrival. The engine separated from its mounting and came to rest on its left side forward of the wing assembly. One propeller blade was twisted back under the engine, while the opposing blade was intact.

Figure 15. The wing assembly separated, and the fuselage was consumed by fire. (Photo: SIAF)

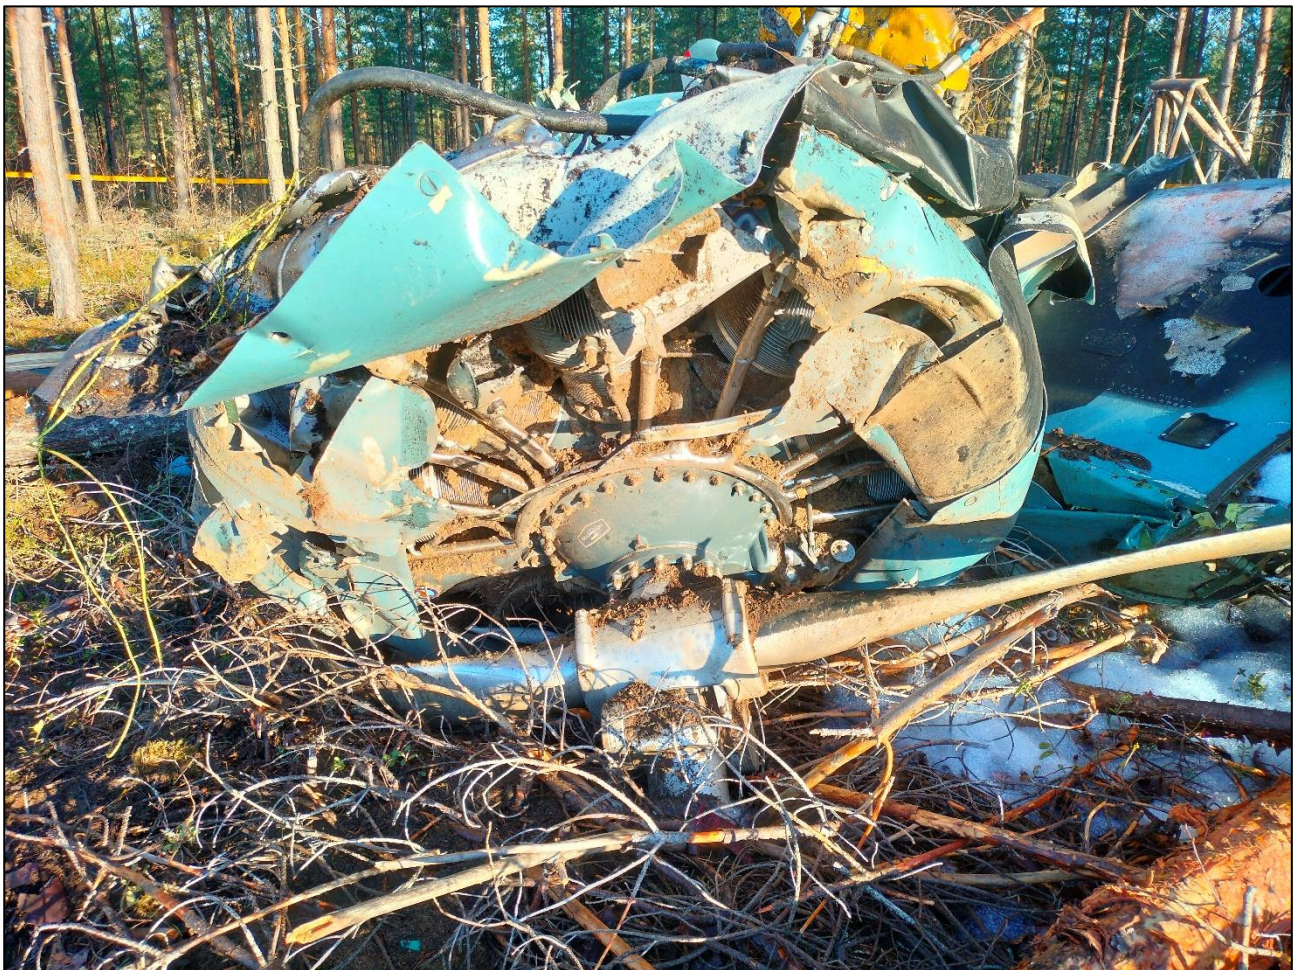
The engine mount and the engine had separated from the fuselage. The propeller remained attached to the engine. One blade was intact, but damage sustained by the opposing blade prevented engine rotation during the on-site investigation. The cockpit-mounted engine and propeller controls were bent and detached from their fittings. Visual inspection of the cylinders revealed no damage, except for one cylinder that displayed several impact marks near the head and partial separation of the intake valve cover. Buckling and bending of valve rods and rod tubes were found in seven of the cylinders. The oil cooler was separated at its mountings, and the severely damaged oil tank was almost completely detached from its attachments. The accessory section remained in place but had sustained major damage. The oil filter, carburetor, and fuel pump were intact. No fuel was found in the carburetor. Visual inspection of the oil filter revealed no presence of chips or other anomalies. The exhaust manifold was crushed against the rear of the engine, while the intake manifold was damaged and partially crushed between the engine and the exhaust manifold.

Figure 16. The engine. (Photo: SIAF)

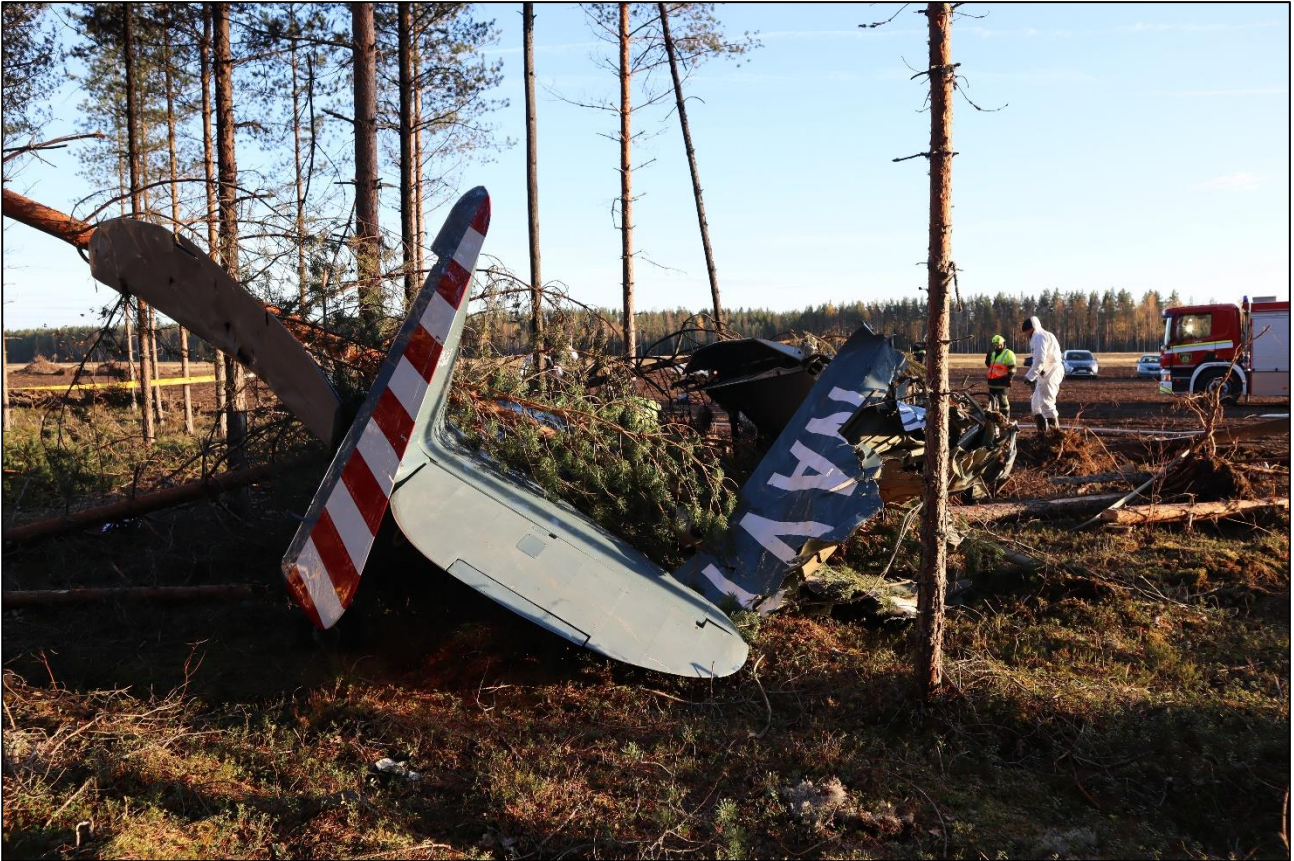
The forward and center fuselage between the nose and the aft end of the cockpit were destroyed by impact and fire, whereas the rear fuselage and the empennage were mostly intact. The tubular steel cockpit structure did not sustain significant deformation but was separated from its mountings. The front and rear cockpit instrument panels were separated and sustained major thermal damage, and some instruments were dislodged and melted by heat. Although the seat belts were charred, investigators were able to determine that the buckles were intact and secured on impact. It was concluded that the distortion and deformation of the wings and other structural components resulted from ground impact. All major components of the airplane were located at the accident site. The airplane was not fitted with flight recorders.

Figure 18. The empennage. (Photo: SIAF)

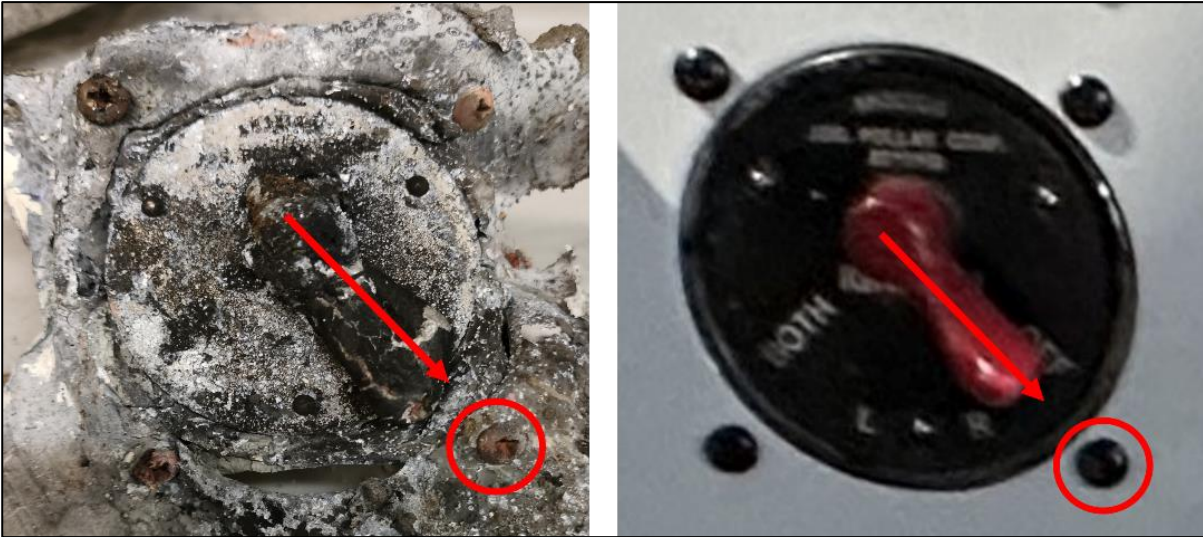
Although the engine-mounted ignition system components were in place, the wiring between the engine and the ignition switch was consumed by fire. The magnetos and the ignition harness exhibited impact damage and signatures of fire. While all spark plugs remained attached to the cylinders, some of them were impact-fractured. The ignition switch was found in OFF position.

Figure 19. The ignition switch was found in OFF position. The right-hand inset shows the switch in its original condition. (Photos: SIAF, airplane owner, edited by SIAF)

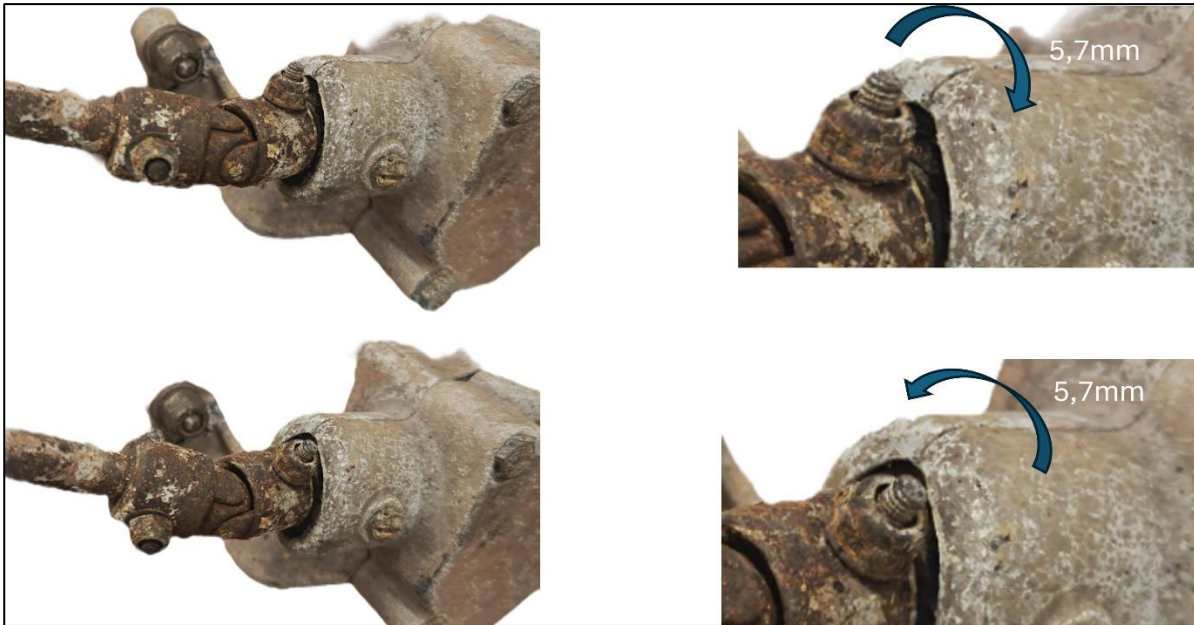
Considerable backlash was evident in the selector mechanism. Its cause was traced to the transmission and to the joints before the selector valve. It was possible to measure backlash between the front cockpit selector and the transmission, but components below the transmission were destroyed. Backlash was most pronounced at the transmission. Backlash at the joint that had connected the control rod to the selector valve plunger could not be measured because the valve was destroyed by fire.

Figure 25. Backlash was found in the fuel selector mechanism. Torsional backlash at the control rod joint in the front cockpit selector and the transmission was 5.7 mm, and the same amount of play had existed at the selector valve end. (Photo: SIAF)

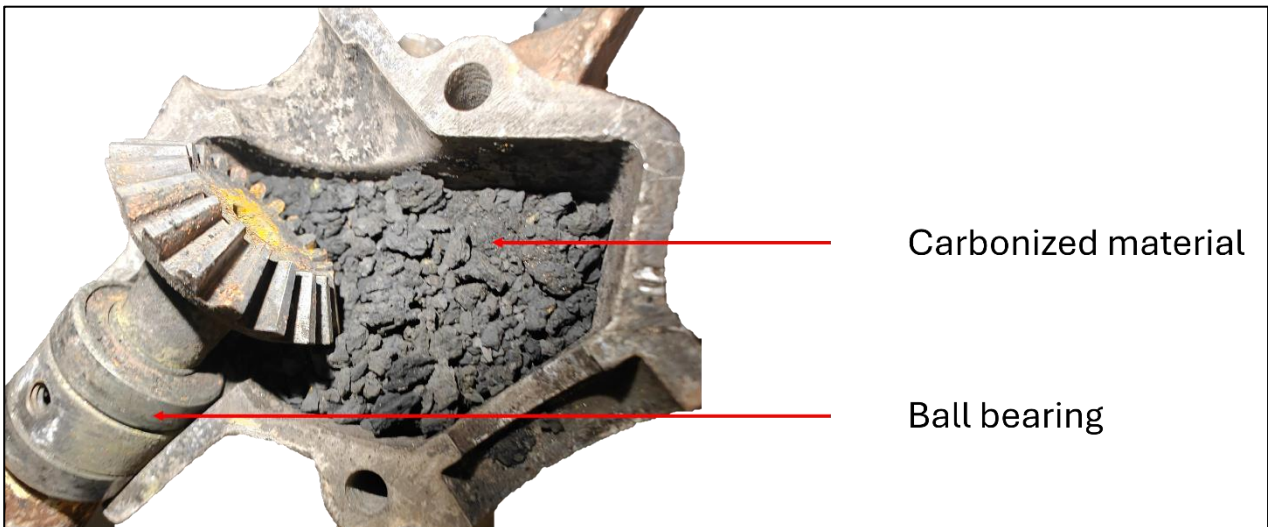
Carbonized material was found inside the transmission. It was most likely grease that had been subjected to high temperatures during post-impact fire.

Figure 26. Carbonized material inside the transmission. (Photo: SIAF)

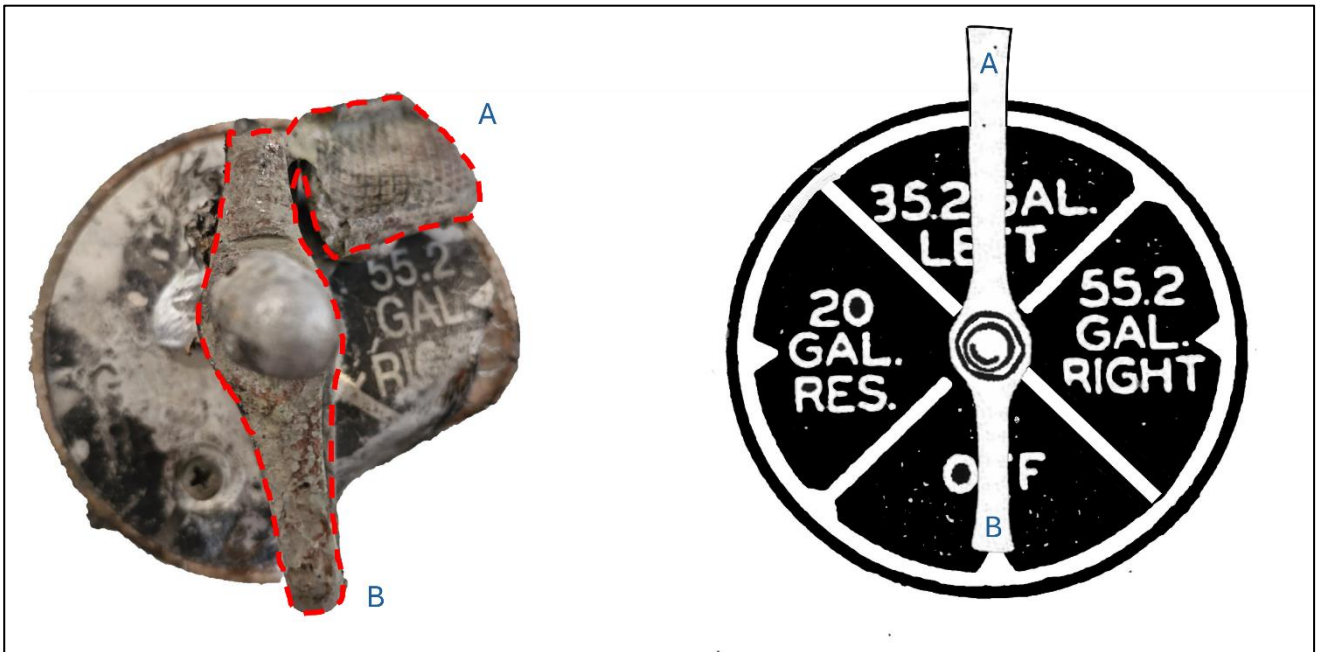
The flight control system components located in the front cockpit were almost completely destroyed, and both cockpits and instrument panels had sustained severe and extensive damage. The rear cockpit fuel selector was damaged, and the selector valve control rod was fractured. The selector was in OFF position. The propeller controls exhibited separation, bending and partial melting.

Figure 28. The rear cockpit fuel selector was found in OFF position. The selector handle with a partially melted and deformed longer grip (A) is outlined with the dashed red line. (Photo and annotations: SIAF)

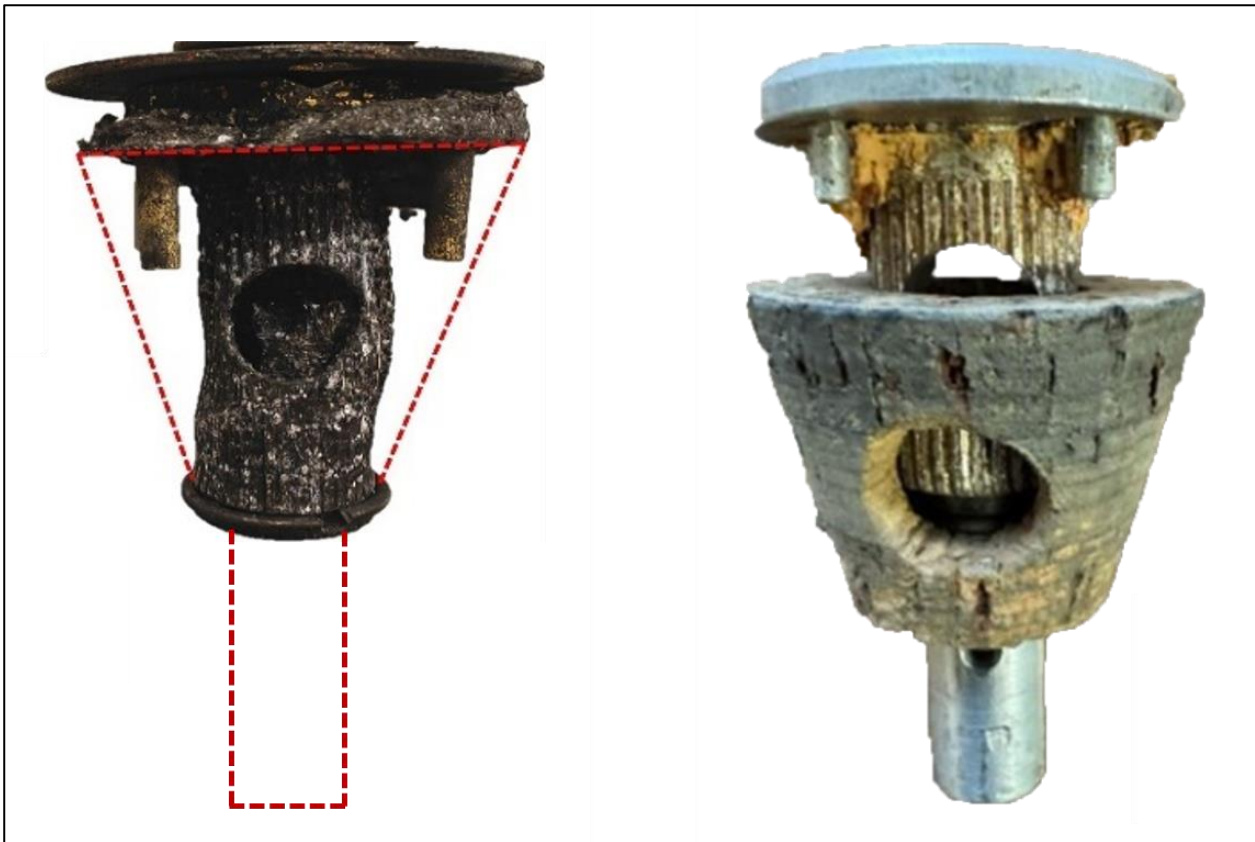
Although the selector valve body was consumed by fire, the valve plunger (see figures 14 and 29) was recovered. It had sustained major fire damage, and the cork seal was destroyed. The

studs shown in figure 29 lock the plunger to the seal when a selector is turned, while a spring presses the plunger toward the valve body to ensure effective sealing. The melted spring had been under tension on impact. The metal locking plate below the spring has detents that hold the valve in the selected position and provide distinct stop during tank switchover.

Figure 29. The selector valve plunger from the accident airplane is shown on the left, and an intact plunger assembly on the right. The cork seal was consumed by fire. The seal of the intact valve has been moved down from its normal position to give a better understanding of the construction. The dashed red line indicates the outline and the normal position of the seal and the metal tube, visible below the seal in the right-hand inset. (Photo: SIAF)
