Collision between Airliner and Passenger Stair at Helsinki Airport on August 28, 2025

L2025-03

Investigation: L2025-03
Investigation report 4/2026
ISBN: 978-951-836-697-6 (PDF)
ISSN: 2341-5991

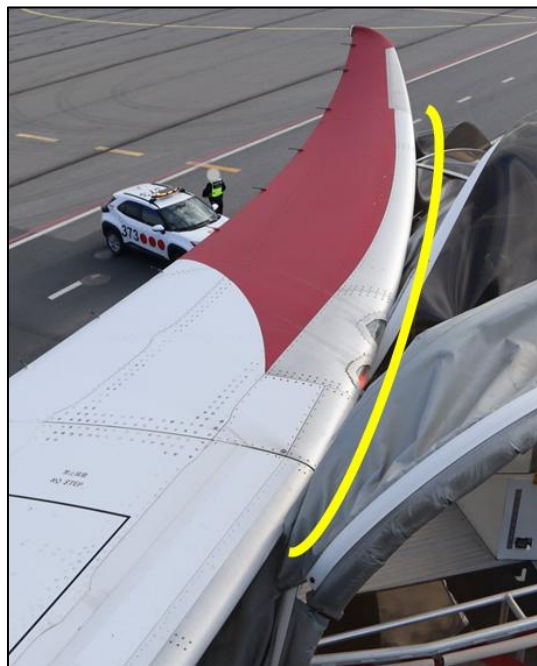
Airplane damage was limited to the leading edge of the left wing tip, which exhibited mainly scratches and a dent near the leading edge center point. The wing structure was unaffected, and the integral fuel tank did not sustain damage.

Figure 2. The yellow line indicates the damaged wing section. (Photo: SIAF)

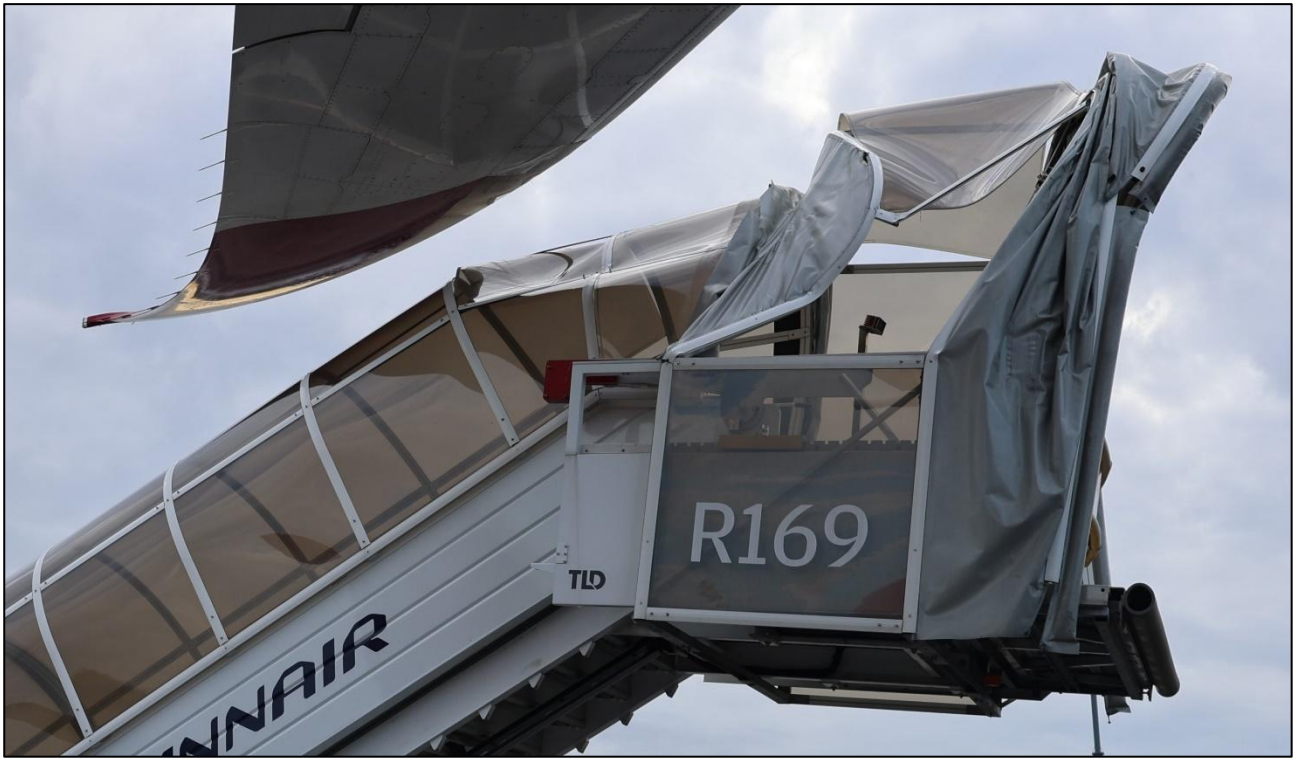
The stair vehicle sustained damage to the stairway elevating mechanism, upper section of the stairway and the canopy.

Figure 3. Damaged stairway canopy. (Photo: SIAF)

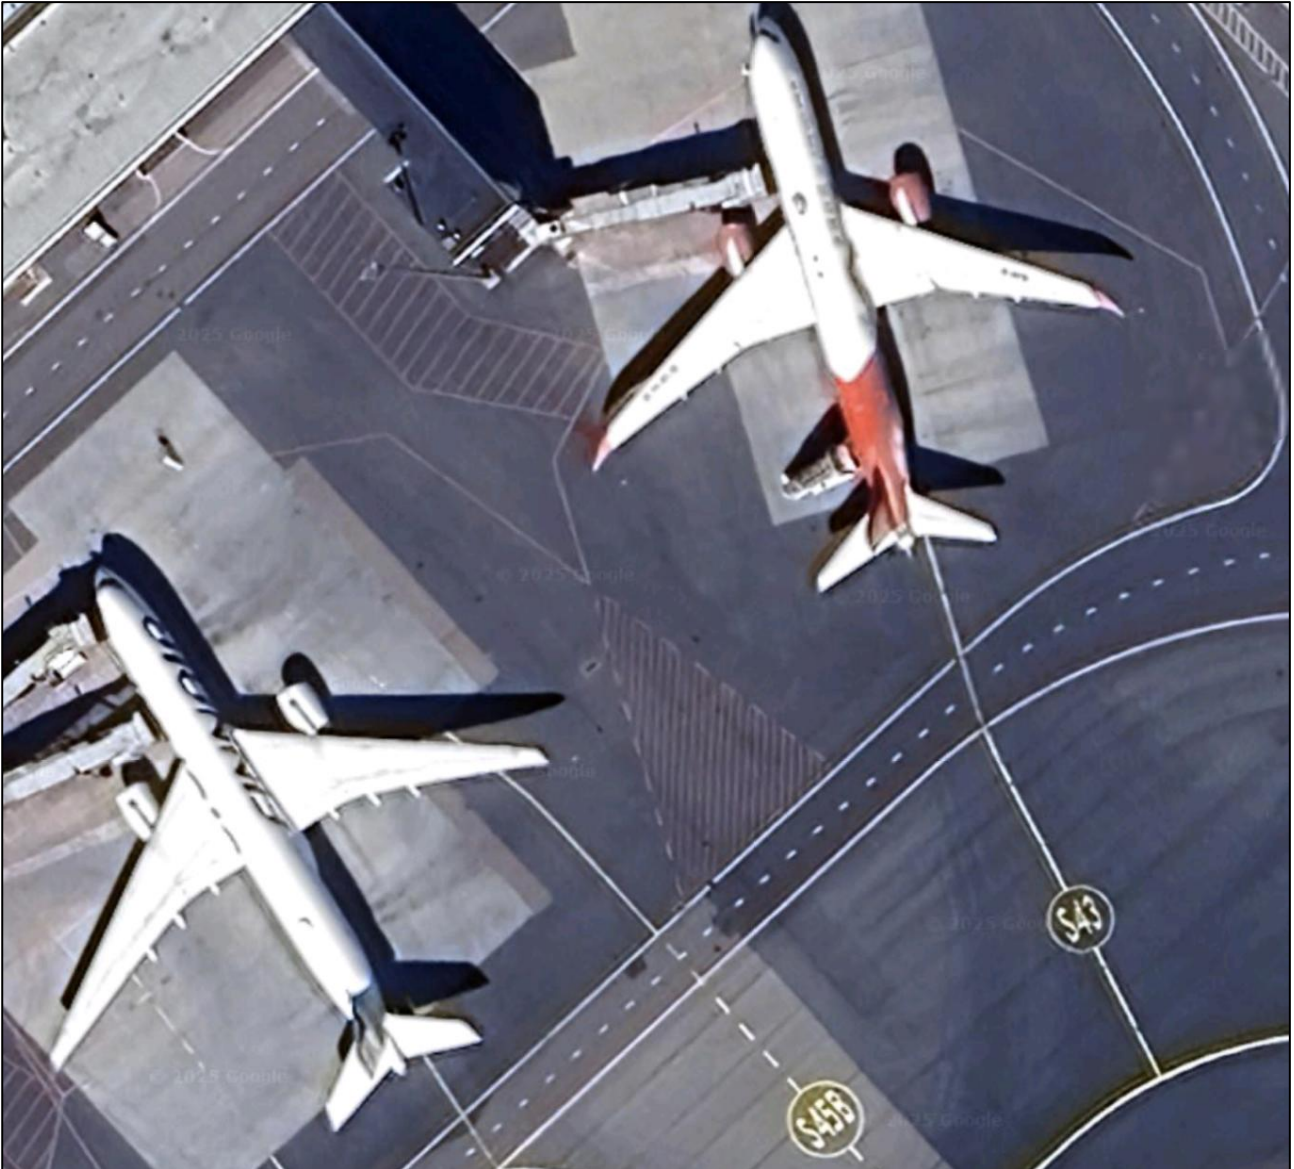
Figure 4. Aerial view of S45 and S43, with a triangular hatched no-parking zone in between. ERLs continue as a dashed line where they border the no-parking zone. The airplanes (Airbus A350-900 and Boeing 787-9) shown are in the same category as the incident airplane. (Photo: Google Maps ©2025)

Parking on an ERL has become a norm at Helsinki airport. The collision occurred between S43 and S45. These stands are in close proximity, and their ERAs overlap partially.

A no-parking zone that partially covers both S43 and S45 ERAs is shown in the overlap section.

Due to space constraints, ground support equipment may be parked in no-parking zones for loading or unloading an airplane occupying the adjacent stand, or for other reasons. This will in practice lead to situations where dollies or other loading equipment are parked inside S43 and S45 ERAs during an airplane's arrival on either one of these stands.

An airport can be regarded as a workplace of mutual hazards and therefore needs a body that assumes overall responsibility for safety management. A common risk assessment method shall in particular look at the simultaneous use of those aprons that have overlapping equipment restraint areas.

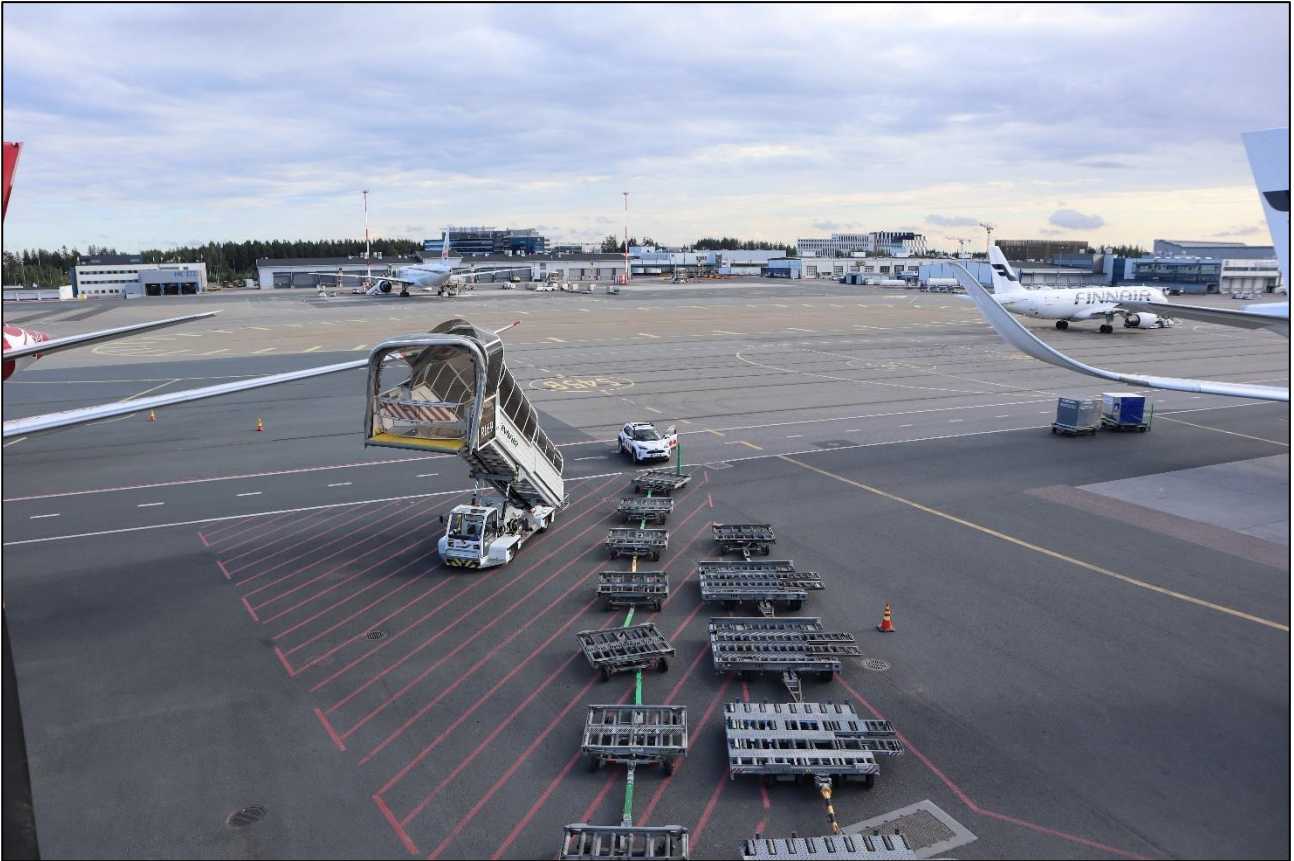
Dollies that had been used during the loading of another airplane docked on adjacent stand S45 were parked between stands S43 and S45. Some of them were within the section of equipment restraint area (ERA) of S43 that was marked on the tarmac as a no-parking zone.

Figure 5. The location of dollies and the stair vehicle after the collision. (Photo: SIAF)

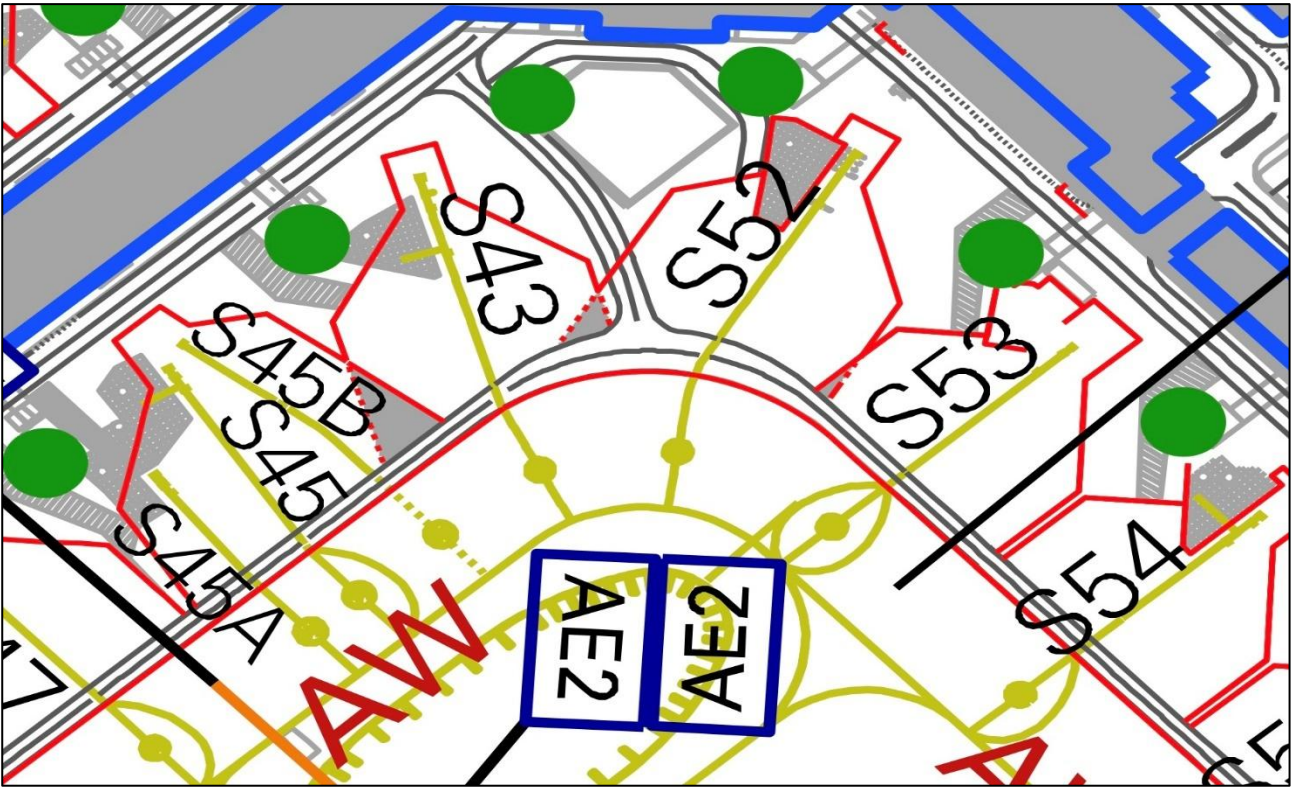
Finavia's apron chart shows taxiways, service roads and stand boundaries among other information. The stand boundaries do not coincide with tarmac markings in that the boundaries of overlapping ERAs are drawn both with broken and continuous lines (figure 6). The apron information board (figure 7) shows ERA boundaries with continuous red lines. Ramp personnel referring to the board may therefore come to an understanding that a vehicle is not within S43 ERA. Actually, the ERL runs along the opposite edge of the no-parking zone. The markings on the information board and the apron chart do not agree with the ERL painted on tarmac. Ramp personnel may have difficulty with creating a mental picture of ERA boundaries as well as their continuation and direction in the overlap area. This may lead to the misconception of a vehicle being parked on or outside an ERL, even though it is actually inside the ERA. The special features of S43 and S45 are not known to all employees

Figure 6. Stands as shown on the apron chart (effective as of September 1, 2025). (Chart: Finavia)

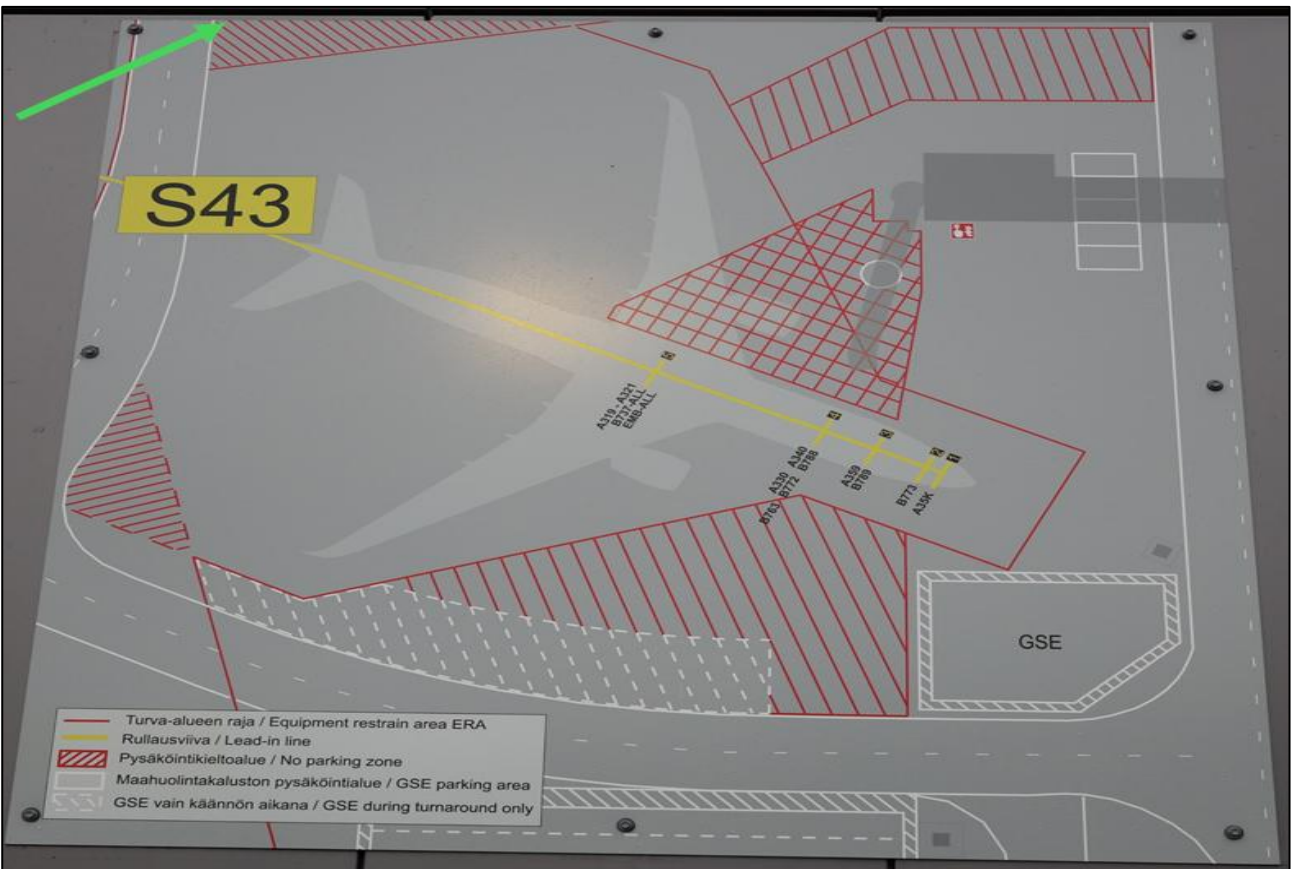
Figure 7. S43 information board on the terminal wall. The green arrow indicates the location of the stair vehicle inside the red hatched area. (Photo: SIAF)

Stand overlapping for space maximization places particular requirements on the clarity of signs and markings. Tarmac markings are not identical between stands, and the diagram on the stand S43 information board does not correspond fully to tarmac markings. Tarmac markings are difficult to visualize when viewed from the apron – they are much easier to view and interpret in aerial photos. Markings are major contributors to safe working conditions.

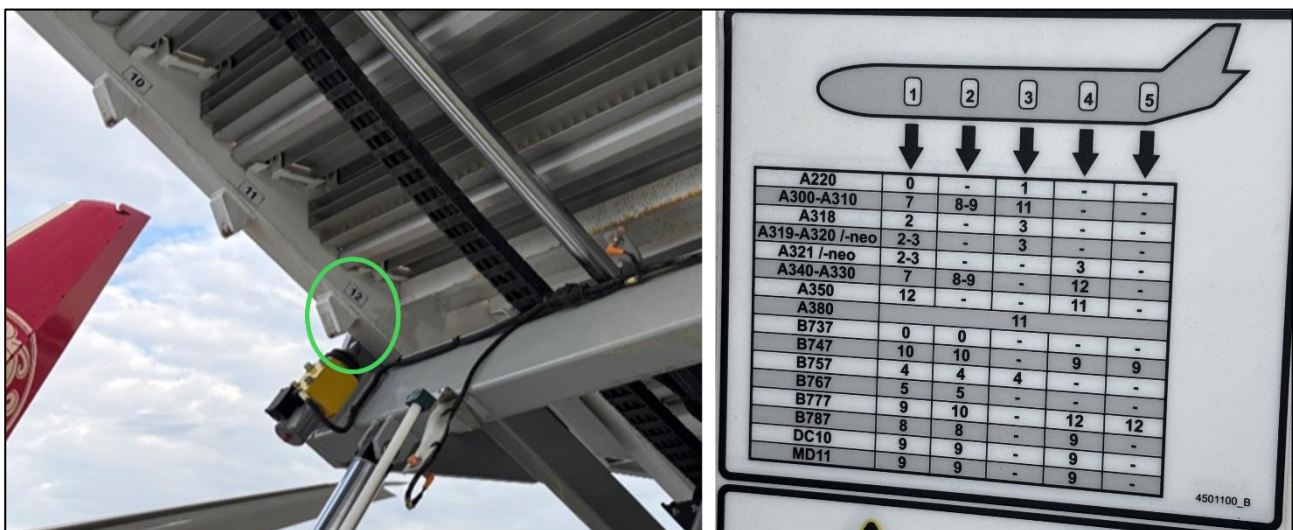
The operator moves the vehicle to a position next to the airplane's fuselage after engine spooldown and adjusts the height of the stairway for the airplane type, after which the top platform is adjusted visually. The height is determined from numbers located under the stairway. A total of 12 selectable heights, or levels, are available, which means that the overall height of the vehicle can vary between 5.93 and 8.14 m. The height for the incident airplane type should have been set at level 9, but at the time of impact the stairway was set to level 12.

Figure 8. On the left, number 12 indicating stairway level is circled in green. On the right, an instruction placard in the driving cab. (Photo: SIAF)
