## Aviation Accident near Eura Aerodrome on May 17, 2025

L2025-01

## SYNOPSIS

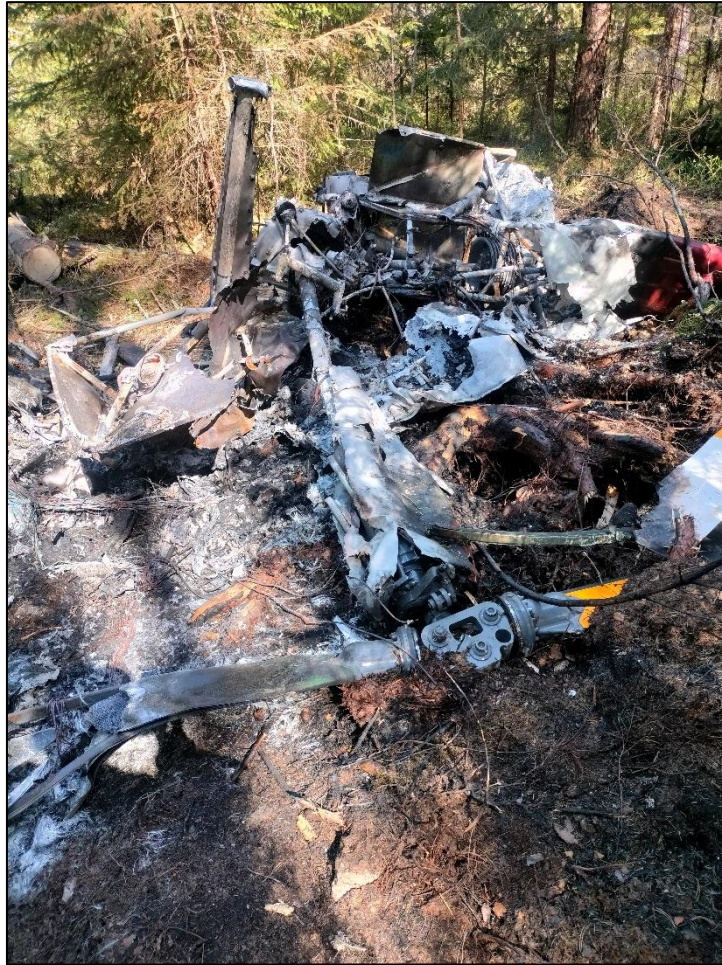
**Figure 6.** ES-ETR main fuselage and main rotor after completion of rescue operation. (Photo: SIAF)

The main fuselage was consumed by fire. The engine and the main gearbox remained attached to the airframe, the main rotor remained connected to the gearbox and rotor control system continuity was established. The hydraulic servos remained attached but were melted by fire. The main rotor blades, which were disintegrated and partially consumed by fire, remained attached to the rotor hub at the roots. Examination of components remaining after the impact and fire showed no evidence of damage that could have contributed to the accident.

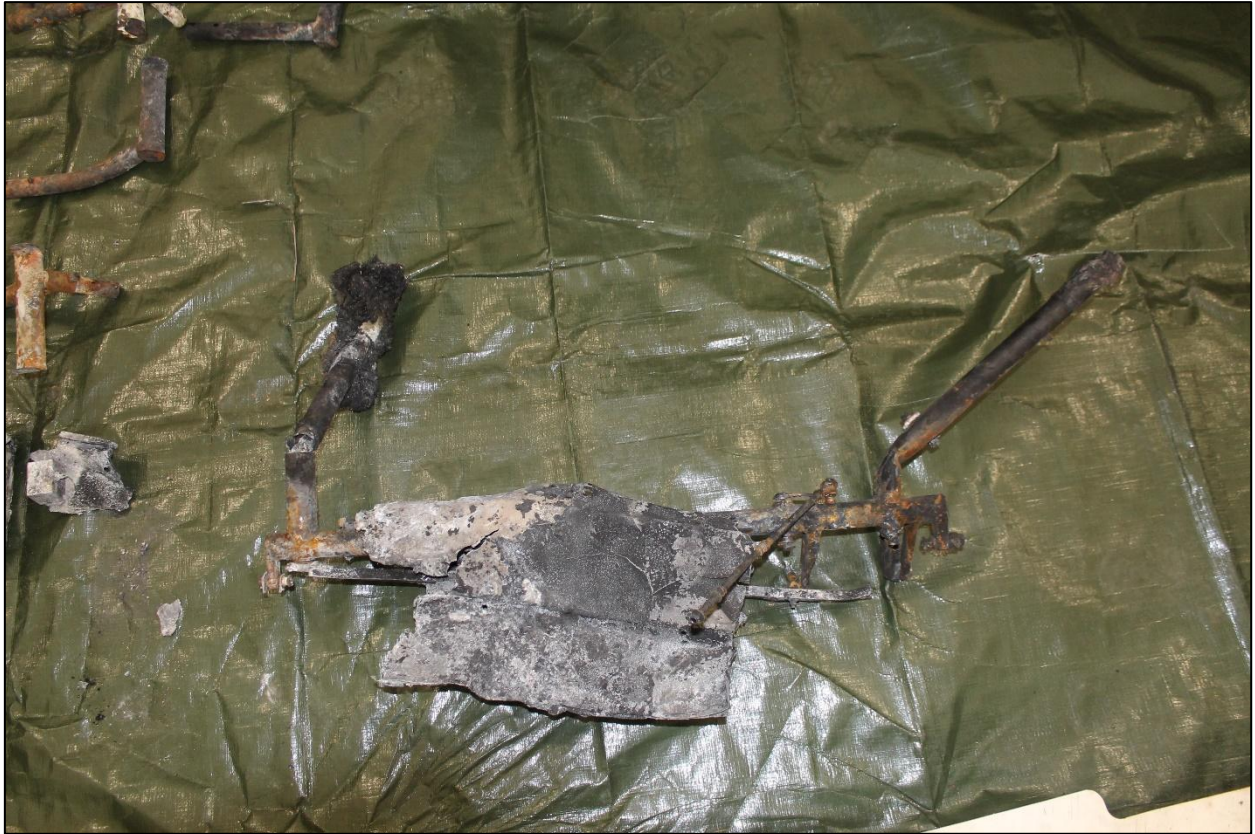
The collective stick of the dual control system was found fitted to the left of the left seat, while the left cyclic stick and left anti-torque pedals were recovered from the vicinity of the crash site. The end fittings of the flight control system push-pull tubes remained in place although the tubes were destroyed by fire. The hydraulic servos were in place but severely fire-damaged. Examination of components remaining after the impact and fire showed no evidence of defects or damage that could have contributed to the accident.

**Figure 7.** ES-ETR collective lever. (Photo: SIAF)

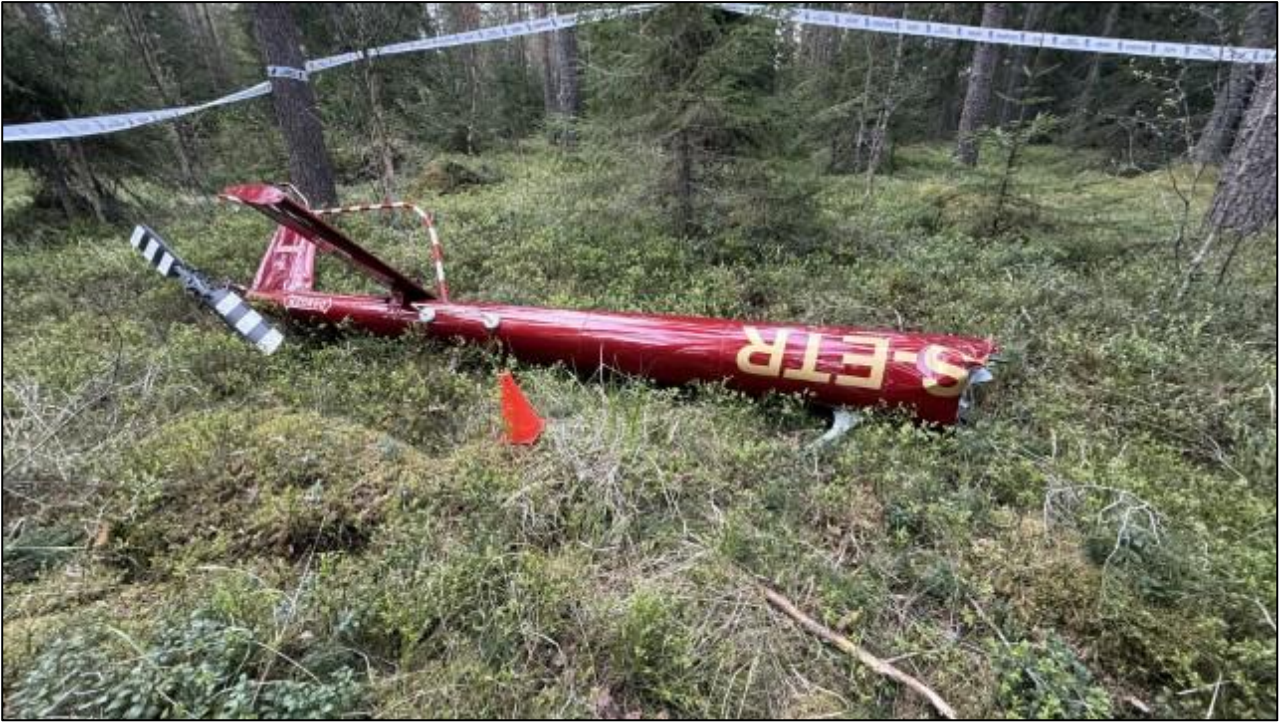
The tailboom, which had separated at a point 95 cm aft of its attachments to the main fuselage, was located some distance away from the main fuselage, to which its front section remained attached. The tailboom was undamaged except for slight bending of the vertical stabilizer, and the tail rotor drive shaft, the tail rotor gearbox and the tail rotor were in place and free to rotate. The rotor control system between the point of boom separation and the rotor remained intact. While the point of separation showed no signs of an external impact, stretching and tearing of the aluminum skin in the area were apparent.

**Figure 8.** The tailboom of ES-ETR separated during the collision sequence. (Photo: SIAF)

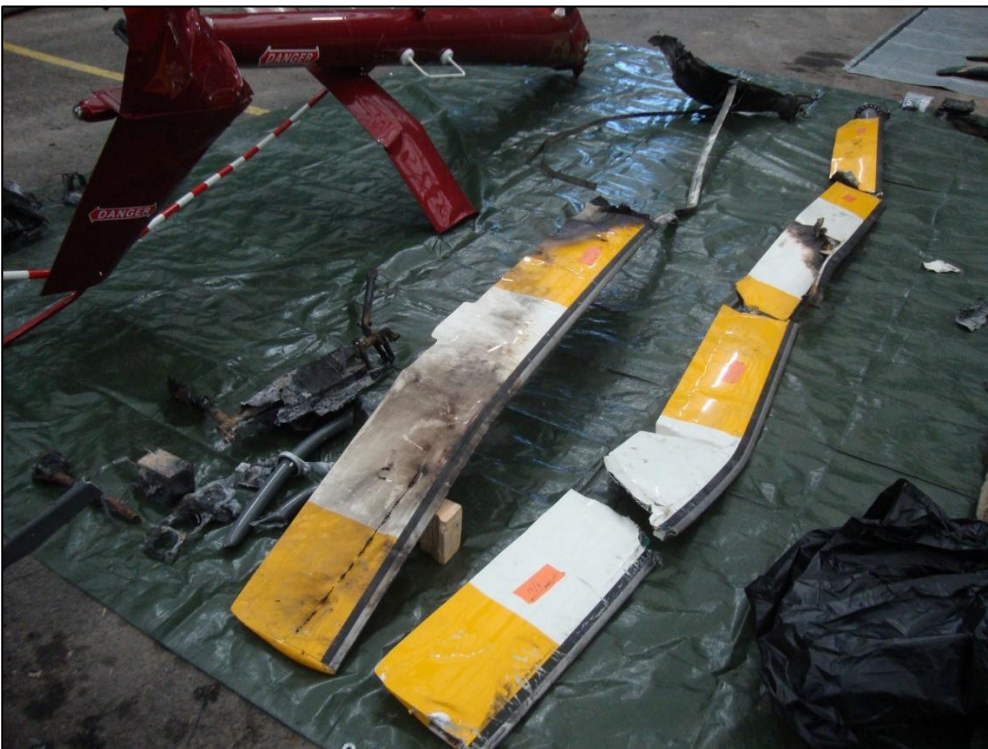
Both main rotor blades remained attached to the hub at the roots. One blade was severely fire-damaged between the root and mid-span, although the leading edge structure was continuous all the way to the blade tip, and no impact marks were noted on the leading edge of the outer blade section. The other blade had bent aft prior to breaking into four sections that were located near the main wreckage.

**Figure 9.** The main rotor blades of ES-ETR. One blade was destroyed between the root and mid-span, while the other broke into four sections. (Photo: SIAF)

Two major impact marks were found on the leading edge of the outermost section of the blade. A 20 mm diameter mark was located at a distance of 2 cm from the blade tip, and a 50 mm diameter indentation was evident at the point of breakage. The blade had bent slightly aft before disintegration. The impact signatures were consistent with damage found in a main rotor servo piston, the aft strut and right skid on OE-XOS.

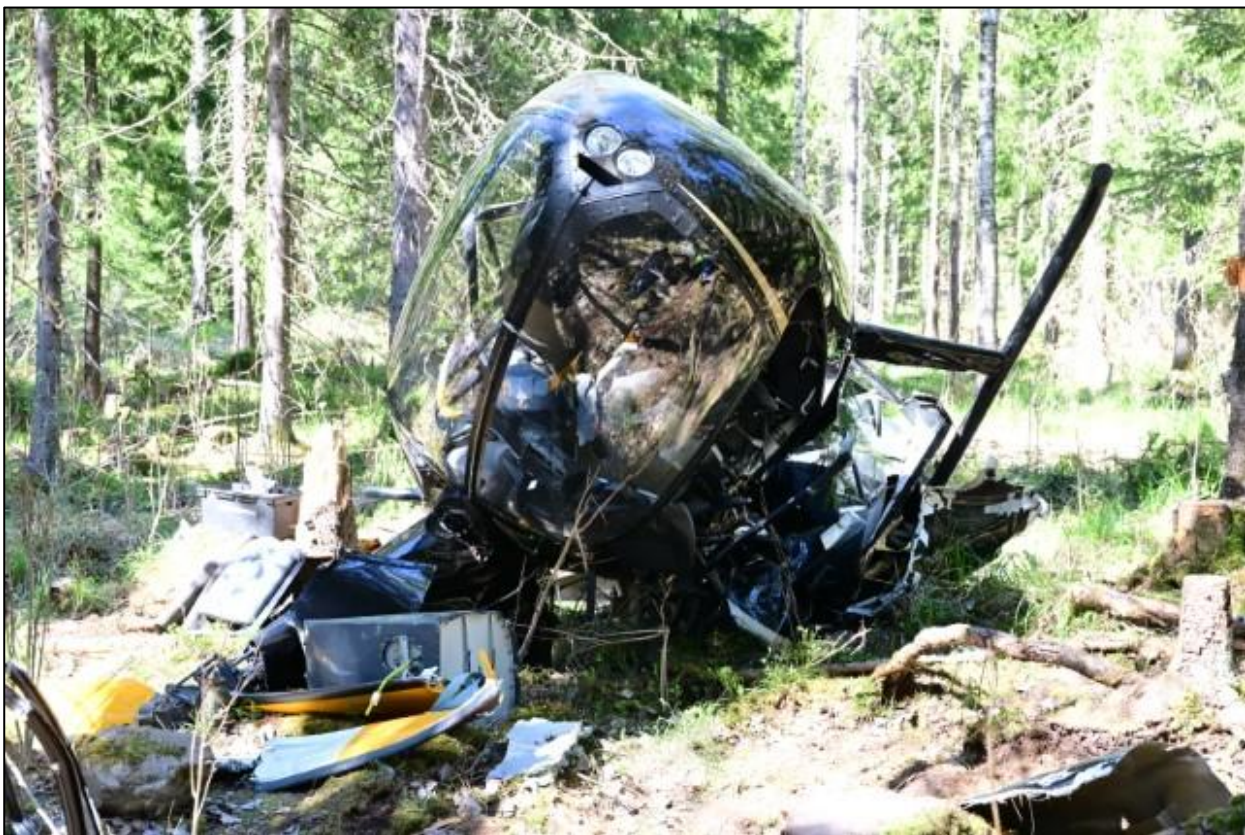
The fuselage impacted ground inverted and tail first and remained relatively intact. The fuel tank ruptured allowing fuel to escape to environment, but there was no fire.

**Figure 10.** OE-XOS fuselage. (Photo: SIAF)

The rear section of the cabin aft of the rear seats was crushed, and the structure below the front seats exhibited deformation. The seat harness remained intact, and cockpit controls and switches were in a position corresponding to cruise flight. Although the ELT mode switch was in “armed” position<sup>6</sup>, the unit did not activate on impact.

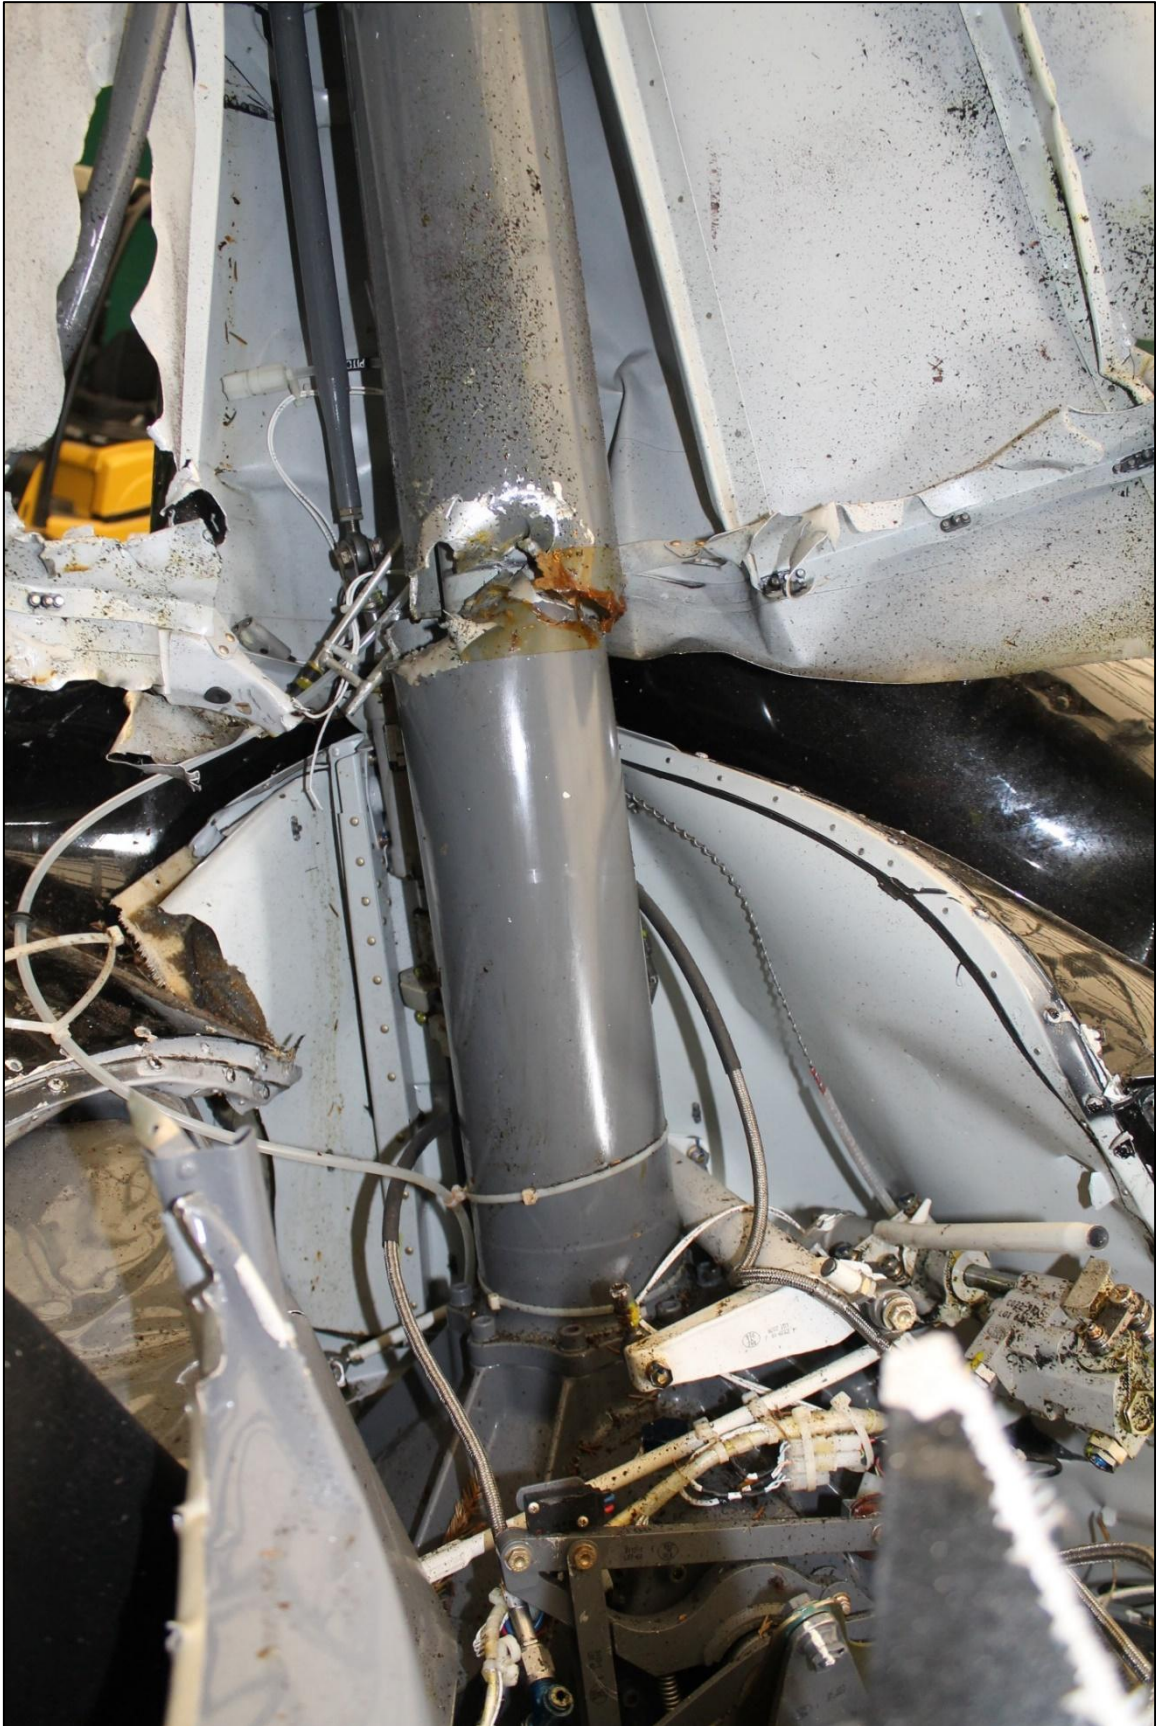
The engine and the main gearbox remained attached but exhibited damage caused by main fuselage deformation during ground impact. The main rotor mast was bent forward and fractured about 40 cm above the gearbox. An impact mark and traces of yellow paint consistent with the finish of the rotor blades were apparent on the rear face of the mast at the fracture point, while the flight control servo located behind the mast was bent and fractured at the piston root because of an external impact. The impact marks were consistent with damage to the tip of one main rotor blade on ES-ETR.

**Figure 11.** The main rotor mast of OE-XOS was fractured about 40 cm above the main gearbox.  
(Photo: SIAF)

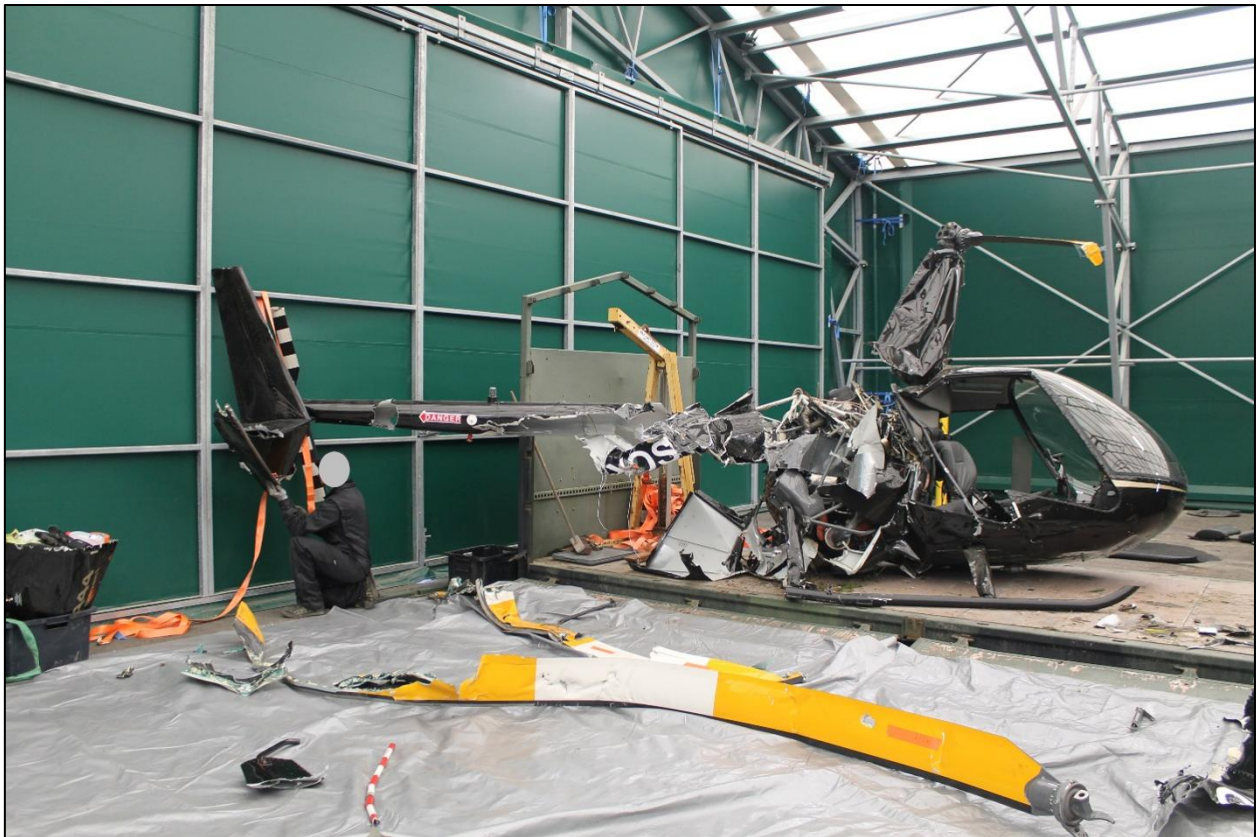
The tailboom was sheared off. Traces of yellow paint from a main rotor blade were apparent in a cut mark that began on the lower surface of the boom near its midpoint and continued to the junction of the boom and the main fuselage, indicating that the damage had progressed at an upward angle from aft to front toward the upper fuselage. The tail rotor gearbox and the tail rotor remained in place and operated correctly. The horizontal stabilizer and the lower section of the vertical stabilizers were cut off due to an impact in aft-to-front direction, and their fragments were located around the accident site. The cut marks exhibited traces of yellow paint consistent with the finish of a main rotor blade.

**Figure 12.** The tailboom of OE-XOS, which was cut off near midpoint, was lifted to its original position for reconstruction purposes. (Photo: SIAF)

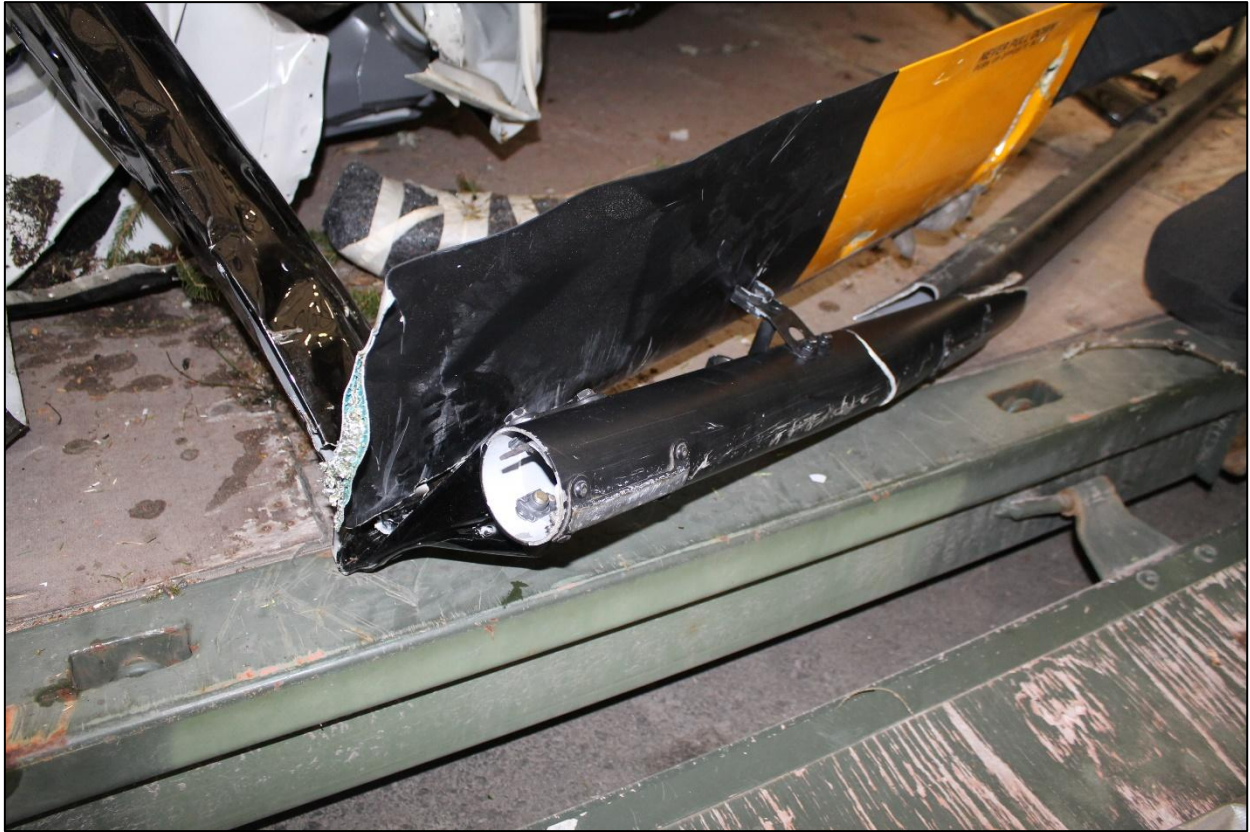
The aft end of the right skid had fracture-separated and was recovered next to the main fuselage. Traces at the fracture point matched the damage sustained by a main rotor blade of ES-ETR.

**Figure 13.** The rear section of the right skid and strut of OE-XOS and a main rotor blade of ES-ETR. Matching damage is apparent. (Photo: SIAF)

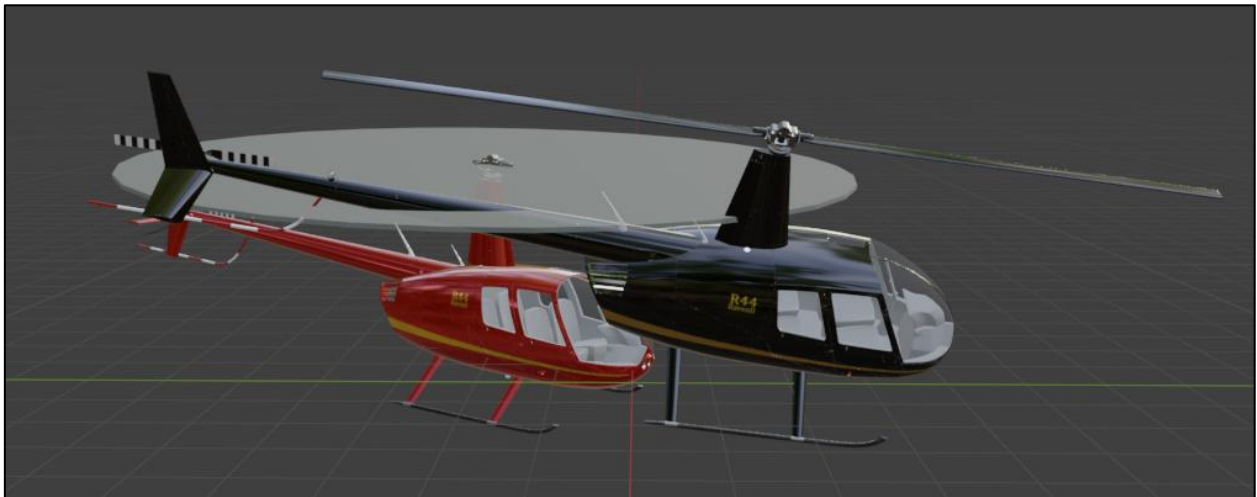
**Figure 14.** Estimated attitude of the helicopters on impact, based on damage described in this paragraph. (Figure: SIAF)

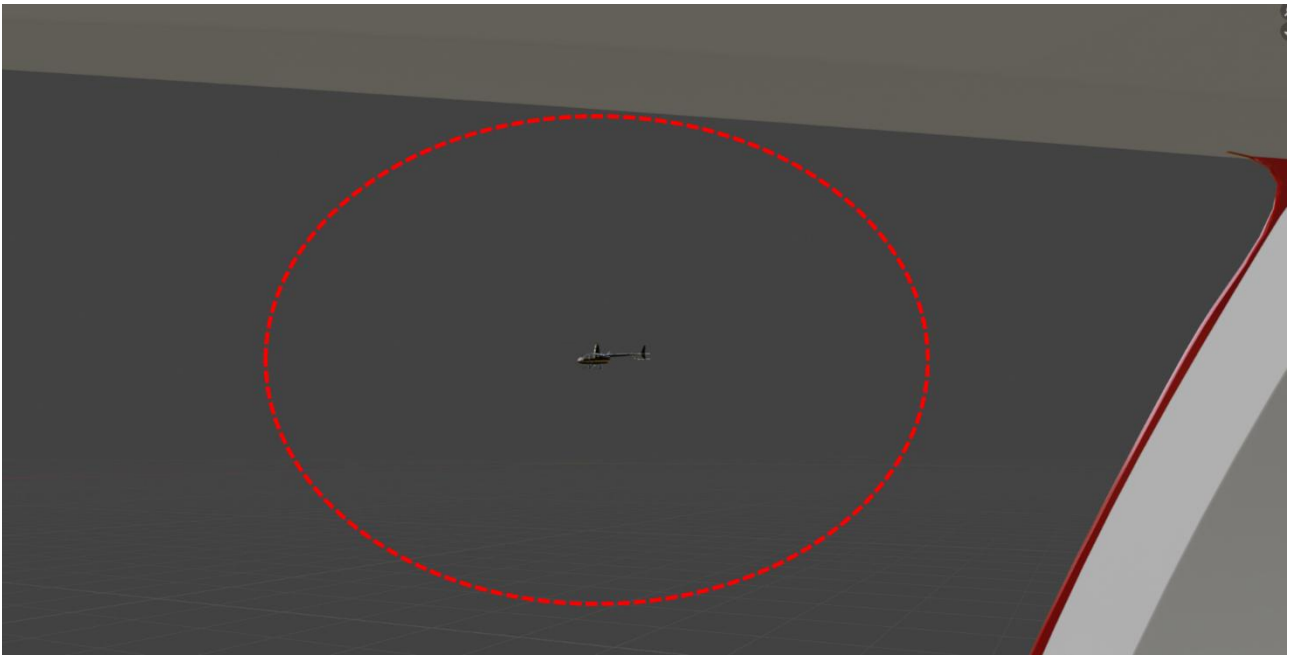
**Figure 18.** The upper rear corner of the right-hand cabin door is shown in the figure, which illustrates the visual field of the ES-ETR pilot in the direction of OE-XOS immediately before turn initiation, supposing that the pilot was scanning the area behind and to the right of his helicopter. The line of sight extends to the right and slightly behind at an angle of about  $100^\circ$ , and  $6^\circ$  up. The position of OE-XOS is approximate because only inaccurate information was available. This “circle of ambiguity” is shown by the red dashed line. (Figure: SIAF)

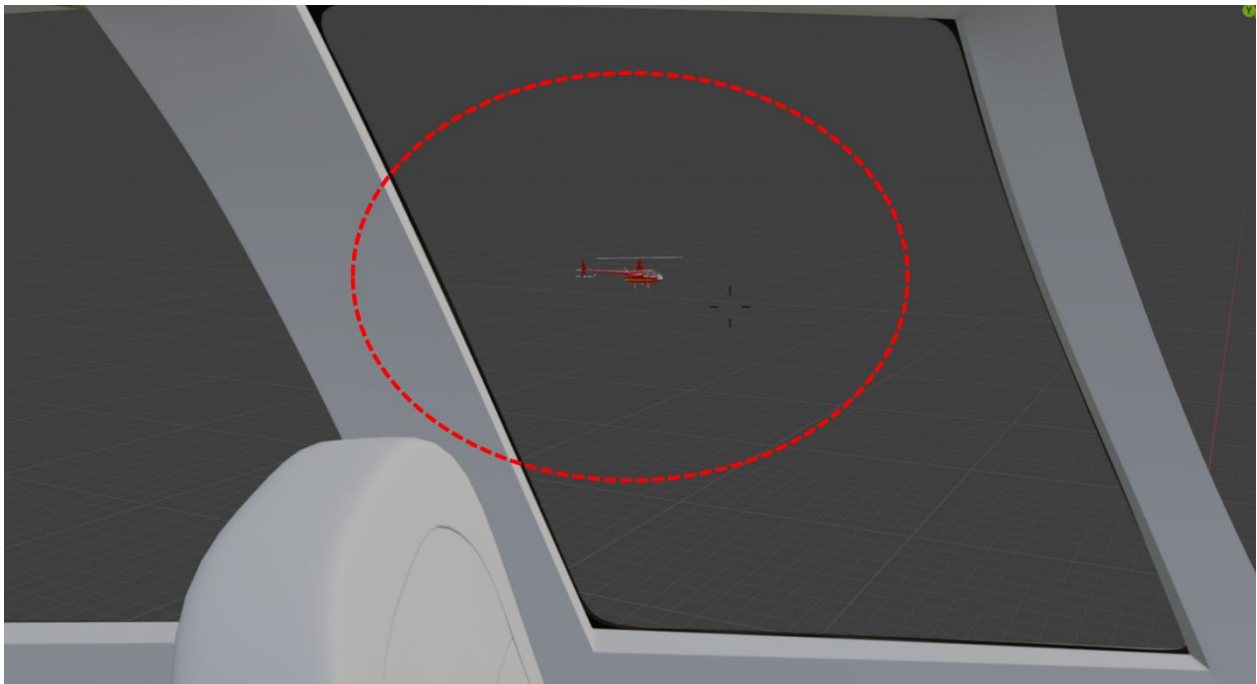
**Figure 19.** The left-hand cabin door and the left windshield are shown the figure, which illustrates the visual field of the OE-XOS pilot in the direction of ES-ETR immediately before turn initiation, supposing that the pilot was scanning the area to the left of his helicopter. The left seat occupant is not shown. The line of sight extends to the left at an angle of about  $80^\circ$  relative to the helicopter’s longitudinal axis, and  $6^\circ$  down. The position of ES-ETR is approximate because only inaccurate information was available. This “circle of ambiguity” is shown by the red dashed line. (Figure: SIAF)
