# Collision of Airplane with Ground Power Unit at Helsinki Airport on August 16, 2025

L2025-02

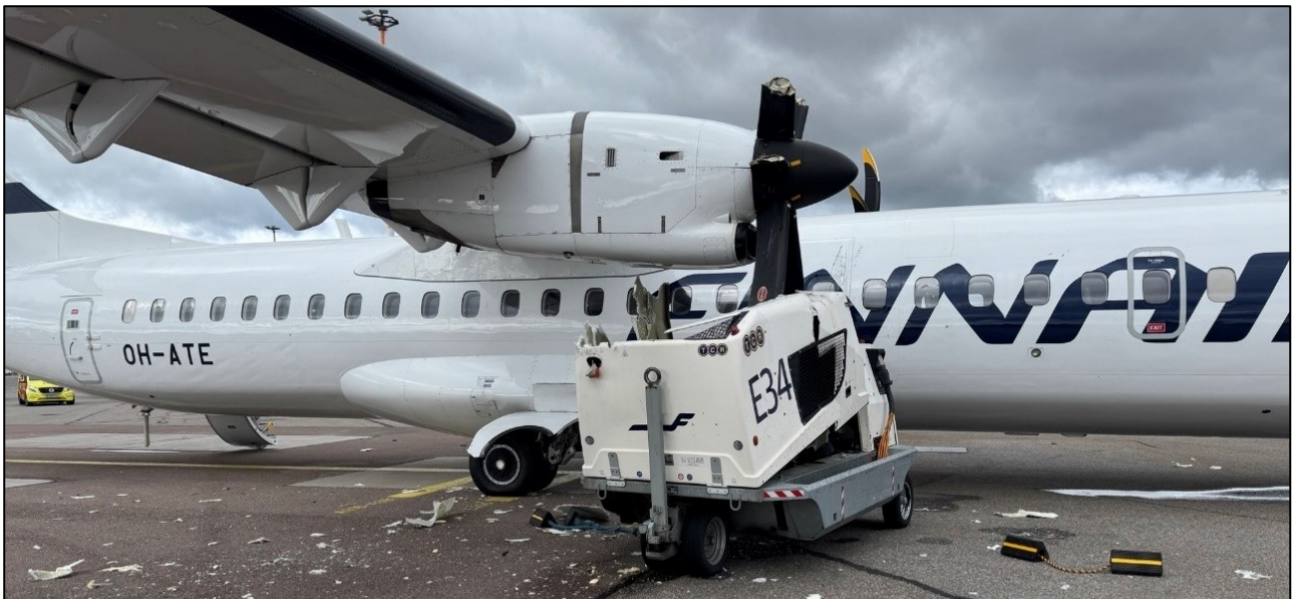
At 1038, the flight crew received start-up approval from air traffic control (ATC). Because parking brake was not engaged, the airplane rolled forward after engine start. A dispatcher was in position to give hand signals during engine start and to assist in the removal of the wheel chocks and in GPU operation. While adjacent to the airplane on the right-hand side level with the cockpit, he turned around, saw the airplane coming toward him and dashed to safety on the left-hand side of the airplane. The flight crew was running a checklist and failed to notice airplane movement. After rolling about nine meters the airplane struck the GPU.

**Figure 1.** The airplane and the ground power unit after the collision. (Photo: SIAF)

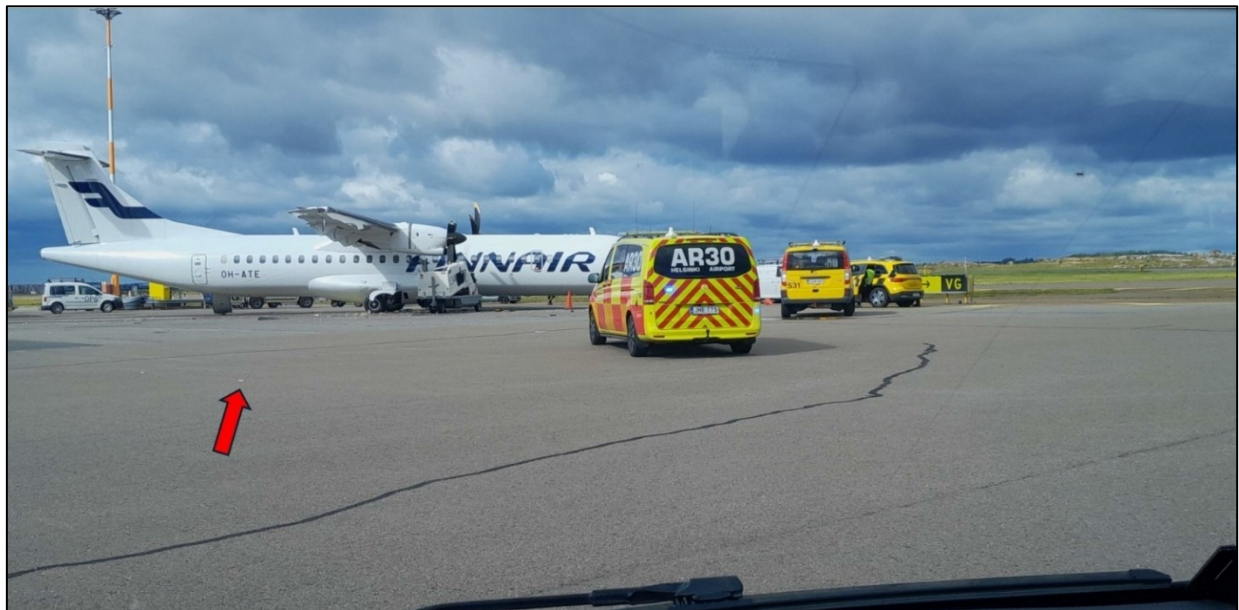
**Figure 3.** Vehicle positions on the downwind side of the airplane before command post relocation. The red arrow shows debris location. (Photo and annotation: Central Uusimaa Rescue Department)

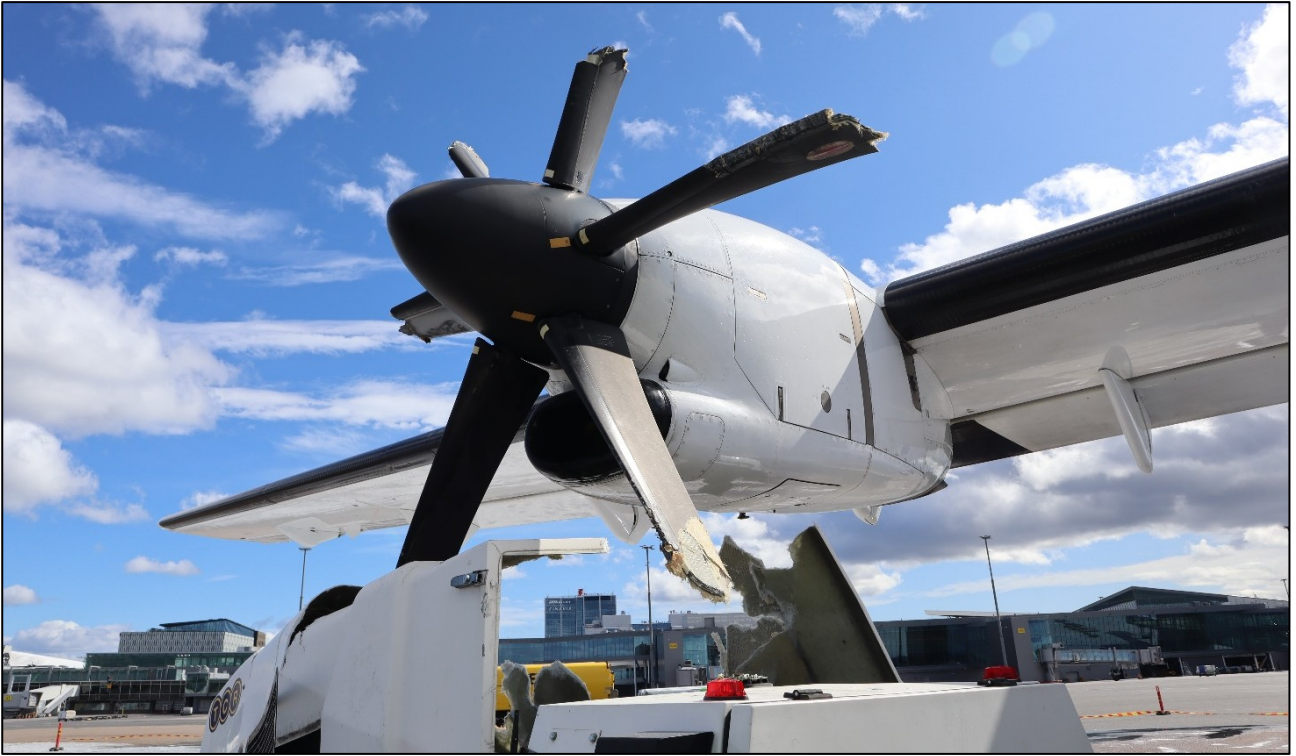
The airplane's fuselage sustained major damage on impact with the GPU. The right-hand engine was damaged. The propeller disintegrated, and fragments caused extensive airframe damage when propeller and GPU splinters punctured the pressure hull.<sup>12</sup> Propeller fragments struck cabin windows located in line with the propeller, dislodging the inner pane complete with the frame. Frame fragments ended up on the floor and on passengers. Outer surfaces of the windows were extensively scratched.

**Figure 4.** The propeller blades disintegrated on impact. (Photo: SIAF)

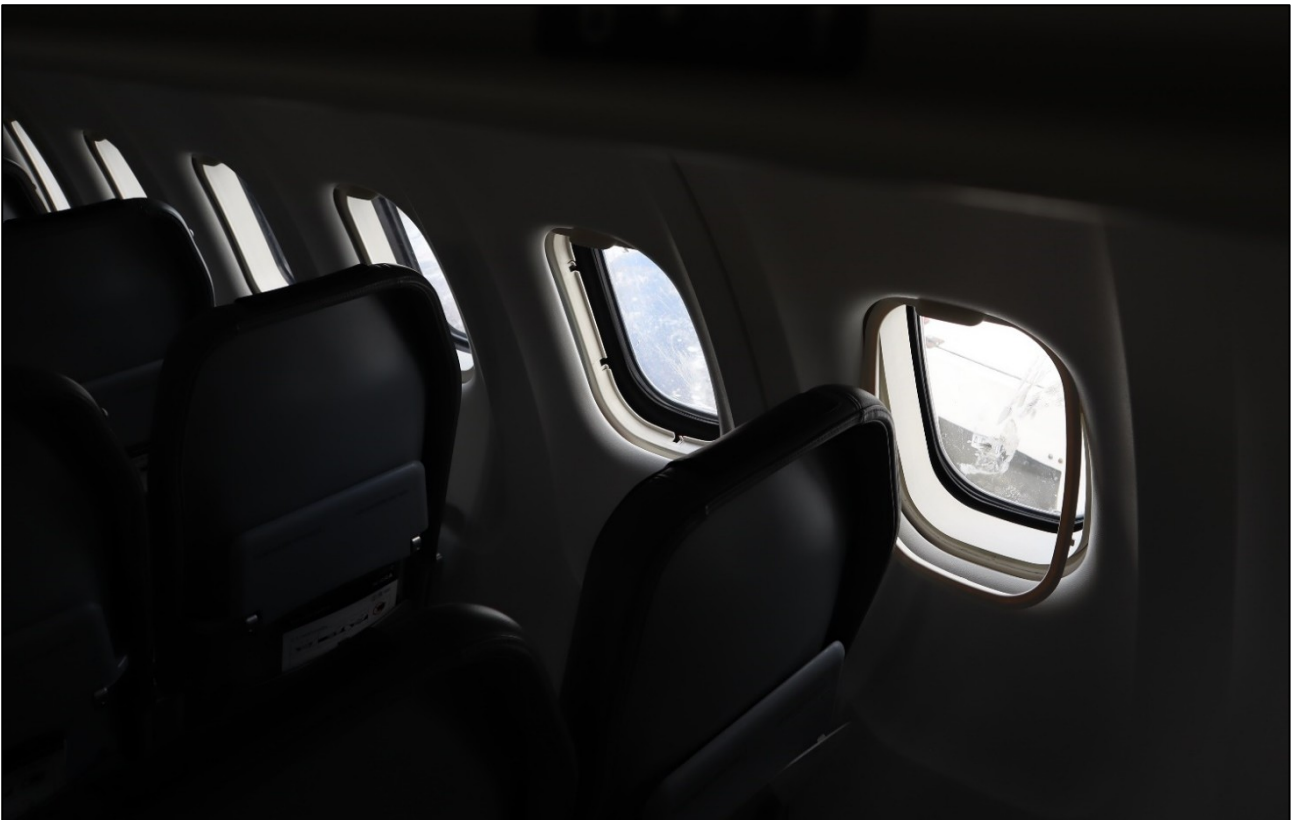
**Figure 5.** Propeller and GPU fragments struck cabin windows in line with the propeller, dislodging the inner panes complete with frames. (Photo: SIAF)

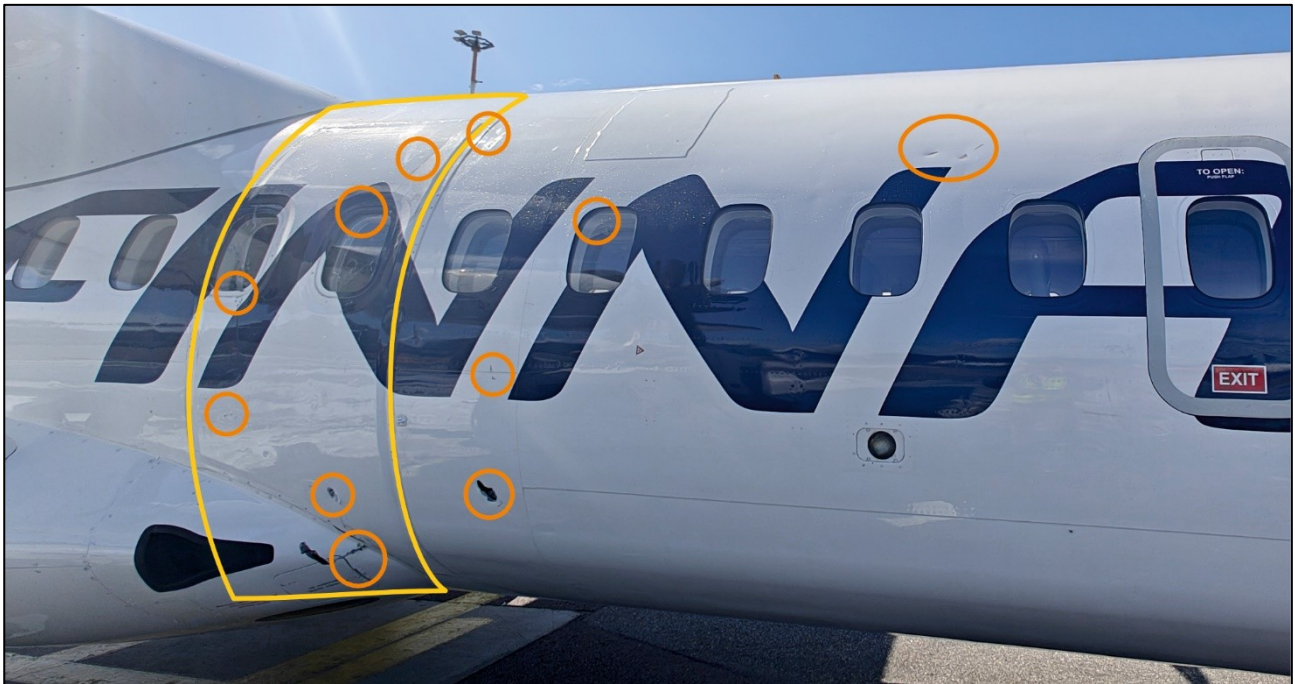
**Figure 6.** The orange circles indicate airframe damage. The yellow rectangle shows the reinforced fuselage section. (Photo: SIAF)

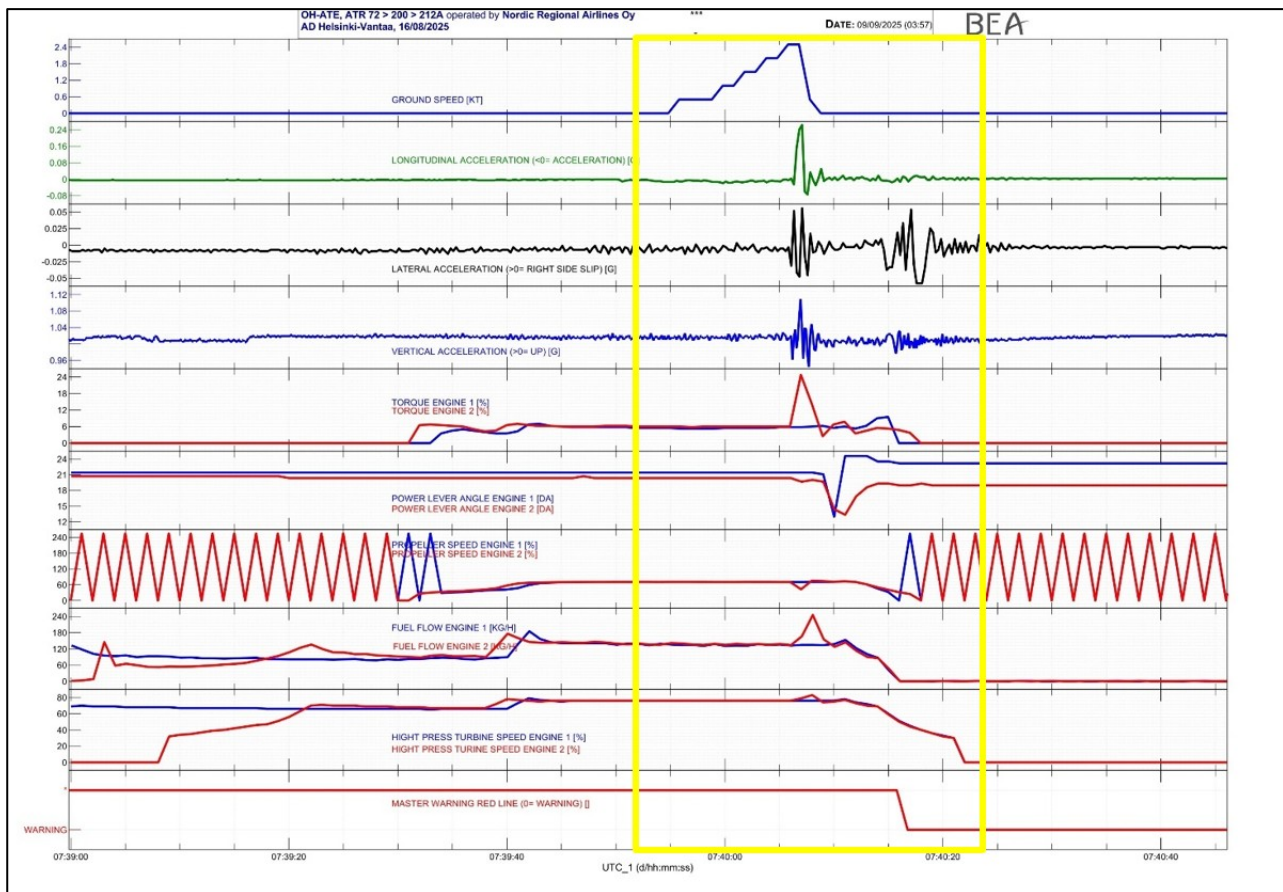
Longitudinal acceleration exhibited a sudden peak of approximately +0.23 g, corresponding to rapid deceleration. Simultaneously, ground speed decreased to zero, and propeller speed decayed by nearly 30 % (70.5 % → 42.75 %), and then increased by more than 30 % until reduced again (76 % → 70.5 %) after 5 s. Engine no. 2 torque momentarily more than quadrupled until restored to the previous value (6 % → 24.74 % → 6 %). These abrupt and transient parameter variations are consistent with a propeller strike against the GPU.

**Figure 10.** Flight data recorder data. The yellow box marks the 35 s timeframe inside which the propeller hit the GPU and the crew shut down the engines. (Figure: BEA, annotations SIAF)

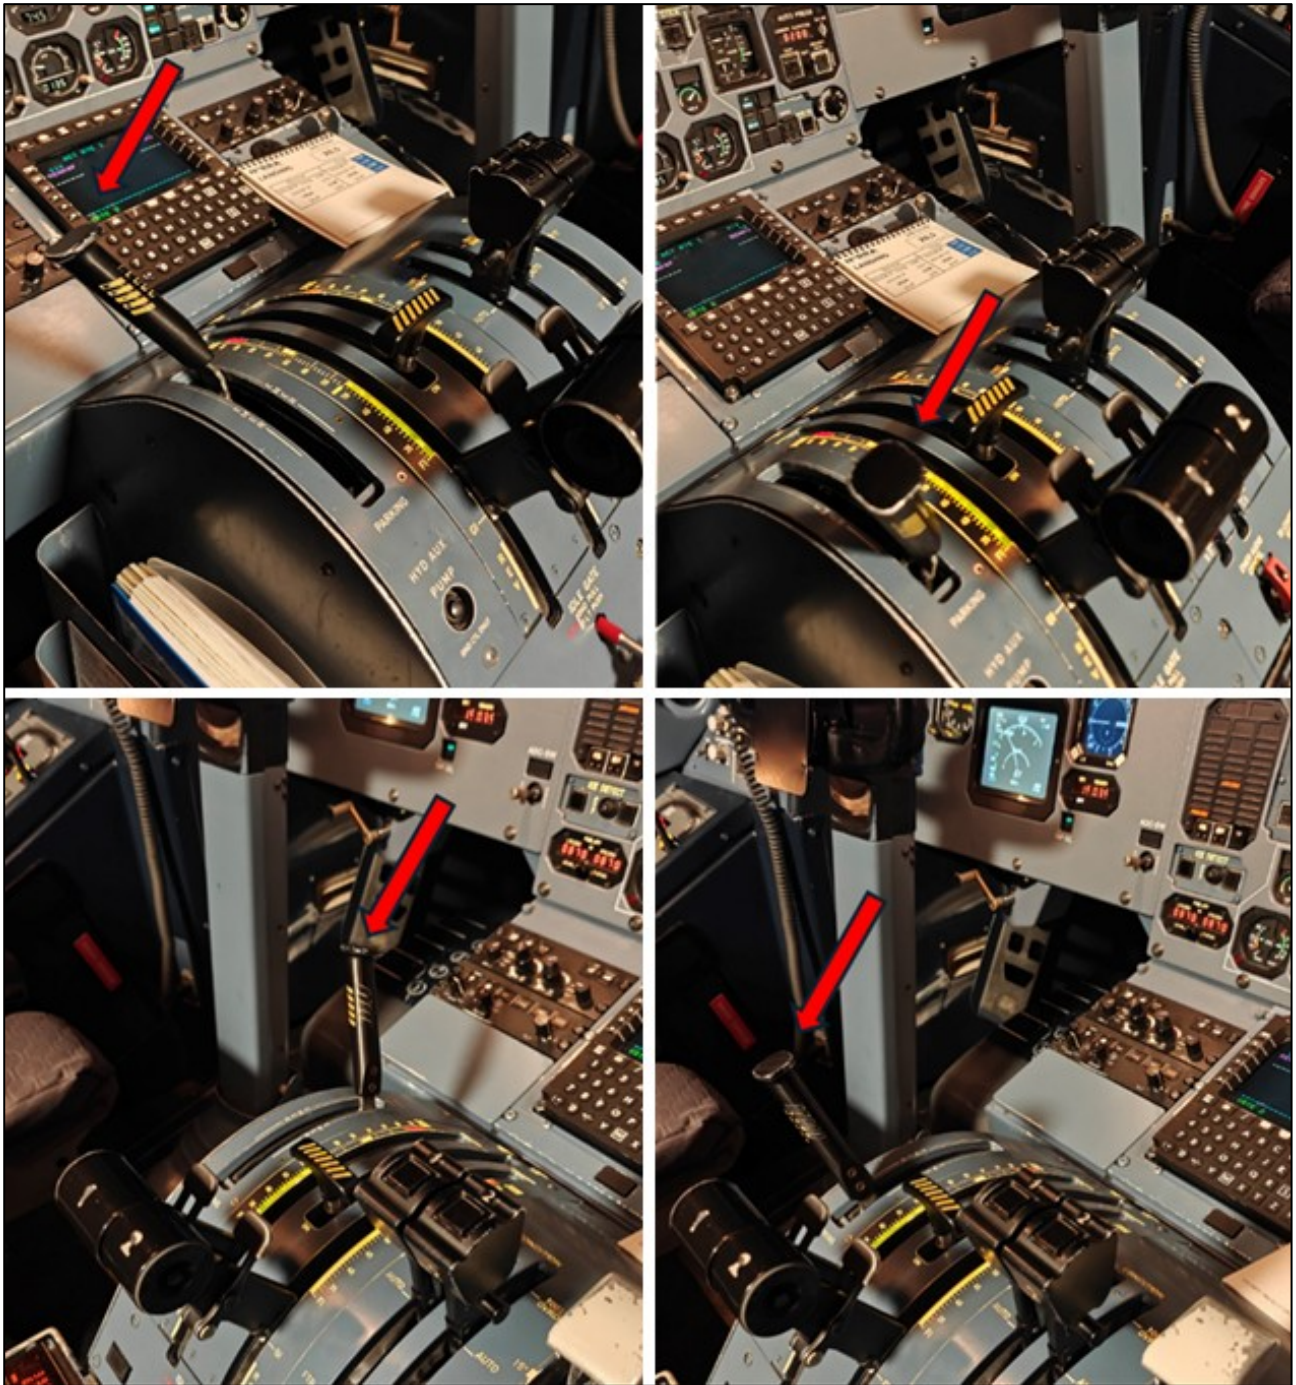
The flight crew did not engage parking brake or verify brake handle position although this is listed on the reverse side of Flight Deck Preparation checklist and included as an item to be double-checked in Before Engine Start checklist. Company procedures allow a flight crew member to run Flight Deck Preparation checklist using the flow method provided that all items are verified verbally. Flight Deck Preparation checklist shall always be performed when the airplane is out of maintenance or if the cockpit has been left unsupervised.

**Figure 17.** The left-hand photos show the parking brake handle in disengaged position, and in the right-hand photos the handle is in engaged position. The upper and lower photos were taken from the left and right seat, respectively. (Photos: SIAF)
