Aircraft Accident Investigation Commission

FINAL REPORT AIRCRAFT ACCIDENT INVESTIGATION

COPTERLINE OY SIKORSKY S-76C+

**In Tallinn Bay, Estonia
on 10 August 2005**

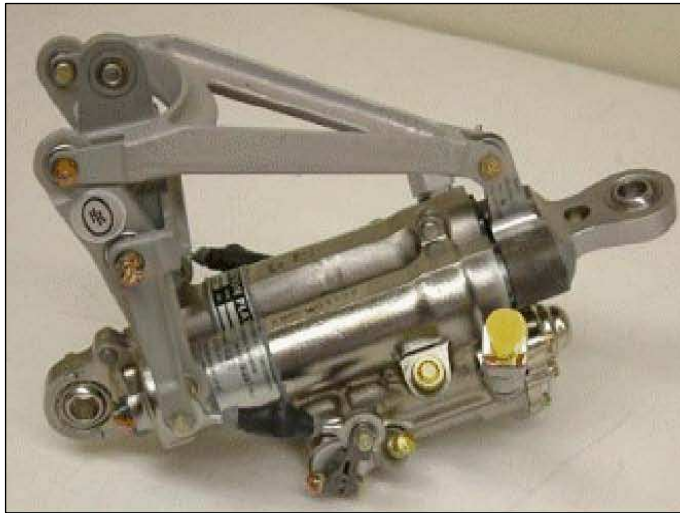
Photo 2. Main rotor forward actuator. (The spherical bearing at the lower left attaches to the helicopter structure above the cabin. The spherical bearing at the upper right connects to the swash-plate.)

The main rotor forward actuator, part number 76650-09805-110, serial number 0846, had been in service for a total of 11 180 hours. On 21 July 2003, the last overhaul of the actuator had been performed by HSI after 8 904.6 hours in service. On 19 August 2003, the actuator had been installed on OH-HCI. At the time of the accident, the forward actuator had been in service for 2 276 hours.

According to the maintenance records, the pistons installed in the main rotor forward actuator in the last overhaul had been in service for 24 100 hours. As the stripping of the aluminum-bronze coating on the pistons was a requirement in an overhaul, it might be assumed that there had been seven reworks of the pistons. However, according to Sikorsky, the pistons were not reworked more than three times.

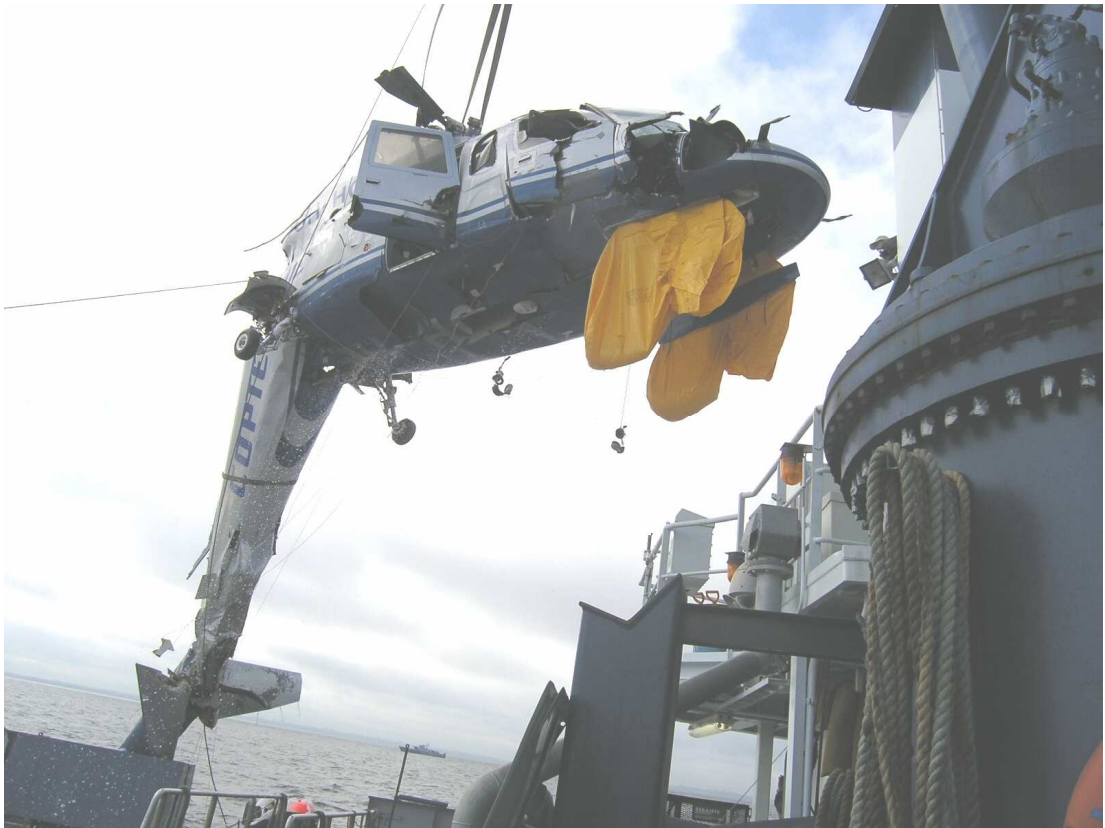
Photo 4. Helicopter OH-HCI recovery from the sea.

The helicopter may have incurred some minor additional damage when it was turned around at the bottom of the sea, and hoisted up onto the ship with the tail still hanging from the main fuselage.

An initial inspection of the helicopter wreckage on board the ship showed that the landing gear was in the extended position. The two front emergency flotation devices had fallen out of their stowage in the nose wheel wells. They had not inflated and hung loosely. They contained tens of liters of water, which probably had leaked in through ruptures caused by the impact or during the recovery of the wreckage. The two rear emergency floats, which were attached to the inner sides of main landing gear doors, were in their stowed positions.

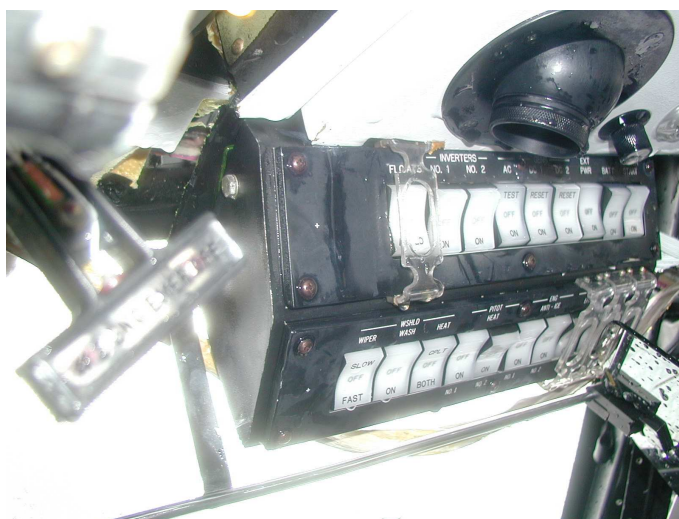
To the right of the emergency flotation system switch in the cockpit overhead panel, two inverter switches were found in the “ON” position and the two switches for the generators next to them were in the “OFF” position. Photos of the cockpit panels could not be taken under water. It should be noted that the positions of switches and levers at impact may have been different from the positions in the recovered helicopter. During the recovery operation in the inverted helicopter with space constraints in the cockpit and poor visibility, the activities of the divers may have resulted in inadvertent changes to some lever and switch positions. However, the flight controls could not be moved without hydraulic pressure.

Photo 5. Overhead control panel with the switch for the emergency floats.

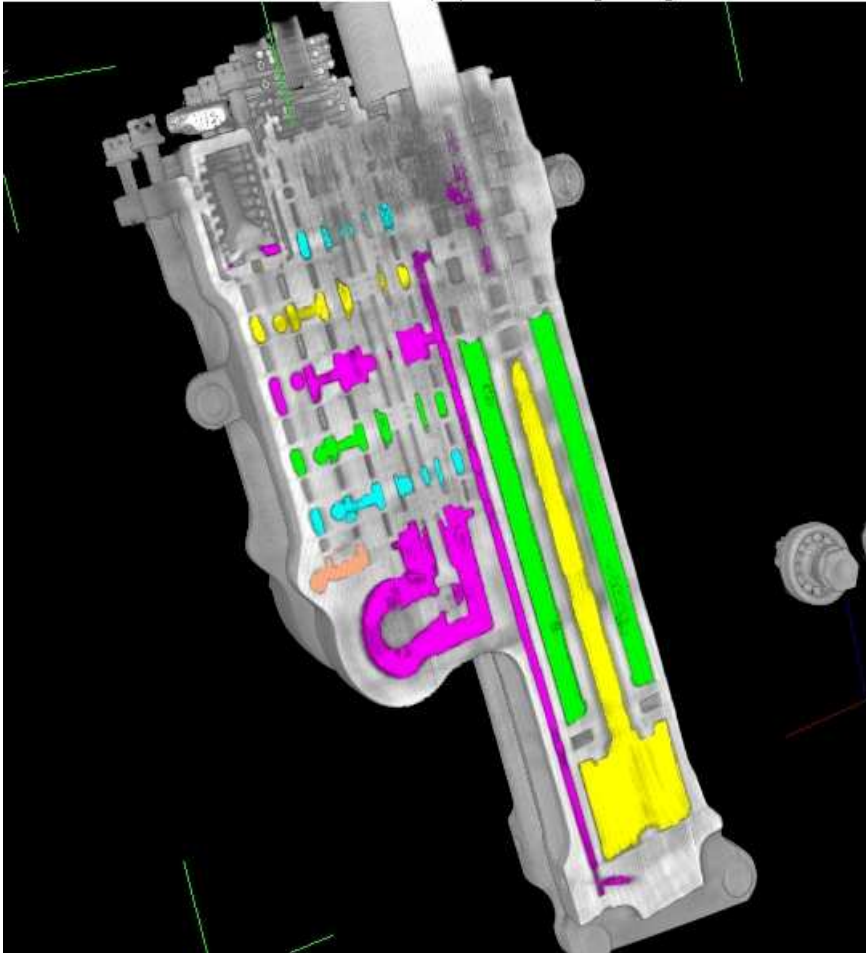
Figure 4. Main rotor forward actuator – cross section through bypass valve, main control valve, and piston highlighting the return hydraulic passage.

Computed tomography found and documented an obstruction by a large flake of metallic material in the hydraulic system no. 2 bypass valve, adjacent to the main control valve, in the main rotor forward actuator, as shown in Figure 5.

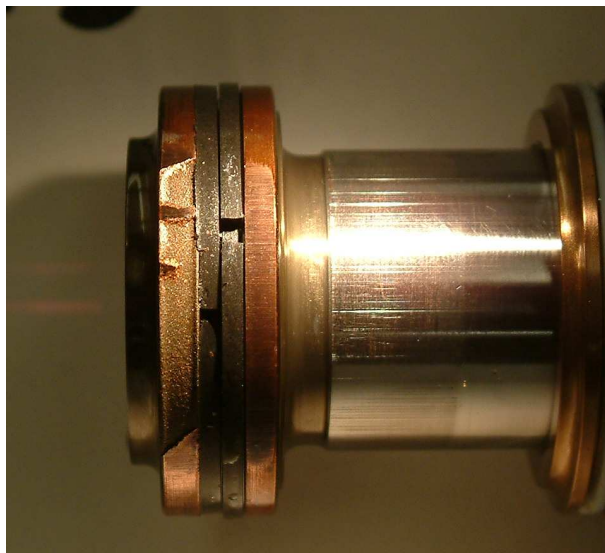
Photo 8. System no. 1 piston with chipped plasma coating

The actuator was disassembled. The piston assembly was removed intact with the rod end still attached and the balance tubes remaining in place. The system no. 1 plasma coating at the base of the piston was chipped around approximately 25% of the circumference, as shown on Photo 8.

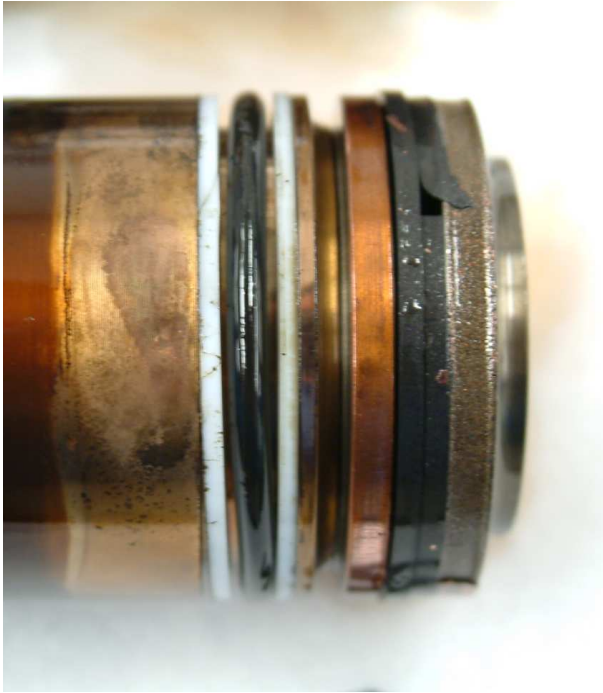
Photo 9. System no. 2 piston with chipped plasma coating

The system no. 2 plasma coating at the base of the piston was chipped around approximately 50% of the circumference, as shown on Photo 9.

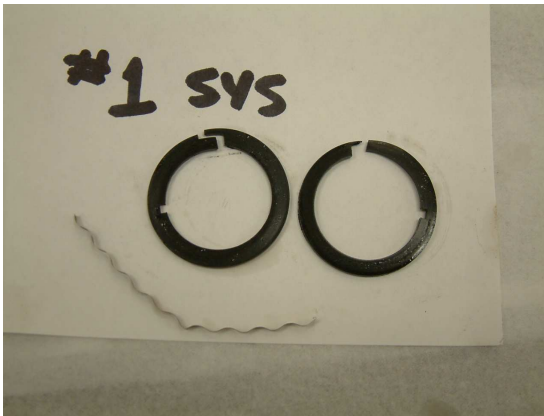
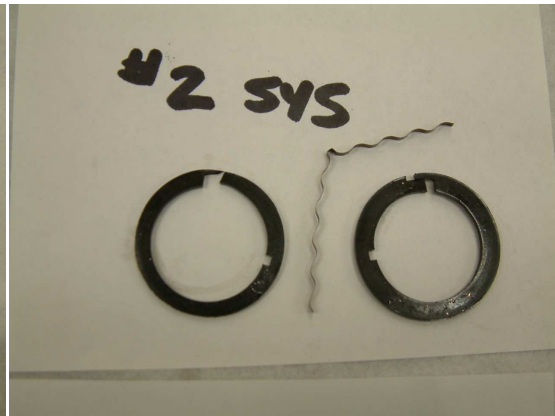
Both the system no. 1 and system no. 2 piston head seals (polytetrafluoroethylene) were severely worn, as shown on Photos 10 and 11. The system no. 2 seals were also extruded with a small piece of plasma-appearing material observed on the seal. A piece of plasma coating was observed in the bottom of the system no. 1 bore.

Photo 10. Worn system no. 1 piston head seals

Photo 11. Worn system no. 2 piston head seals.

The piston head seals for both the no. 1 and no. 2 systems were replaced, and the actuator was reassembled for a new bench test; smooth operation was observed in both directions on system no. 1, system no. 2, and both systems together. All leakage rates were found to be within acceptable limits; system no. 1 Extend position leakage was 258 cc/min; the Retract position leakage was 236 cc/min. Piston velocity was much improved and close to normal.

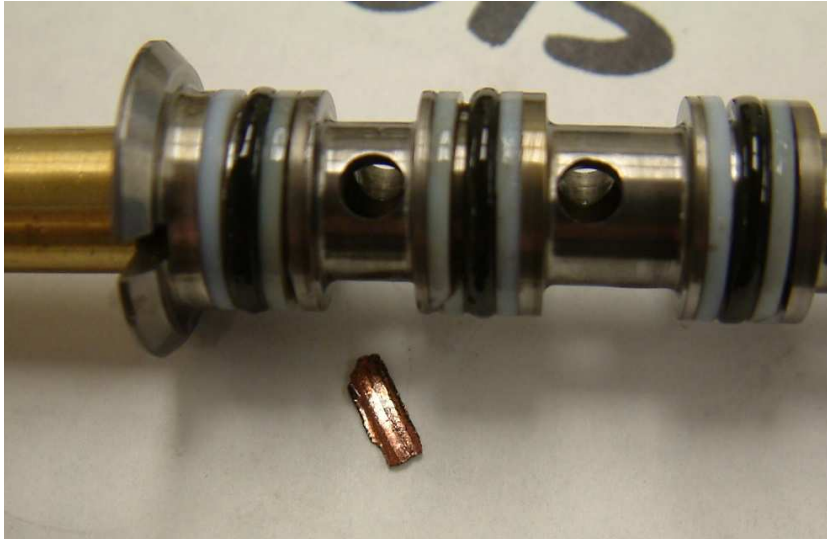
Photo 12. Plasma piece found loose in system no. 2 bypass valve

Aluminum-bronze plasma coating pieces were observed inside the bypass valve chamber, and a large piece of the plasma coating was found when the bypass valve was removed, as shown on Photo 12.

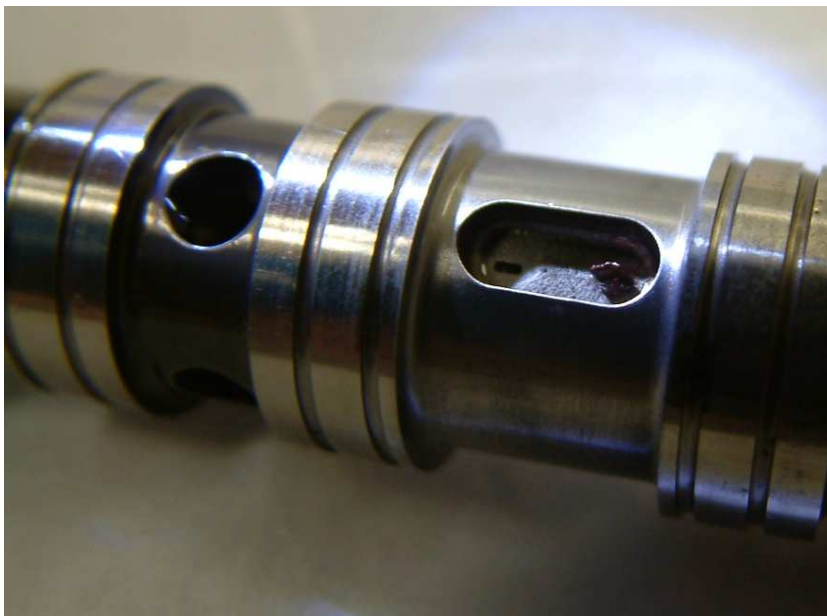
Aluminum-bronze plasma coating pieces were found in one of two C3 return slots of the main control valve sleeve, as shown on Photo 13.

Photo 13. Plasma coating piece(s) in one of the two C₃ return slots of the secondary spool (inner sleeve. The second, not blocked C₃ return slot, is located on the opposite side of the spool and not visible on the photo.)

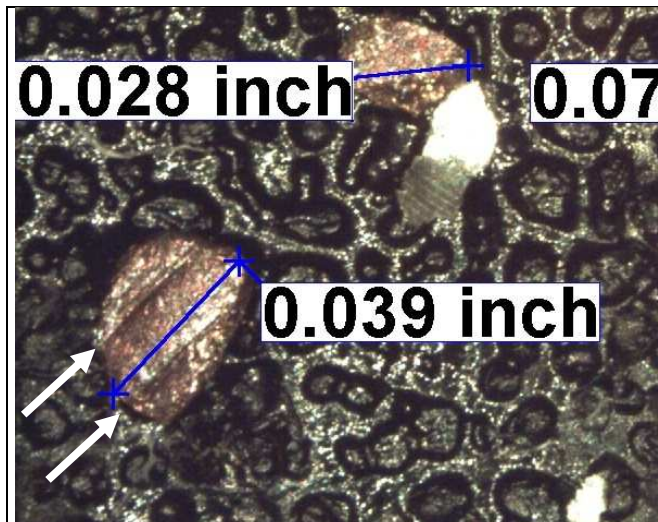
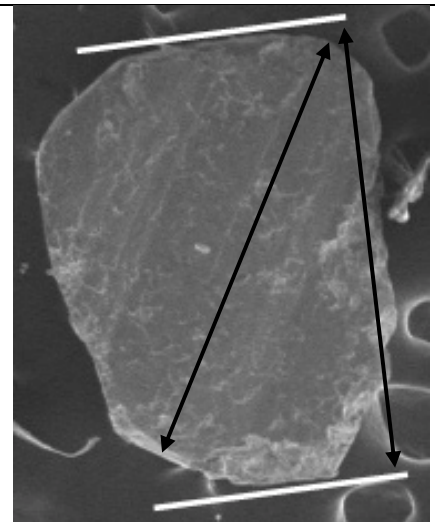
The system no. 2 hydraulic filters and reservoir contained aluminum-bronze flakes and one flake had features with dimensions that nearly matched those of the open (as-found) return port in the hydraulic valve of the actuator (See Figures 7 and 8). The examinations found further contamination downstream of the filters in the reservoir portion of the assembly.

All aluminum-bronze particles, separated from forward hydraulic actuator pistons and found in return filters, had to pass through main control valve spool slits 0.039x 0.015 inch.

Figure 7. Aluminum-bronze flakes found in the system no. 2 hydraulic return filter. The distance between the indicated lines is 0.039 inches.

Figure 8. Scanning electron microscopic magnification of same flake. Lines show two dimensions of 0.039 inch each.

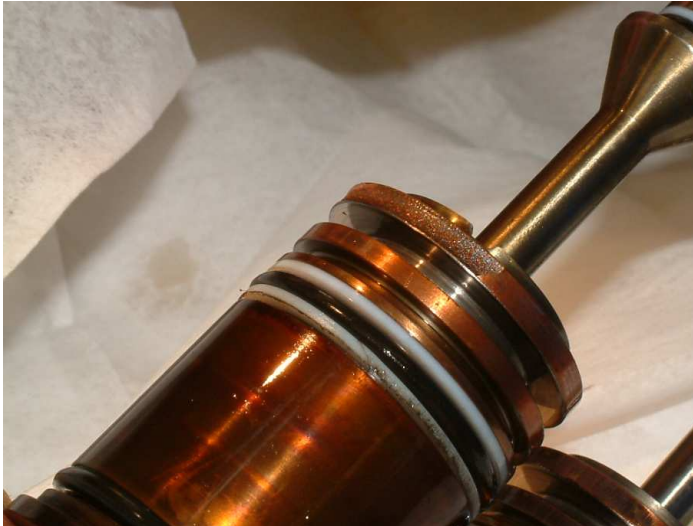
As a result of the NTSB Safety Recommendations, the Sikorsky All Operators Letter (AOL) and the FAA Special Airworthiness Information Bulletin (SAIB), one HR Textron-designed actuator was found to have high internal leakage. The actuator had accumulated 2970.7 hours since its last overhaul. The system no. 1 piston was missing a circumferential piece (25-30 degrees of the diameter) of plasma coating. A copper-colored material was still present in this area, as shown on Photo 14. Additional disassembly efforts resulted in two large additional pieces flaking off, for a total of almost half of the circumference.

Photo 14. S/N 407 system no. 1 piston with flaked plasma. (Note! This piston is not from accident helicopter.)

The system no. 1 piston head seal on the retract side showed signs of wear with the tang on the seal breaking off during removal. The extend side seal had evidence of extrusion (small lip). A small piece of plasma was found inside the piston bore, and an additional small plasma flake was found on the secondary spool of system no. 1.

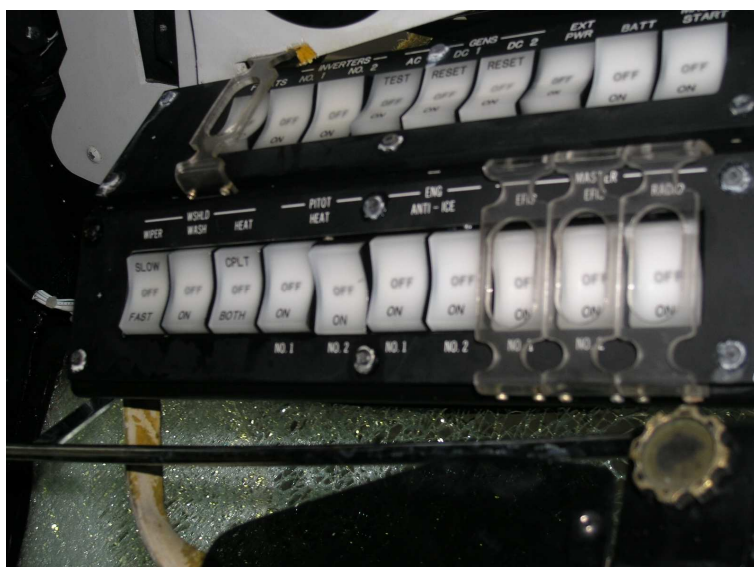
As the helicopter was not equipped with automatically (in contact with water) deploying emergency floats then helicopter did not stay on water surface.

Photo 15. Overhead control panel with the switch for the floats in the upper left corner.

If floats could be inflated before the impact with water it could be that some of floats could possibly be burst at impact. As floats actually were not inflated, it is difficult to assess helicopter's buoyancy after impact with water surface with floats inflated. According to an assessment by a buoyancy expert, without inflated floats and taking into account the openings in the helicopter resulting from the damage and break-up at impact, it probably took about ten seconds for the helicopter to fill with water and to sink. As the centre of gravity of the helicopter, when floating on the water, was probably higher than the waterline, the helicopter fuselage probably turned upside down, possibly as a result of the waves which were in the order of one meter high and also due to the impact forces from rotating helicopter hull.
