Investigation report

B6/2009L

Ultralight aircraft accident at Kauhava aerodrome on 4 August, 2009

OH-U507

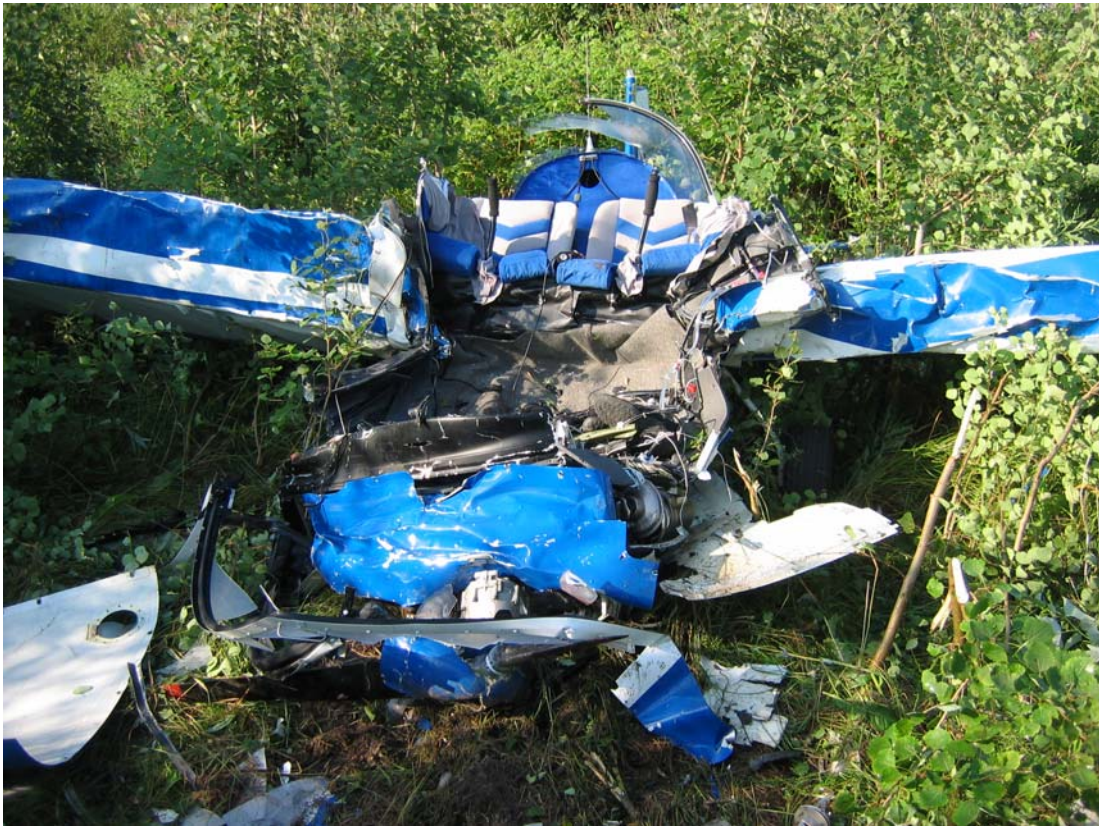
Figure 1. The ultralight aircraft was destroyed when it collided with the ground.

All surface controls were in their places and almost undamaged. Both control sticks were in place, albeit almost completely frozen. The floor bracket of the left rudder tube connection was broken but its left end support was still in place. The right side rudder brackets were intact but the rudder tube connection was bent. The rudder cables were intact and connected to the rudder pedal assembly.

The wing flaps were in place and, apart from minor dents on flap roots, intact. Whereas the right flap was almost fully retracted, the left one hung loose a bit more extended. The flap release button had come loose. The flap handle was not locked into the retracted position.

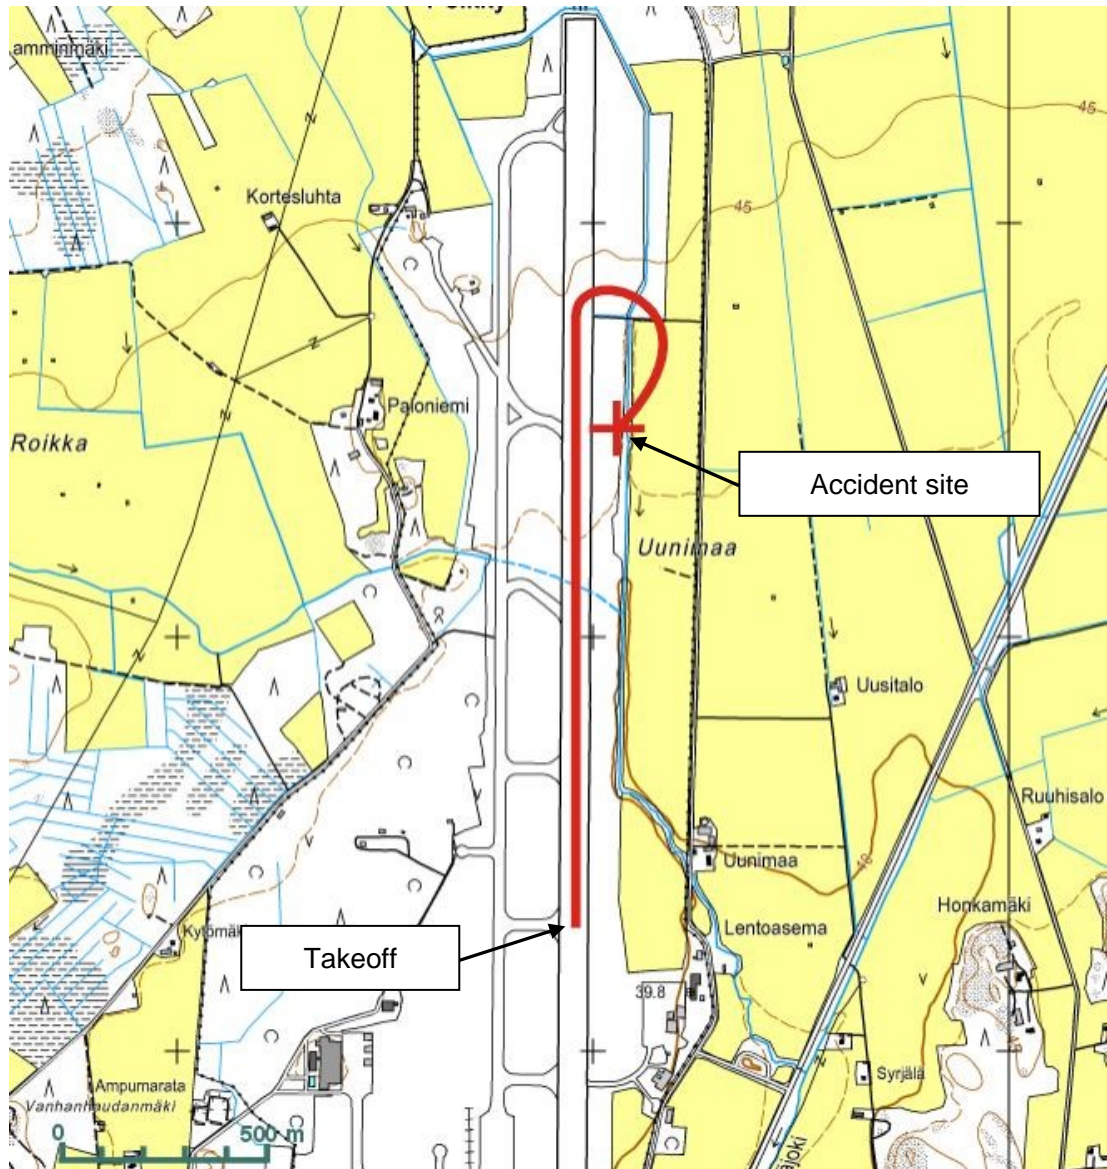
According to radiotelephony recordings, the aircraft flew four left traffic circuits. The first one was a standard traffic circuit. The three following ones were flown at 1200 feet (360 m) and they included engine failure practice on the downwind leg, ending in spot landings. According to the pilot's radio call the intention was to fly the first spot landing as a touch-and-go. However, it resulted in a go-around, which the student flight instructor announced on the radio. The second spot landing was flown as a touch-and-go as planned. During the third circuit for a spot landing the student flight instructor called that the landing would end in a stop-and-go, after which they would practice engine failure at takeoff. After the simulated engine failure they intended to turn back and land on the runway in the opposite direction of takeoff. Prior to the takeoff, the student flight instructor called that they would start the simulated engine failure at 500 feet (150 m). The investigation revealed that they had kept the QNH setting on the altimeter, indicating MSL altitude. As a result of this, they were at 350 feet (107 m) AGL at the time.

they started the simulated engine failure, the engine's noise was no longer discernible when it was set to idle. After this, the aircraft started a right descending turn. According to the eyewitness, the nose of the aircraft dipped fairly low during the onset of the glide. After they had turned approximately 180 degrees, they were at approximately 50 metres with a bank angle of 30–45 degrees. At the end of the turn the aircraft abruptly rolled some more to the right and went into a dive. It eventually collided with the ground at an almost vertical attitude. Observations based on radar recordings support the eyewitness account as regards the aircraft's manoeuvring. The onboard GPS navigator was not turned on during the flight.

Figure 2. The estimated path of the accident flight (Cadastral index map/Ministry of Justice/National Land Survey of Finland)

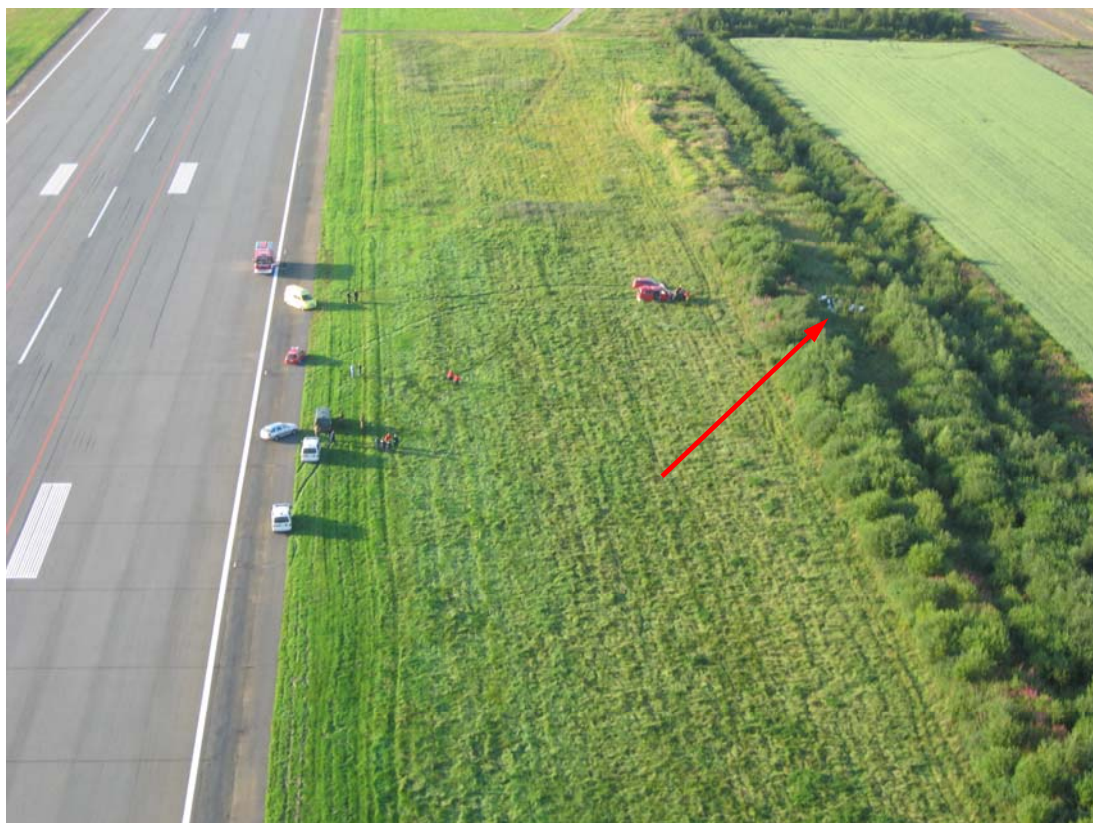
Figure 3. The accident site photographed from the air. The red arrow indicates the accident location.

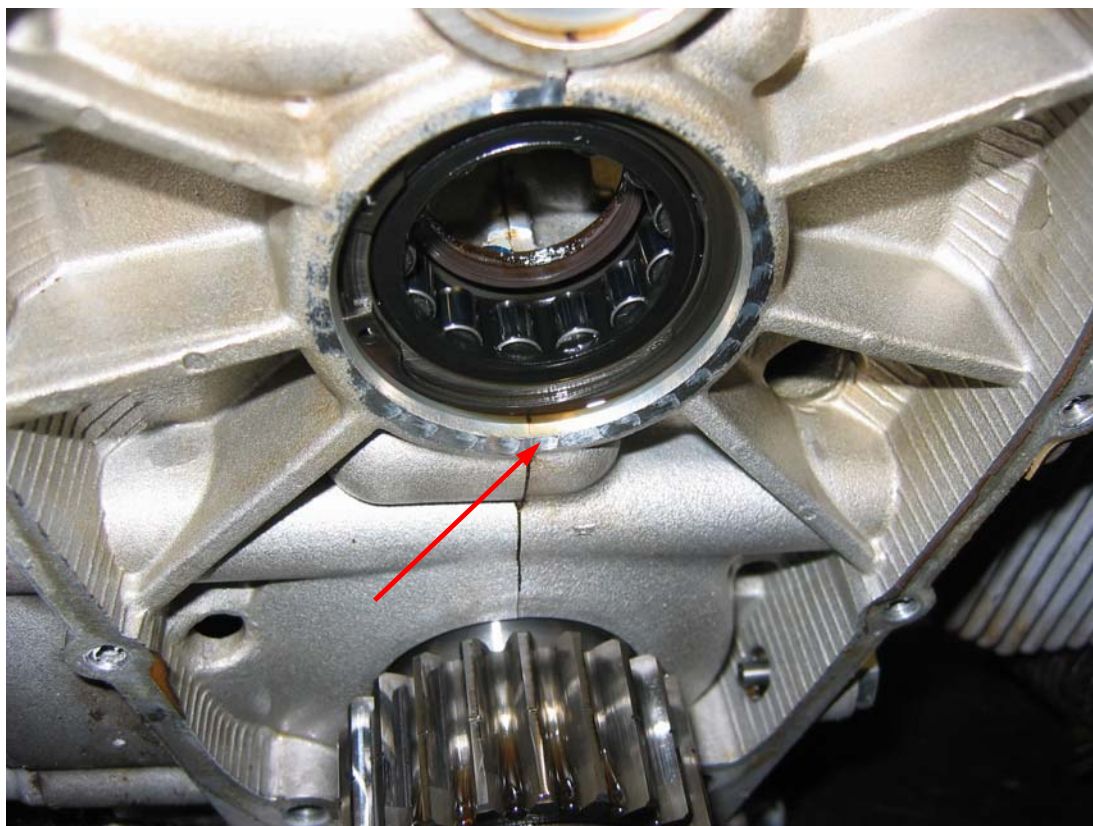
There was a clear mark in the crank case on the side of the gear, as if a lathe blade had chipped it (Fig. 4). This mark was left when the rotating gear assembly of the vacuum pump (optional accessory) had hit the crank case at the moment of impact. This mark definitely proves that the engine was running until the collision with the ground. The engine speed had been low, near idle. Due to the propeller speed reduction unit, Rotax 912 series engines do not windmill.

Figure 4. The mark left by the vacuum pump gear assembly on the gear side of the crank case indicates that the propeller axle was spinning at the time of the impact. The red arrow indicates the mark.

Technical inspections did not find any fault in the aircraft prior to the accident. The aircraft was airworthy before the accident flight. Judging by the marks on the inside of the engine as well as damage to the propeller, it can be deduced that the engine was running when the aircraft collided with the ground. The investigation commission does not regard the condition of the aircraft as a cause or contributing factor to the accident.
