Investigation report

D9/2010L

Ultralight aircraft emergency landing in Ruukki on 29 August 2010

OH-U482

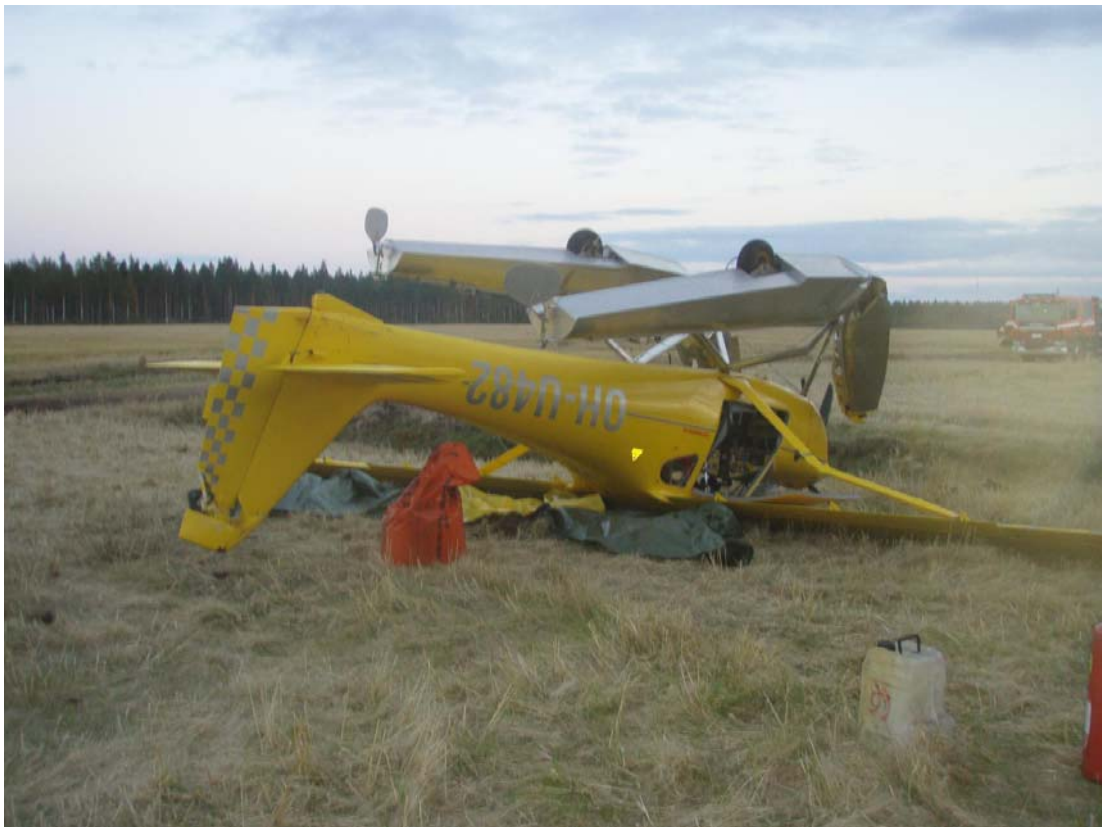
At Siikajoki the engine began to run rough and lose RPMs. When the pilot increased power the engine died, forcing him to land in a field where the aircraft ran into a cross-wise ditch at the end of the landing roll. As a result of this the aircraft nosed over, causing serious damage to the aircraft floats. In addition, the wings, the propeller, the engine mount and the tip of the vertical stabiliser were damaged.

Figure1. The aircraft at the site of the emergency landing

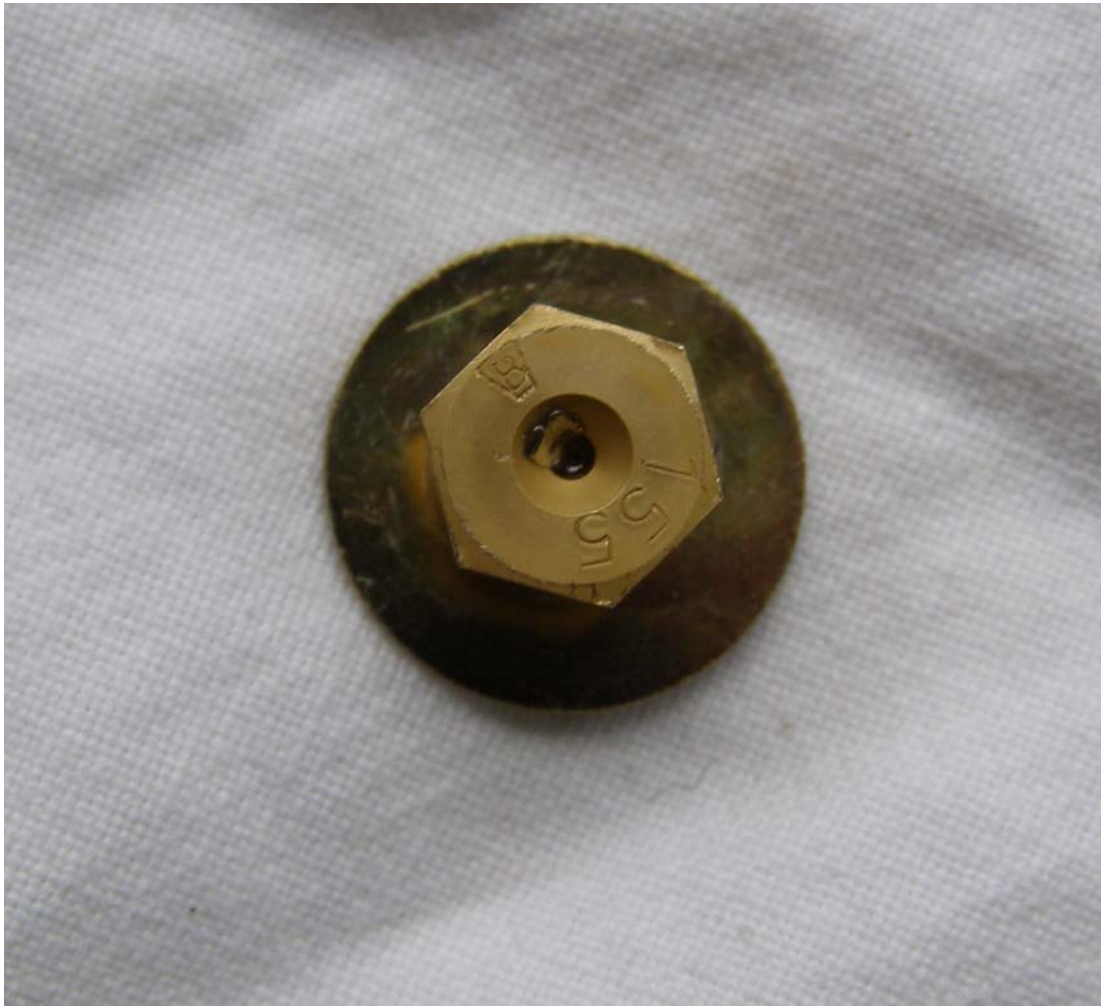
The carburettors were removed from the engine and the float chamber covers were opened. At this time several metal flakes were found on the bottom of the right carburettor pins, which had clogged the main jet nozzle. As the float was being disassembled it was detected that the flakes had come off of the surface of the carburettor pin. The left carburettor pin was intact.

Figure 2.. Metal flakes in the main jet nozzle

3. The engine misfire was caused by metal flakes from the carburettor pin which ended up in the main jet nozzle, ultimately clogging it.
4. In view of possible flaking on the surface coating of the carburettor pin the engine manufacturer had published a Service Bulletin for the engine and carburettors in question.

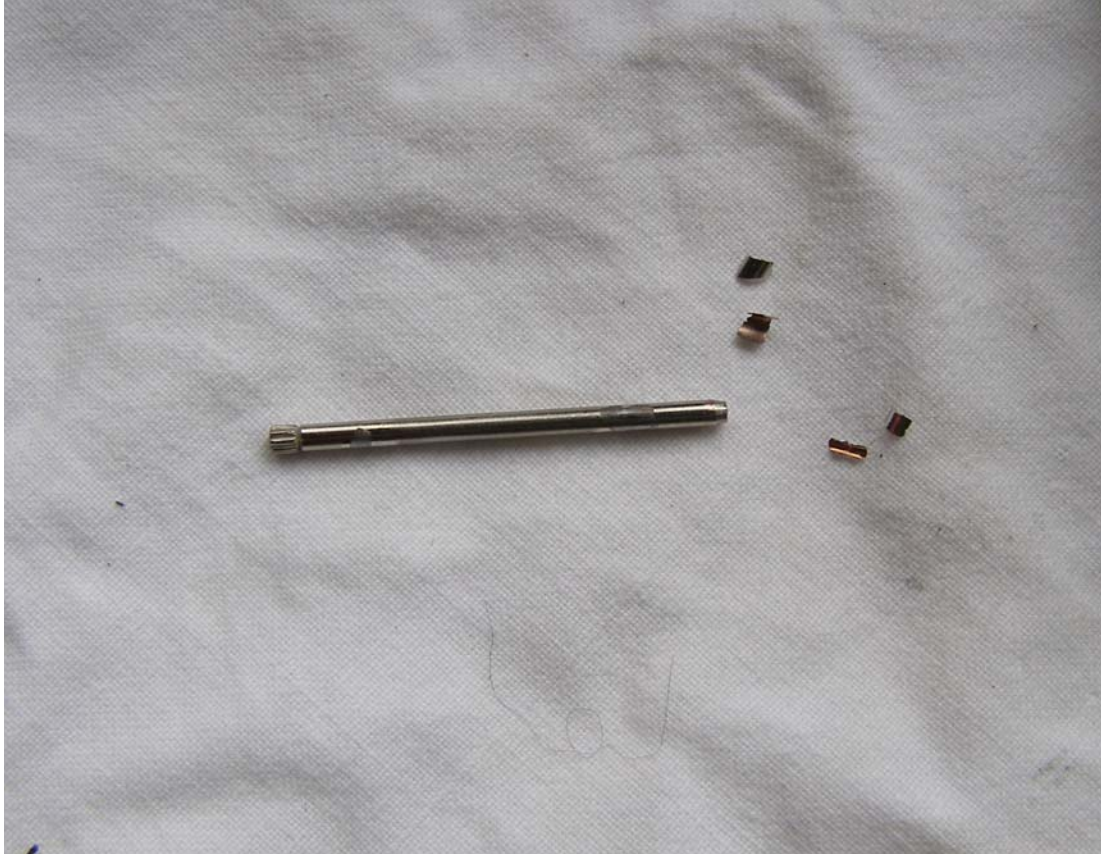
The investigators sent the carburettor pin to the Austrian Air Accident Investigation Bureau who, in turn, forwarded it on to BRP-Powertrain Inc, the engine manufacturer, for laboratory testing. The pin was inspected with a scanning electron microscope. Results showed that the steel pin had a 2 µm copper coating covered by a 4 µm-thick layer of nickel. The pins (part no. 929700) for which the manufacturer published the Service Bulletin are constructed in this manner. The replacement pins (part no. 929701) are not copper coated. There is no visible difference between said pins.

Figure 3. The carburettor pin exhibiting some flaking on its nickel surface coating

The engine misfire was caused by metal flakes from the carburettor pin ending up in the main jet nozzle, ultimately clogging it. The carburettor pins have a manufacturing flaw which prompted the engine manufacture to publish a Service Bulletin. The carburettor pins should have been replaced with the new types no later than 1 Dec 2005.

On 23 Sept 2005 the engine manufacturer published Service Bulletin SB-912-048 regarding the possibility of flaking on the surface coating of the carburettor pin. The Service Bulletin relates to engines with serial numbers 912 ULS 5643752-5645438 and whose carburettor pin serial number is 929700.

The Service Bulletin provides detailed instructions for changing the pin. The old pins were to be returned to the manufacturer or to a designated service centre.
