Investigation report

B 4/2000 M

Mv. MARIA VG, incident at Sea of Bothnia off Pori, November 7, 2000

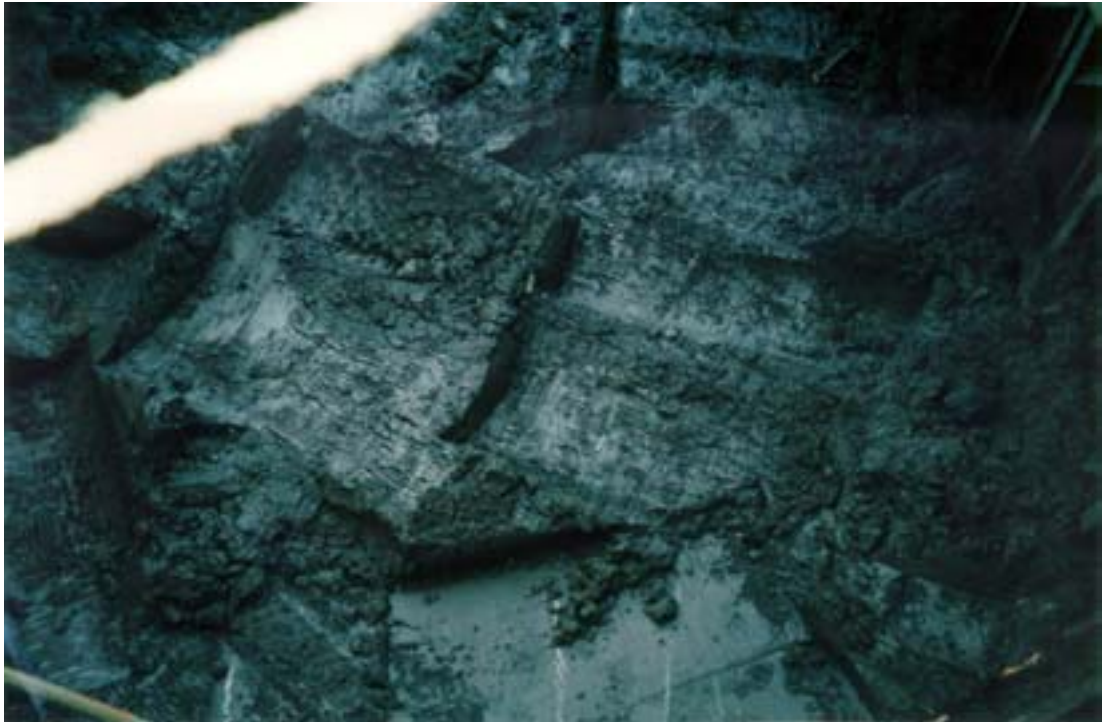
The Maritime Inspector of the Finnish Maritime Administration and the crew of the ship inspected the ship immediately after arrival at Rauma. It was noted that the cargo was badly slurred and that it had shifted both in the bow and stern sections of the hold at a distance of 10 – 15 metres causing the vessel to list. All ballast tanks and bilges of the vessel were gauged. The ballast tanks and the port bilge (opposite the list) were empty. The bilge on the side of the list had about 1 metre of water, which equals the depth of the well. It was estimated that this water had separated from the liquefied cargo. No visible damage or leaks to the vessel herself were detected. The Maritime Inspector pronounced the liquefied cargo unfit for maritime transportation and detained the ship. The entire cargo was unloaded at Rauma on November 9, 2000.

Figure 3 Cargo under discharge at the Port of Rauma on November 9, 2000

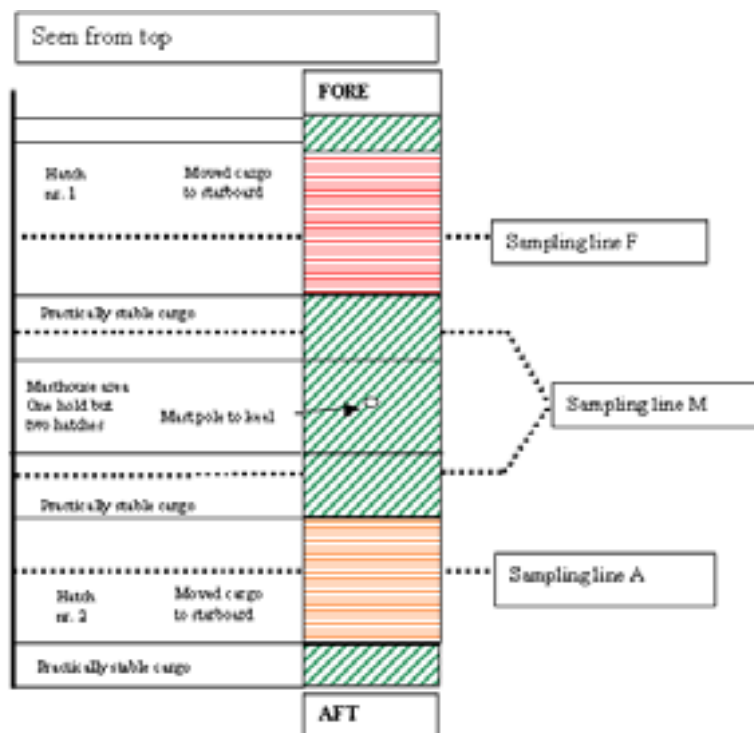
The cargo was sampled in connection with the unloading at Rauma. The sampling locations and levels are indicated in Figure 4. The general samples and the separate water content samples were analysed at the laboratory of VTT Communities and Infrastructure (since 2001 VTT Building and Transport). The water contents of the samples are presented in Table 1 according to location and level. (Separate water content sample and general sample from the same location are specified – the greater water content of the general sample is explained by the sampling method).

Figure 4. Sampling lines at the discharge of the cargo of the MARIA VG.

Table 1. Water contents of the cargo samples of the MARIA VG taken during unloading at the port of Rauma by location and level.

Sampling Line	Sampling level	Sample code (1)	Water content (%)	Sample code (2)	Water content (%)
F (Fore)	0 – 0.5 m from top of cargo	f1	46.5	F1	60.6
	Middle of cargo at about 1.5 m	f2	42.9	F2	46.0
	Bottom of cargo/hold	f3	38.9	F3	41.7
M (Mast House)	0 – 0.5 m from top of cargo	m1	39.0	M1	42.6
	Middle of cargo at about 1.5 m	m2	42.8	M2	44.7
	Bottom of cargo/hold	m3	39.8	M3	42.6
A (Aft)	0 – 0.5 m from top of cargo	a1	42.5	A1	50.3
	Middle of cargo at about 1.5 m	a2	42.6	A2	43.7
	Bottom of cargo/hold	a3	42.5	A3	45.4
average			41.9

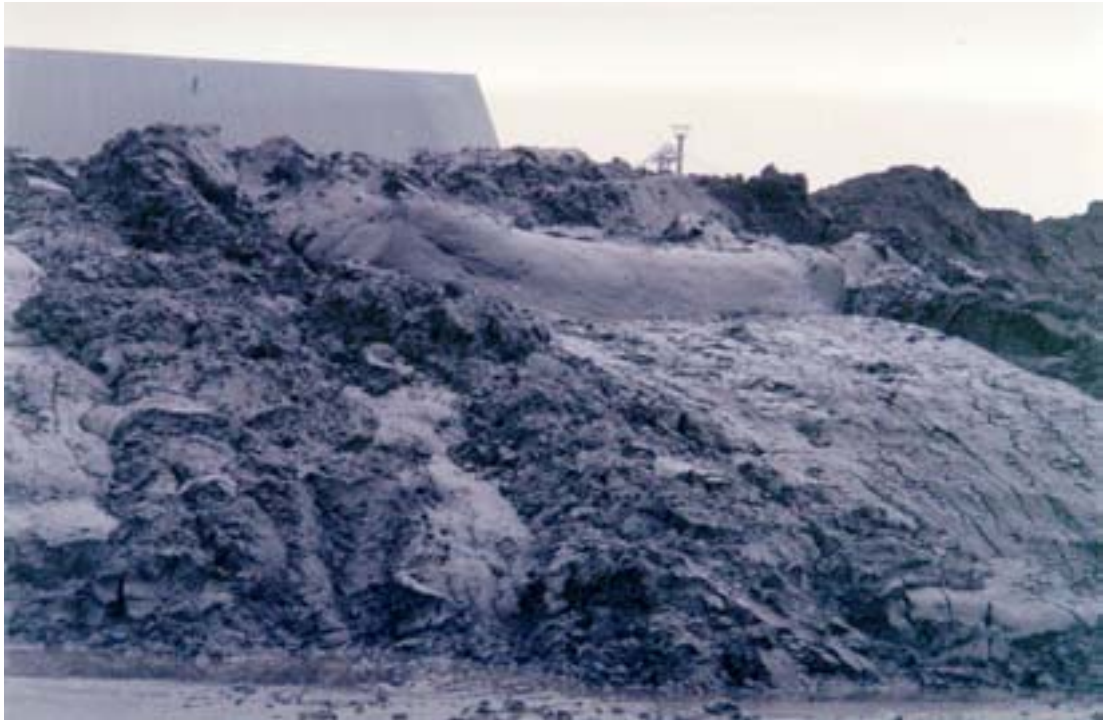
Figure 6 Liquefied pile of ilmenite clay at Tahkoluoto, winter 2001

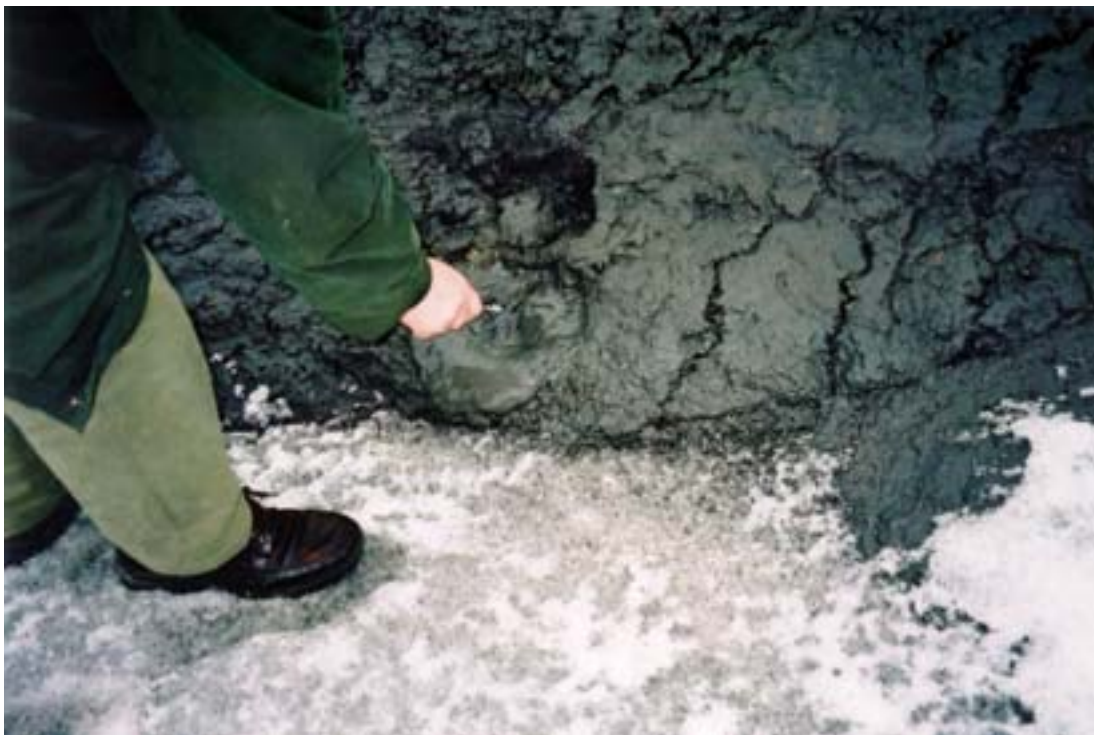
Figure 7 A close look with a spoon, ilmenite clay storage at Tahkoluoto, winter 2001

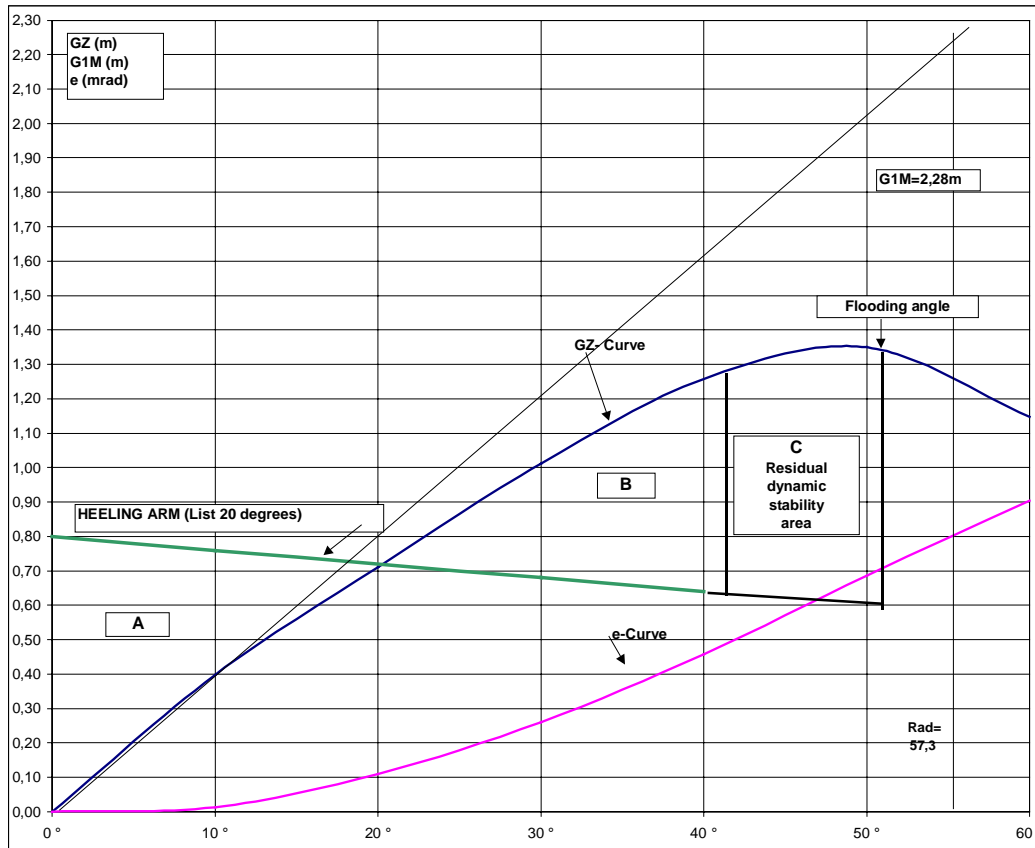
The stability of MARIA VG with 20 degree list fully loaded with ilmenite clay

Corrected with the effect of free surfaces vessel's GM is 2,28 metres and she had a very good intact transverse stability. In high sea a too good GM causes heavy rolling with great g – forces affecting the cargo. The shift of the ilmenite cargo causing a permanent 20 degree list in the situation corresponds with the movement of the centre of gravity of the whole cargo of 2662 tonnes some 1,16 metres to the listed side (in reality, only the cargo in fore and aft part shifted).
