## Accident Resulting in the Death of a Captain at Kittilä Airport on 4 January 2018

L2018-01

Investigation: L2018-01  
Investigation report: 13/2018  
ISBN: 978-951-836-528-3 (PDF)

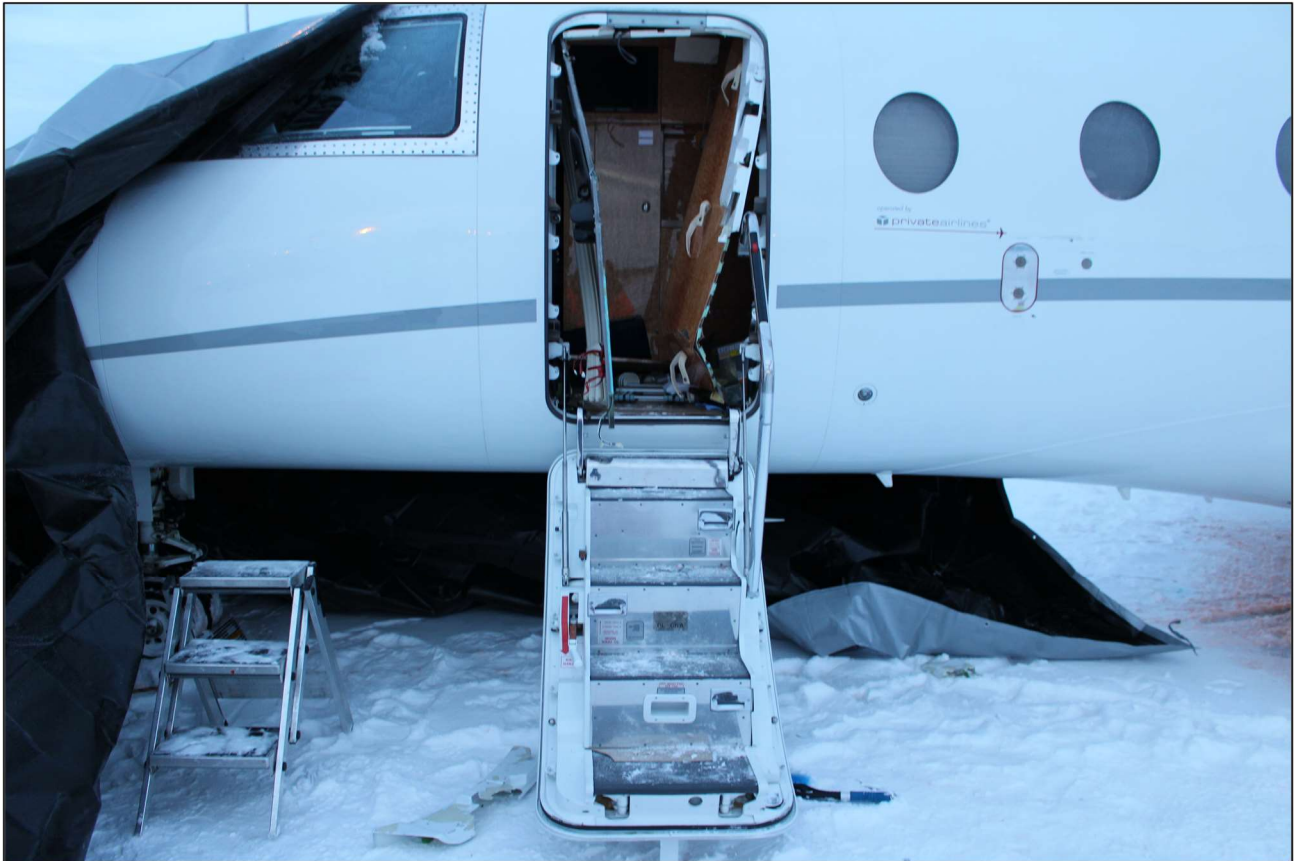
**Image 1.** Post-accident photo of the doorway. (Photo: SIAF)

There was minor damage to the outside of the aircraft. The external surface of the door had small dents and a few scratches. During testing the door appeared to close and open normally once the wall panels that were damaged or displaced during the accident sequence were repositioned.

The cabin sustained substantial damage. The cockpit's aft left bulkhead and the cabin's forward left bulkhead were nearly torn off, left hanging by only a few fastenings near the doorway. The airstairs' acoustic entry curtain and the extinguisher, flashlight and crash axe,

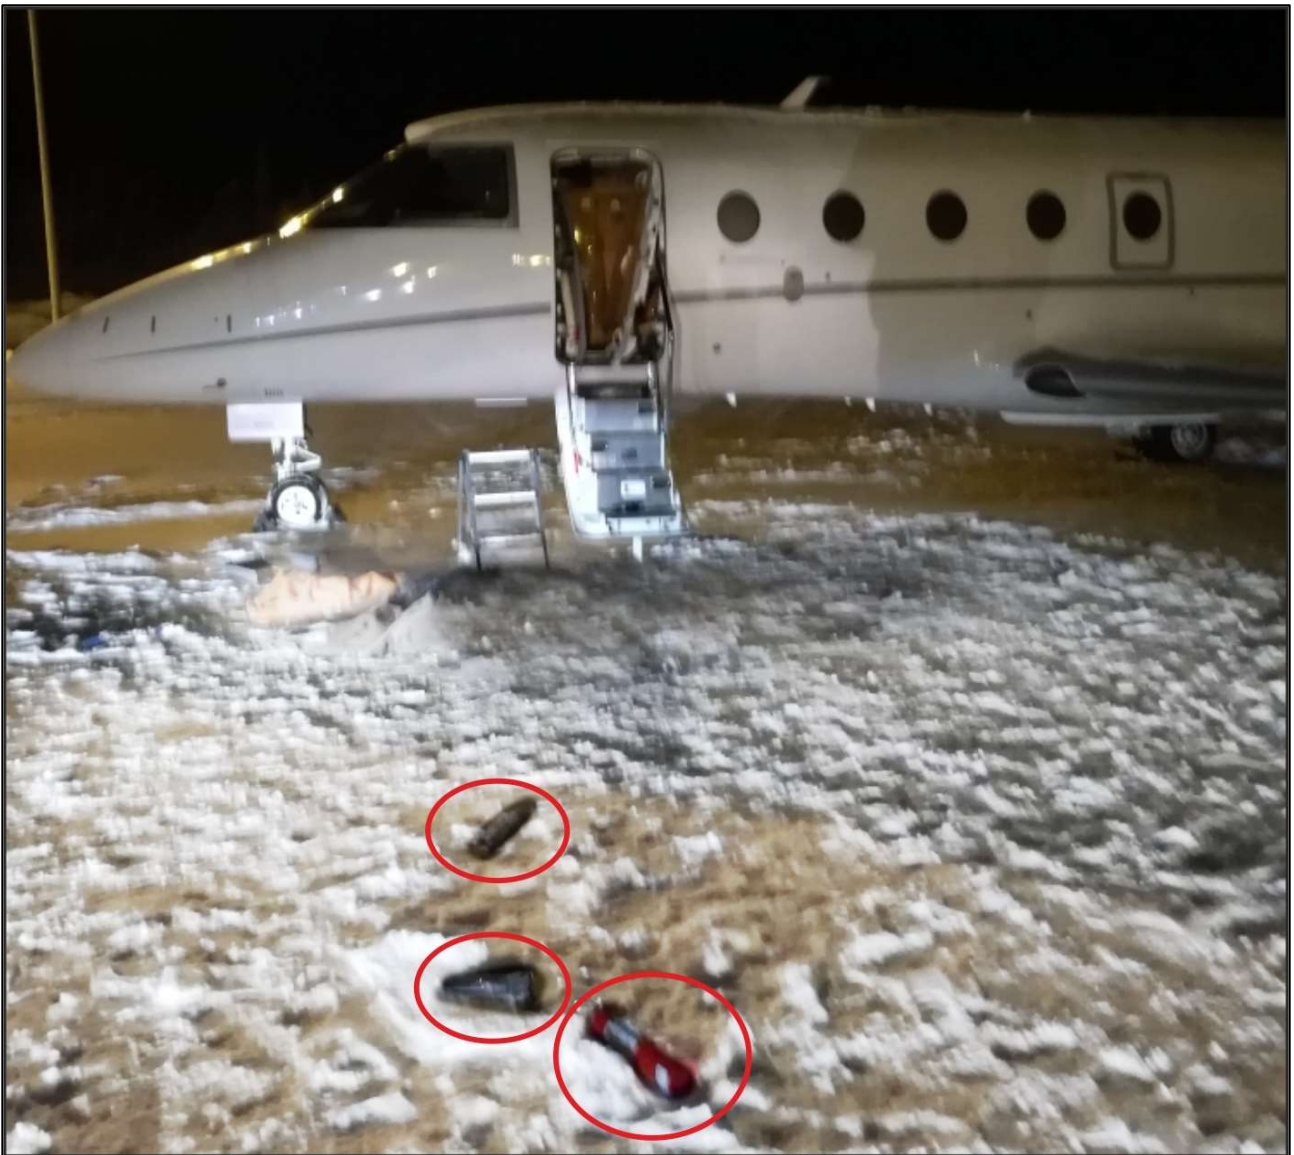
**Image 2.** In the forefront of the photo are the loose items ejected from inside. (Photo: Lapland Police Department)

which were fastened to the cockpit's aft bulkhead, came loose from their fastenings and were ejected out approximately 5 m from the door. When the front cabin bulkhead came loose, the tableware storage drawers on the bulkhead broke and the dishes were broken. Several cabin wall panels came loose from their lower fastenings. The cabinets in the aft cabin toilet had opened. The oxygen box in the headliner, closest to the door, had opened and two oxygen masks were hanging on their air hoses.

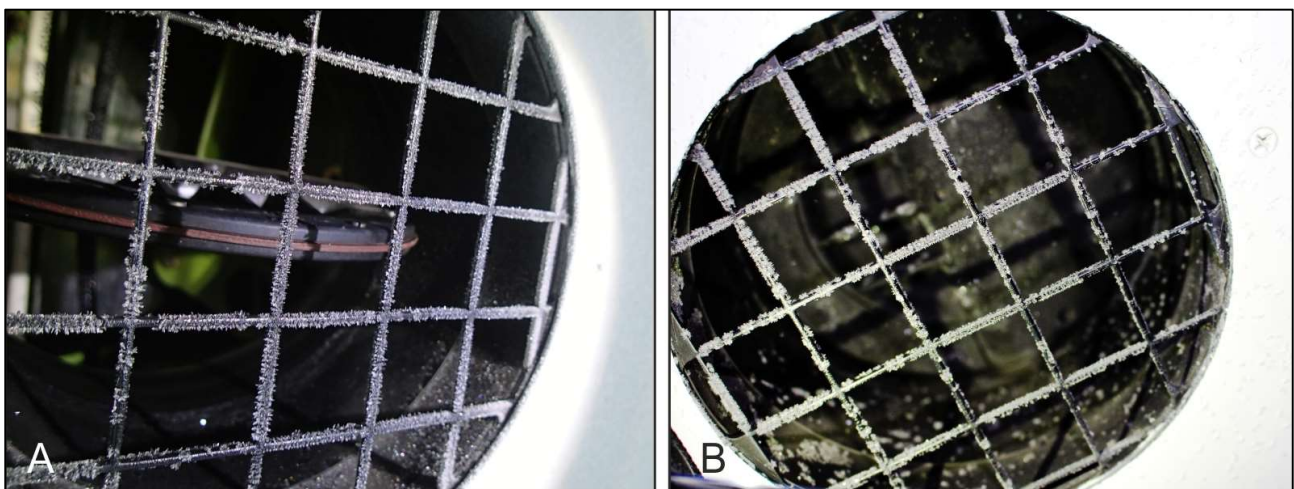
The outflow valve exhaust opening is positioned below the cockpit, on the right side of the front fuselage. The opening is protected by a metal grill and the actual valve is deeper inside the fuselage. According to the cold weather operating instructions the pilot must check the outflow valve during the walkaround check. It must be ascertained that no packed snow or ice has accumulated inside the valve. In Kittilä, in the conditions that prevailed at the time of the occurrence, this would have required the use of a flashlight or some other light source. According to the co-pilot’s statement the outflow valve was not checked visually at this stage. The outflow valve opened and closed normally during testing, and no snow or ice was detected. The aircraft was parked outside in sub-zero temperatures after the accident and before testing. This was done so as to preserve the conditions that prevailed at the time of the accident, so that a possibly frozen outflow valve could not have thawed in the meantime.

**Image 5.** 5A: Outflow valve open.  
5B: Outflow valve closed. (Photos: SIAF)

- Failure to check the outflow valve may result in inadvertent cabin pressurisation when APU bleed air is ducted into the cabin while the door is closed.
- When operating in cold conditions, the instructions in the Cold Weather Operations Manual must be followed.

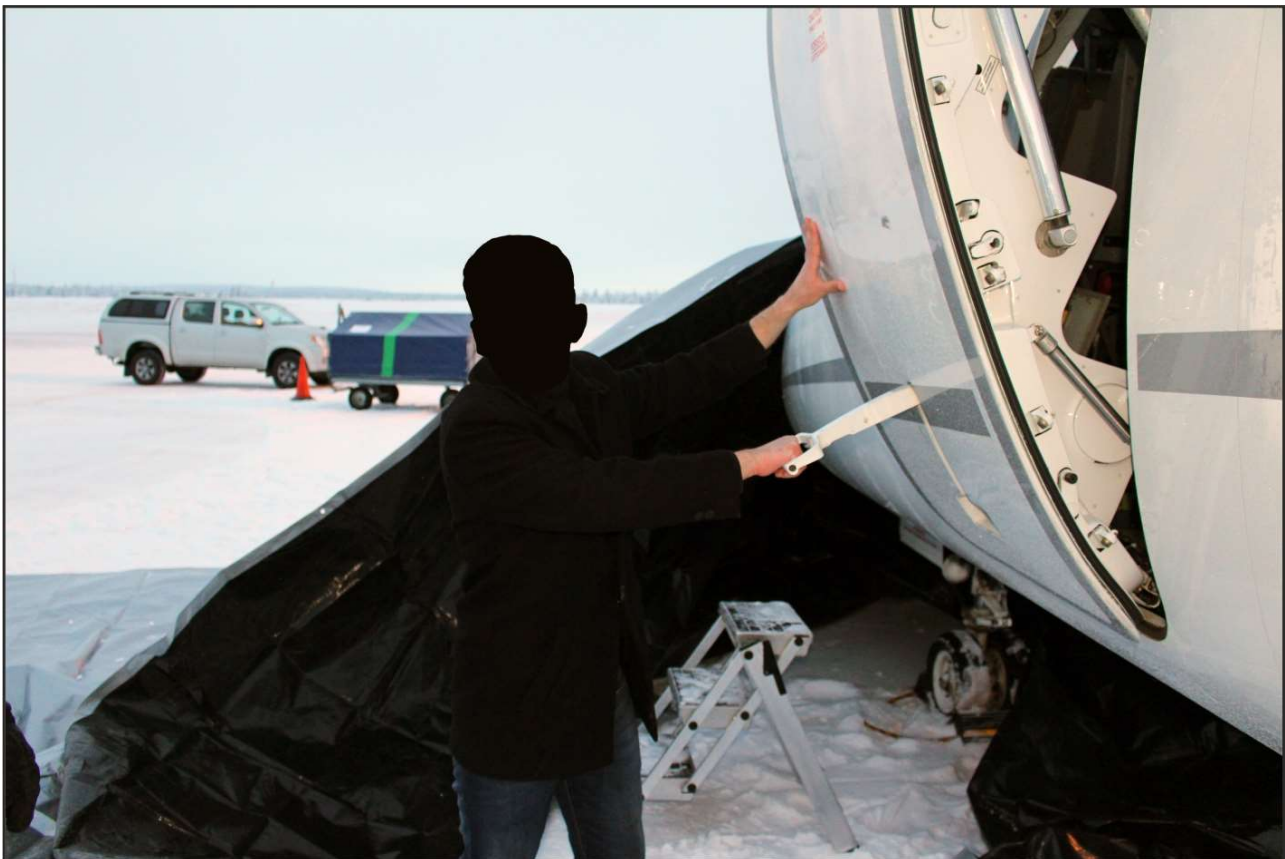
**Image 7.** Typical hand positions when opening the door. (Photo: SIAF)
