Bulletin: Capsizing and sinking of the Pilot boat L-242 (FIN) in the Gulf of Finland off Emäsalo 8 December 2017

Marine Accident: M2017-04

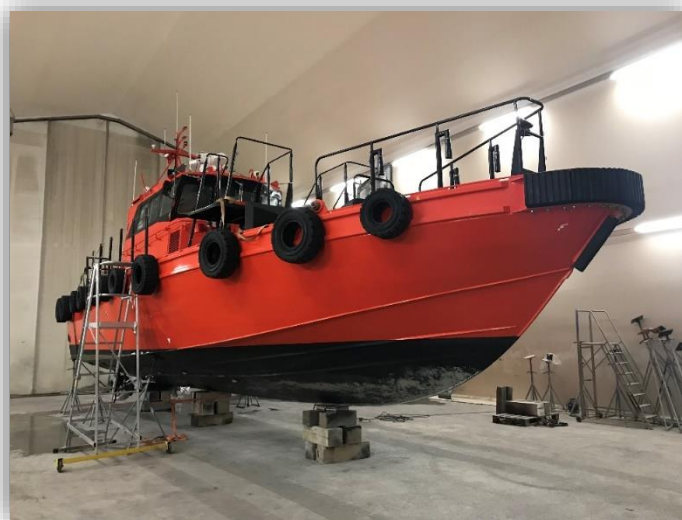
Photo. The L-242 pilot boat, raised from the sea for the investigation
