Patient's death as a result of anaesthesia administered during magnetic resonance imaging in January 2025

T2025-01

Investigation ID: T2025-01
Publication series: 2/2026
ISBN: 978-951-836-692-1 (PDF)
ISSN: 2341-5991

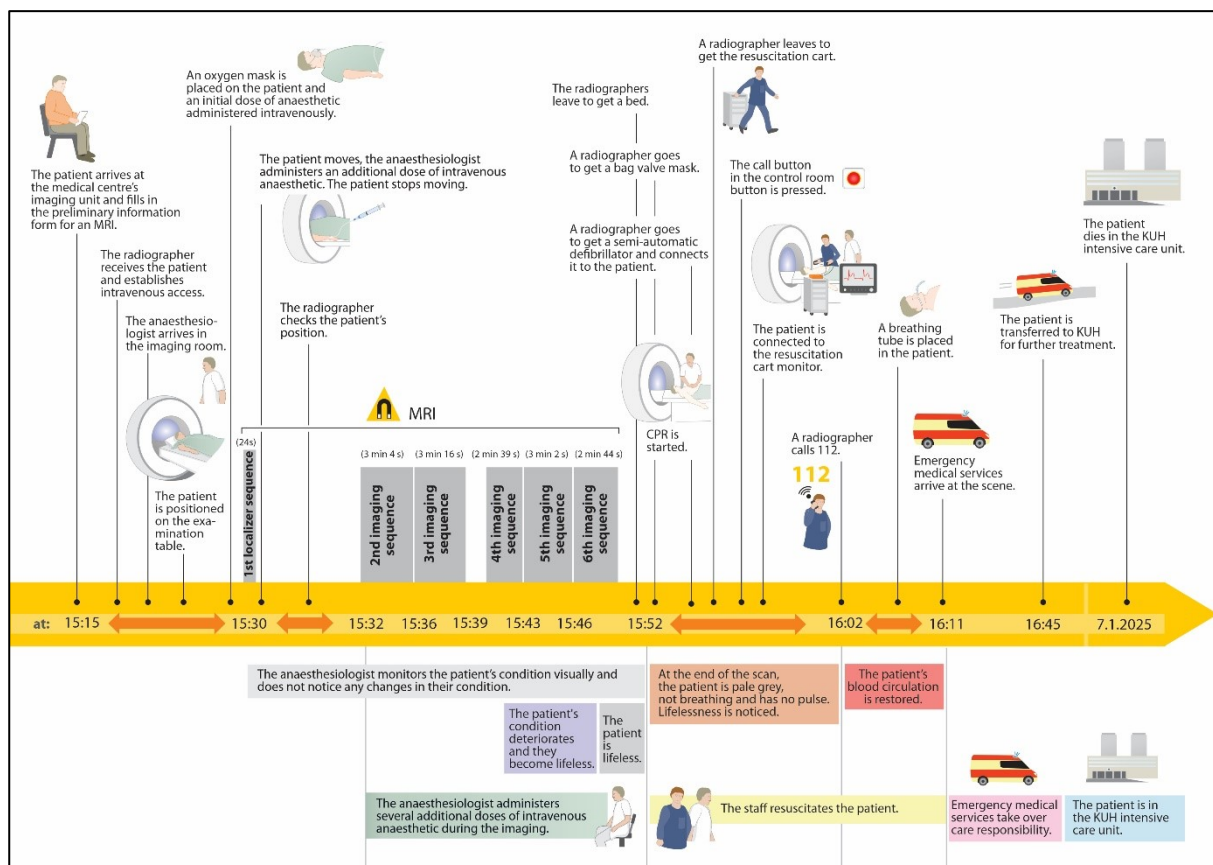
Image 1. Sequence of events. (Image: SIAF)

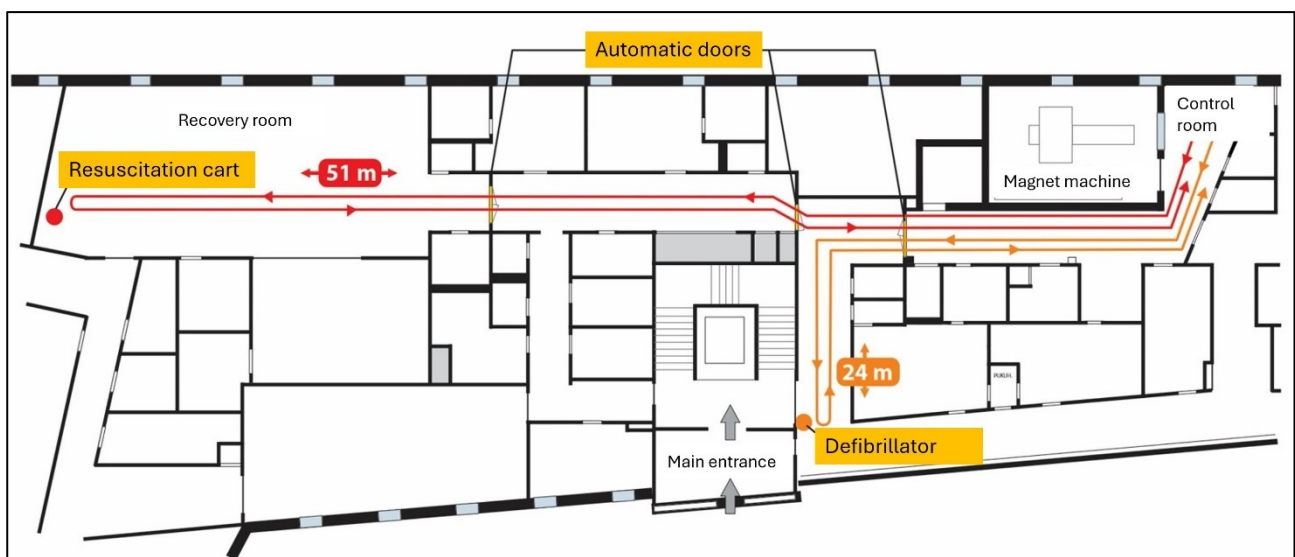
When viewed from the main entrance, the MRI room was located opposite the surgical ward. The resuscitation cart and bag valve mask needed to resuscitate the patient were retrieved from the recovery room, which was approximately 51 metres away and located behind three closed doors. The defibrillator was retrieved from the lobby near the main entrance, which was approximately 24 metres away from the imaging rooms and behind one closed door.

Image 2. Location of the MRI room and its control room in the medical centre building. Resuscitation was performed on the floor of the control room, and the arrow lines show the distances and locations from which the equipment was taken for resuscitation purposes. (Image: SIAF)

The imaging unit was not prepared for a patient becoming lifeless during imaging. The anaesthesiologist did not bring any equipment to handle an emergency situation. The imaging unit was only prepared for an emergency caused by an allergic reaction. The bag valve mask used to assist the patient's breathing had to be retrieved from the operating room's recovery room, which was located more than 50 metres from the imaging unit. Similarly, the semi-automated defibrillator and the resuscitation cart had to be retrieved from outside the imaging unit and they were not compatible with the MRI room.

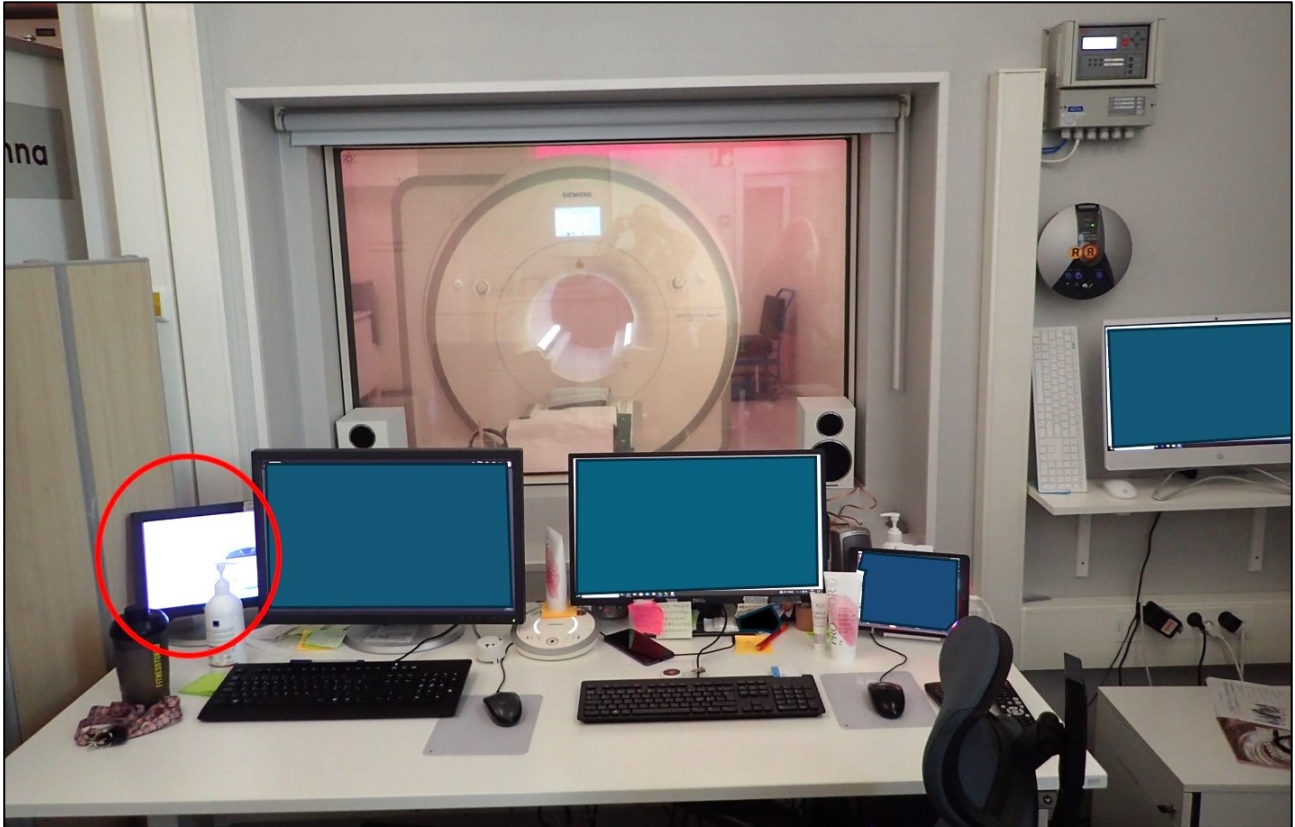
Image 3. The photo shows the control and monitoring point for the MRI scanner. The red circle on the left marks the monitoring camera screen at one end of the MRI scanner. The screens shown in the photo have been blurred. (Photo: SIAF)

A monitoring camera mounted on the back wall of the MRI room was focused on the patient's head area. The camera did not have a recording function. There was an MRI-compatible¹⁴ wheelchair available for patient transfer.
