## Investigation report

D12/2009M

# STS POGORIA, Distress off Hanko, Finland, 7.7.2009

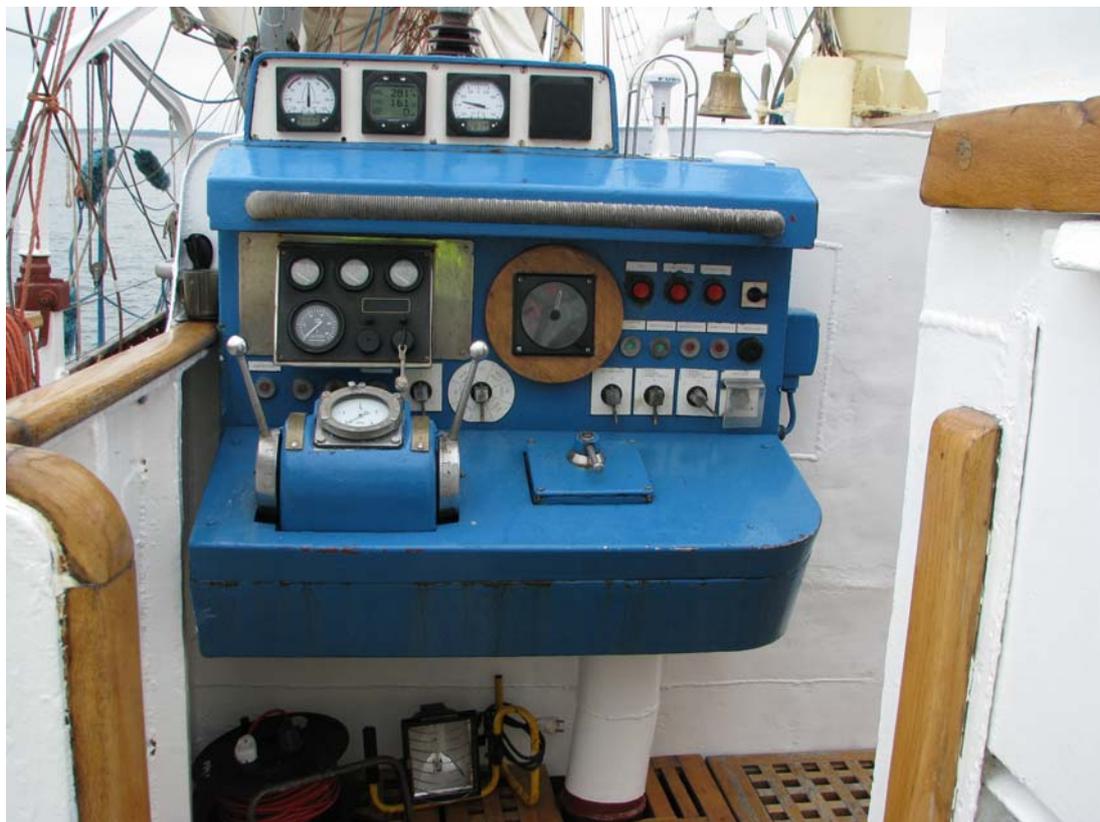
*Figure 3. Manoeuvring pulpit on Port side aft. The Navigating bridge and Radio station are on the right inside the deckhouse. Engine was not in use when the accident occurred.*

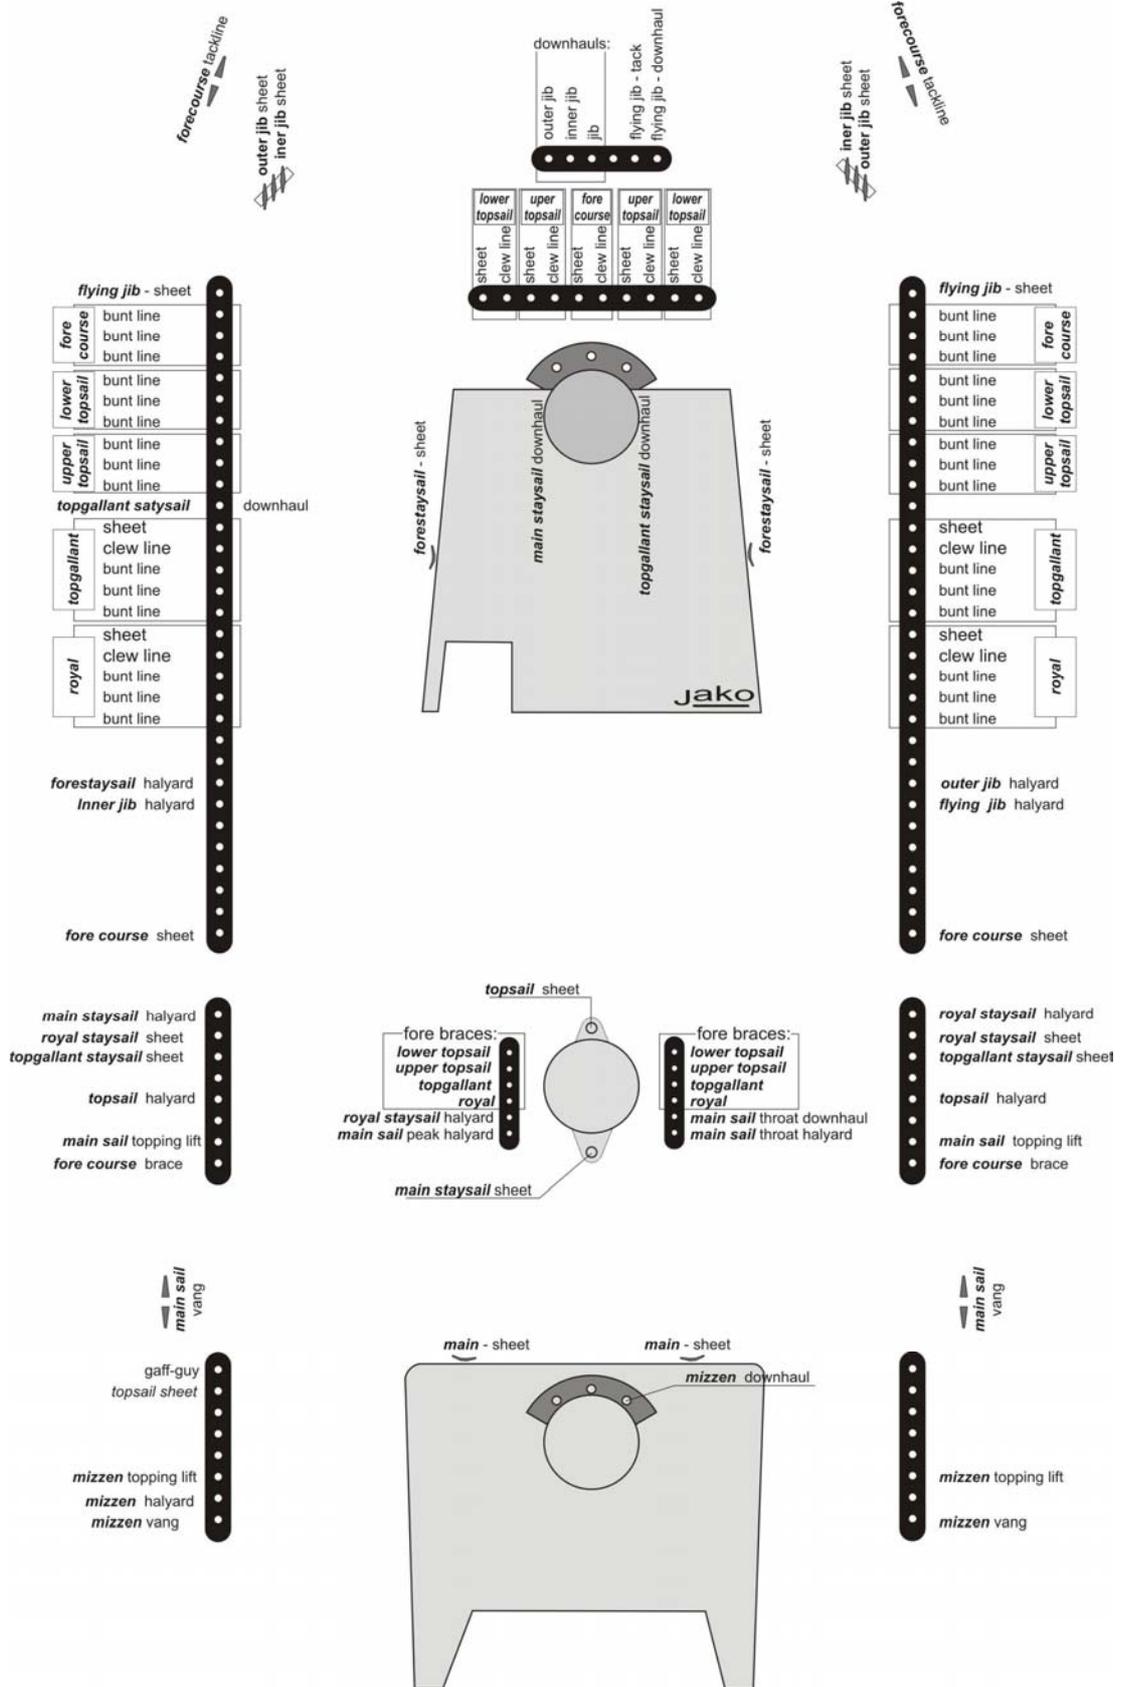
Figure 5. POGORIA's rig arrangement.

The vessel has three masts with maximum 15 sails, The total sail area is 1050 m<sup>2</sup>. The vessel's sail and rig arrangements are shown in figures 4 and 5.

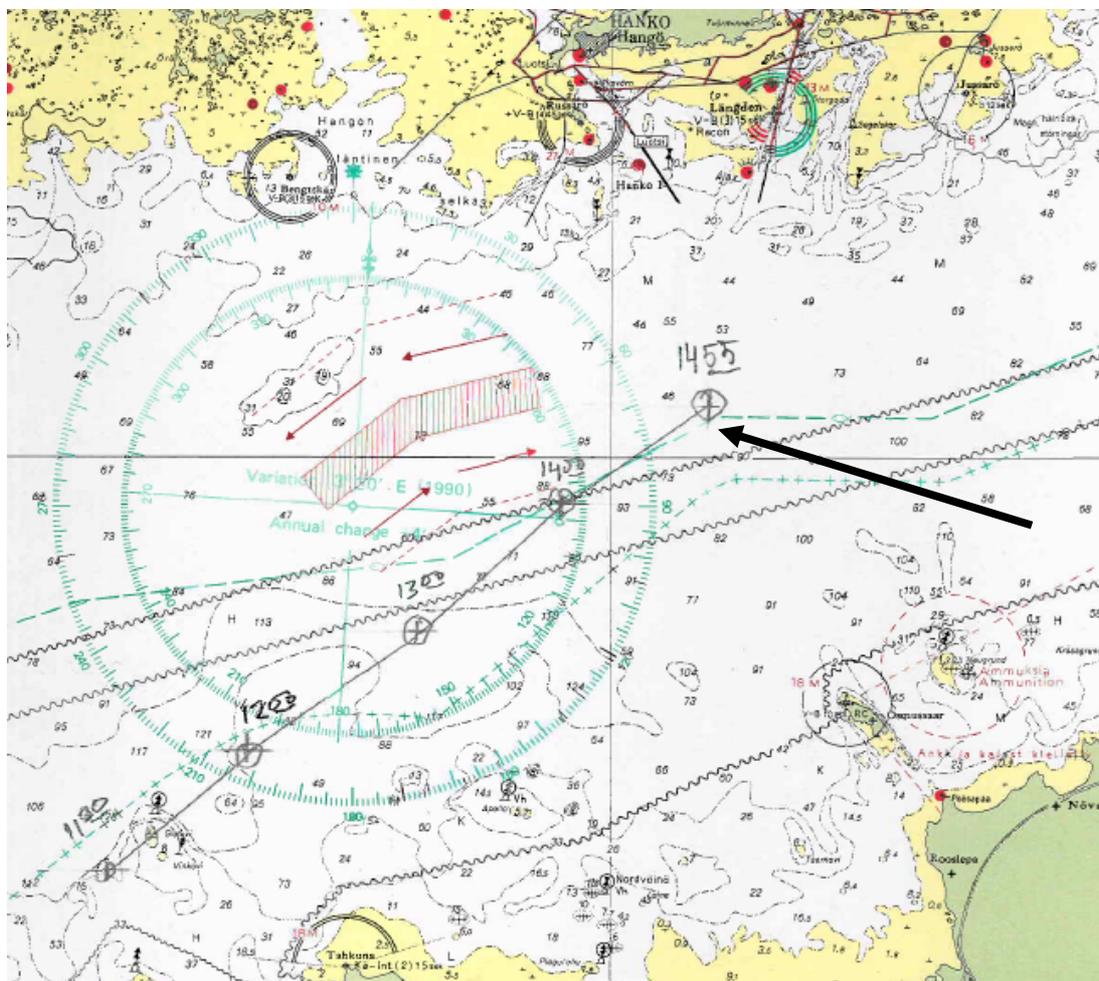
Figure 6. POGORIA's track, produced with the log book information. The arrow shows the Wind direction

The vessel had passed between 11.20-11.30 hours the Glotov shallow of 8 meters. With the draft of 4 meters and the wave height of 2 meters or more the route cannot be considered to show good seamanship.

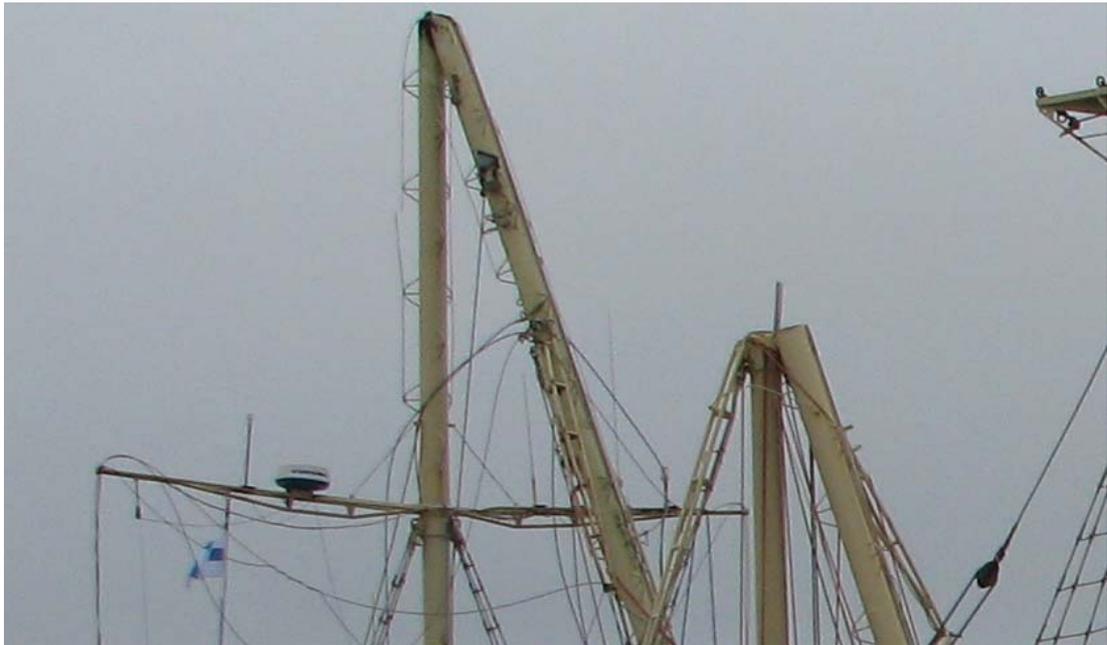
The Mainmast broke from five points and the Mainsail was torn. The Mizzenmast broke above the upper spreader. The top part stayed hanging downwards. As the main engine's exhaust pipe was inside the Mizzenmast, the pipe was blocked and the engine could not be started.

Figure 7. The bended Mizzen Mast.

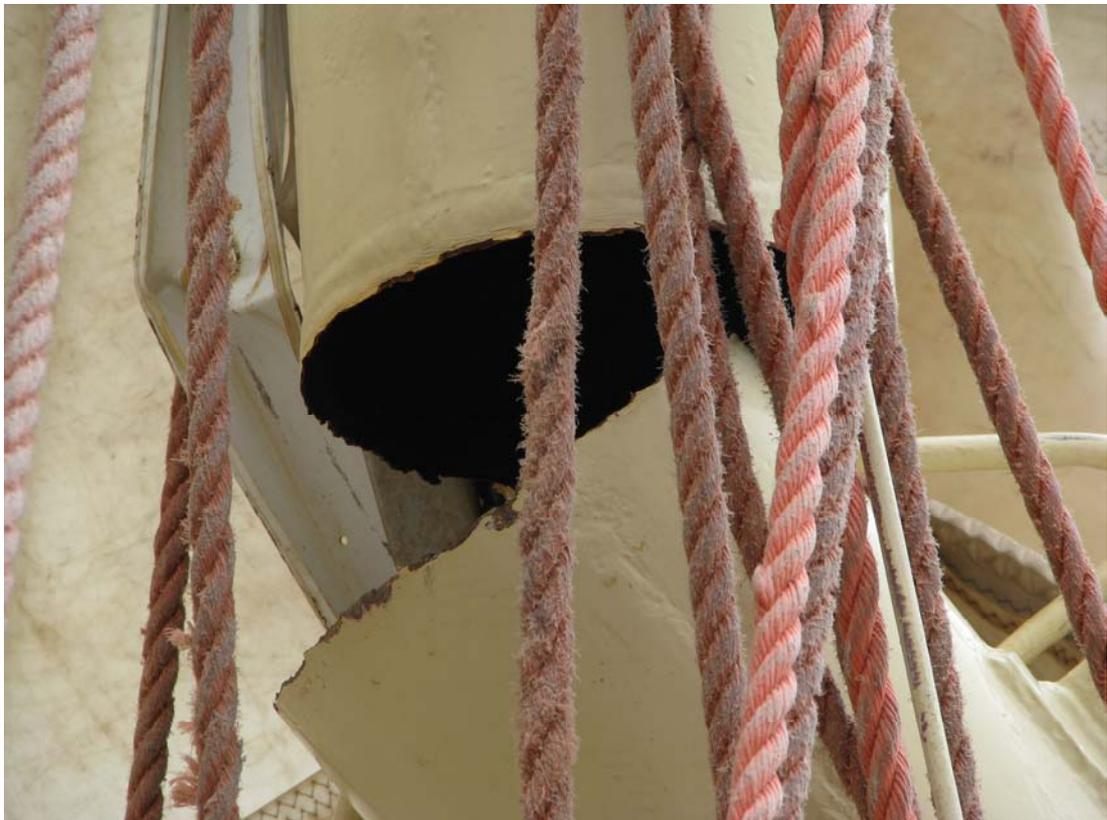
In Hanko the damages were visually evaluated. The masts had broken right beside the weld seams. There was clear corrosion in the masts.

*Figure 9. Broken mast, right at the weld seams.*

In the investigation it was quite soon obvious that the strength of the masts had been weakened during the three decades. Clear corrosion, even corroded holes could be seen.

The condition of the masts must be inspected continuously. Even accurate visual investigation should have shown the defects.

Onboard a sail vessel there shall be a systematic survey program. With the program the condition of the masts is assessed frequently. The inspections shall be documented. This guarantees that the inspections are done extensively enough.

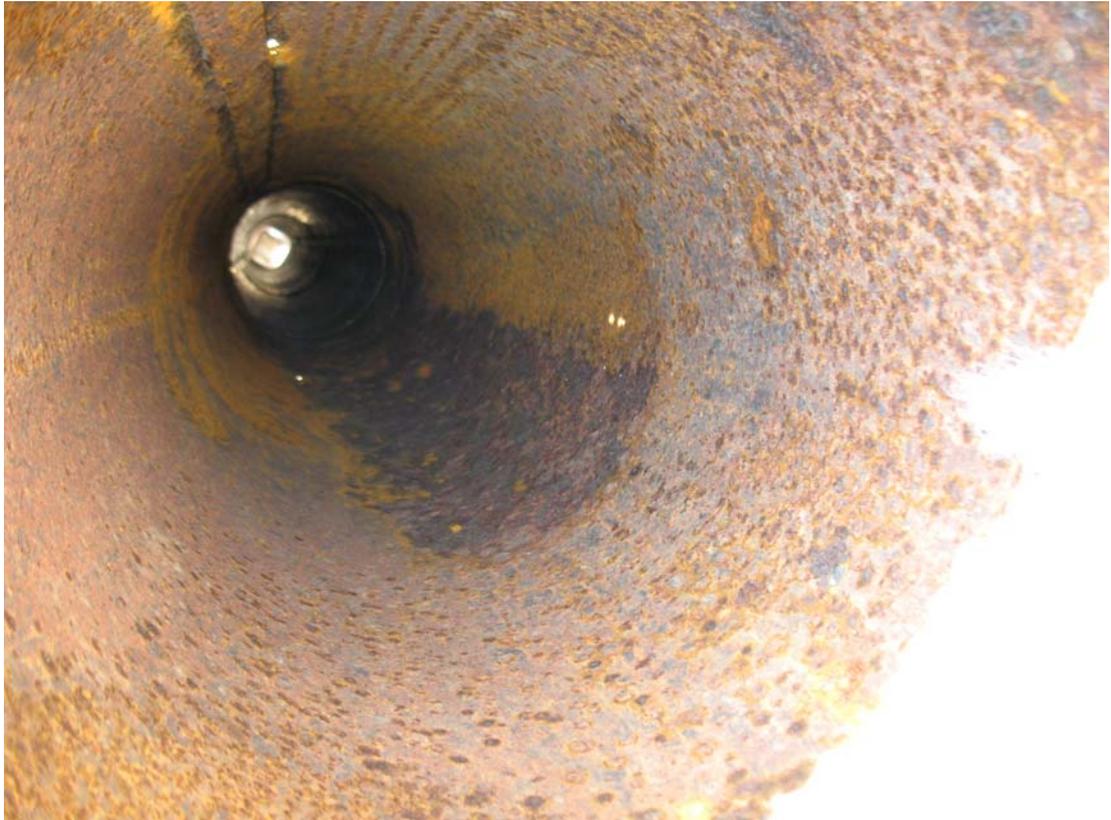
*Figure 10. Corrosion inside a mast. (FMA)*

The Maritime Inspector made an IMO Port State Control<sup>4</sup> on 8.7.2009. The conclusion of the inspection was that the prime cause of the accident was the corrosion of the steel masts.

*The Polish Maritime Administration carries out an examination on the condition of masts of the Sail Training vessels under Polish flag*
