**Accident Investigation Board of Finland  
Annual Report 2005**

## MISSION OF ACCIDENT INVESTIGATION BOARD

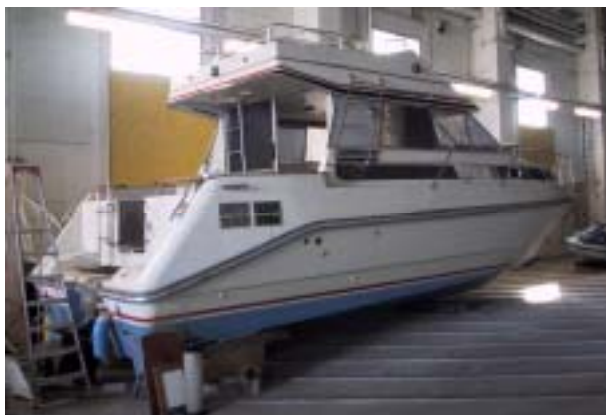
There are many facts that support the view that it was HAMANE SPIRIT that had been the vessel that rammed SARA. This could not be fully proved. The investigation did not succeed in getting a complete picture of the traffic situation in the accident area in spite of numerous attempts.

There were no physical injuries to the persons onboard. SARA's hull was damaged to such an extent that the hull insurers considered her a total loss.

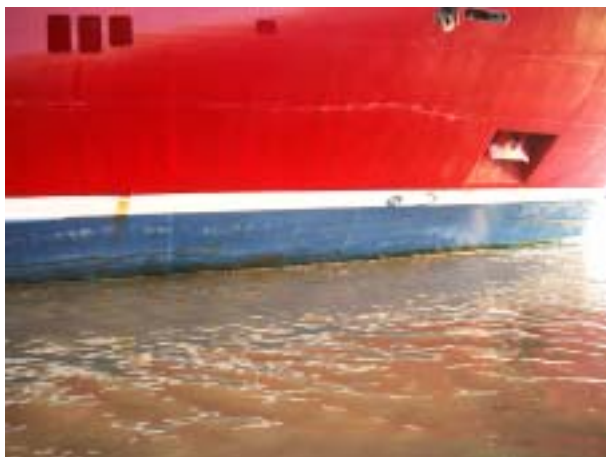
**C 7/2004 M**

**Ms ISABELLA (FIN) /ROSPIGGEN (SWE),  
incident at harbor of Stockholm on August  
30, 2004**

The collision was not noticed by the crew at ms ISABELLA's bridge and it resumed her voyage to Mariehamn, Åland. Damages to ms ISABELLA were only minor scratches on paint. ROSPIGGEN was damaged to her left light stand, bridge roof, two radar antennas, mast, funnel, antennas and Aldis-lights. Smaller boat with its davits was also damaged. Autopilot and two GPS-systems went off-line as they were damaged. After informing ISABELLA of the collision ROSPIGGEN sailed to dockyards for renovation.
