Investigation report

D6/2010L

An ultralight amphibian aircraft crashed into water in Taipalsaari on 26 June 2010

SeaMax M-22

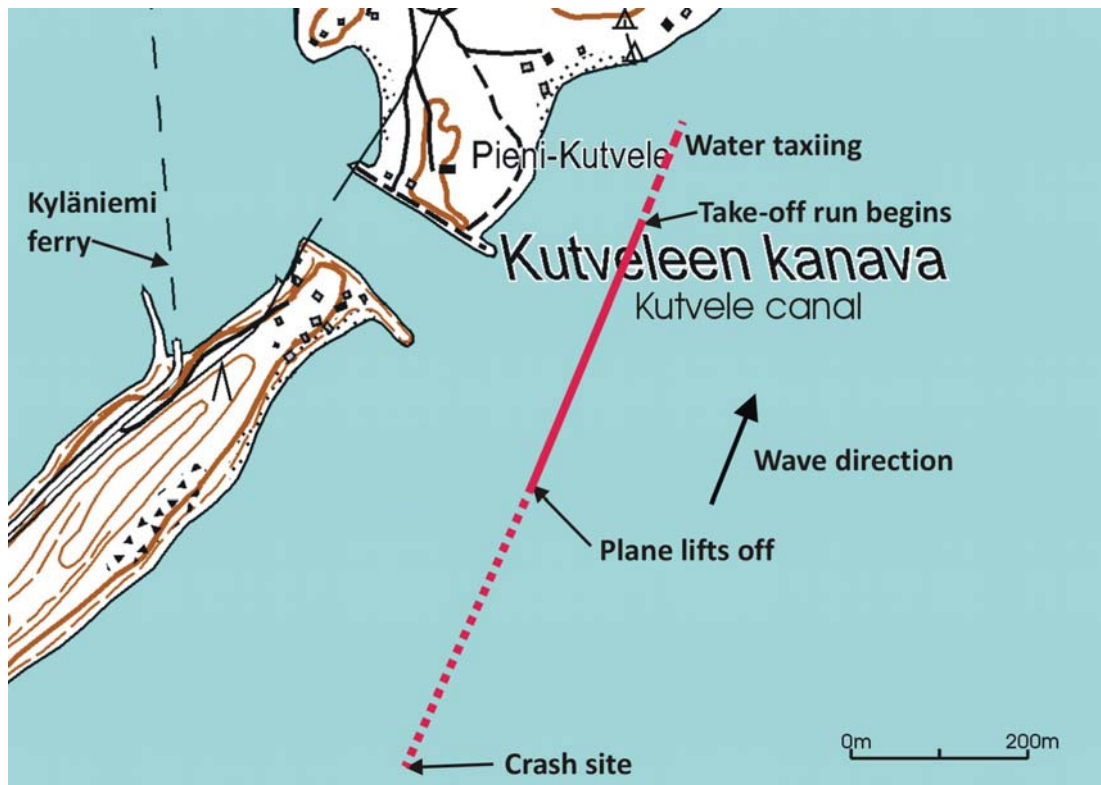
The pilot intended to fly to Immola aerodrome (EFIM). Before the flight, he checked the aircraft as usual and used the bilge pump for about 10 seconds. After this the pilot and his assistants pushed the aircraft into the water rear first. The pilot water-taxied the plane towards Kutvele canal. During taxiing, the waves occasionally broke over the hull. Water had condensed inside the canopy. The pilot tried to take off, but the aircraft would not lift off the water, and he tried again. During take-off, the aircraft did not start planing normally and the tail was lower than usual. The climb angle was rather steep immediately after take-off. The water rudder was down at take-off. The pilot tried to make the climb angle lower, without succeeding. He then reduced engine power, which caused a sudden nose-up movement. The plane stalled immediately and fell into the lake in a steep angle from a height of more than 20 metres. The pilot exited the aircraft, inflated the life vest and remained floating close to the aircraft. (Figure 1)

Figure 1. Accident flight shown on a map. (KTJ/Ministry of Justice/National Land Survey of Finland)
