Investigation report

L2013-01

Helicopter accident on a heli-sawing flight near the city of Tampere on 10 January 2013

Hughes 369D

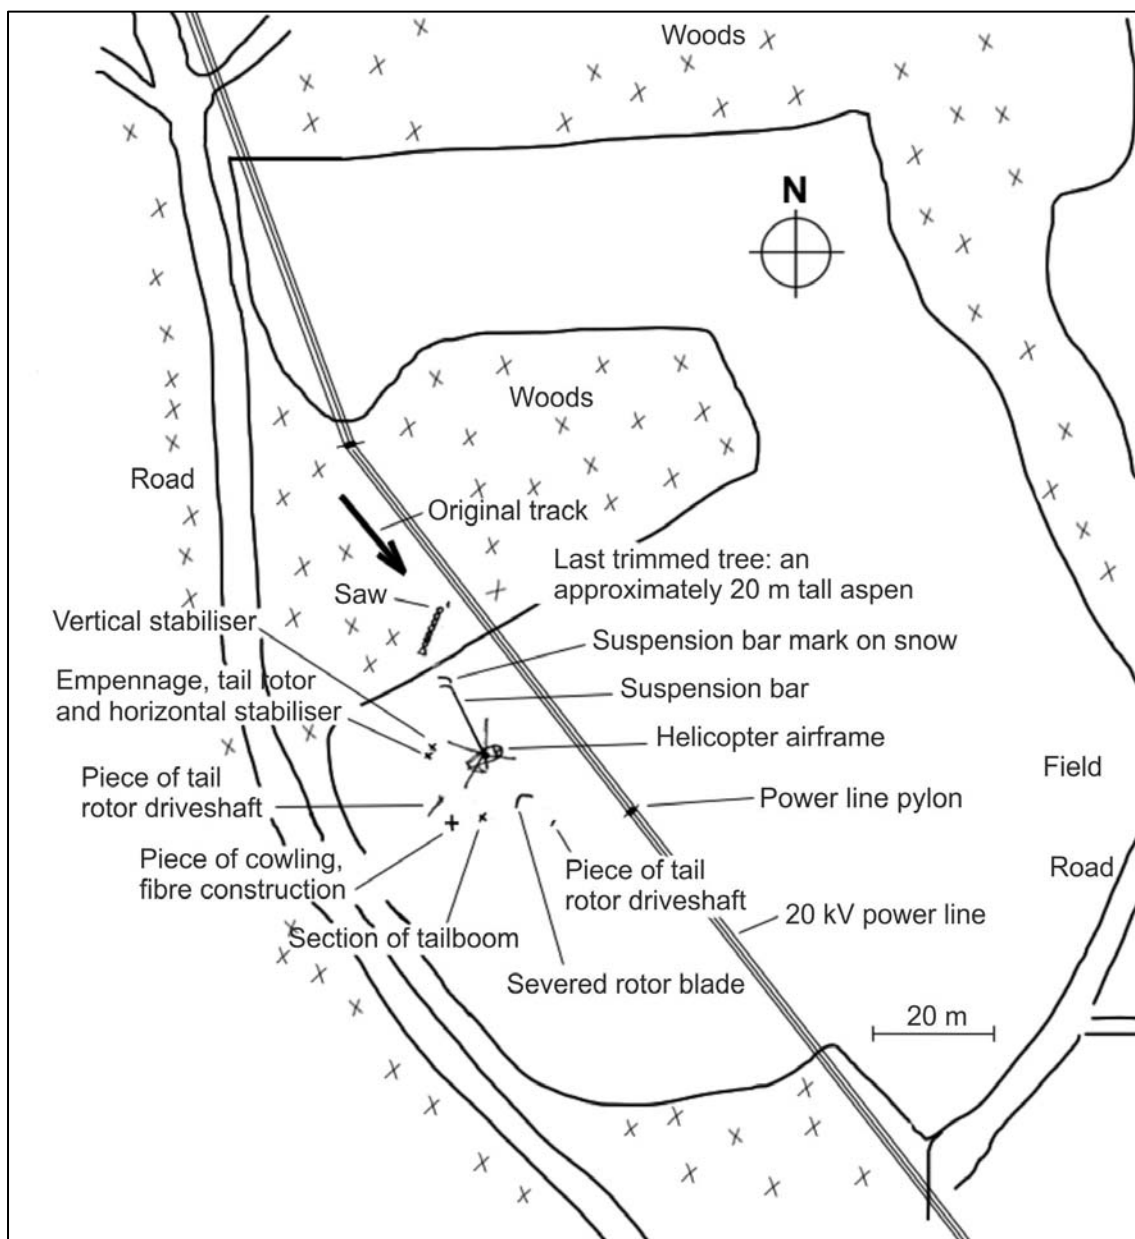
Figure 4. A sketch of the accident site.

The roughly 18 m long suspension bar of the saw, having separated from the sawing unit, lay approximately 10 m from the saw on the field. The bar was bent at approximately two metres from the place where it broke off. The bent suspension bar had left a mark on the snow at approximately two metres before the place where it lay. One end of the bar was still attached to the bottom of the helicopter, to the external cargo hook. The original track of the helicopter was approximately 145 degrees but the airframe veered approximately 90 degrees to the left once it collided with the ground. The magnetic compass was pointing towards 55 degrees. There was a power line 16 m from the nose of the helicopter; the closest power line pylon was 21 m from the airframe. The local road was approximately 40 m behind the helicopter. The snow layer was approximately 30 cm thick.

Both of the helicopter's skids broke off in the collision with the ground. The airframe was lying on its bottom on the ground. The lower section of the left windshield was shattered next to the antitorque pedals. One of the main rotor's five blades was broken off close to the root of the blade. Another blade was bent downward and its leading edge was crushed. The third blade was bent upward and the remaining two blades seemed intact. The rotor blades had struck the tailboom, slashing it into three separate sections. The root of the tailboom was bent towards the right side of the airframe and the middle part lay approximately eight metres from the airframe, in front of the helicopter in its original heading. The empennage section, including the tail rotor, the tail rotor gearbox and the horizontal stabiliser, which were still attached to the empennage, lay approximately seven metres to the right of the airframe in relation to the track of the helicopter. The vertical stabiliser lay next to them. In addition, two pieces of the tail rotor's driveshaft and a fibre cowling from above the engine's compressor were close to the airframe. The stabilisers and the driveshaft parts had rotor slash marks on them. The tail rotor was intact. The helicopter's seats had maintained their integrity.
