Investigation report

B 5/2000 M

MV JANRA, capsizing in Northern Baltic 23.12.2000

Accident Investigation Board Finland

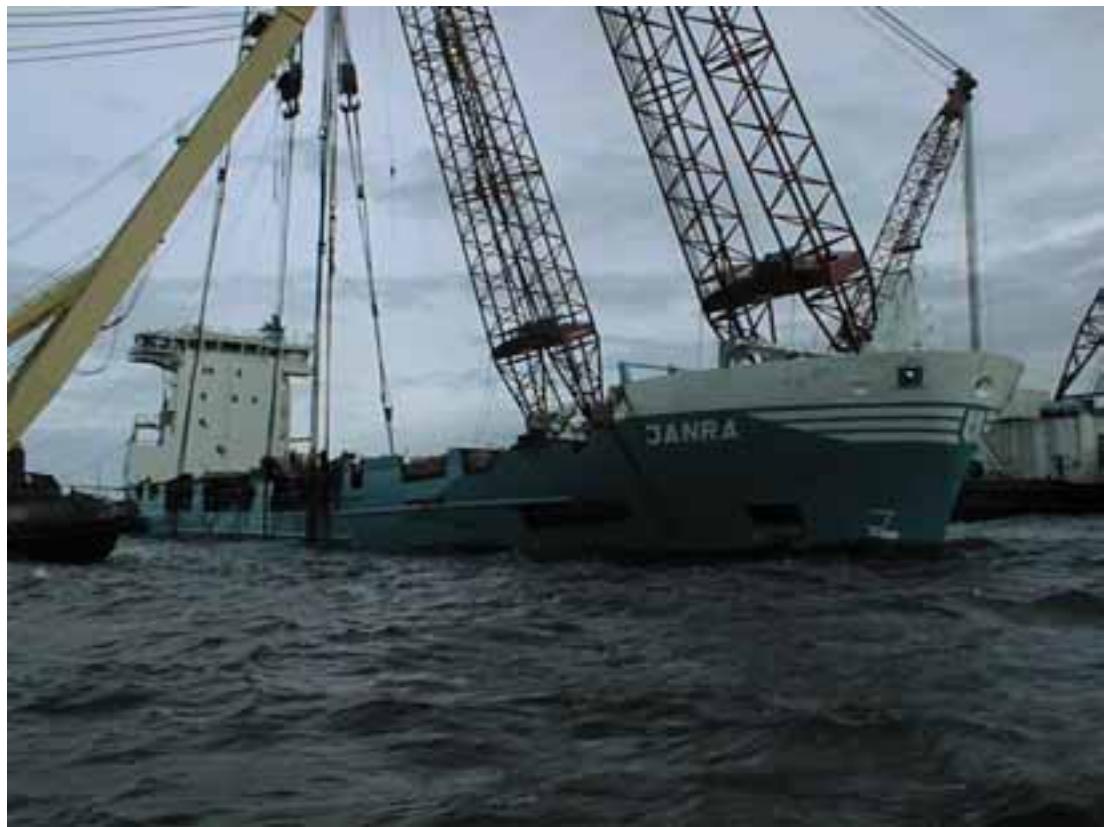
Figure 1. JANRA turned upright on February 17, 2001.

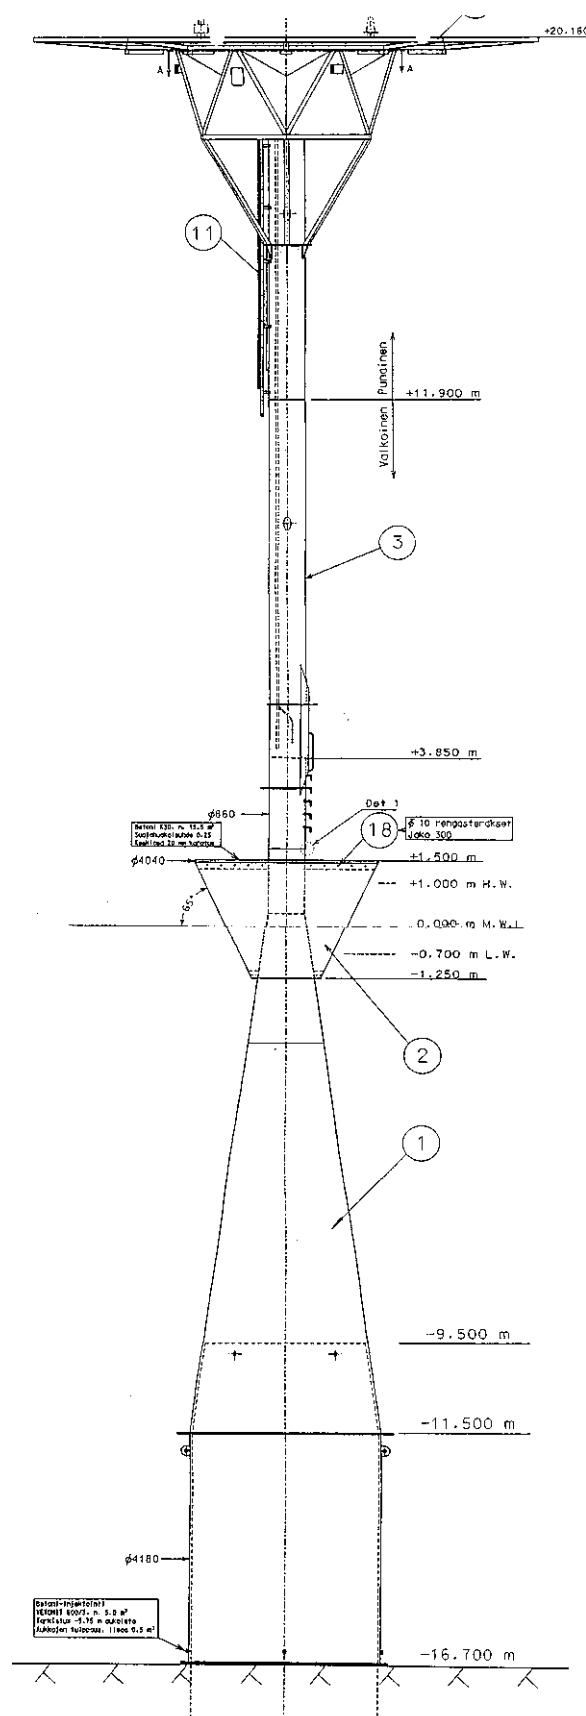
Figure 11. The construction drawing of the Tröskeln Västra edge mark.

The latest construction was of steel on a concrete base in the sea bottom. The construction drawing of the mark is in figure 11. The height of the mark above water level was 20 metres and its diameter was 860 mm. On top of the mark was a helicopter platform and an ice deflector cone was at the water level.

Energy problems with the mark. When JANRA collided with the Tröskeln Västra in the morning of December 23, 2000 the edge mark was unlit and the racon did not work. These faults were observed in November 4, 2000 and thereafter the warning message "Remark Tröskeln Västra nr 6385 in Position 59° 39.58' N 019° 51.72' E, reported unlit" was sent by the authorities via Turku Radio and Navtex.

The assumed reason for the faults was a lack of energy because the solar panels did not get enough light during the short daylight. This assumption could not be confirmed. The South Western Maritime District of the Finnish Maritime Administration was responsible for service of the edge mark Tröskeln Västra and they had tried to repair the faults on November 12 and 27 and on December 9 and 21, 2000, but the weather conditions had prevented the repair.

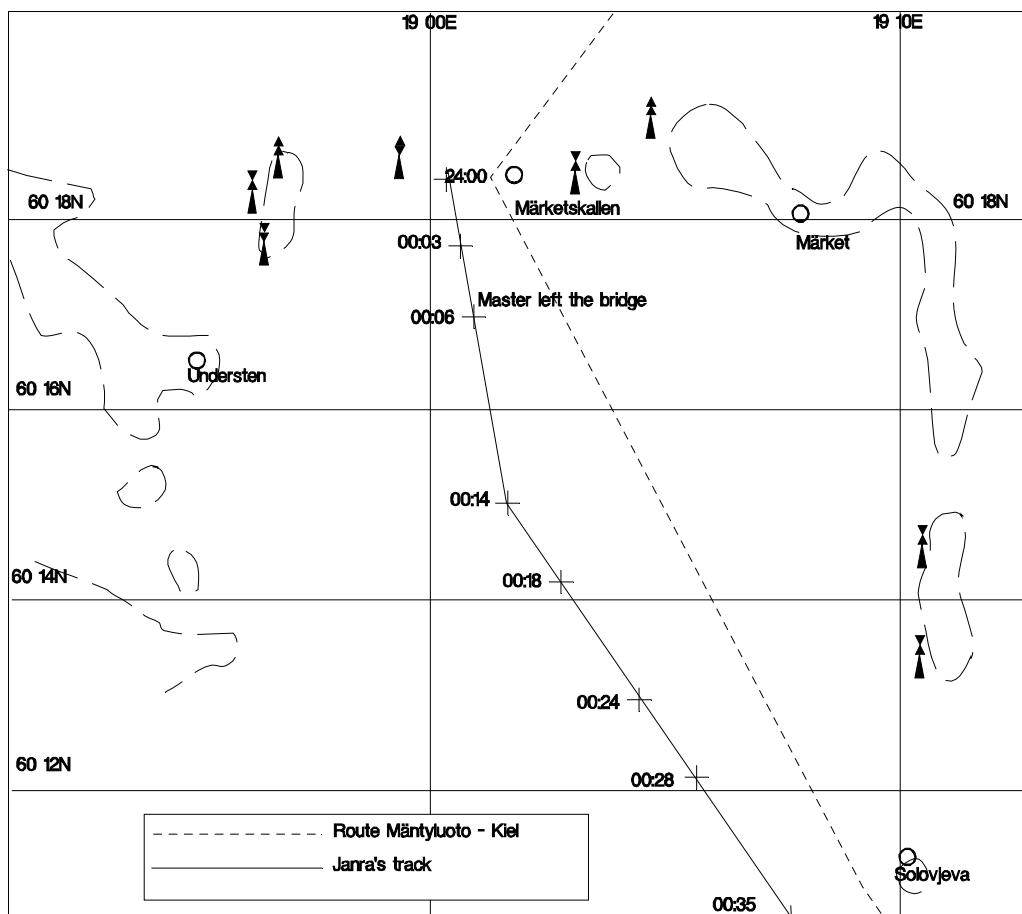
Figure 12. JANRA was using MÄNTYLUOTO–KIEL passage plan although the voyage started from Rauma.

JANRA used the Rauma-Kiel passage plan when she left Rauma at 17:07 on December 22, 2000. The Passage plan was changed to Mäntyluoto-Kiel plan several times between 18:44 and 21:31. Rauma-Kiel plan was turned on again two times between 20:31–21:31. Finally Mäntyluoto-Kiel passage plan was left on at 21:31. JANRA followed closely the plan Rauma-Kiel but it was far away from the loaded Mäntyluoto-Kiel plan which was on the electronic chart as illustrated in figure 12.

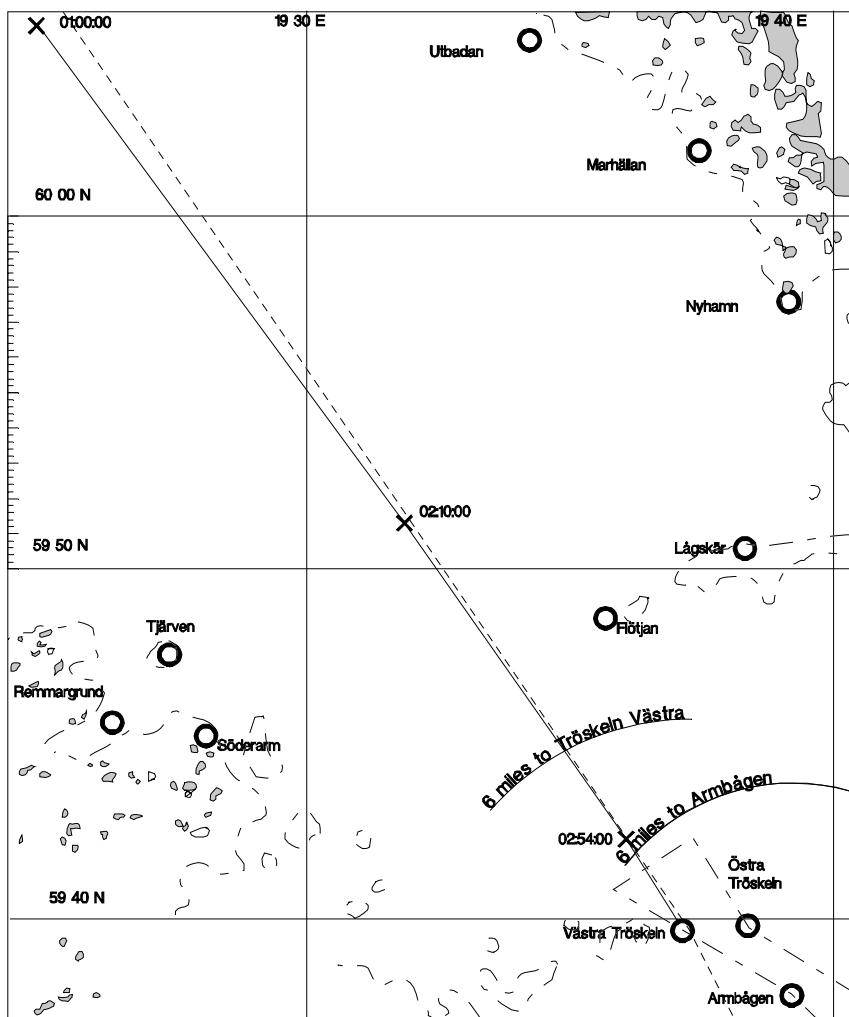
Figure 13. JANRA turned one degree to starboard at 02:10 and two degrees to starboard at 02:54. JANRA had followed the passage plan carefully from 02:10 to 02:54.

JANRA's approach to the northern part of the deep-water route and Tröskeln Västra edge mark is shown in figure 13. At one o'clock she was on the starboard side of her programmed track. JANRA turned one degree to starboard at 02:10, when she was 0.19' on the starboard from the intended track. From 02:10 to 02:54 JANRA followed her passage plan and the cross track error kept decreasing (table 9).

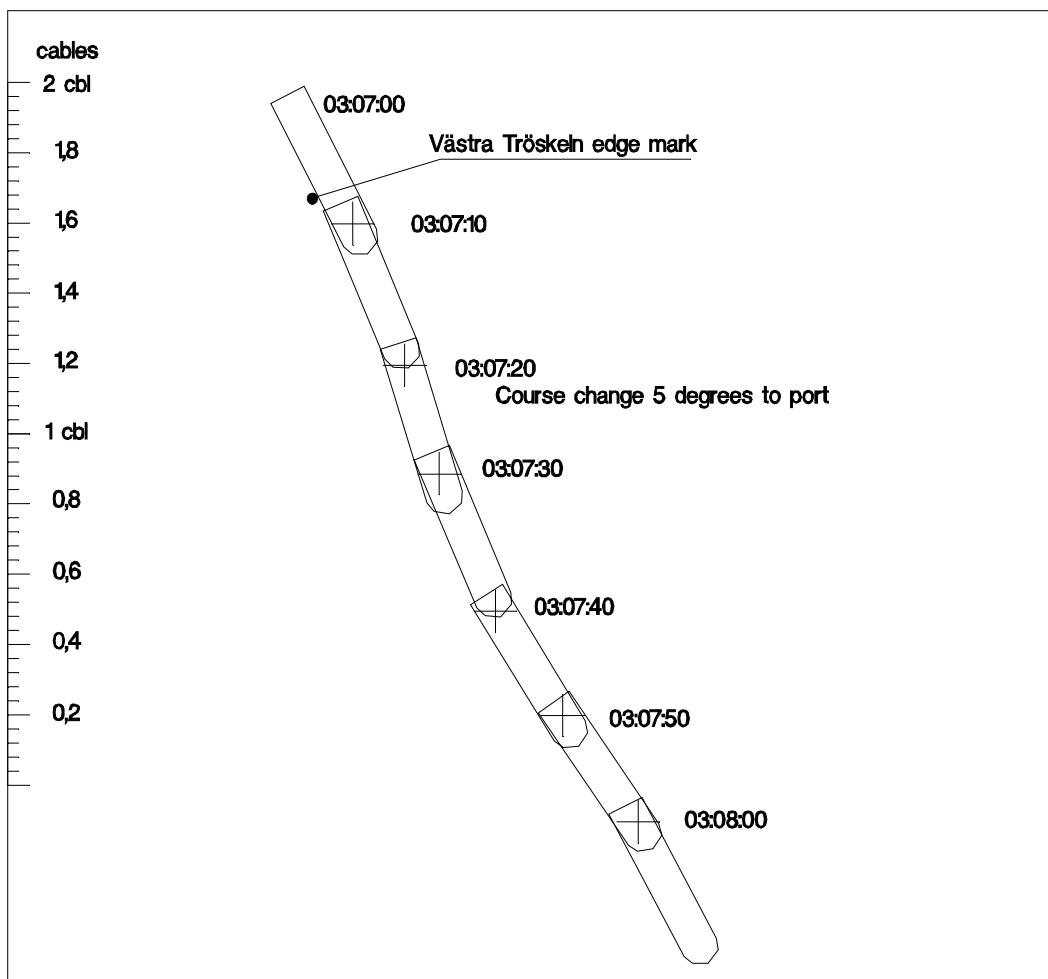
Figure 16. JANRA's s-turn after the impact. Heading is estimated between 03:07:00 and 03:08:00.

The collision took place at 03:06:54 (figures 15 and 16, table 11). The OOW felt the ship shake. He changed the course 5° to port back to the original course at about 03:07:20 (figure 16, table 12). The reaction was involuntary. He felt that the course change to starboard caused something evil and he tried to have it 'undone' by a course change back to the original course. When the first officer rushed to the bridge and asked the OOW "What happened?" the answer was "I do not know". The ship was on original course 147° again. The OOW had cancelled the course changes from his mind. The master was not informed about the latest course changes. Average Course Over Ground after the accident was 149° and before the accident between 147° – 148° .

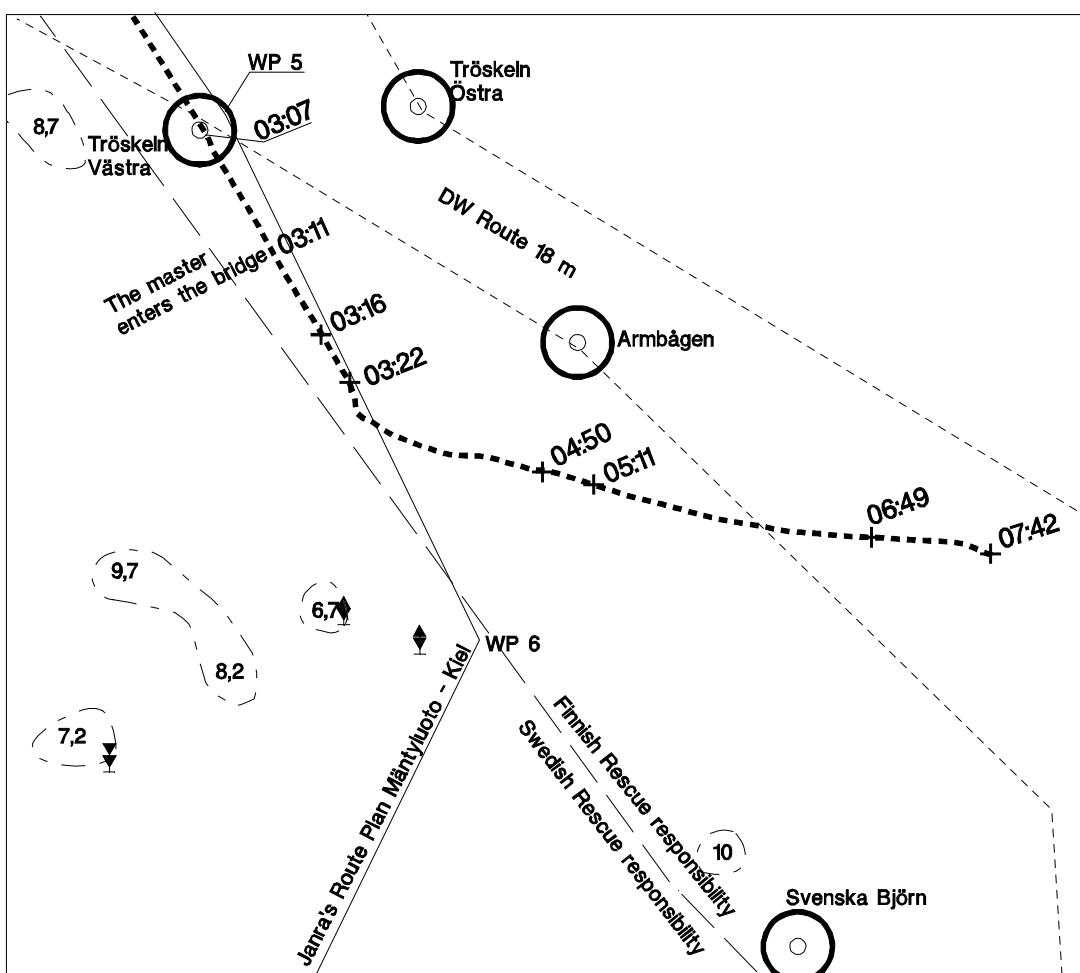
The track of JANRA after the collision is shown in figure 18. The rescue activities and the development of the list are listed in table 14 and the corresponding location of the vessel is shown in figure 18.

Figure 18. The track of JANRA after the collision. All activities took place on Finnish rescue area.

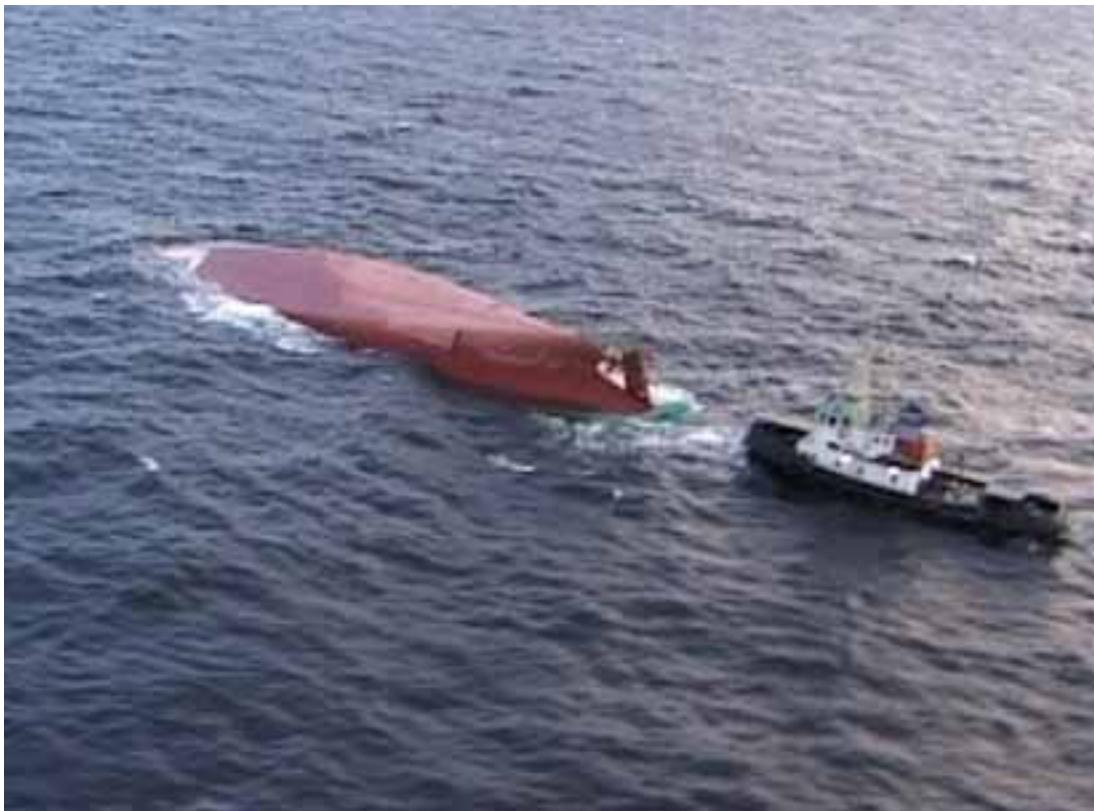
Figure 19. JANRA photographed on December 24, 2000 at 11 hours. The tow is fastened to her rudder.

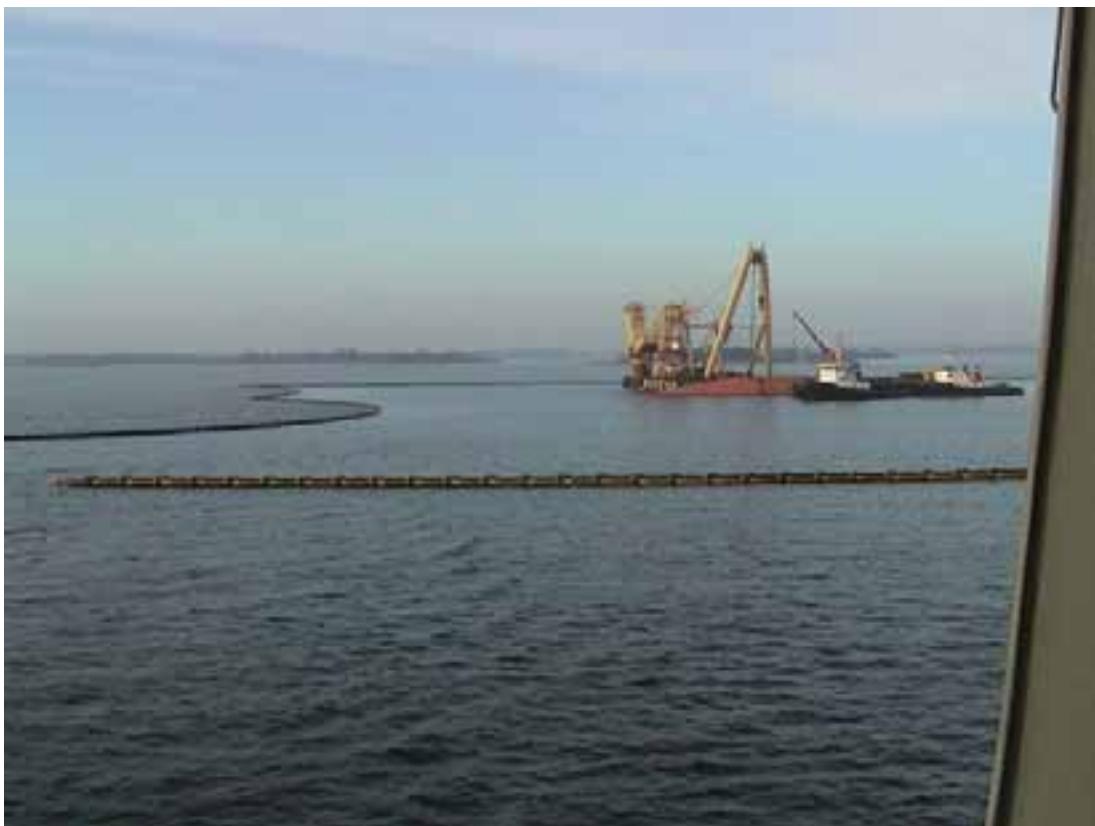
Figure 29. The oil prevention booms around JANRA during the rescue operation in Åland.

Oil prevention during initial salvage actions. The Finnish Environmental Center sent the oil prevention vessel HALLI to the accident scene. JANRA had caused a minor oil spill. HALLI arrived at the scene on December 24, at 0.30 am. JANRA was drifting approximately to South at a speed of 0.7 knots. During the night tugboat NEPTUN owned by Alfons Håkans Ab had arrived. The company had made a salvage agreement for the vessel. The Coast Guard vessel UISKO was warning bypassing traffic of the accident. The waves were too high to collect oil.

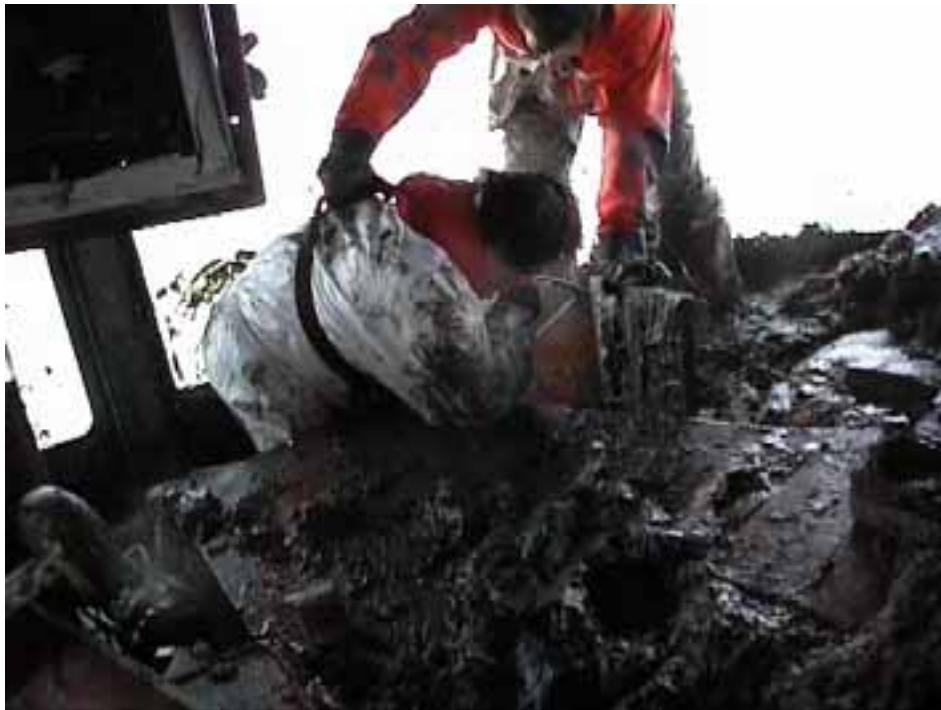
Difficulties for this retrieval was caused by the 1 metre high layer of mud which had been accumulated to the bridge when the ship sank to the bottom during salvage attempts.

Figure 30. The investigators searching for the electronic chart computer.

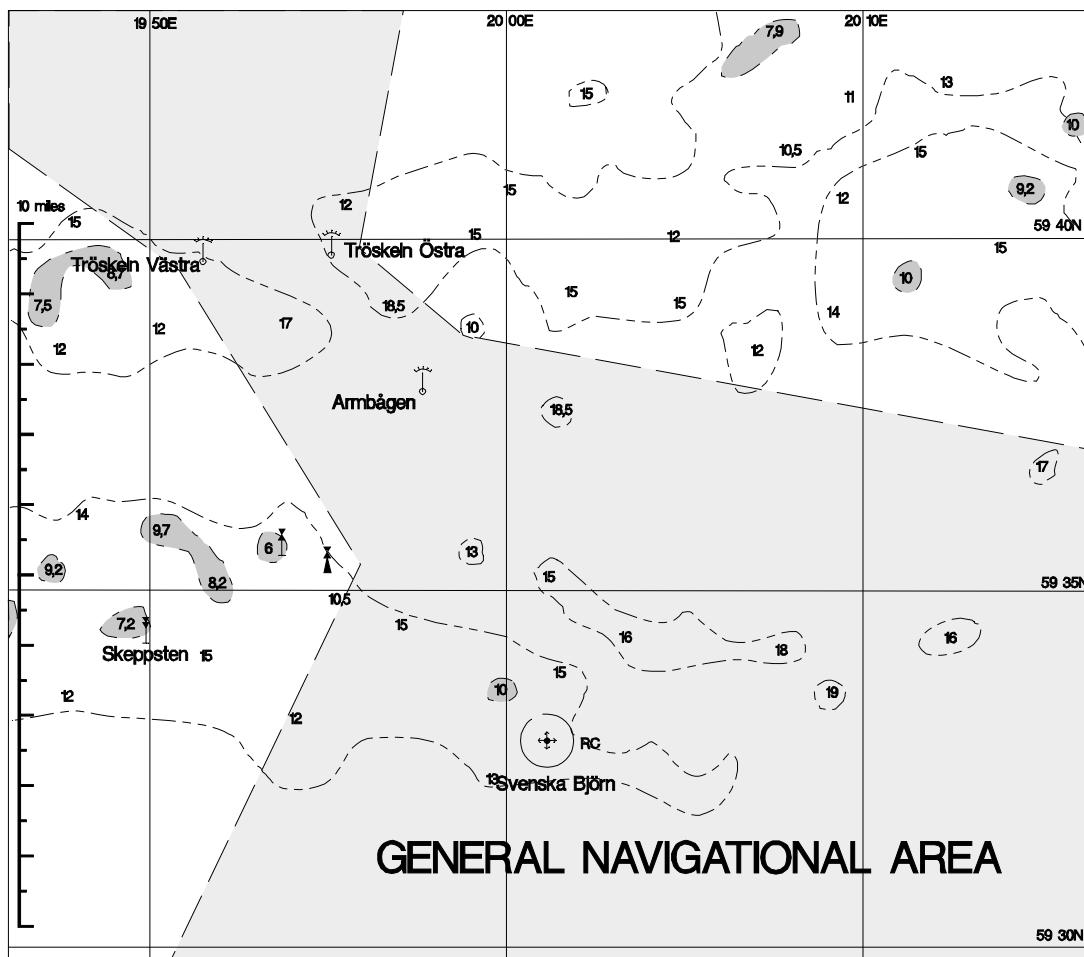
The edge marks were designed to warn deep draught vessels. The deep draught bulk carriers have always navigated safely between the edge marks without accidents. This proves that the fairway making has been effective. The deep draught route marking has been successful and justified what comes to the original goal to safeguard the bulk carrier traffic. The impacts have happened only to vessels with shallow draft. The problem is concentrated on shallow draft vessels, which do not really need the deep draught route at all. Hence the edge marks have become a danger for the shallow draft vessels because the edge marks are inside the navigational area for shallow draft vessels. JANRA is not alone in this group.

Figure 35. The area can be seen as a wide 'shallow water' route on board a shallow draft vessel.
