Investigation report

C4/2006M

C5/2006M

M/S HOBURGEN on 7.10.2006 and M/T ARCTICA on 14.10.2006, ramming of edge mark Tröskeln Östra

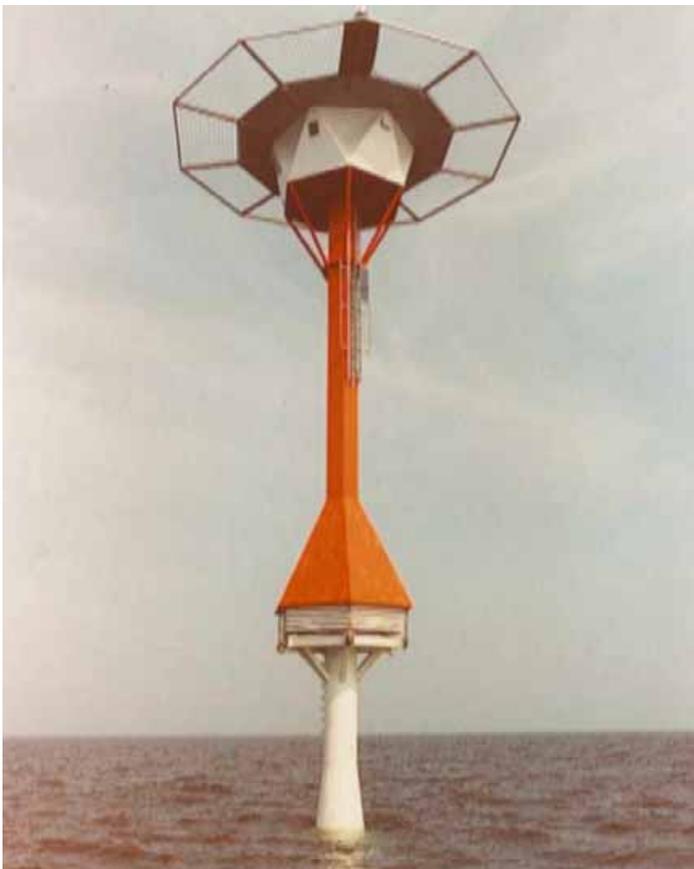
Figure 5. Edge mark Tröskeln Östra. (Source: Finnish Maritime Administration)

Tröskeln Östra was a steel-frame edge mark, fixed to the seabed. The height of the mark from the surface was 20 m, as was its identification light. There was a helideck on top of the mark (fig. 5). The helideck had solar panels for charging the batteries of the lights.

Damage to Tröskeln Östra. When the HOBURGEN rammed the edge mark it was bent just above the surface and the helideck fell to the sea. There was no lighting on the edge mark after the collision. Figure 12 shows Tröskeln Östra after the collision.

Planned safety equipment repairs and traffic arrangements. According to the Finnish Maritime Administration at least the edge mark Tröskeln Östra is going to be rebuilt. After the JANRA rammed Tröskeln Västra it was replaced with a light buoy (a large ice buoy).

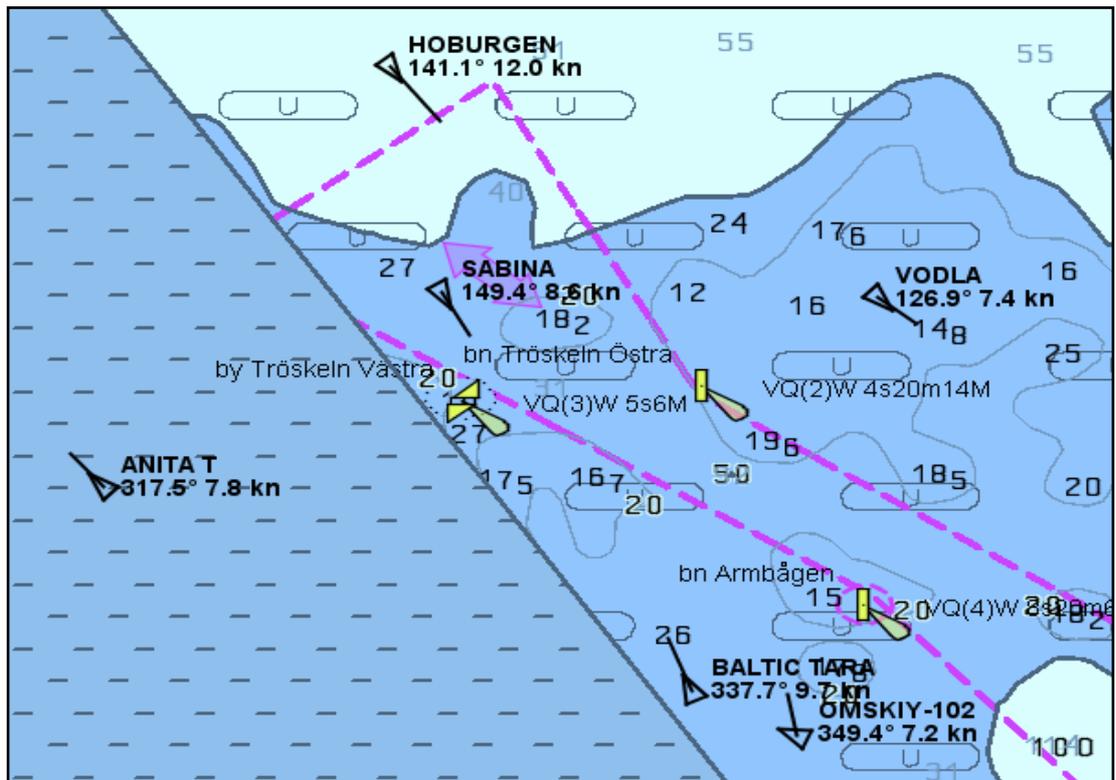
Figure 7. Traffic situation according to AIS messages as the HOBURGEN approached the deep-water route zone. (Source: Finnish Maritime Administration, VTS recordings, Archipelago VTS)

The HOBURGEN approached the narrowing deep-water route delineated by edge marks on a southeasterly course on the port side of the route. Two vessels, heading north, were coming towards it. Their tracks came very close to that of the HOBURGEN. At 21:45:12 Finnish time the third mate altered course 10 degrees to port from course 142 degrees to course 132 degrees. This happened 7 minutes and 40 seconds before the collision. At 21:50 the look-out (deck cadet) asked for permission to leave the bridge for a moment. The third mate excused the cadet, ordering him to make a safety round while he was outside.

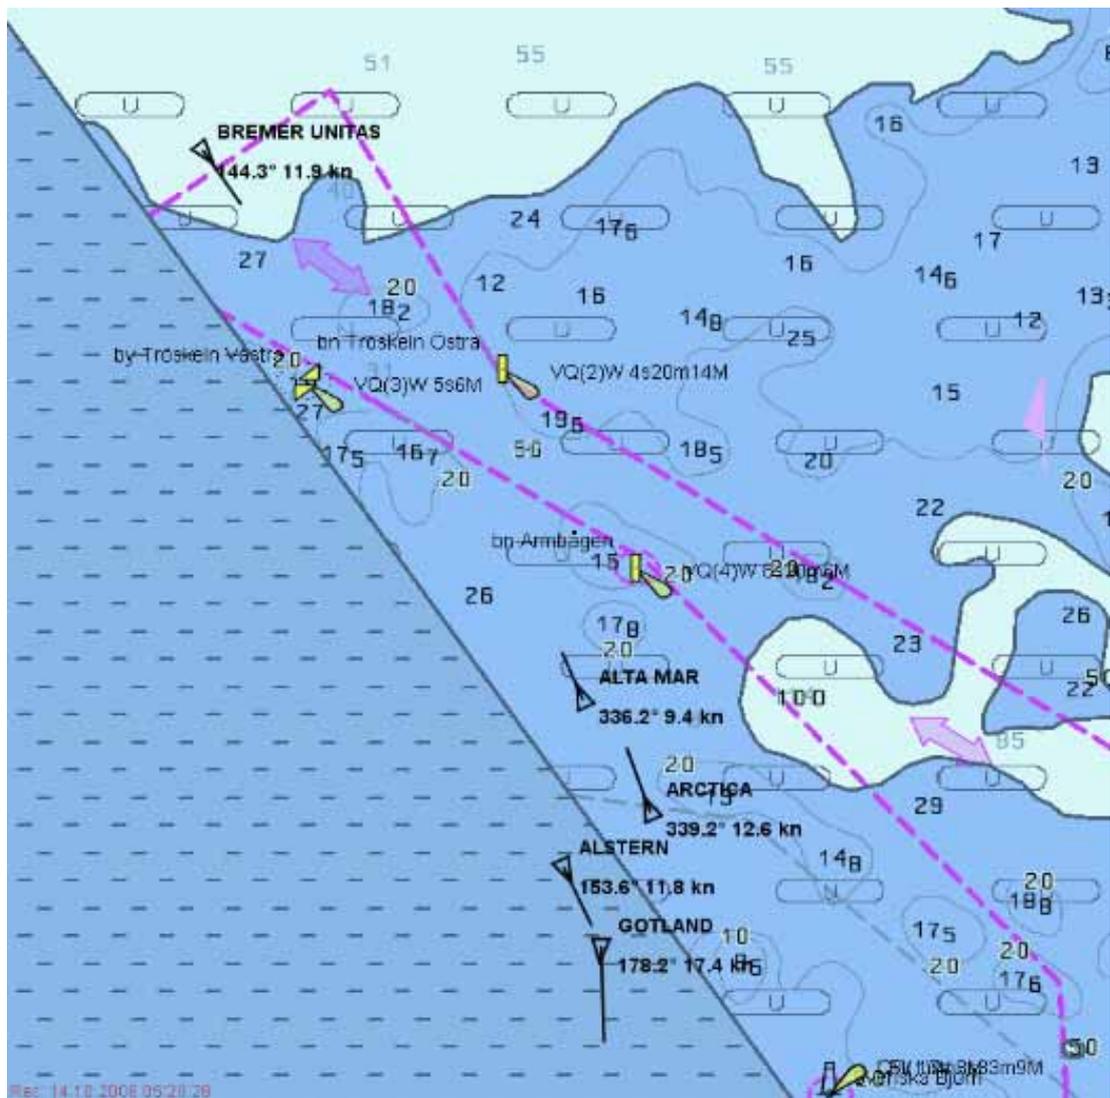
Figure 10a. Traffic situation at 05:20:20 as the ARCTICA changed course from 337 degrees to 342 degrees. (Source: Finnish Maritime Administration, VTS records, Archipelago VTS)

The ARCTICA's heading varied between 341°-342° until approximately 30 seconds before impact when she seems to have turned 2-3 degrees to port while maintaining her speed. At 05:40:31 AIS-recorded time, her bow hit the remaining stump of Tröskeln Östra. This caused a rapid turn to the port, towards 325 degrees, and her speed momentarily decreased from approximately 13 kt to 11.5 kt.

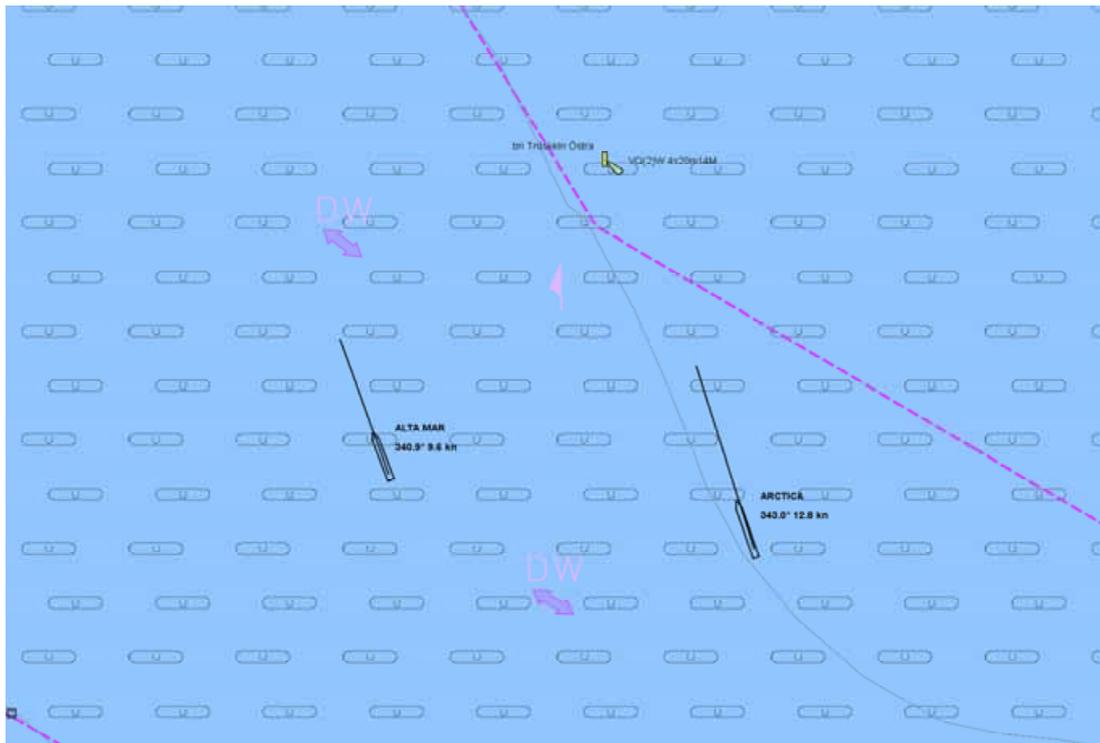
Figure 10b. The ARCTICA overtaking the ALTA MAR a couple of minutes before the collision. (Source: Finnish Maritime Administration, VTS records, Archipelago VTS)

When it comes to the HOBURGEN accident, the tracks of the BALTIC TARA and OMSKIY-102 (fig.14), as well as those of the ARCTICA and ALTA MAR (fig. 10), are clearly more precarious than those parallel or clearly perpendicular to the deep-water route. This is because they merge with deep-water route traffic at oblique angles.

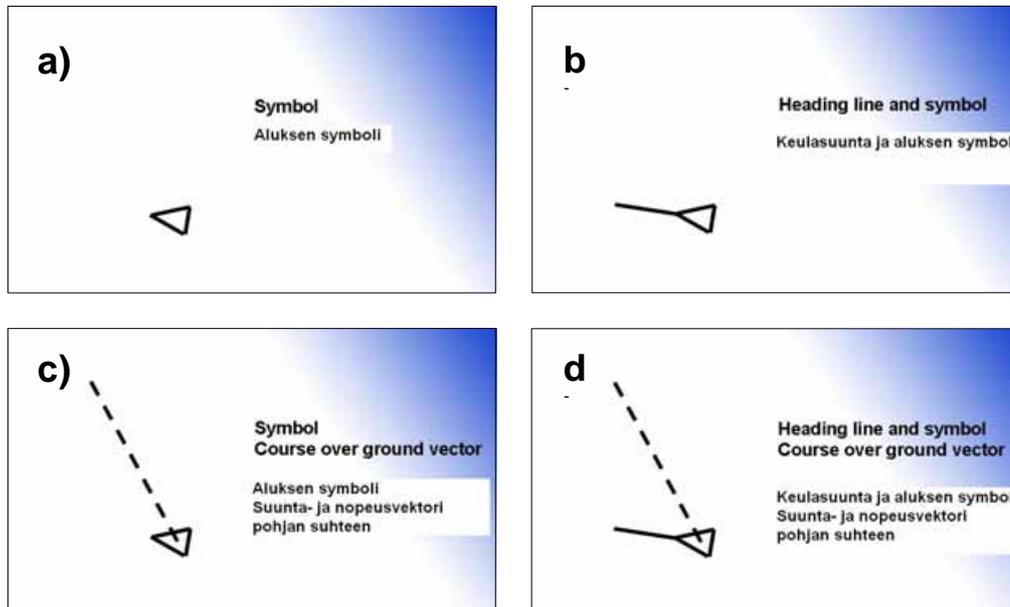
Figure 18. Different modes of displaying AIS information on an electronic chart. The information content of different display modes:
 a): Position and heading (direction of the equilateral triangle),
 b): Position and heading line,
 c): Position and heading (direction of the equilateral triangle) as well as the COG vector,
 d): Position and heading line as well as the COG vector.

Figure 18 shows the four different AIS display modes, all of which are possible on electronic charts. It is normally possible to select the mode in electronic charts, including ECDIS.

The symbol of the vessel in figure 18 is drawn in accordance with the same erroneous manner which the OMSKIY-102 transmitted. In other words, the symbol's incorrect heading points approximately 60 degrees to port from the vessel's true COG. Of the four modes of displaying AIS information (images a-d in figure 18) the material provided to the investigation commission included the modes b) on the top right (figure 16) and c) bottom left (figure 17).
