Statens haverikommission
Swedish Accident Investigation Board

Report RS 2008:03e

**Loss of M/S FINNBIRCH
between Öland and Gotland,
1 november 2006**

Case S-130/06

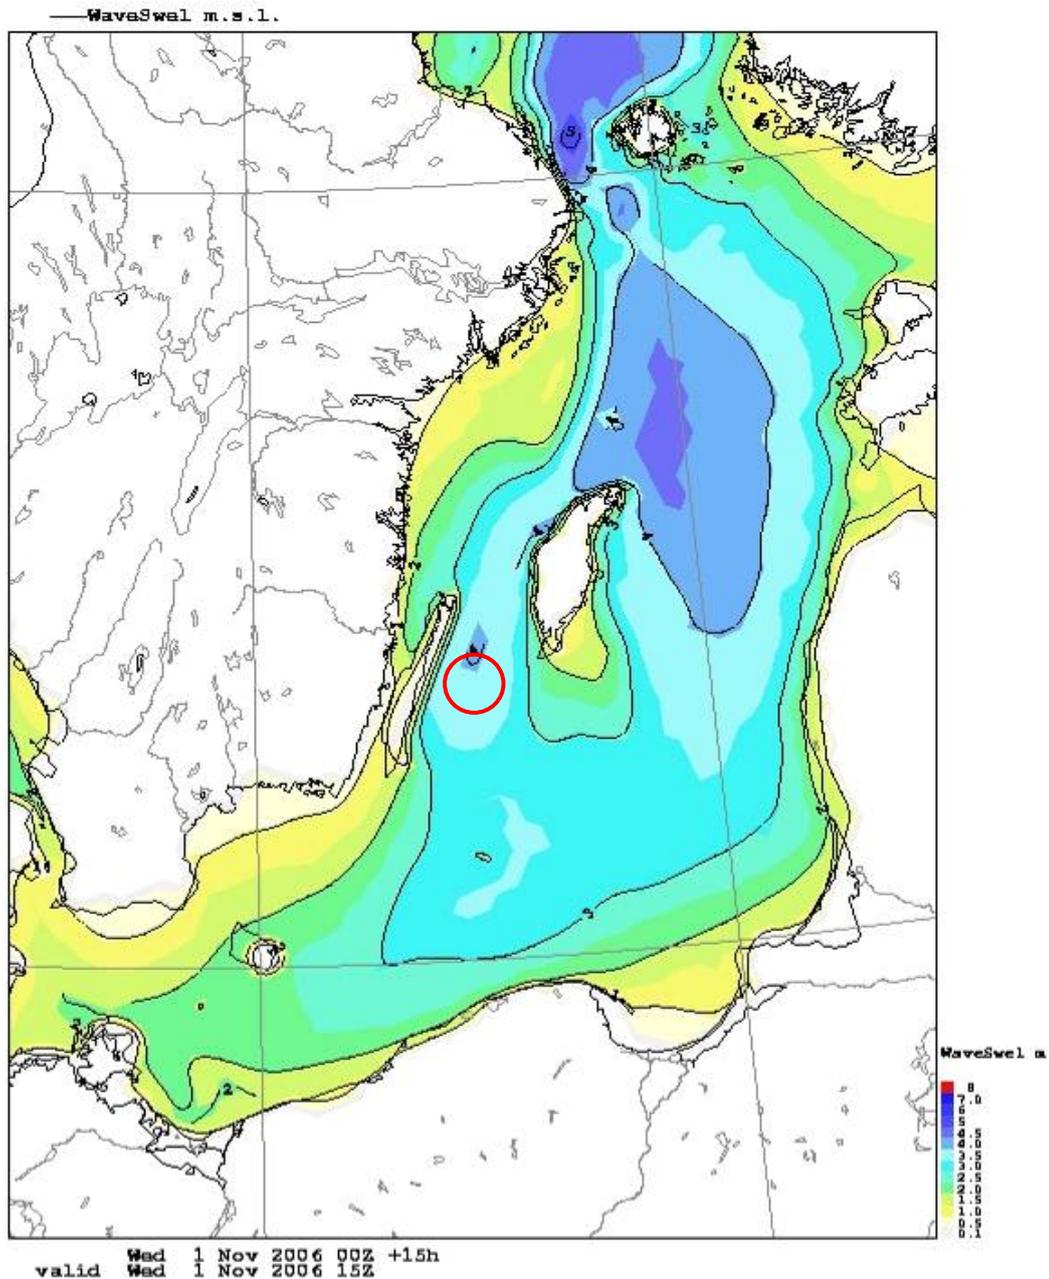
The maximum significant wave height in the area occurred at approximately 2200 hours, this being then, according to SMHI, 5 m, with wavelength 84 m.

Fig. 2. The calculated significant wave heights according to SMHI at the approximate time of the accident. Note the area between Öland and Gotland with greater wave heights which coincides with the position of the accident (red circle indicates approximate position).

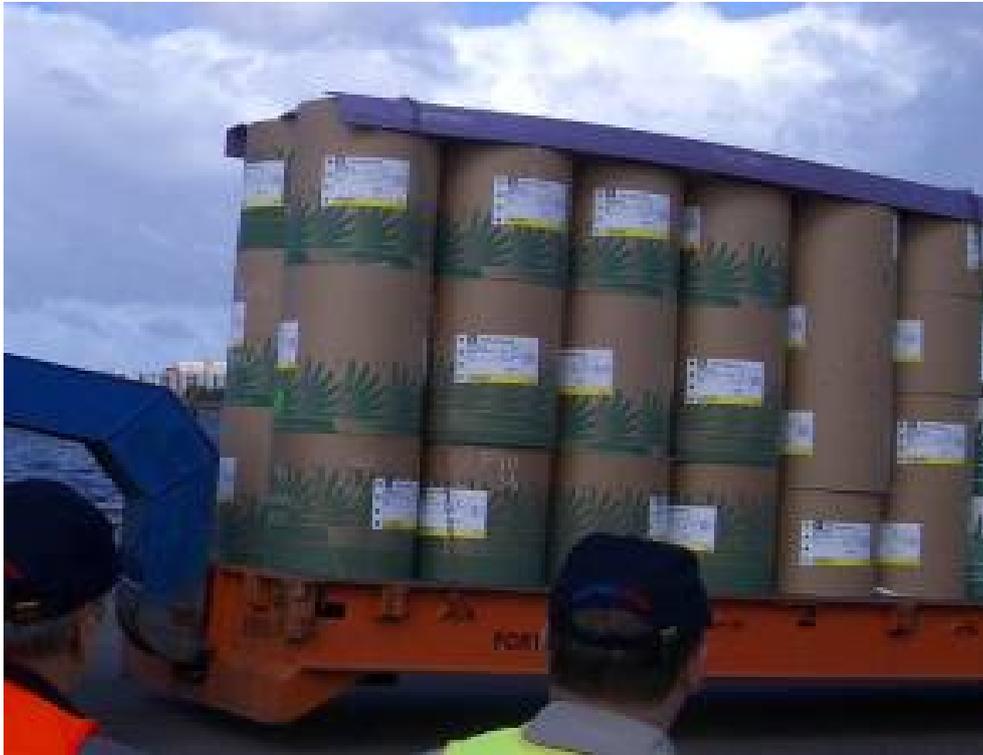
An example is shown below, from discharge of cargo from M/V Antares at Rostock in September 2004, of how two chains per long corner protection have been used in Finnlines traffic on the Baltic Sea. Large paper reels, so-called jumbo reels were also in the cargo, completely unsecured, on roll-trailers. The Master of Finnbirch has been shown the picture below and is of the opinion that this level of securing of papers reels may not have been unlikely on Finnbirch.

Fig. 8 Paper reels on a roll-trailer during discharge of cargo from M/V Antares at Rostock in September 2004. Two chains per long corner protection secure this cargo.

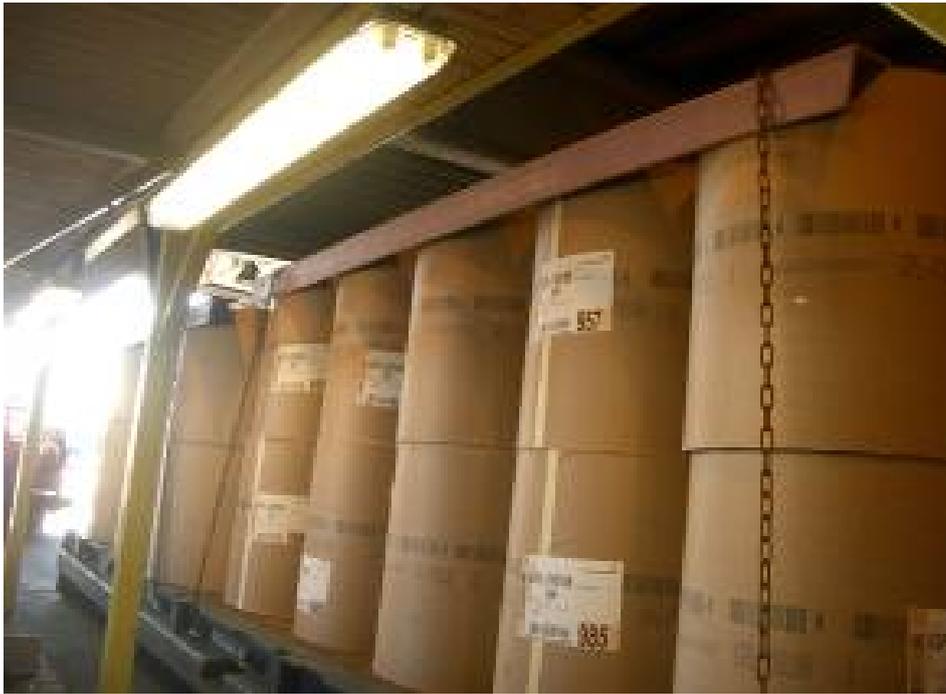
Fig. 9 Paper reels stowed on a cargo transport unit in the Helsinki terminal, a cargo section 5.25 m long secured with corner protection and two chains. Photo taken during visit by SHK in September 2007.

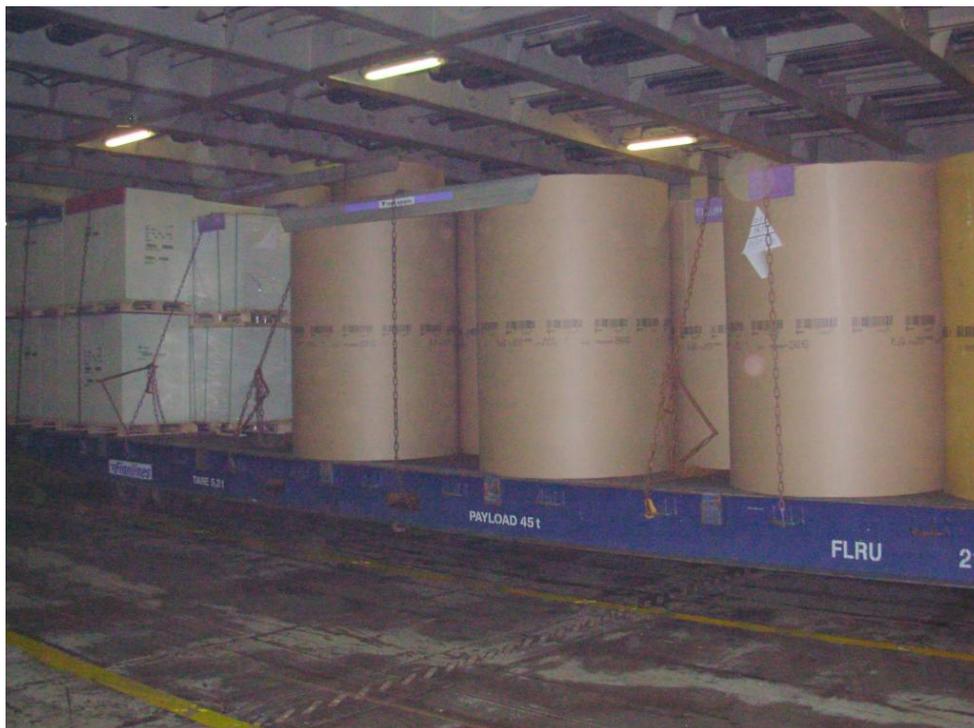
Fig. 10 Securing of large diameter reels on board the sistership Finnforest. A lashing has been placed over the midpoint of a long corner protection which holds two reels. At the left are palletted goods in the form of sheet paper. Photo taken during a visit by SHK in September 2007.

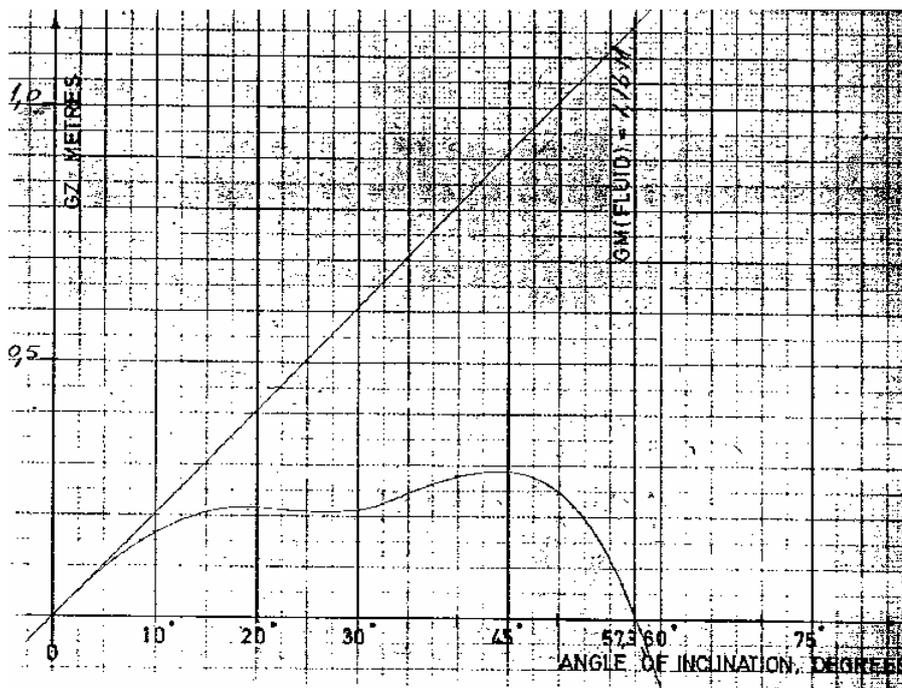
The dip in the GZ curve which appears with certain loading cases and is described above, appears clearly in the cases calculated (Fig. 34).

Fig. 34 Extract from the stability book. Lever curve for loading case 4 with a displacement of 13110 ton and $GM=1,16$ m.

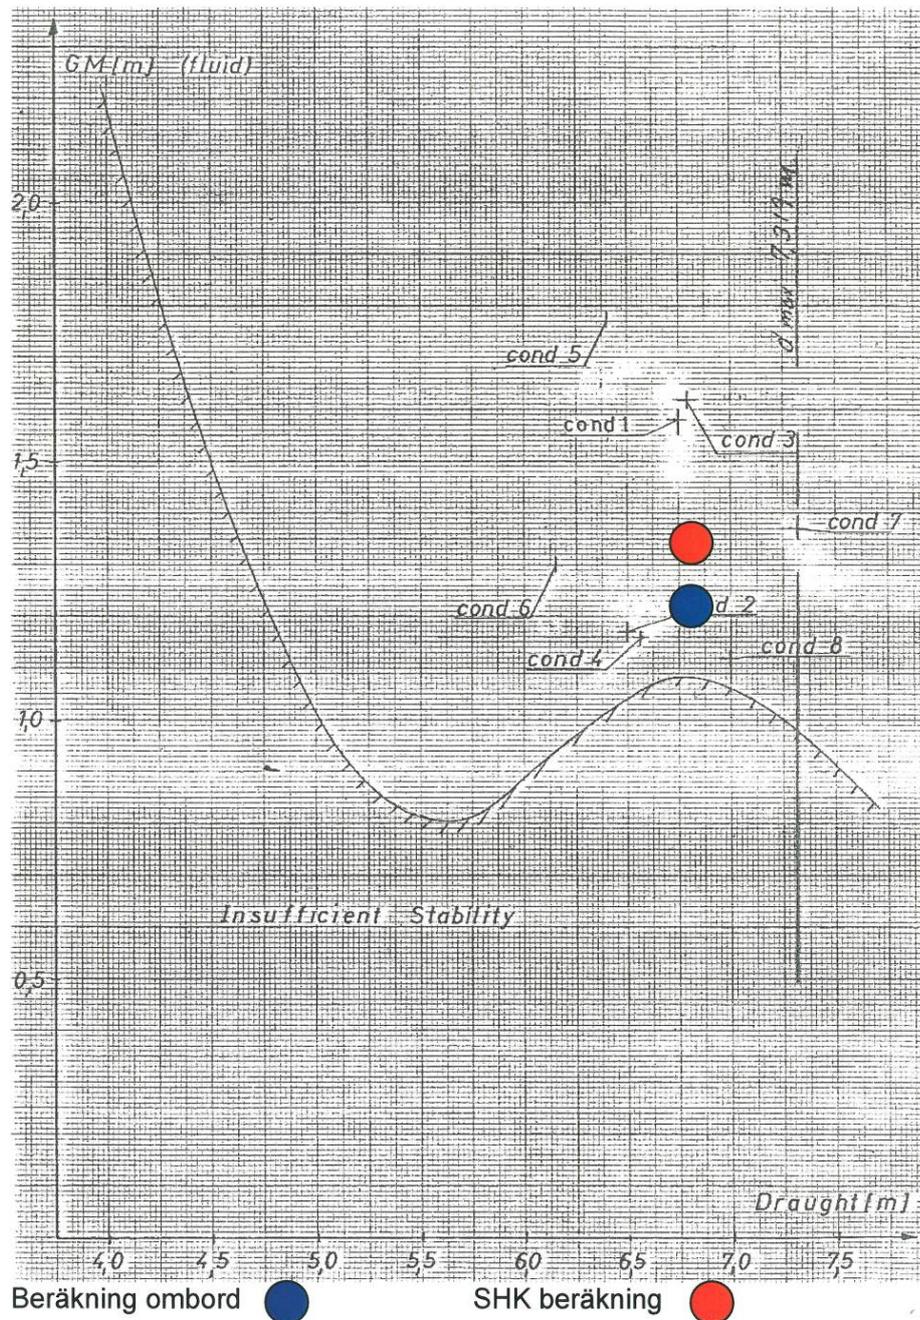
The least permissible GM and the highest permissible centre of gravity with different draughts are given in a table and a diagram in the stability book. The diagram, (Fig. 35) shows that the area around a draught between 6.5 and 7.0 m is particularly sensitive with respect to stability. This draught corresponds with the draught on departure from Helsinki and was usual for the ship.

Fig 35 The curve shows the requirement for metacentre height, GM, with different draughts. The calculated GM for the loading condition on departure are shown on the diagram. (Blue dot shows onboard calculations and red dot shows SHK calculations.)

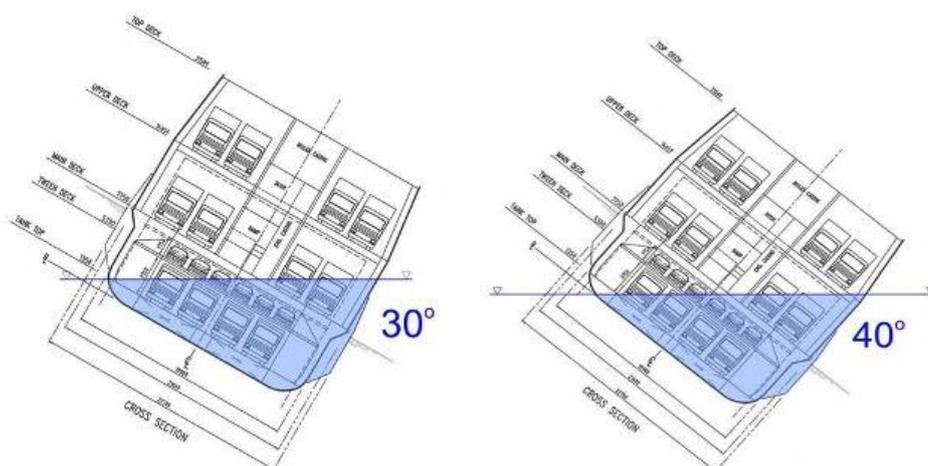
"The list of Finnbirch is within the interval port 22 ° and port 45 °. The value of the ship's list is not completely reliable as the horizon could not be used as a horizontal reference and the measurements have only been made when the ship was close to the target-angle zero degrees. No consideration has been given to the altitude of the helicopter over the surface or when the target angle has varied from zero degrees. No mean value of the list is presented as Finnbirch was pitching and rolling continuously with a periodicity of approximately 13 seconds with seas in a direction from the starboard quarter."

On the basis of the report, SHK has calculated the mean value of all the observations of the starboard list as 32.3 degrees.

Figur 37 Simplified sketches, from forward, of when the water level reached the Upper Deck with different heeling angles.

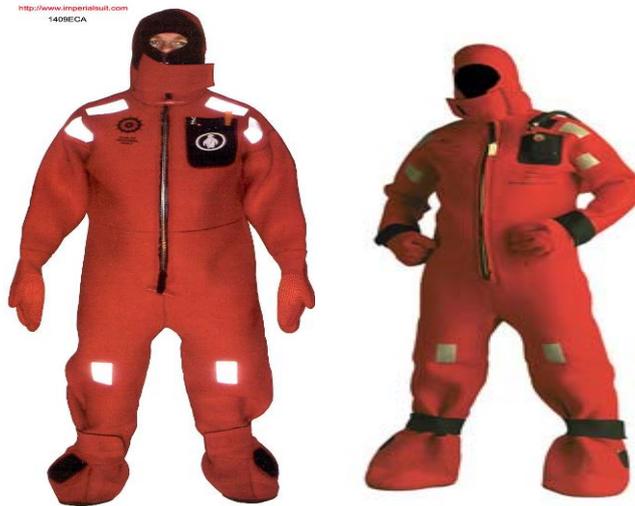
Of the fourteen suits, three have been slashed. The material of one of these has been compressed to approximately 3 mm as compared with the normal original thickness of 5 mm. It is assumed that this suit is that worn by the Chief Officer whose body was found on the wreck at 70 m depth, three weeks after the sinking.

The other suits were intact. Some contained small quantities of water which indicates some form of leakage even with closed suits. Some of the crew has reported some leakage at the level of the hood.

All suits have been polluted with oil to varying degrees indicating clearly that the survivors had been swimming in oil-covered water. The medical report states that one crewman vomited an oil-water mixture.

Fig. 39 The survival suits on board were of two types, Imperial at left and Stearn at right.

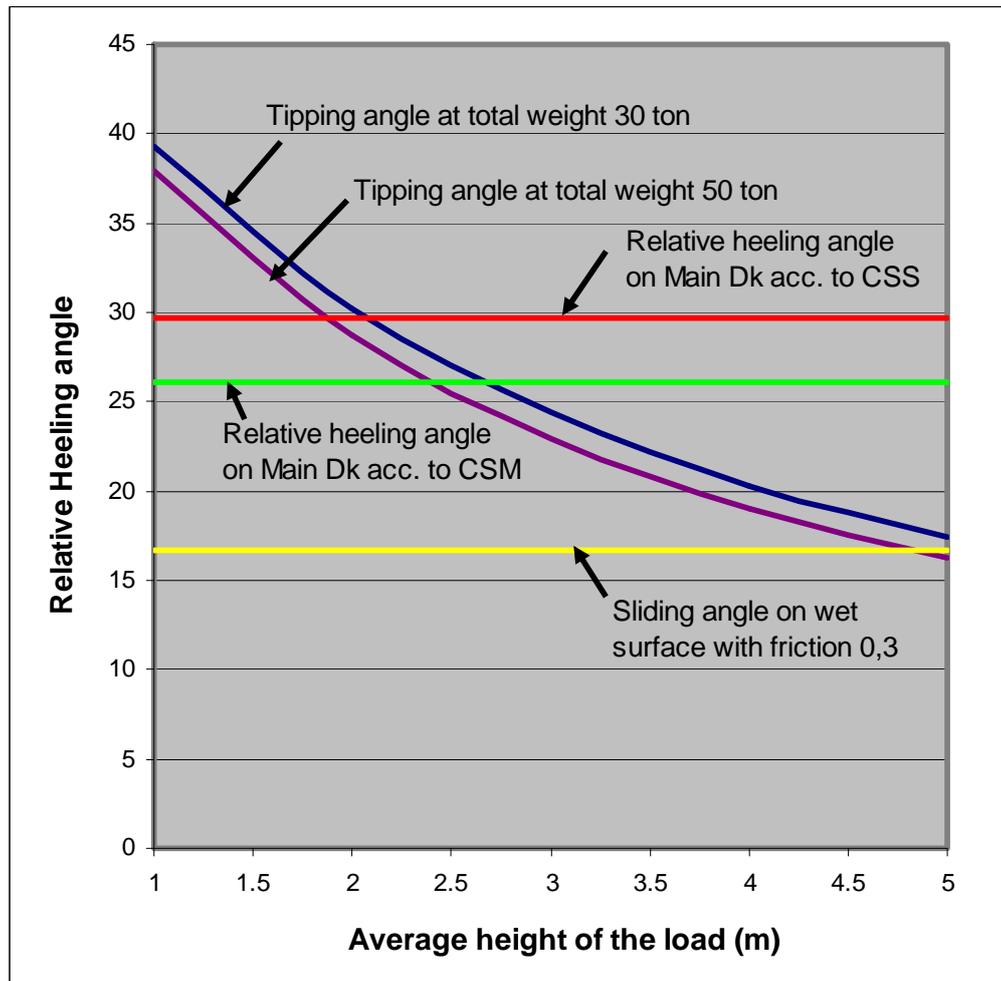
Fig. 41 Tipping angles for roll-trailers with total weight 30-50 tonnes as a function of the height of the load.

From the diagram above, it can be seen that a roll-trailer which has a total weight of 50 tonnes and is loaded to 3.5 m height without lashing to prevent tipping, will tip at a heeling angle just over 20 degrees. For these calculations, parameter values for a roll-trailer according to the below have been used. The range of the parameter values for Finnlines 40 ft roll-trailers are given in brackets.

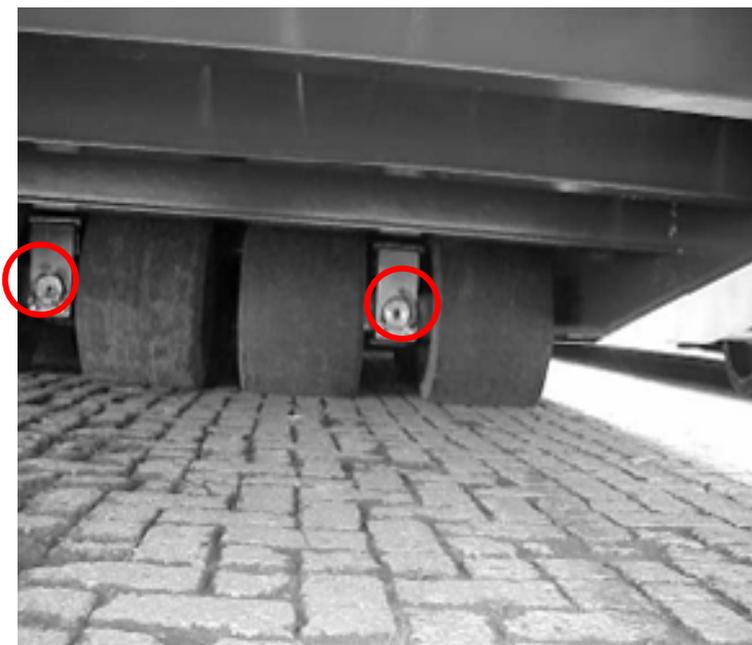
That roll-trailers are sensitive to tripping depends primarily on the main part of the load being carried by the boggie and that this has a relatively small support width.

At the boggie end, the roll-trailer tips around the support points of the boggie package. The transverse distance between these is approximately 1.35 - 1.45 m which should be compared with the total width of the trailer, approximately 2.5 m.

Fig. 42 Tipping points at the boggie end of a normal 40 ft. roll-trailer.

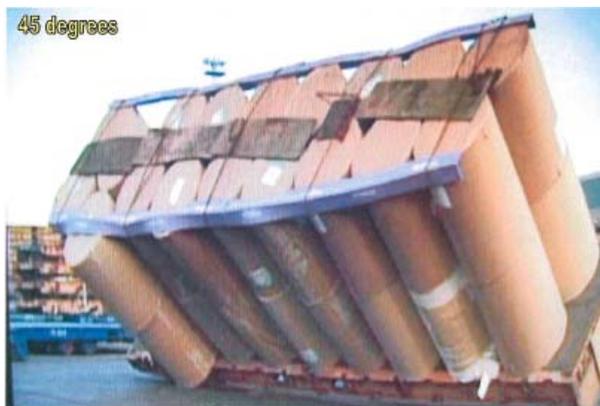
In certain heeling tests performed in 1987, the load tipped and slid from the roll-trailer before the trailer itself tipped. During tests performed in November 2007, the load remained on the roll-trailer until the heeling angle had reached approximately 45 degrees as shown by the photo below.

Fig. 44 Heeling test, Finnlines, October 2007.

The documentation from the tests in 2007 relate only to arrangements with three lashings per corner protection. Tests were not performed with two lashings per corner protection as permitted by Finnlines' guidelines for transport on the Baltic. Finnlines' report that heeling tests were performed later with two chains per corner protection and that the cargo slid off the cargo transport unit with a 30 degree static heeling angle. SHK has not studied these later tests nor the circumstances under which they were performed.

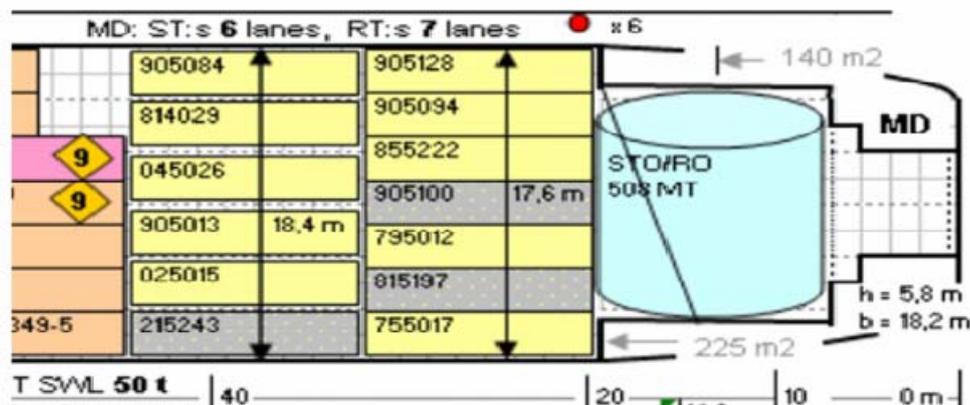
Fig. 45 Extract from cargo plan for the final voyage of Finnbirch showing the cargo units at the forward end of the Main Deck.

The static tipping angle has been calculated for a number of the roll-trailers stowed forward on the Main Deck. The parameter values from Finnlines for the different roll-trailers have been used in the calculations. Calculations have been performed for stowing patterns in which the entire area of the platform of the roll-trailer have been used and for patterns in which a margin of some centimetres has remained free. The following tipping angles were obtained for the roll-trailers stowed forward on the Main Deck.

The second row of roll-trailers from the front contained a number of units loaded with approximately 90 m³ of board with a loading height approximately 3 m. The total weight of these units was 40-45 tonnes. These units have also tipped with a theoretical heeling angle of 20-25 degrees.

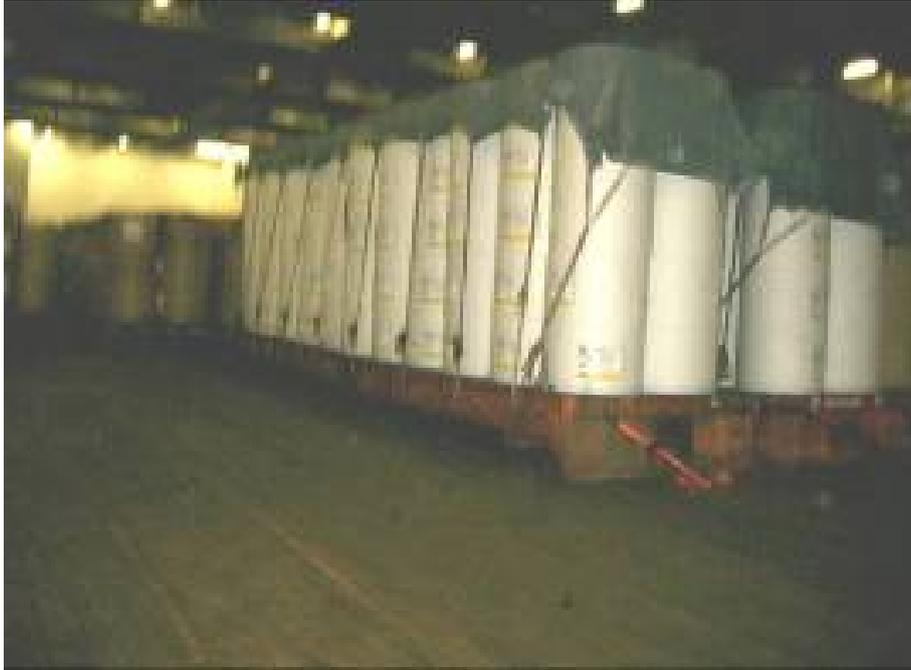
Fig. 46 Roll-trailers stowed on the Main Deck on board Finnforest. The load is secured with WisaFix hoods.

Each of the two roll-trailers was loaded with 110 reels in two lines of 11 sections i.e. a total of 22 stacks with 5 reels in each stack. The reels had a diameter of 999 mm and a width (height) of 660 mm. Each reel weighed approximately 460 kg.

The calculations below show that the reel stacks began to tip at a heeling angle of approximately 17.5 degrees with tension force S_{TF} 0.1 ton and immediately the entire load tipped because of the elasticity of the straps and hood. In the calculations it has been assumed that the internal friction between the reel stacks is 0.25. If the tension in the straps had been approximately 0.5 tonne, the tipping would have instead begun at approximately 20 degrees relative heeling angle. Finnlines has reported that there were no units secured with WisaFix hoods on board Finnbirch on its final voyage.

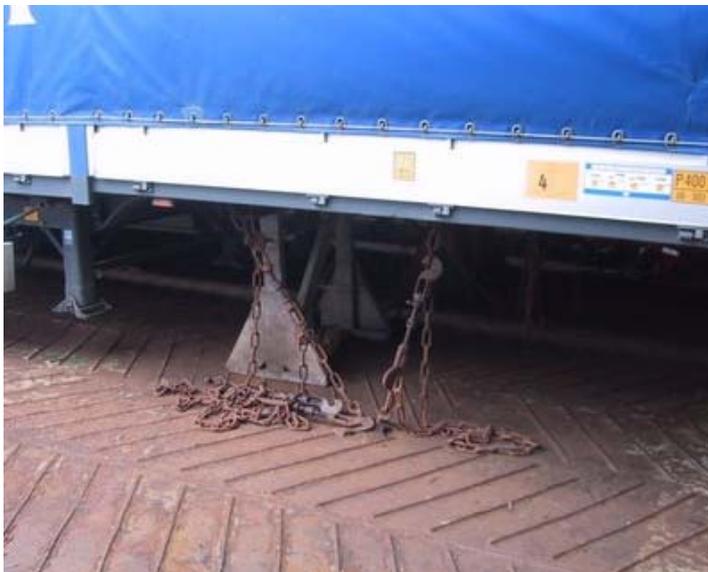
Fig. 49 Arrangement in which the longitudinal lashing angle is small.

In consideration of the situation in the above photo from the cargo-securing on board Finnforest, it is seen that the angle between the longitudinal axis of the ship and the lashings may be small in some cases. Calculations have therefore been performed with longitudinal angles of both 30 and 15 degrees.

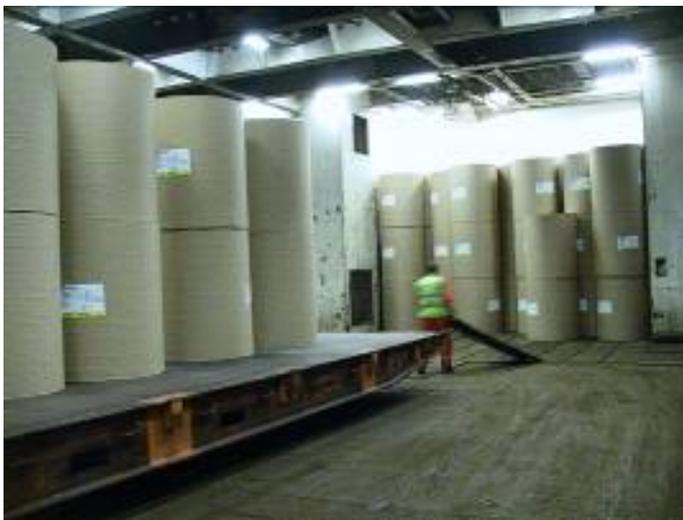
Fig. 51 Sto-ro cargo on board Finnforest in December 2007.

The photo above from sto-ro loading on board Finnforest shows the reels crotch stowed. Alternate reels then project out from the remainder. It is possible that these might tip sideways with any considerable rolling. If the outermost row has tipped, the following row might well follow.

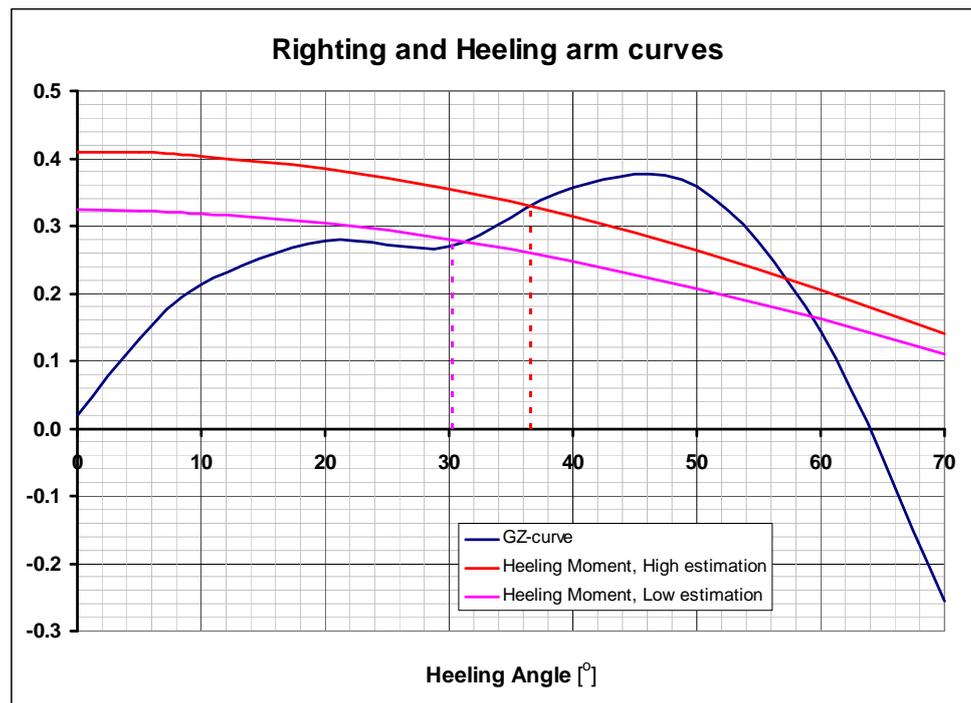
With a heeling moment according to the preceding section and a shifting and a righting arm curve according to the stability calculations in Appendix 2, a static list of 30-37 degrees is obtained.

Fig. 52 The list is read on the x-axis as a function of the heeling moment where this intersects the GZ curve

This list is close to the values which, based on video-films from the helicopters were calculated by the Swedish Defence Forces Intelligence and Security Centre.

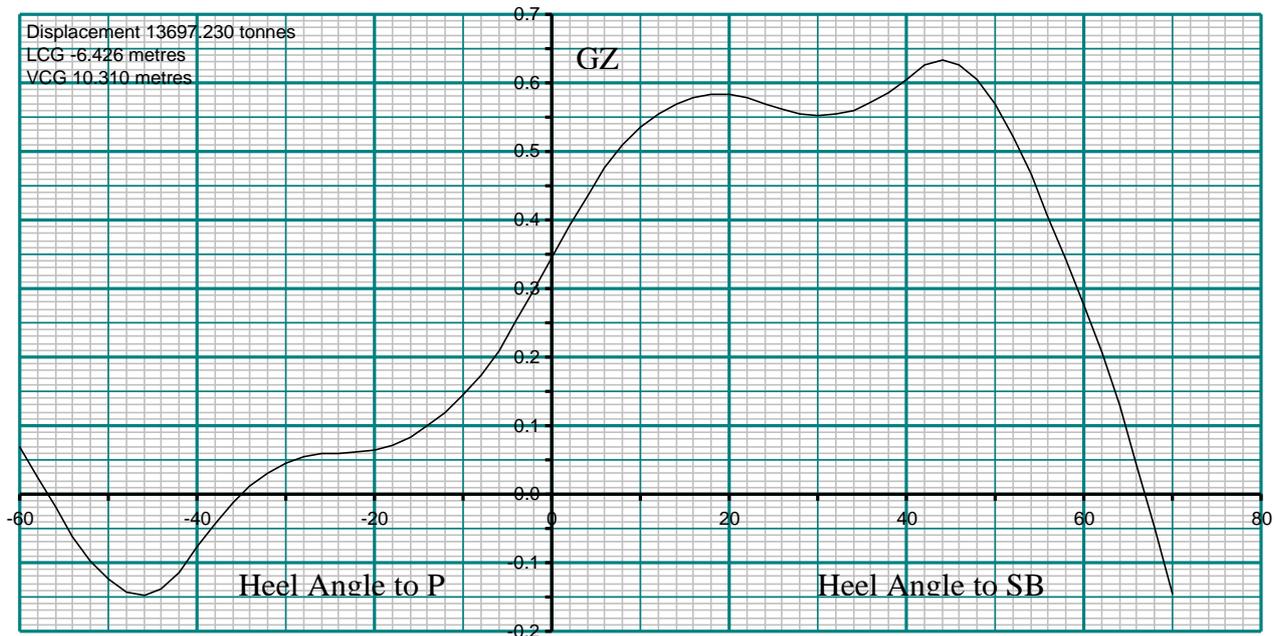
GZ-curve with cargo displacement.

Equilibrium ($GZ=0$) is obtained at -35 degrees (permanent heeling to port). In this position the lever GZ is increasing with increasing heeling angle (to starboard).

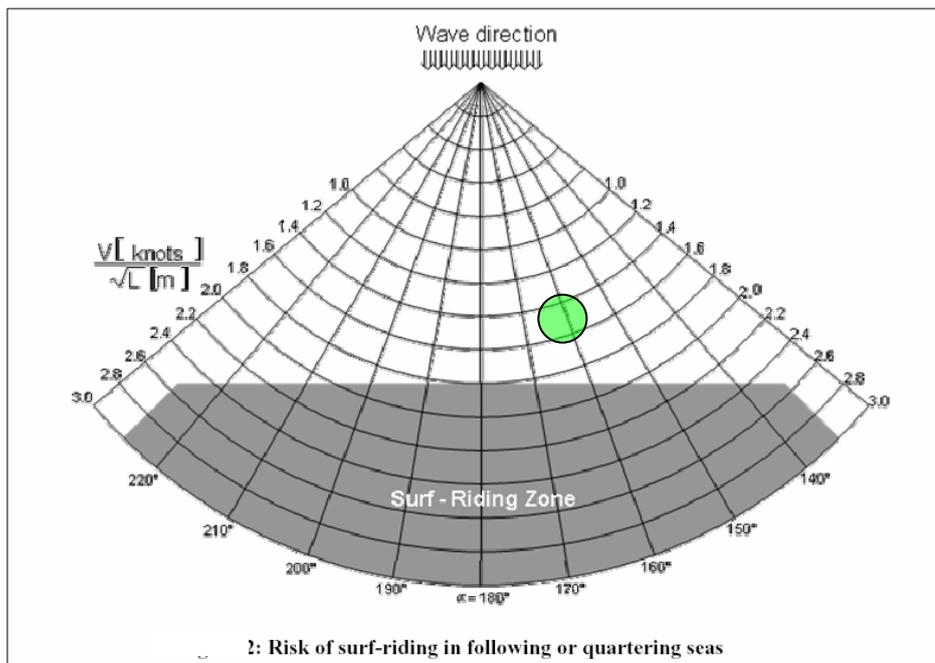
Table 2: Table and below figure shows the criteria for surfing and broaching to. The criteria are not satisfied.

Figure 3: Criteria for surfing and broaching to. The criteria are not satisfied.

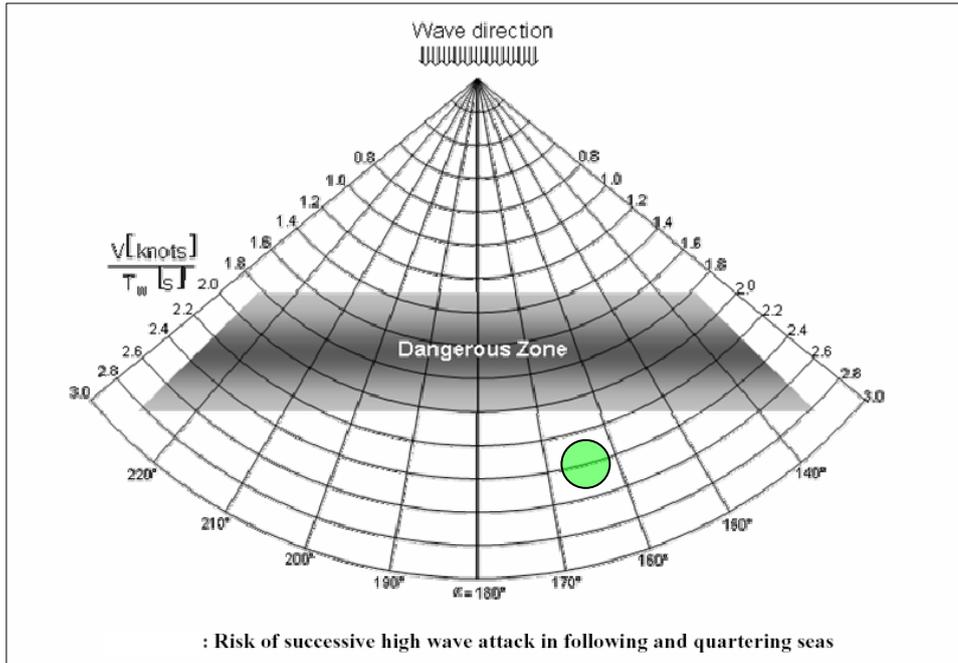
Criteria		Danger?
Average wave length > 0,8 L	Actual about $80/137=0,58 L$	No
Average wave height > 0,04 L	Actual about $4/137=0,03 L$	No
Figure 4	Actual $V/T_w = 2,4$	No

Figure 4: Criteria for successive high-wave attack. The criteria are not satisfied.
