Aviation Accident at Selänpää Aerodrome on July 16, 2023

L2023-02

SYNOPSIS

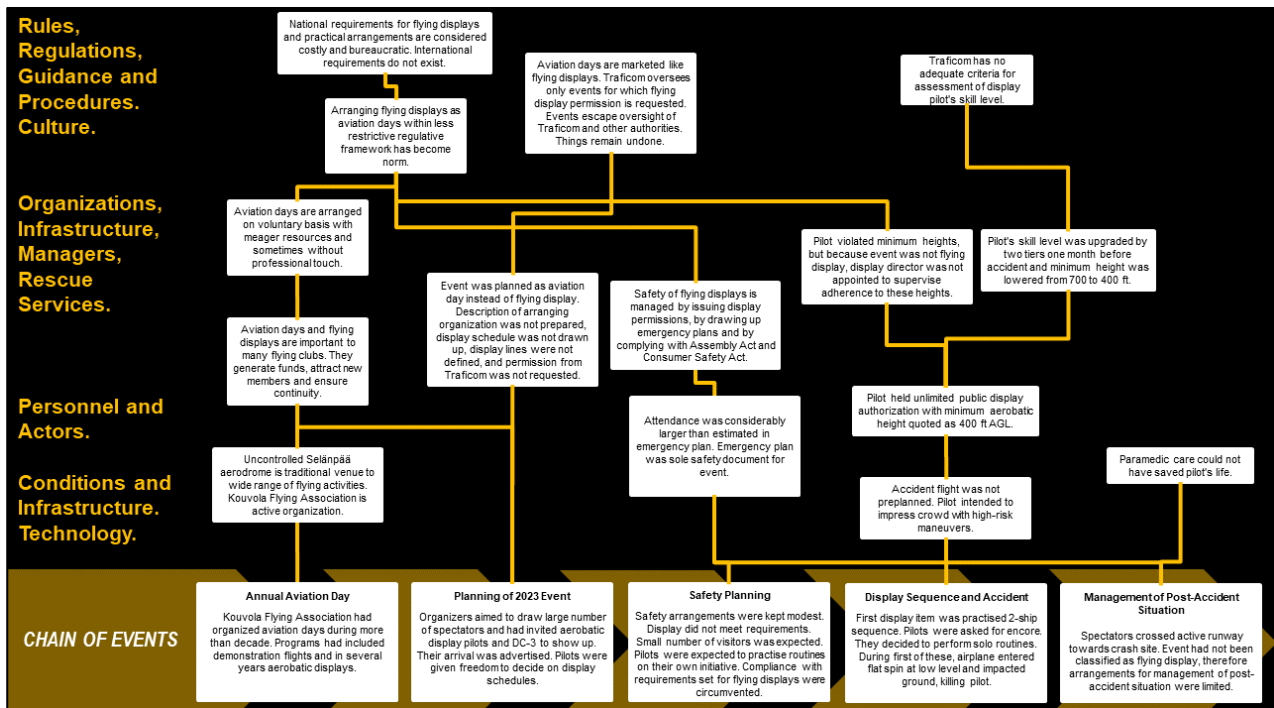
A SIAF-developed format of the AcciMap approach²¹ was used to support the analysis of the occurrence. The following text is arranged in accordance with an AcciMap diagram created during the investigation and shown below. The occurrence is depicted as a chain of events along the bottom of the diagram. Contributing factors at various levels can be examined by moving up and down the diagram.

Figure 3. AcciMap diagram, investigation L2023-02. (Figure: SIAF)
