Serious Incident on Norwegian Flight on August 11, 2024

L2024-01

SYNOPSIS

Investigation designator: L2024-01
Investigation report 5/2025
ISBN: 978-951-836-682-2 (PDF)
ISSN: 2341-5991

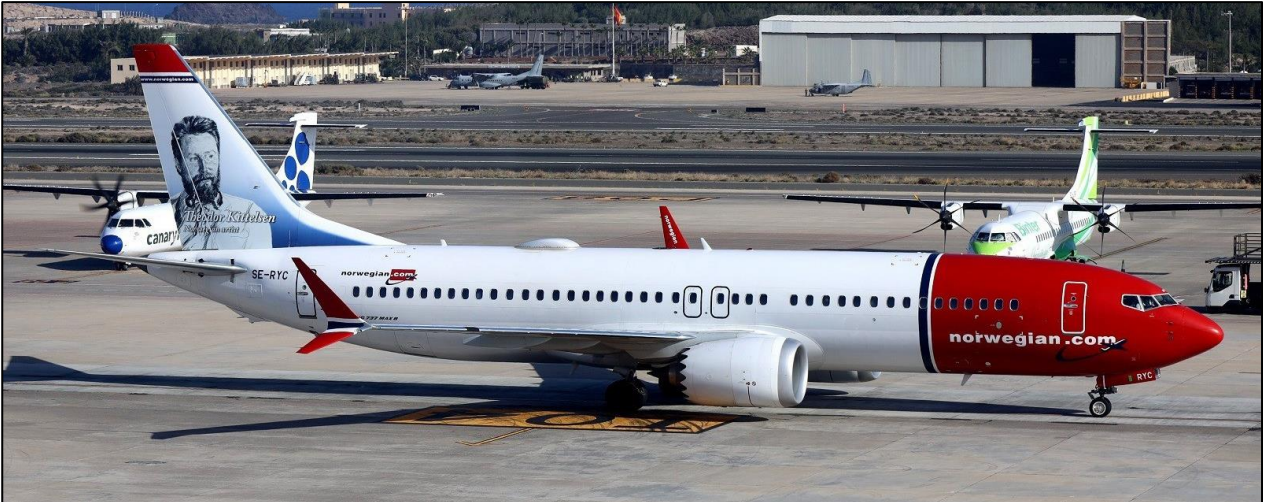
Figure 3. Occurrence airplane was Boeing 737-MAX 8, registered SE-RYC. (Photo: Norwegian)

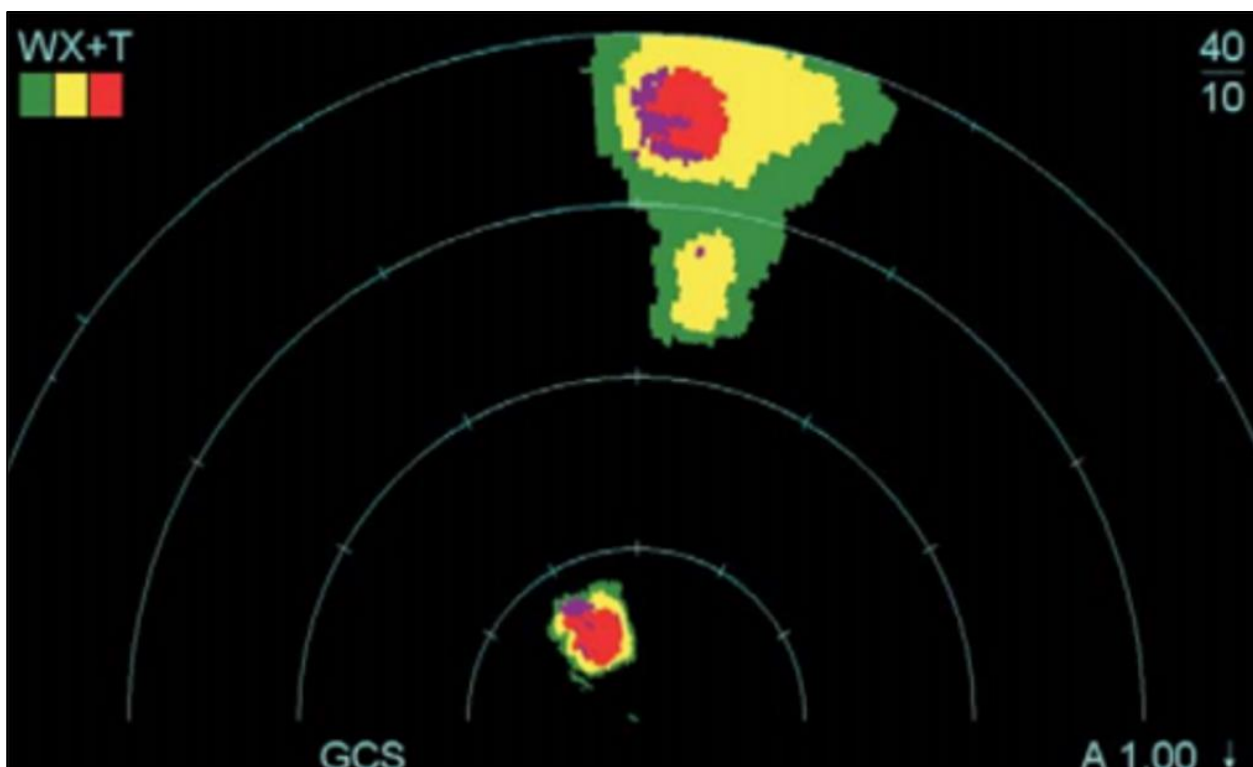
In MAP mode, the radar shows terrain features and weather, and no turbulence information is displayed. The display uses a standard set of colors, each of which represents a specific level of reflectivity. Generally speaking, black represents dry air mass. Green represents normal, static cloud that does not affect the conduct of the flight. Yellow represents a denser or developing cloud with rain potential, among other meteorological phenomena. A small red area bordered in yellow represents high cloud density. The cloud may contain water droplets in a liquid form or various solid forms. High cloud density is also a common indication of vertical air currents and possible electrical charge, which may appear as lightning. Magenta represents a turbulent area.

At least low reflectivity level will be needed for turbulence detection. The radar cannot detect clear air turbulence (CAT)¹⁴.

Figure 4. Weather radar display. (Photo: Norwegian)

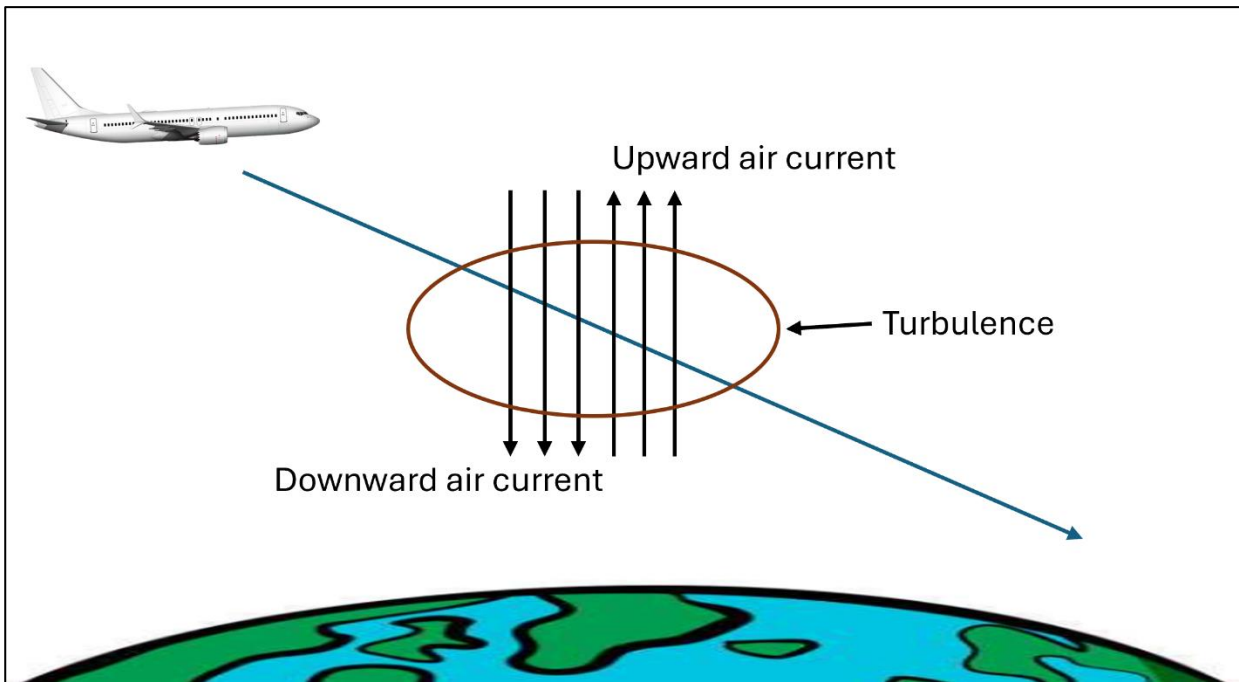
Figure 8. Air flow change between updrafts and downdrafts. (Figure: SIAF)

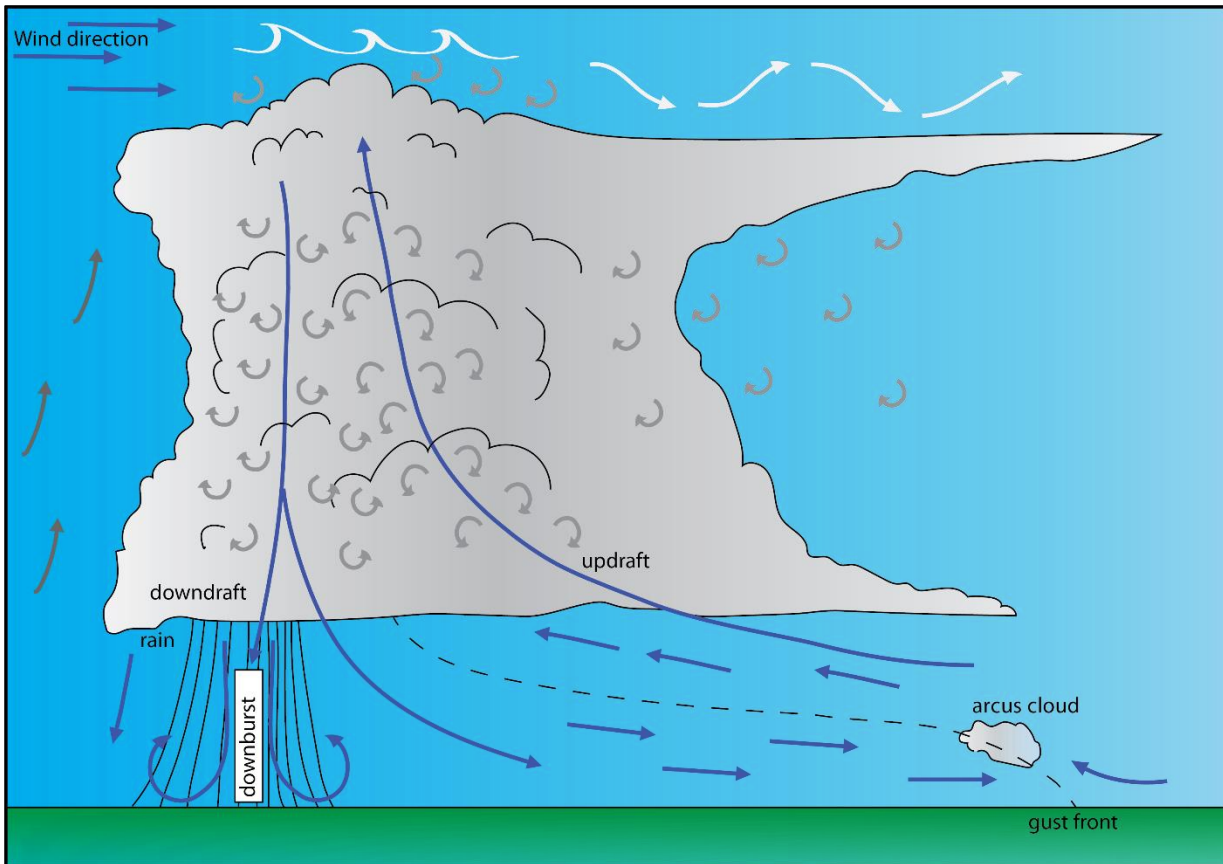
Figure 9 shows the structure of a typical thunderstorm. Blue and dark gray arrows indicate updrafts and downdrafts that occur within and in the vicinity of the cloud, while light gray

arrows represent turbulent air flow inside and above the cloud. White waves and arrows above the cloud top indicate wavy air currents.

Figure 9. Structure of thunderstorm. (Figure: Finnish Meteorological Institute)

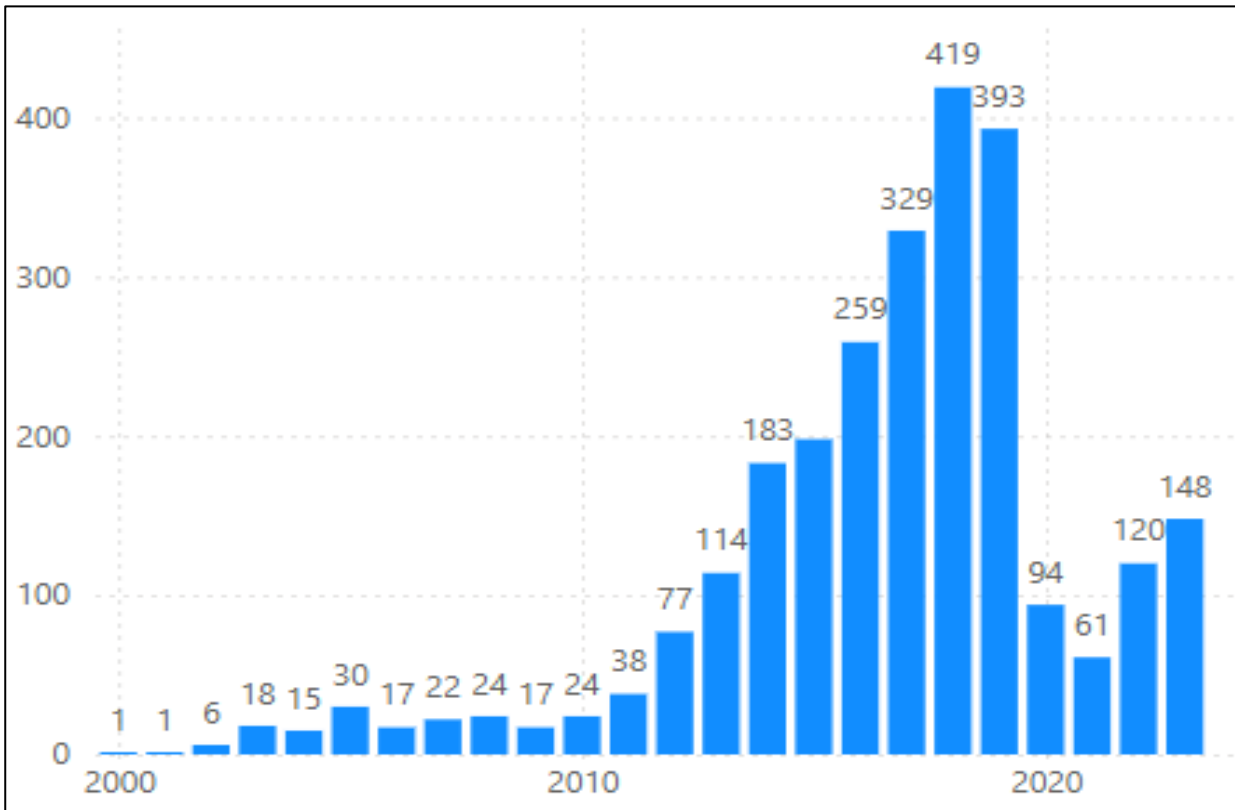
The investigation team retrieved data on turbulence-related injuries that have occurred in Europe since the early 2000s from ECCAIRS²⁹ database. The total number of injuries was 2,700 (figure 11), but only 200 of the reported events had occurred in 2000–2009, when the number remained fairly constant at approximately 20 events per year. The period of 2010–

2019 showed a clear upward trend, which peaked in 2018 when over 400 events were reported. A total of 2,000 events were reported in 2010–2019. From the early 2020s onward, the data reflects the slump in commercial air traffic due to Covid-19, when the number of events dropped dramatically. However, the annual number of reports is again in a marked increase. The number of reports may also be affected by changes in the reporting culture, because the reporting threshold has lowered, and even minor injuries are reported. Finally, it appears that climate change and resulting increased prevalence of extreme weather may have a bearing on the number of turbulence-related occurrences.

Figure 11. Turbulence-related injuries in Europe in 2000–2023. (Figure: SIAF)
