## Hostel fire leading to three fatalities in Äkäslompolo, Kolari on 13 February 2024

Y2024-01

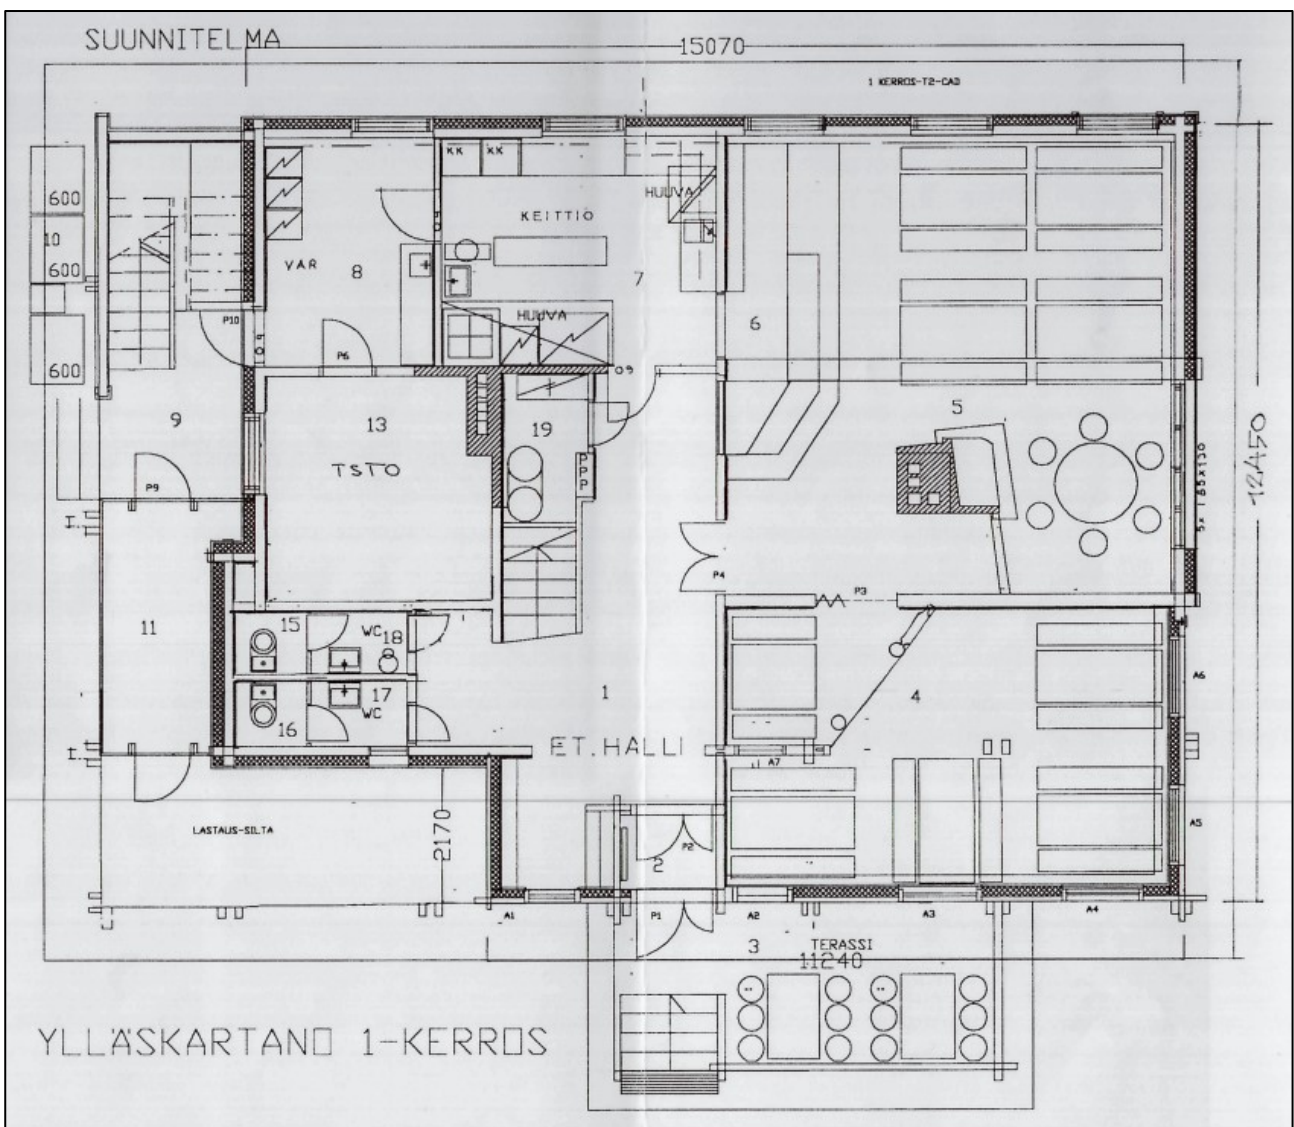
**Figure 4.** Ground floor of the main building. At the time of the accident, room 4 was used to accommodate guests. (Image: Kolari building control services)

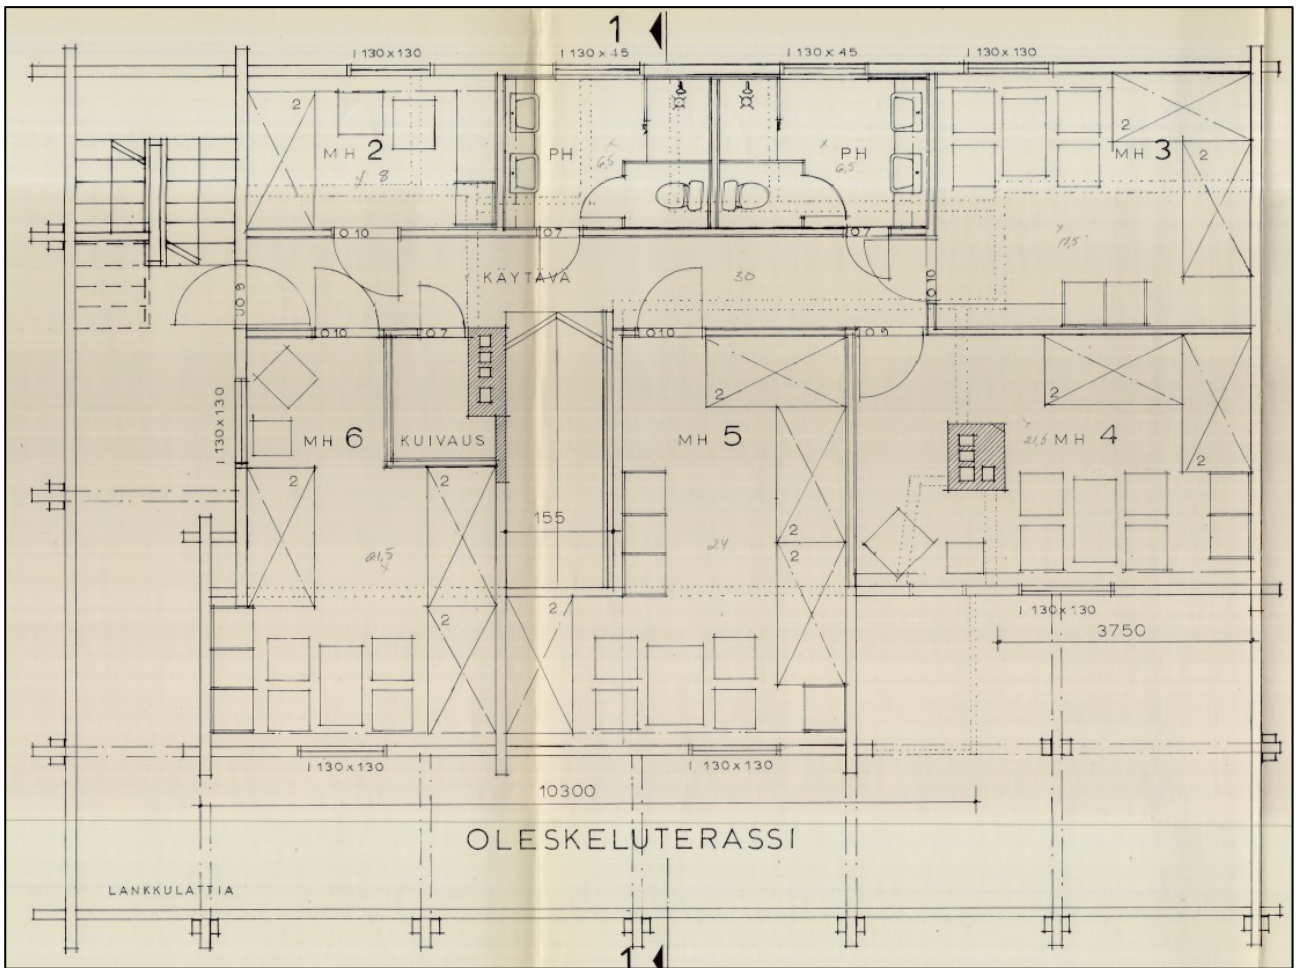
**In October 1974**, the Building Committee of Kolari municipality issued a permit for a building whose purpose of use now was accommodation establishment. According to the permit drawings, the entrance was on the southeast side, and access to the first floor was along a staircase from the lobby. In addition to shared facilities, there was one accommodation room on the ground floor of the building. The first floor contained five accommodation rooms, toilets and showers. All rooms were accessed from inside the building. In the building designs, the floor area was approximately 250 m<sup>2</sup> and there were 24 beds. The building had a deck/balcony on the northwest and southwest sides on both floors. The balcony on the first floor was reached by stairs located at the northwest end.

**Figure 7.** First floor in drawings of the building permit issued in 1974. (Image: Kolari building control services)
