Investigation report

B 3/2000 M

M/T CRYSTAL RUBINO, environmental accident during loading, Port of Hamina, July 20, 2000

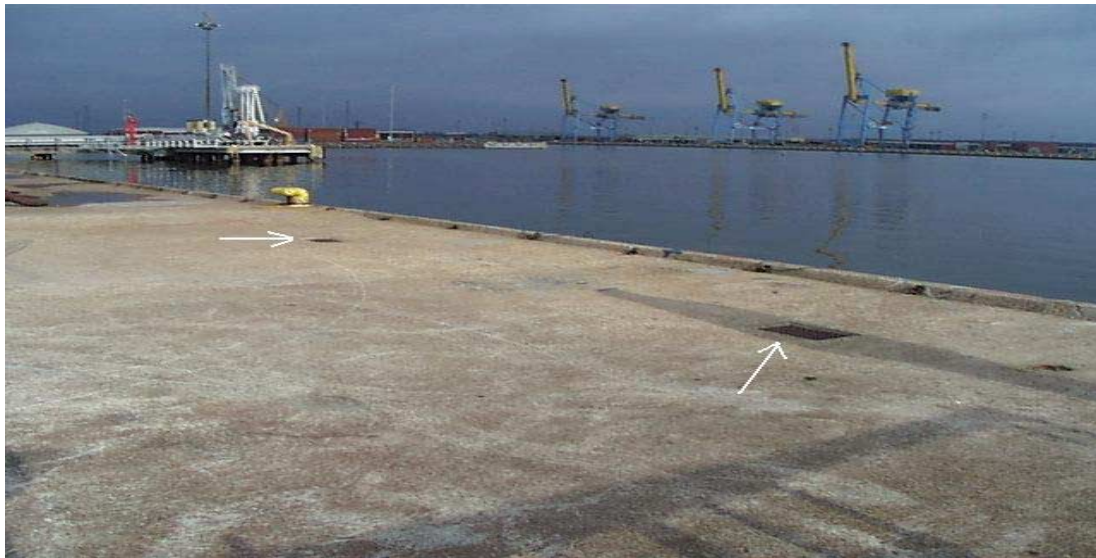
Figure 4 South end of Pier 2

There are three drains in the cargo-handling area on Pier 2 (under the arms). The drains conduct rain water and other possible products into a rain well which has an automatic draining system (float pump). Any liquids which might leak from the hose joints will be further conducted into an underground tank. There are two drains at each end of the pier behind the platform outside of the cargo handling area. These drains lead directly into the sea. During the overload of the vessel spilled cargo drained directly into the sea from these two drains.

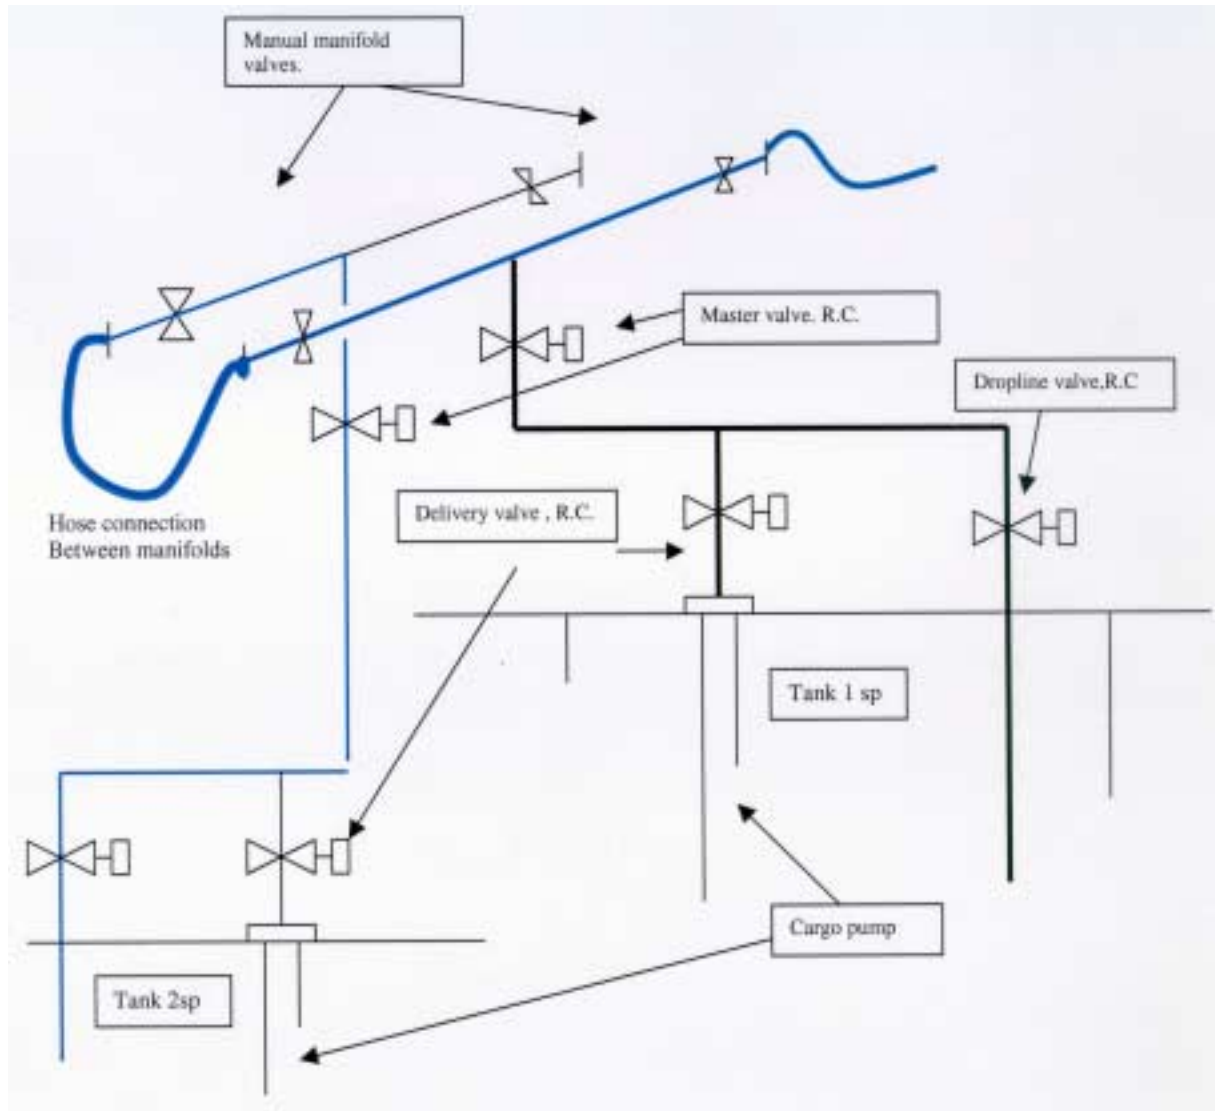
Figure 9 Loading pipeline of the CRYSTAL RUBINO, blue pipeline shows the route of the cargo to tank 2S.

Inspections of the cargo handling equipment were duly performed after 20 July 2000. There was no loading or cargo handling plan found on the vessel for the loading in Hamina on 20 July 2000. A loading plan has indeed been made since 21 July 2000 but there was no evidence of the existence of cargo handling plans. Cargo tank 1P has a capacity of 287,923 m³ at 100% with the surface gauge showing a 41 cm shortage. The upper limit alarm of 96% will sound at 84 cm ullage (shortage) when there is 275,426 m³ of cargo in the tank (at a trim of 0.9 m to stern). The upper limit alarm of 98% will sound at 70 cm ullage (shortage) when there is 281,507 m³ of cargo in the tank (at a trim of 0.9 m to stern). After the 96% alarm, 12,497 m³ of cargo flowed into the tank until it began to overflow through the 'wash hatch', which is to the left (P) of the actual tank hatch. The

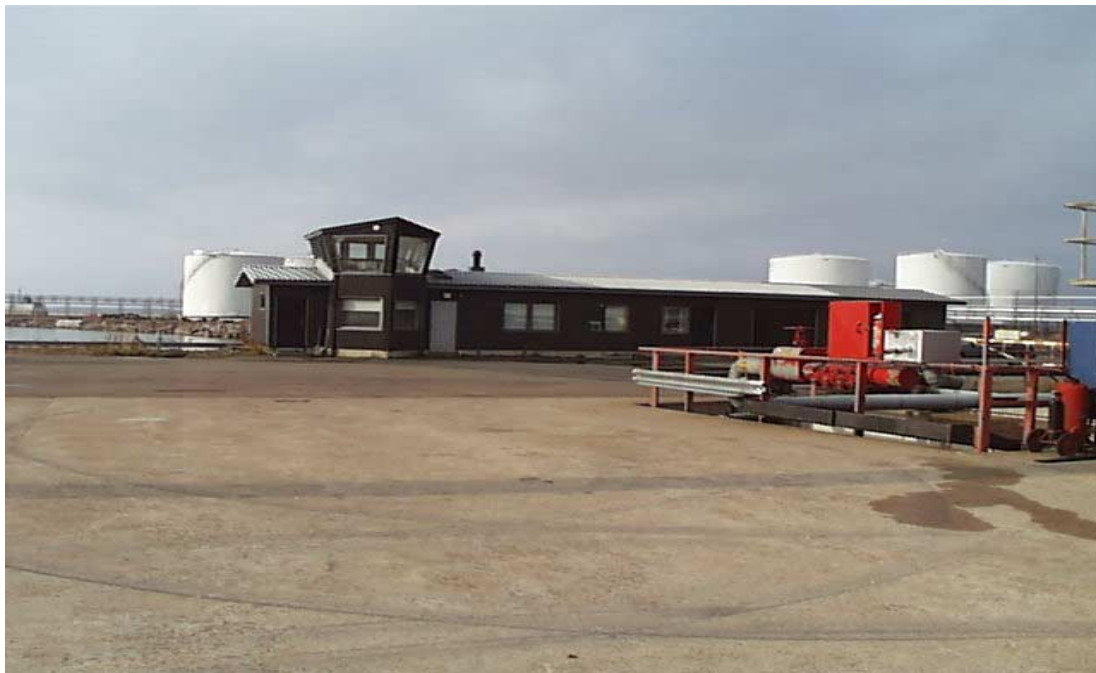
Figure 12 Control room of the representative of the terminal supervising the loading on the second floor. The room below is for the port supervisor. The pier is equipped with oil prevention gear (oil barriers and boat), not in the picture.

The pier watch is not always on the pier but he may also be in the pier house. The control room is on the second floor. If shouting is agreed as the method of communication, it cannot be heard in the control room. The control room offers limited visibility of the ship because the pipelines obstruct the view. In the control room there are emergency stops for the loading pumps of Transkem Oy, Kaukomarkkinat Oy and Suomen Petrooli Oy. However, the pipeline valves can be shut manually on the pier.

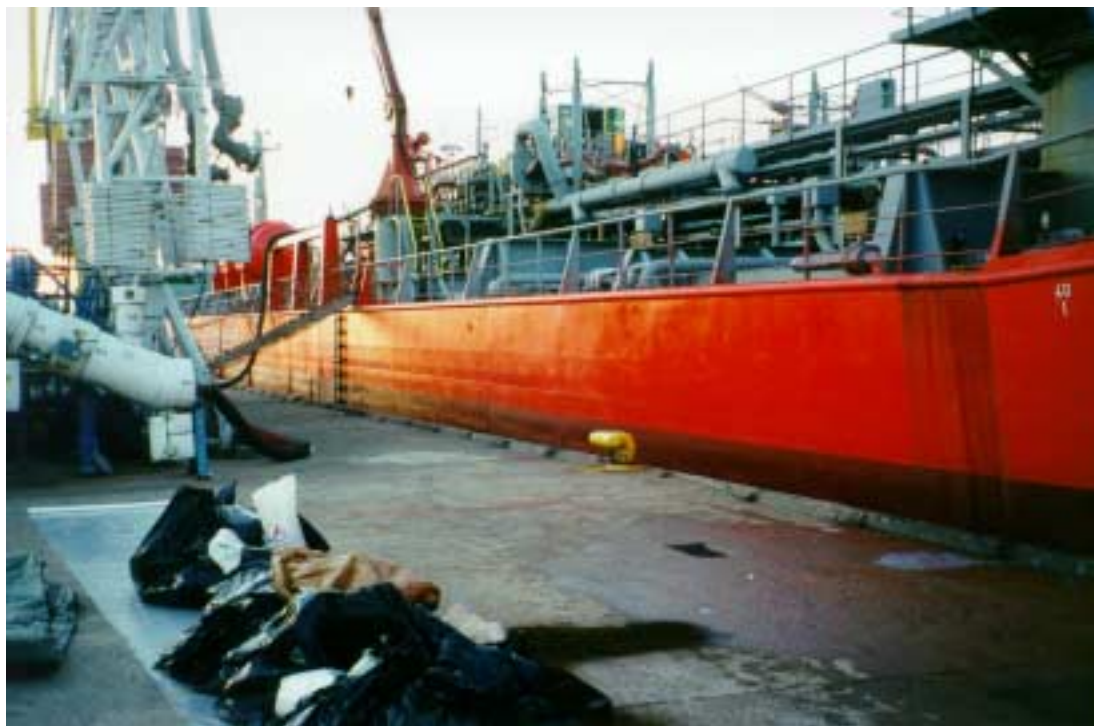
investigation. The Harbour Master sent a representative to the scene. The navigation inspector was present and the Accident Investigation Centre's representative arrived later. Representatives of the ship and the cargo owners were present. Several different participants were present on Pier 2 and on the CRYSTAL RUBINO, each carrying out their own duties. Nobody was in overall charge of the activity. It has been suggested to the investigators that similar situations should be jointly reviewed by the authorities. The first steps regarding this issue have been taken in the South Kymenlaakso area.

Figure 15 Situation on the pier about 4 hours after the accident
