Investigation report

C 1/2000 M

ms OCEAN PRIDE, grounding at Orregrund, March 6, 2000

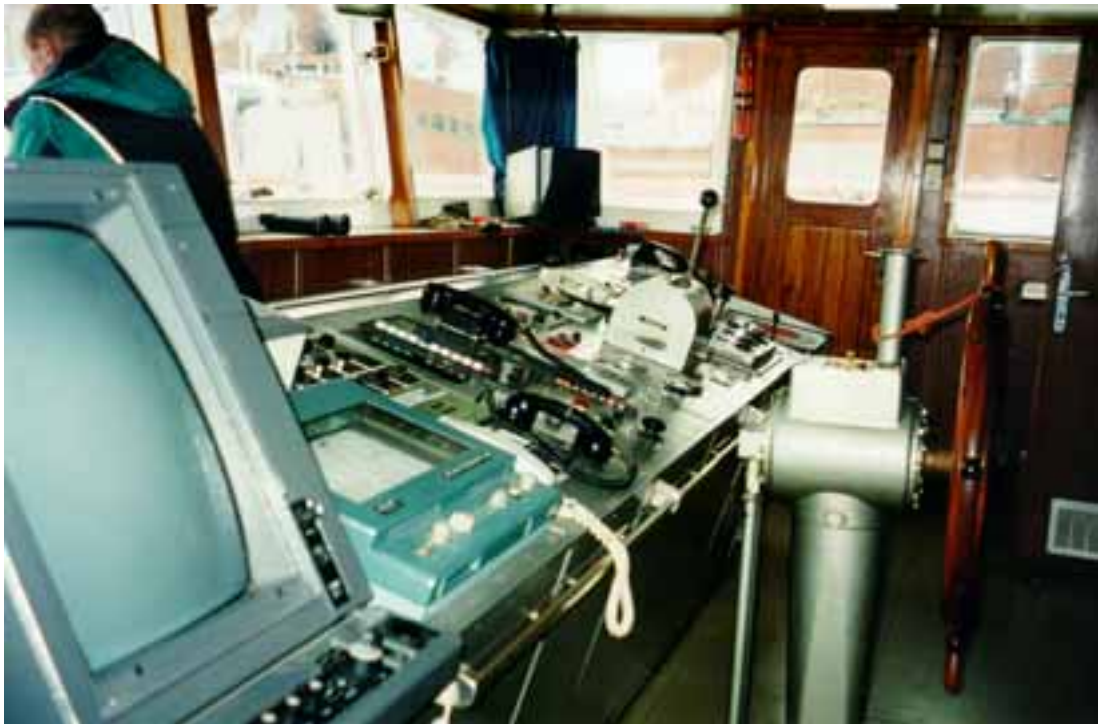
Figure 2. Bridge of the OCEAN PRIDE.

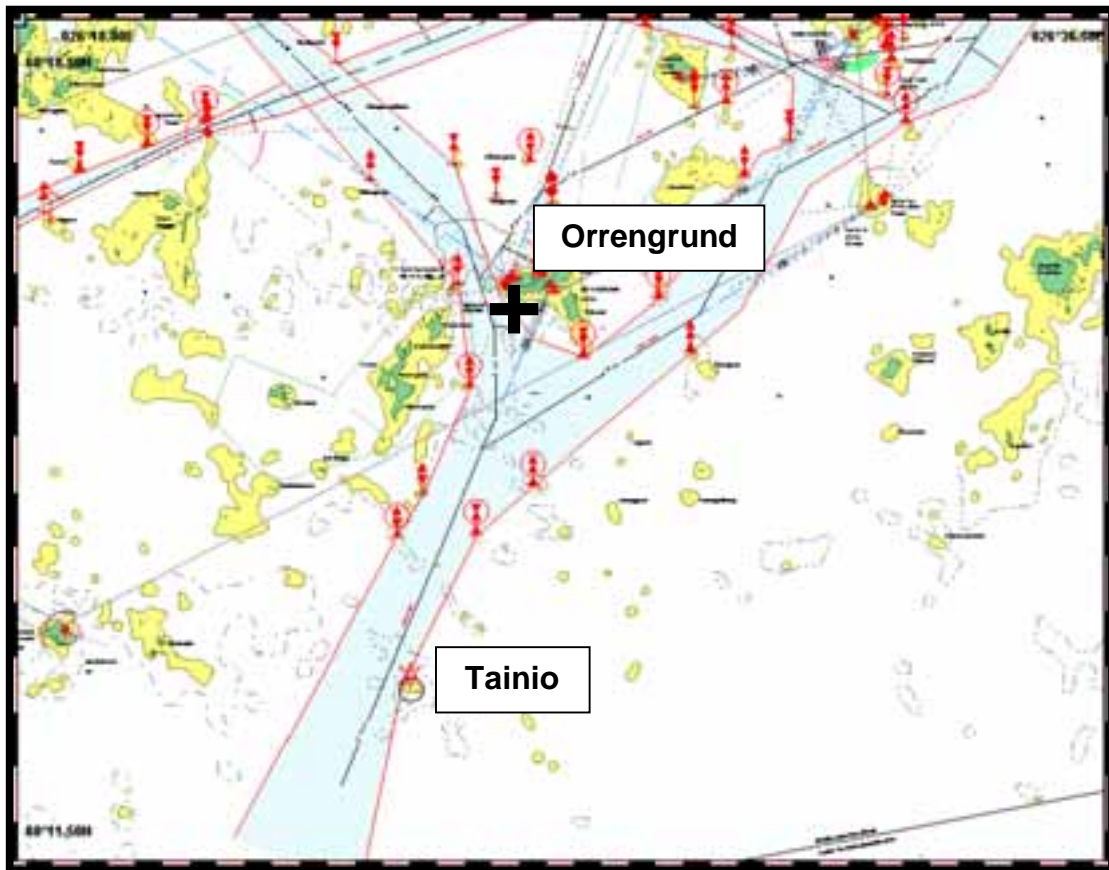
Figure 3. Location of grounding of the OCEAN PRIDE on the shore of Orregrund (marked with X). (The vessel was approaching Orregrund from the south on the 10-metre fairway past the Tainio light house).

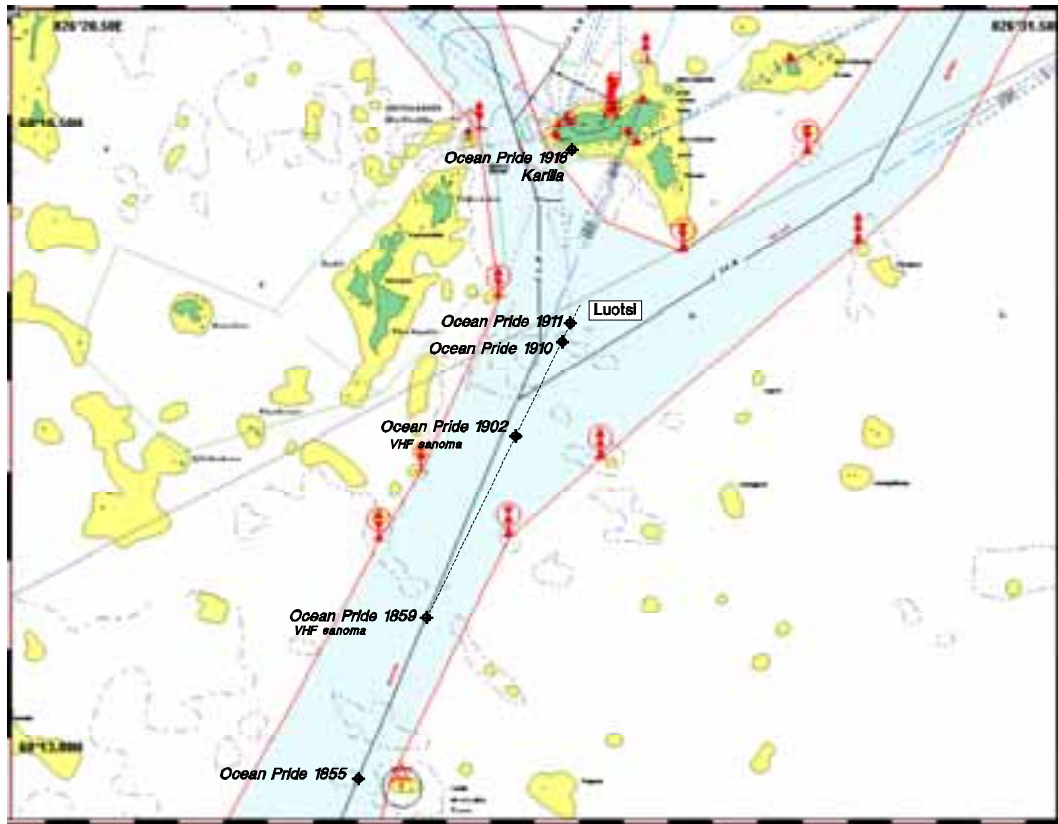
At 18:59 (Figure 5)

Figure 5. Position of the OCEAN PRIDE based on VTS registration.

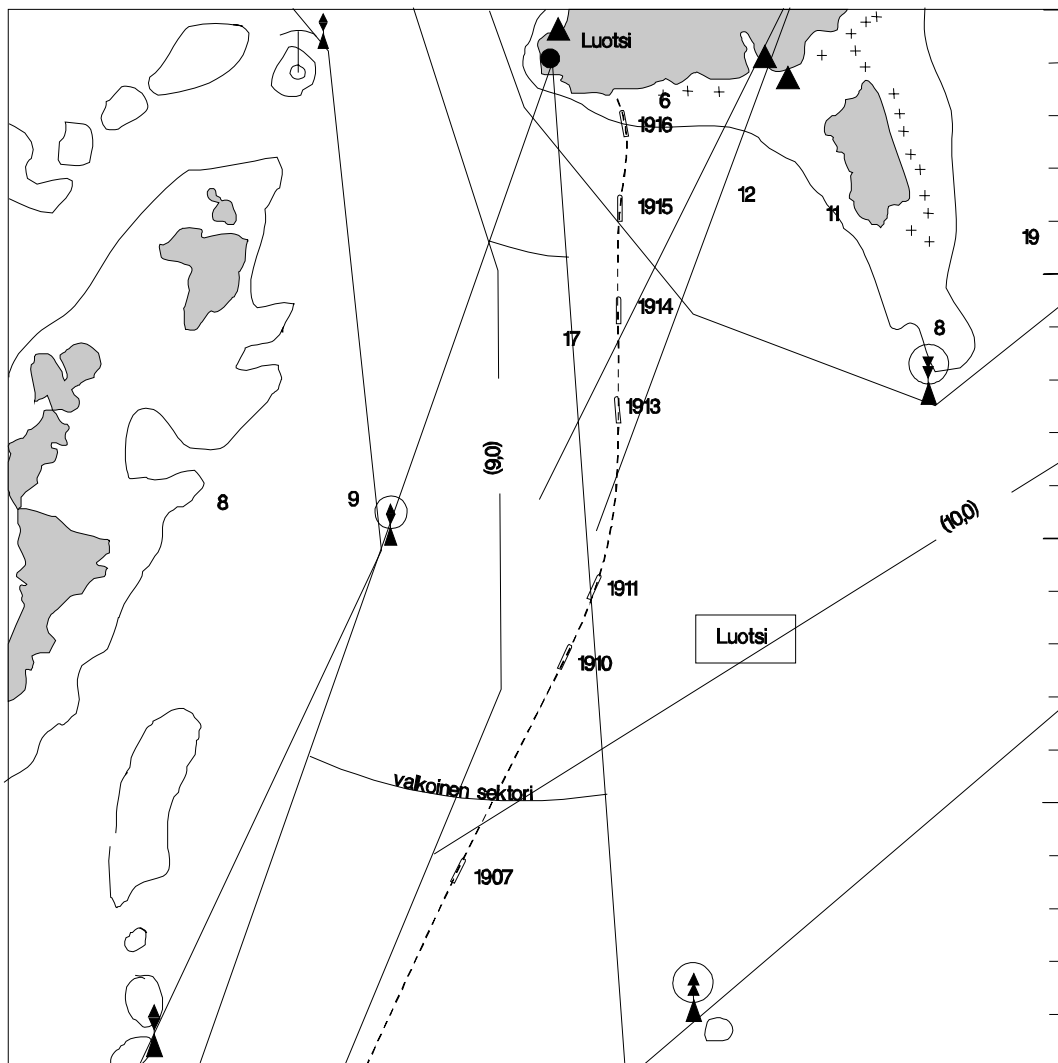
Figure 6a. The accident as simulated along the passage registered by VTS registration (desk top computer simulation).

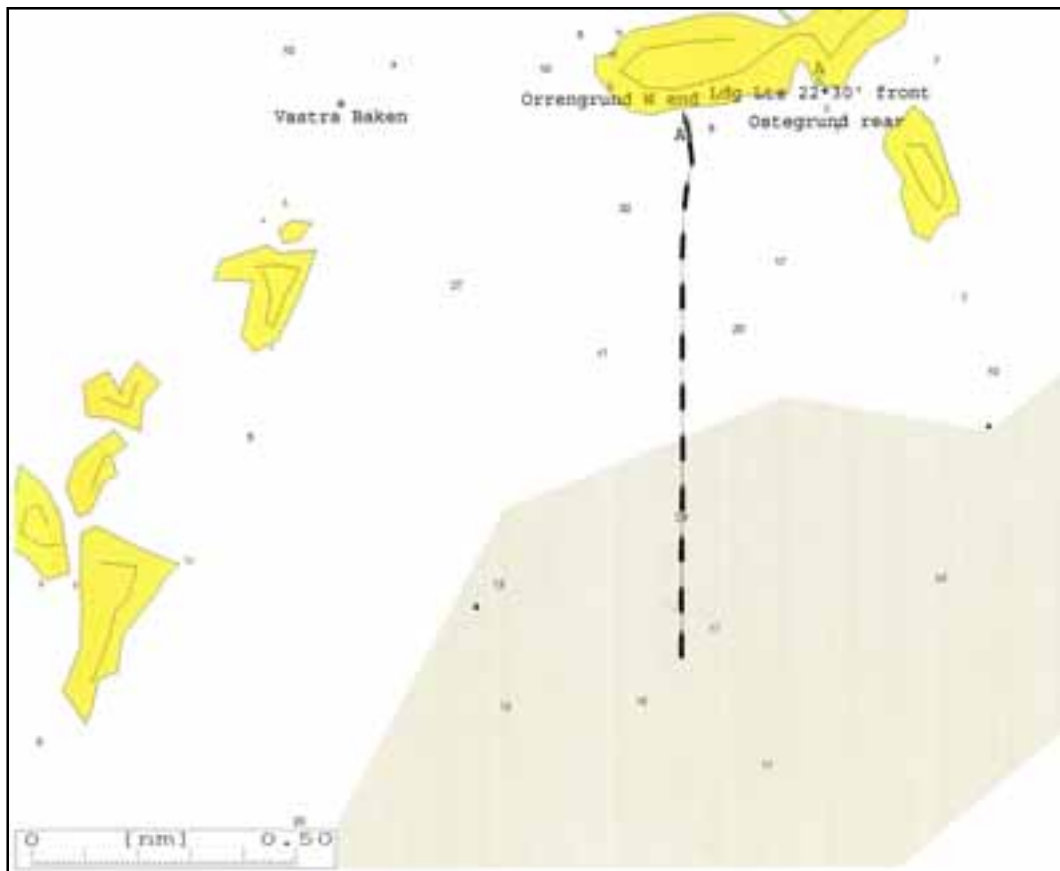
The simulations also aimed at realising the time delays described in the above. Here, 20-40 seconds was estimated to correspond to the time the master had used for trying the various steering methods. Next, the rudder was turned slowly, in about 20 seconds, to a position where the rudder was 35° to port. It was estimated that the Master had used this amount of time to turn the rudder to the corresponding angle using the emergency rudder of the accident vessel.

Figure 6b. Reconstruction of the grounding simulated by bridge simulator (Kymenlaakso Polytechnic, Kotka). The interval of the position markings of the vessel is 30 seconds.

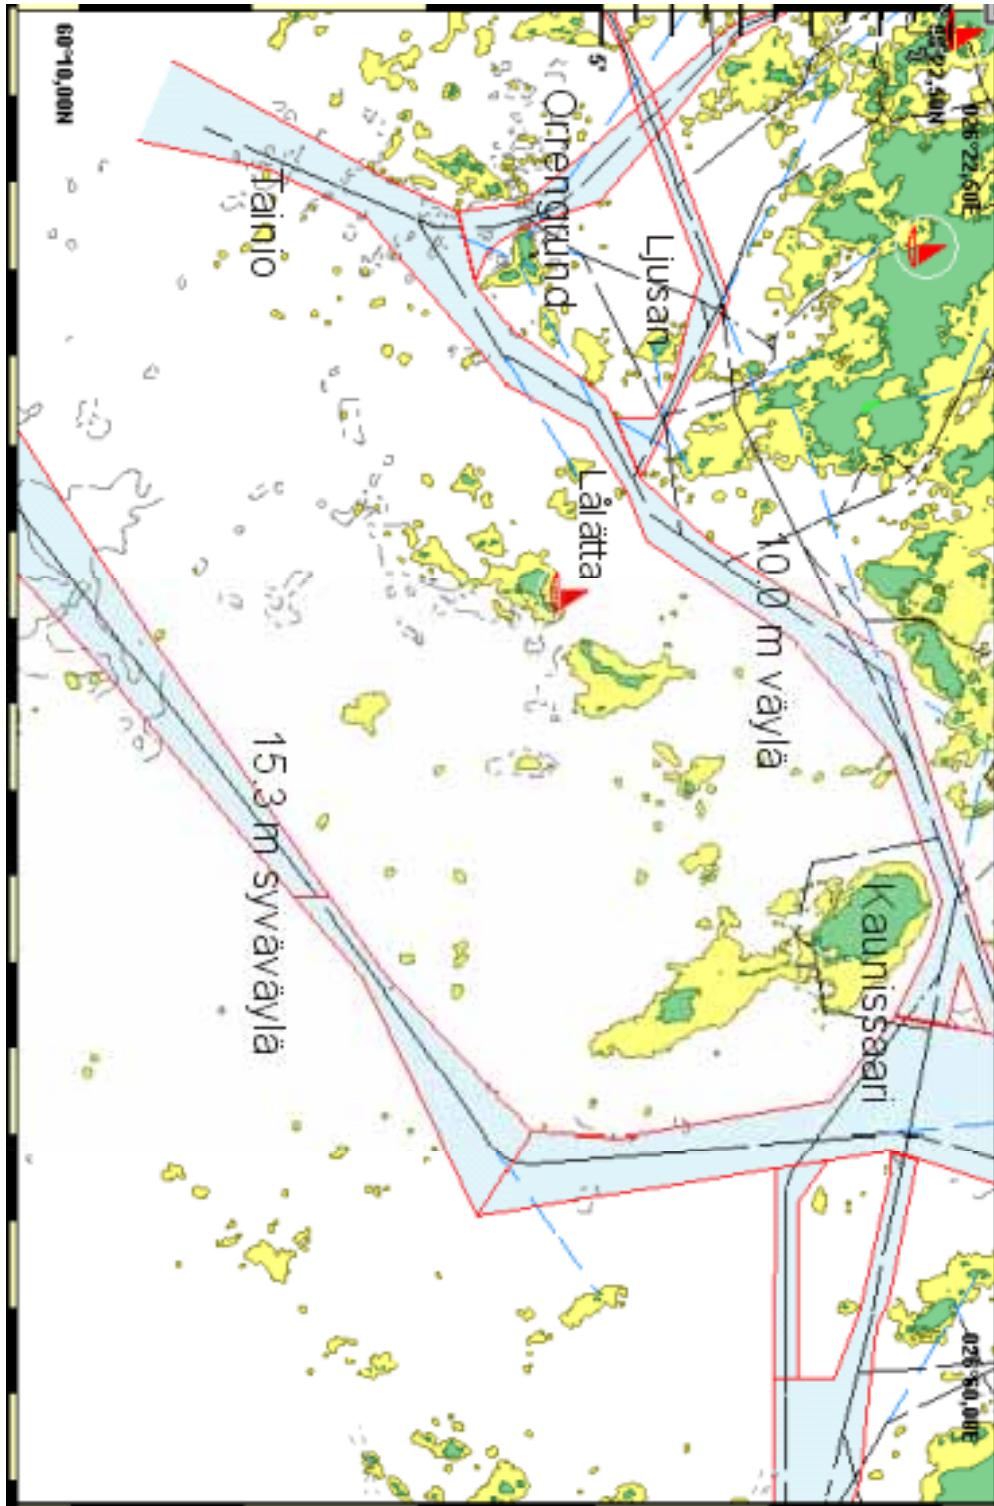
There are two official fairways marked on the chart for entering Kotka from the west sea, south of Tiiskeri (Figure 7).

Figure 7. Fairway choices of the OCEAN PRIDE for entering Kotka.

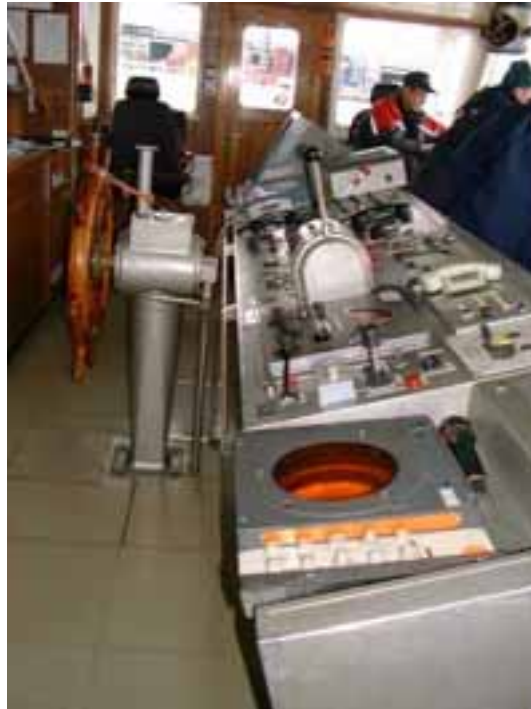
Figure 8. Original one person navigation point of the OCEAN PRIDE.

It was not possible to perform accurate radar navigation at the navigation point due to the location of the best radar. It was situated at the left end of the navigation console and therefore required moving aside a step or two from the actual navigation point (Figure 8).

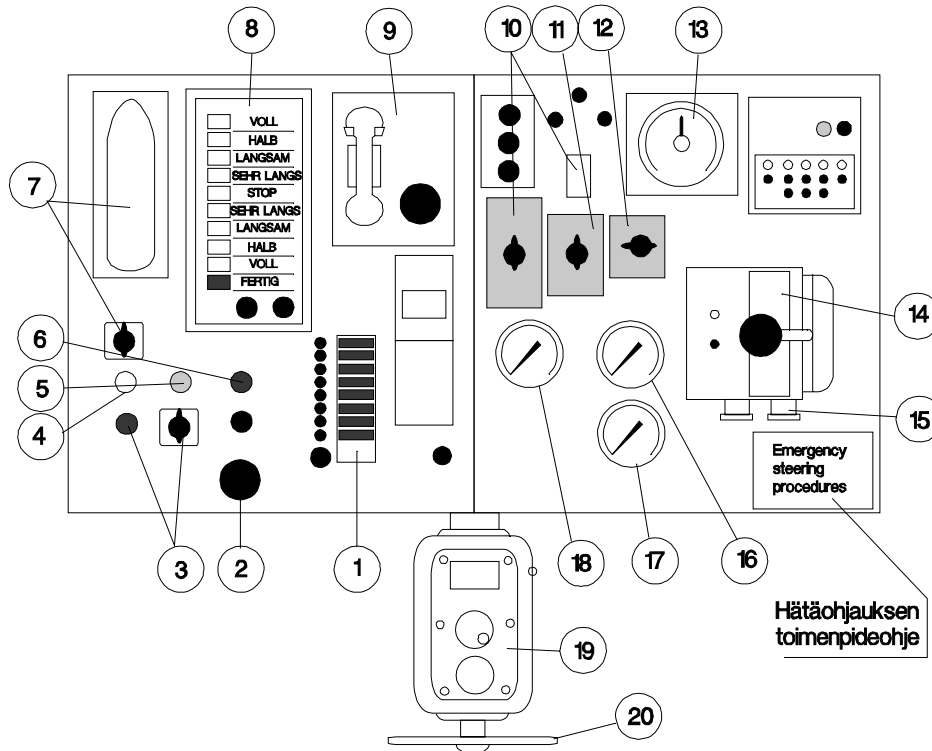
Figure 11. Machine controls of the OCEAN PRIDE in the middle console.

The emergency steering was a rudder operating by 'telemotor'. The manual wheel used for emergency steering was located in the middle of the navigation console of the vessel, next to the steering point for automatic steering, to the left of it. The hydraulic system of the telemotor starts and stops the rudder pump automatically when the desired rudder angle has been achieved. There was a sign of the emergency steering under the machine command relay (Figure 11):

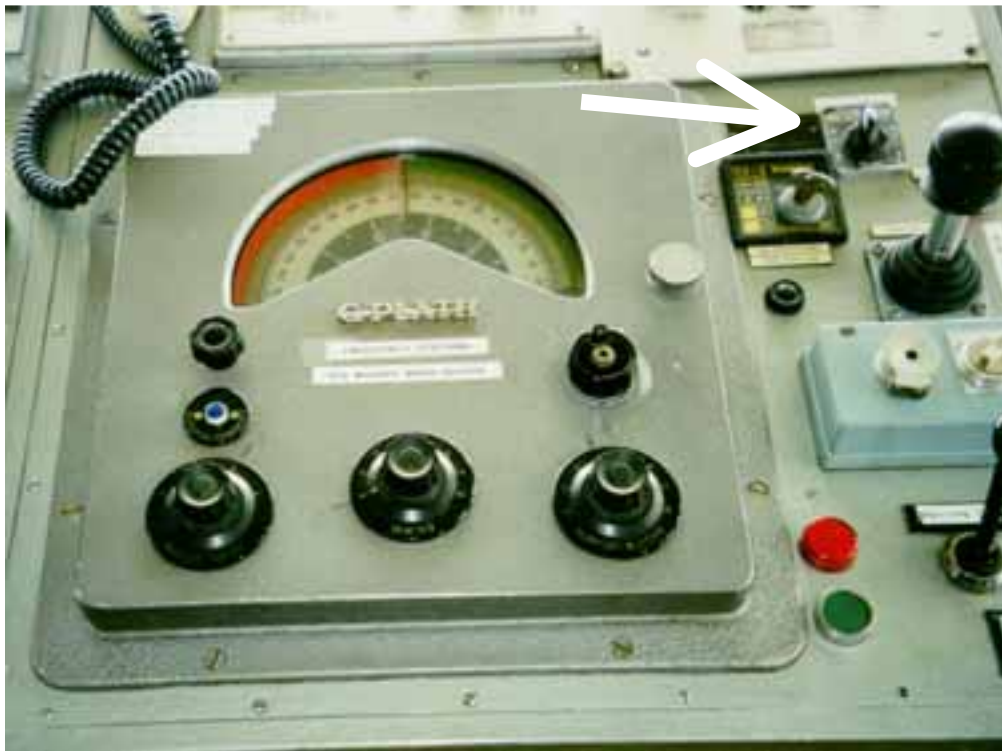
Figure 12. Photograph of the autopilot with the switch for the autopilot and manual steering (marked with arrow).

The selector switch on the bridge of the OCEAN PRIDE is not manufactured by C.PLATH, since it does not carry the company stamp (Figures 12, 14 and 15). It is probably an ordinary four phase switch. Ergonomically the switch does not correspond to the functional entity of the NAVIPILOT.

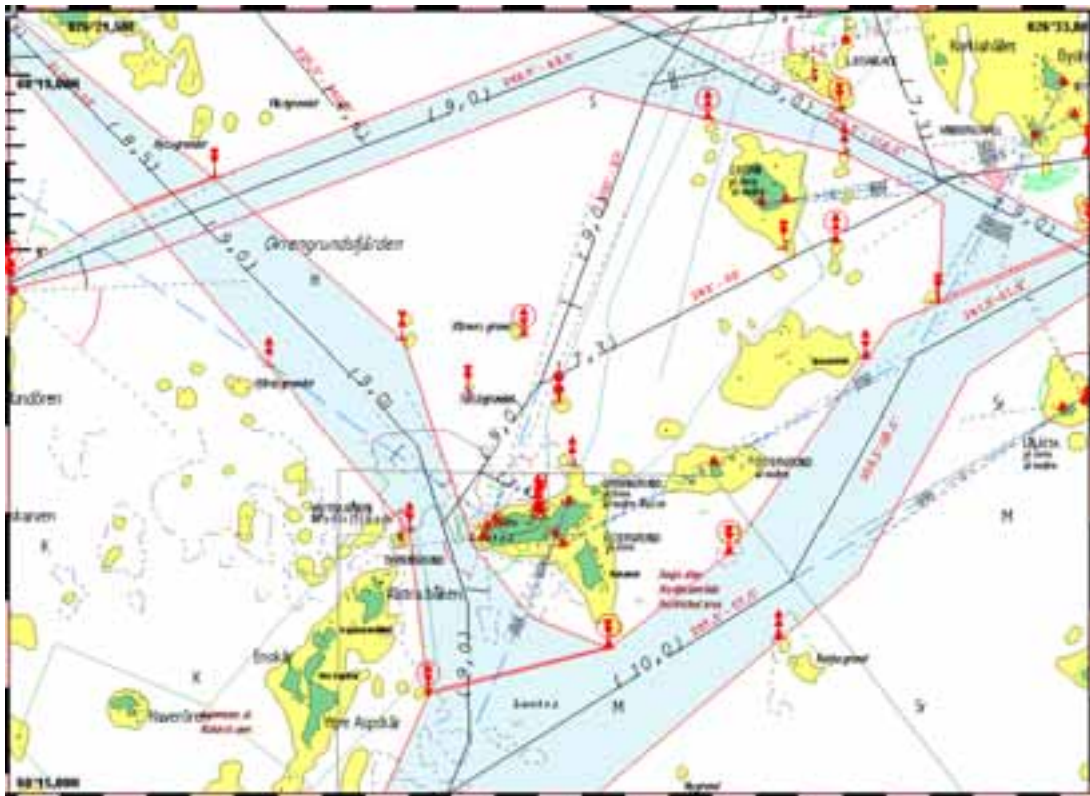
There are two alternative 9 metre fairways north of Orregrund. Both lead to the 9 metre inner fairway further to the north (Figure 16). The fairway shaded on the chart travels

Figure 16. Alternative fairways north of Orrengrund.
