Investigation report

C 1/2002 M

M/S FJORD PEARL, Shifting of Cargo and Danger Situation, January 2, 2002

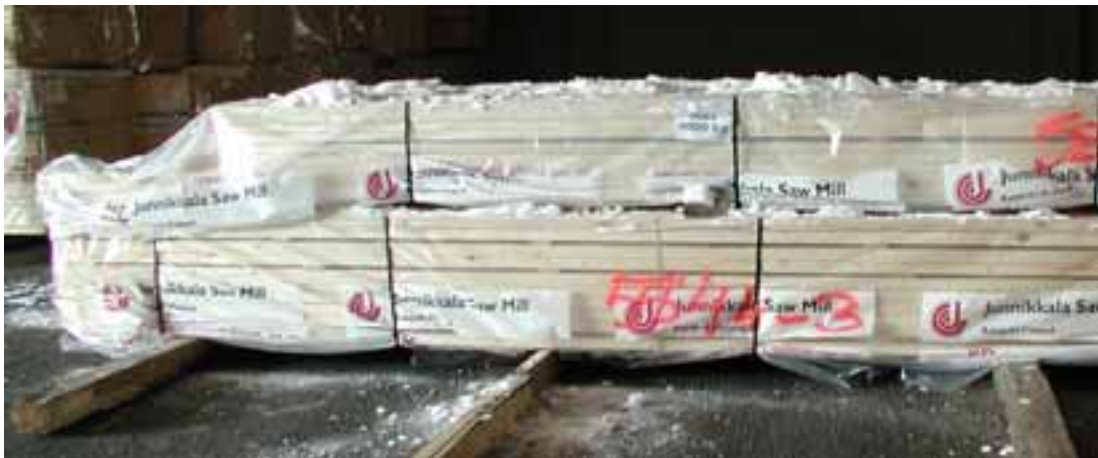
Figure 6. *Wintry timber packages waiting for transfer on board (photo by the Finnish Institute of Occupational Health)*

The sawn timber packages were in part covered with snow and ice. The stevedore removed snow and ice by blasting air and by chiselling. The ice and the snow could not be fully removed. The load was packed as tightly as possible under the supervision of the ship officers. The second tier of deck cargo was placed across. Due to the varying lengths, gaps of half a metre remained here and there.

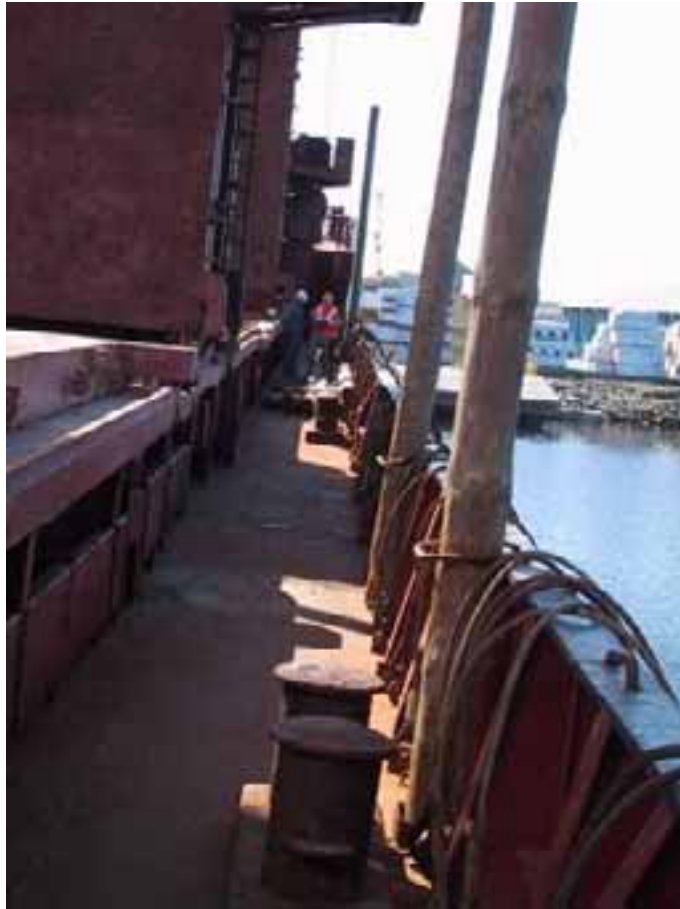
Before loading on the weather deck the crew of the vessel hoisted nine wooden uprights to each side of the vessel with the boom of the ship. The uprights belonged to the ship, were 5-6 m in length and 150-280 mm in diameter. The uprights were lowered through a hoop formed by a bent steel bar on the railing and the bottom end was positioned into a frame on the deck. A gap of 5 cm remained between the uprights and the outermost timber stacks for the cover. The uprights were not used for supporting the deck cargo but for keeping the stacks from toppling during the loading when the deck cargo was not yet secured.

Figure 9. Installation and placement of the uprights on M/S FJORD PEARL, May 2002

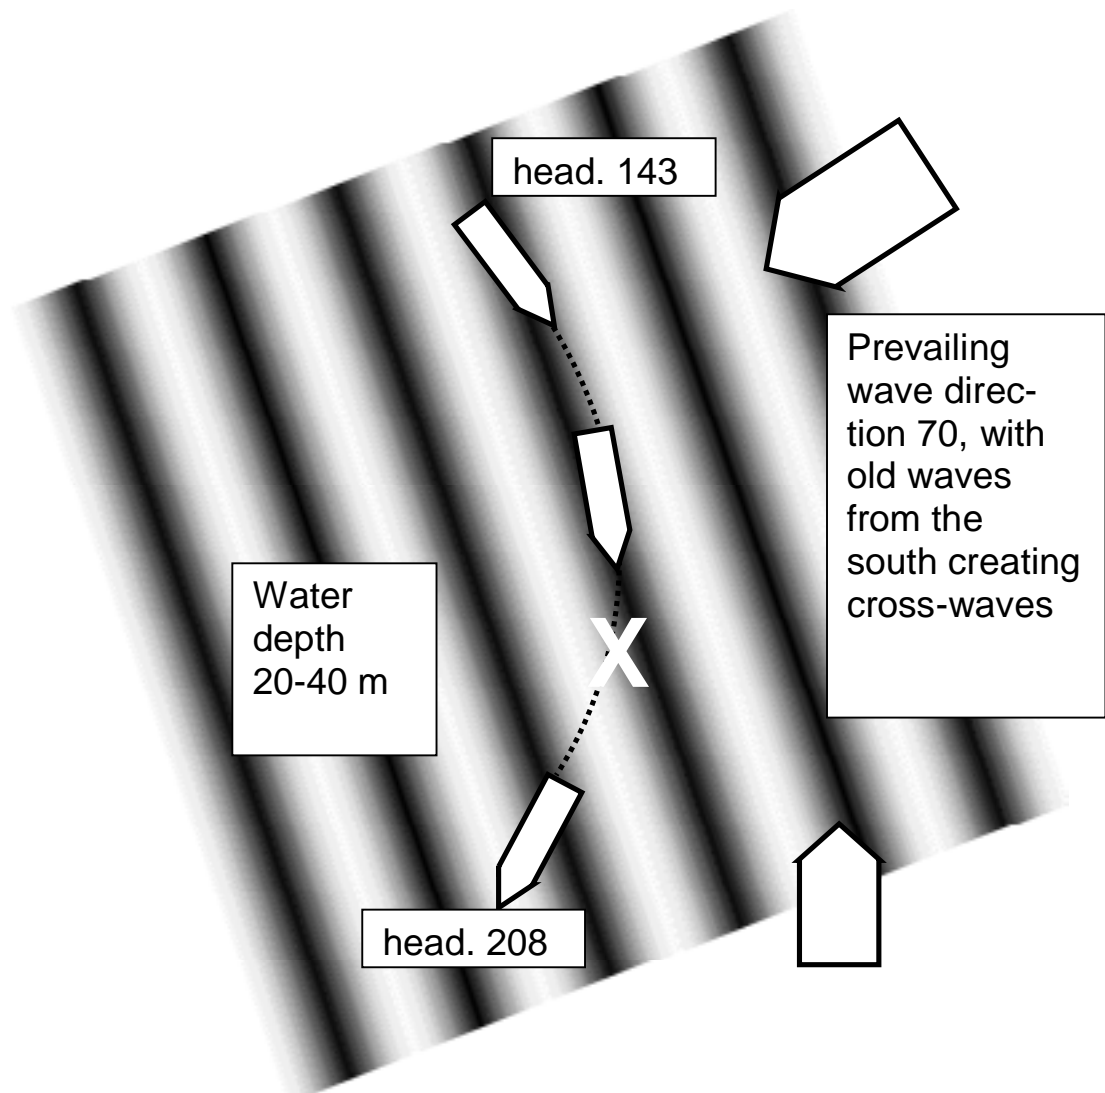
The turning of the vessel was executed in difficult conditions. According to the weather data, the wind speed in gusts was up to 27 m/s. According to the wave data, the prevailing wave period was 8-9 s. The corresponding wavelength was 120 m giving a phase velocity of 13 m/s for the wave. The significant wave height was 3-4 m. The speed of the vessel during the turn was 8 knots or 4.1 m/s. Figure 13 below presents the estimated turning of the vessel. The turning radius is not known but if it were assumed at 1200 m, the required time for the turn would have been 5 minutes. The moment of the cargo shift is not known.

The vessel had to travel parallel to the waves for some time, which amplified the rolling. During the turn the ship was positioned several times diagonally on the crest of the wave with regard to the wave front. In reality, the wave front was not as clear as in the picture, although the prevailing wave direction had already formed. There were moderate cross-waves. X marks the estimated time of the toss.

Figure 13. Turning of the vessel

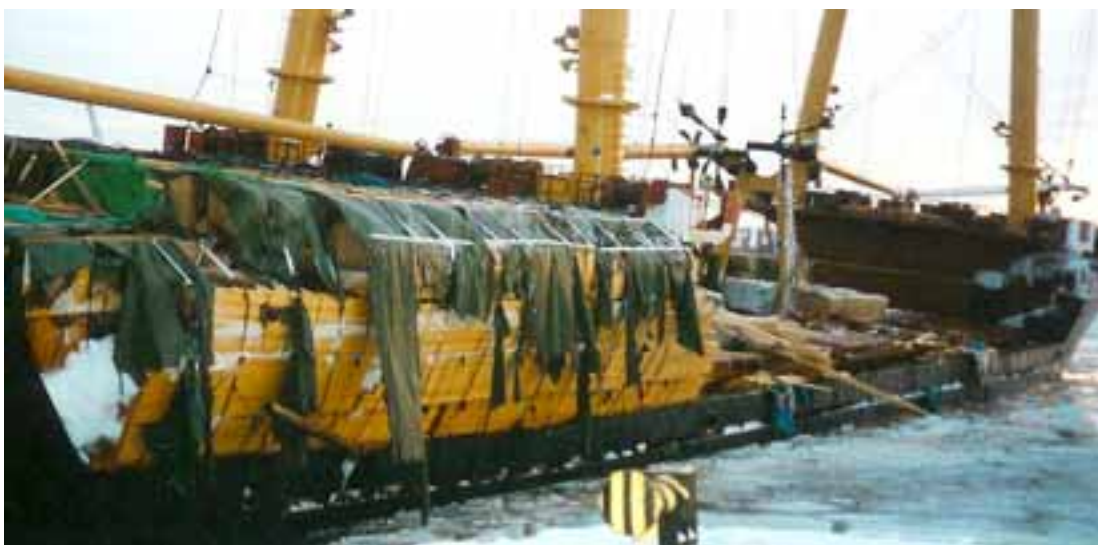
Figure 16. The vessel in the port of Turku, cargo partially unloaded

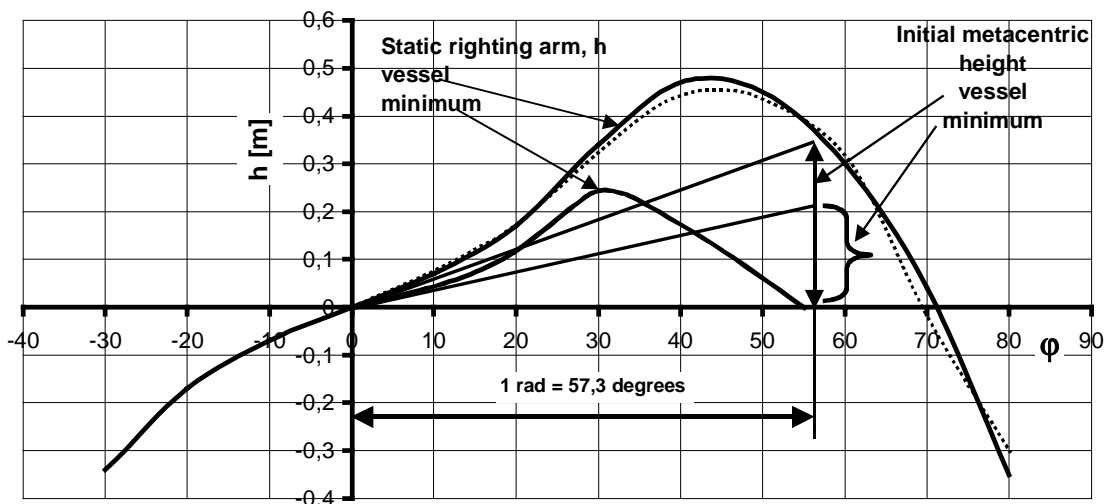
Figure 19 presents the static stability curves. They have been calculated according to the instructions and fulfil the stability criteria. The figure also shows the static stability curve calculated on board the vessel after the accident. The investigation team has studied the stability issues as required by the various situations. Enclosure 3 takes a closer look at stability.

Figure 19. Stability curves calculated on board the vessel

According to the stability curve in figure 19, a static list of 22° would require 2070 tm. In addition to the shift of the deck cargo, e.g. the following factors increase the list:
