2 ANALYSIS

2.1 Timber cargoes exported from Finland, general

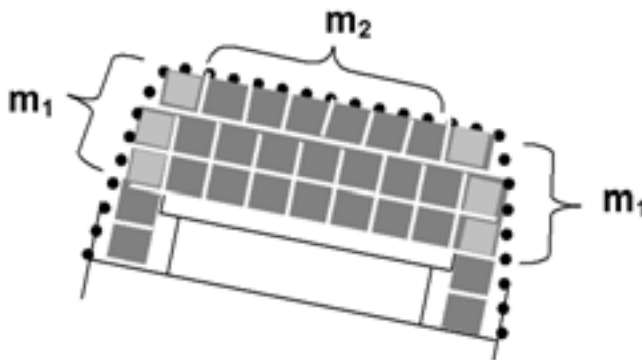
Figure 3. Sawn timber cargo on the hatch cover

The friction coefficients μ_1 and μ_2 are usually different because the materials under the lowermost tiers of the masses are different. In the case of the FJORD PEARL the bottom wood surface of m_2 was lying on steel whereas the lower wood surface of m_1 was lying on a hooded wood surface. In addition, both stacks had the lift ropes in between the surfaces.

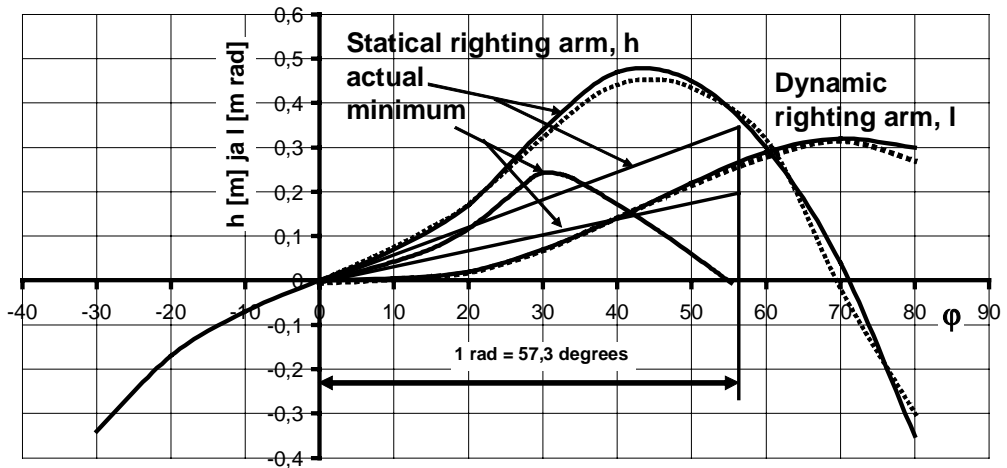
The stability calculations obtained from the ship were appropriate and showed that the stability of the vessel was within the limits of the regulations. The initial metacentric height corrected by the effect of the free liquid surfaces was 0.34 m, whereas the requirement is 0.20 m. The statical and dynamical righting arms are presented in figure 1 below. They have been calculated according to the regulations and fulfil all criteria. The criteria are shown, too. The righting arms calculated on board the vessel after the accident are also included in the figure. The investigation team has performed stability studies for various situations based on these curves.

Figure 1. Stability curves calculated on board the vessel. The figure also includes an example of the minimum curve for the static righting arm. The figure shows the slope of the curves at origin, which gives the initial metacentric height at a heel angle of 1 radian.

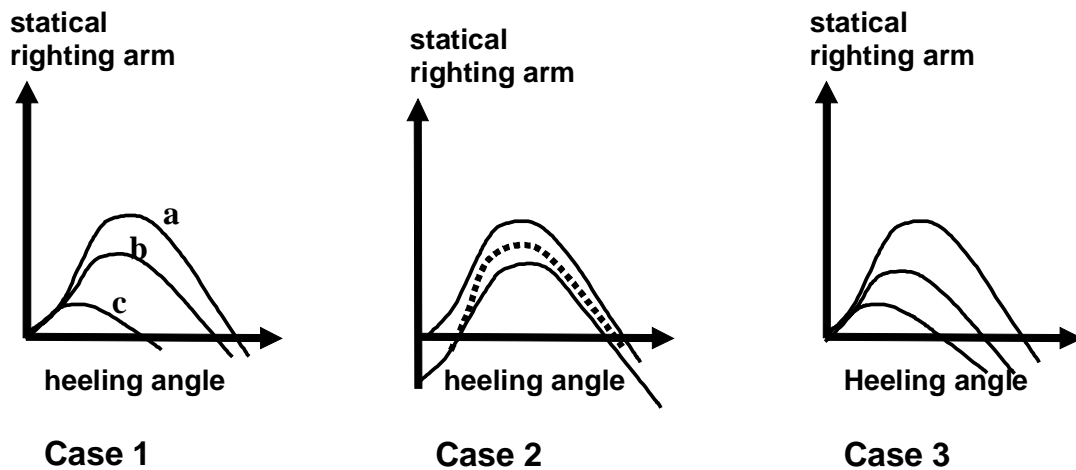
According to the calculations performed on board the ship, the draught of the FJORD PEARL was reduced by about 8 cm in the final situation due to the deck cargo, the list and the shape of the vessel. This had a slightly deteriorating effect on the stability.

Some of the water was accumulating in the double bottom, some in the holds, some in the side tanks and some on the deck. Ice formed on the deck, on the structures of the vessel and on the deck cargo. According to the calculations, the centre of gravity was raised by about 5 cm. Thus, the stability curve must be corrected by the factor $-5 \text{ cm} \times \sin(\text{listing angle})$.

Figure 3. Change of stability curves in the various situations

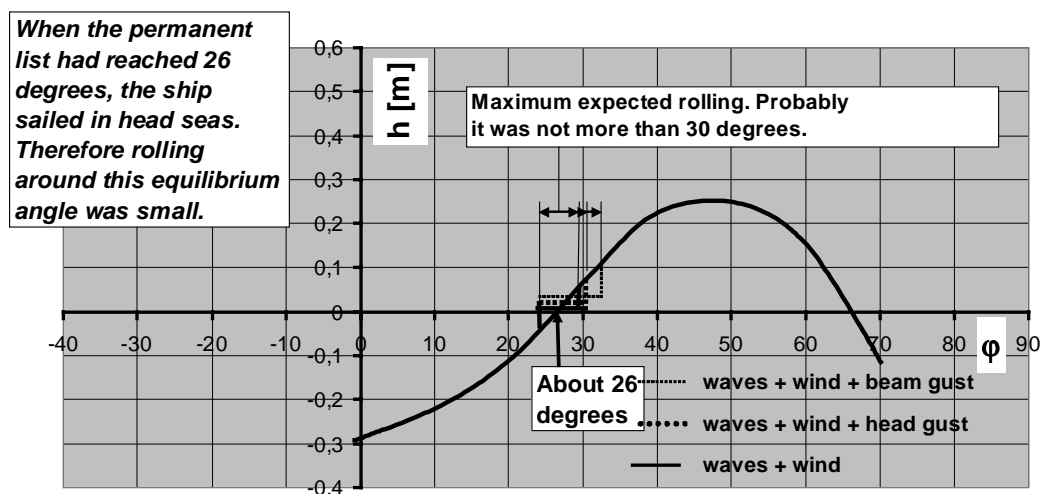
The total increase of the heeling moment = $(600 + 240 - 400 + 180 + 200 + 150 + 100 + 70 - 75)\cos 26^\circ = 958 \text{ tm}$. The difference, $958 - 930$ can be explained as in the above. The statical righting arm corresponding to this situation is presented in figure 6.

Figure 6. Statical righting arm for a heel of 26°

The list of the vessel can be explained with these approximations. The vessel was rolling to both sides of this equilibrium, finally only a few degrees since she was in head seas.

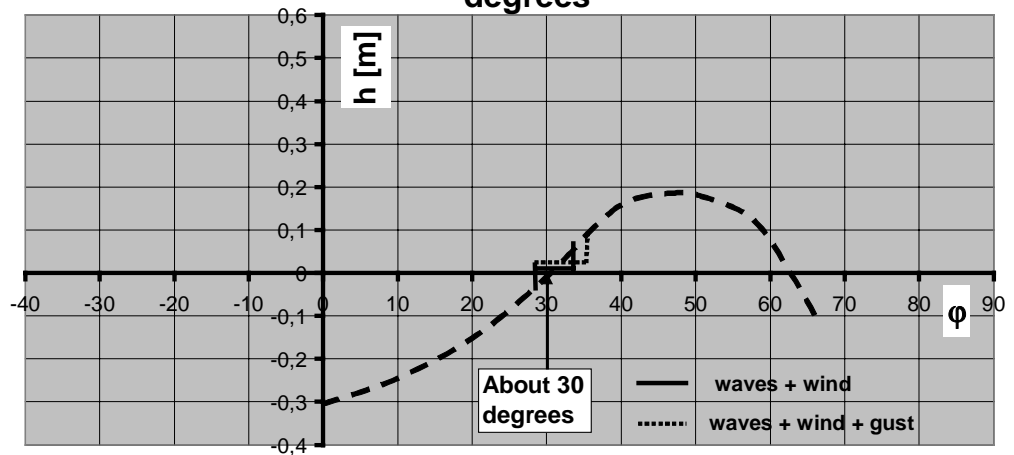
Statical righting arm when 200 t of ice has been added at an initial heel of 26 degrees ==> a heel of 30 degrees

Figure 7. *Approximated situation if 200 tonnes of additional ice accumulate after the accident*

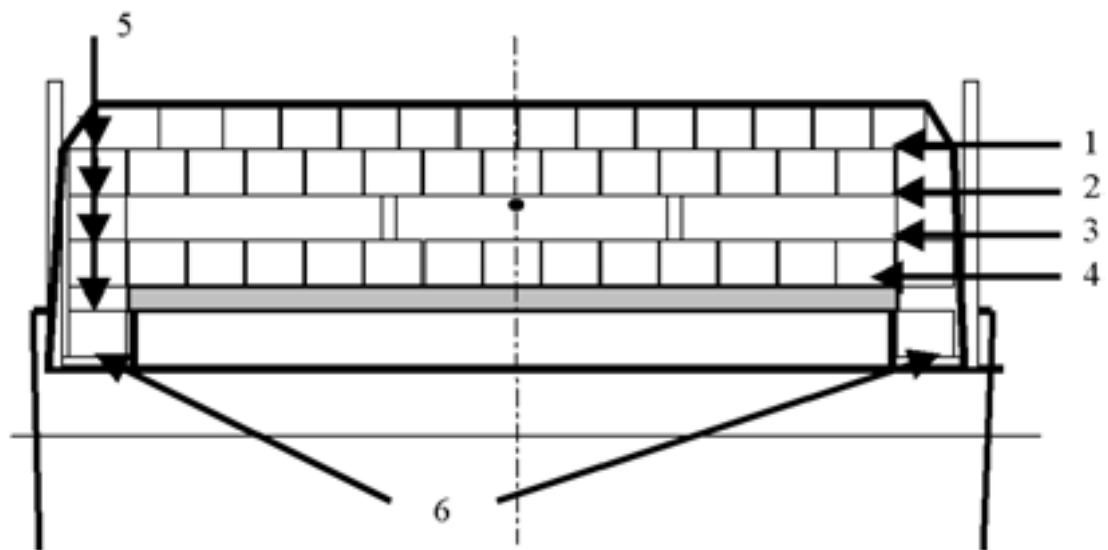
1. Two packages lengthwise stacked staggered on top of one another
2. Packages stowed lengthwise on top of packages stowed across
3. Packages stowed across on top of packages stowed lengthwise
4. Packages lengthwise on top of a cargo hatch
5. At the sides lengthwise packages stowed evenly on top of one another
6. At the sides lengthwise packages on top of ground timber

Figure 3. Various friction surfaces of the deck cargo of the FJORD PEARL
