## **Investigation report**

C 4/1998 M

**ms GERDA, grounding outside port of Kotka, April 7, 1998**

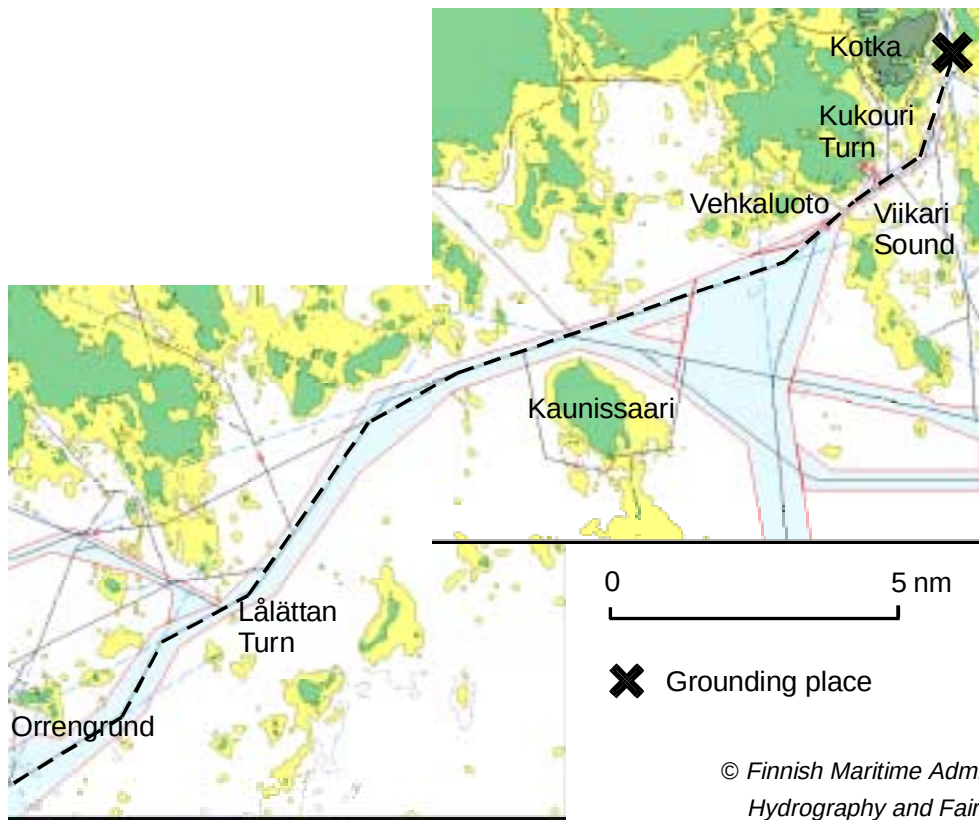
Figure 3. Approach fairway to Kotka used by the GERDA

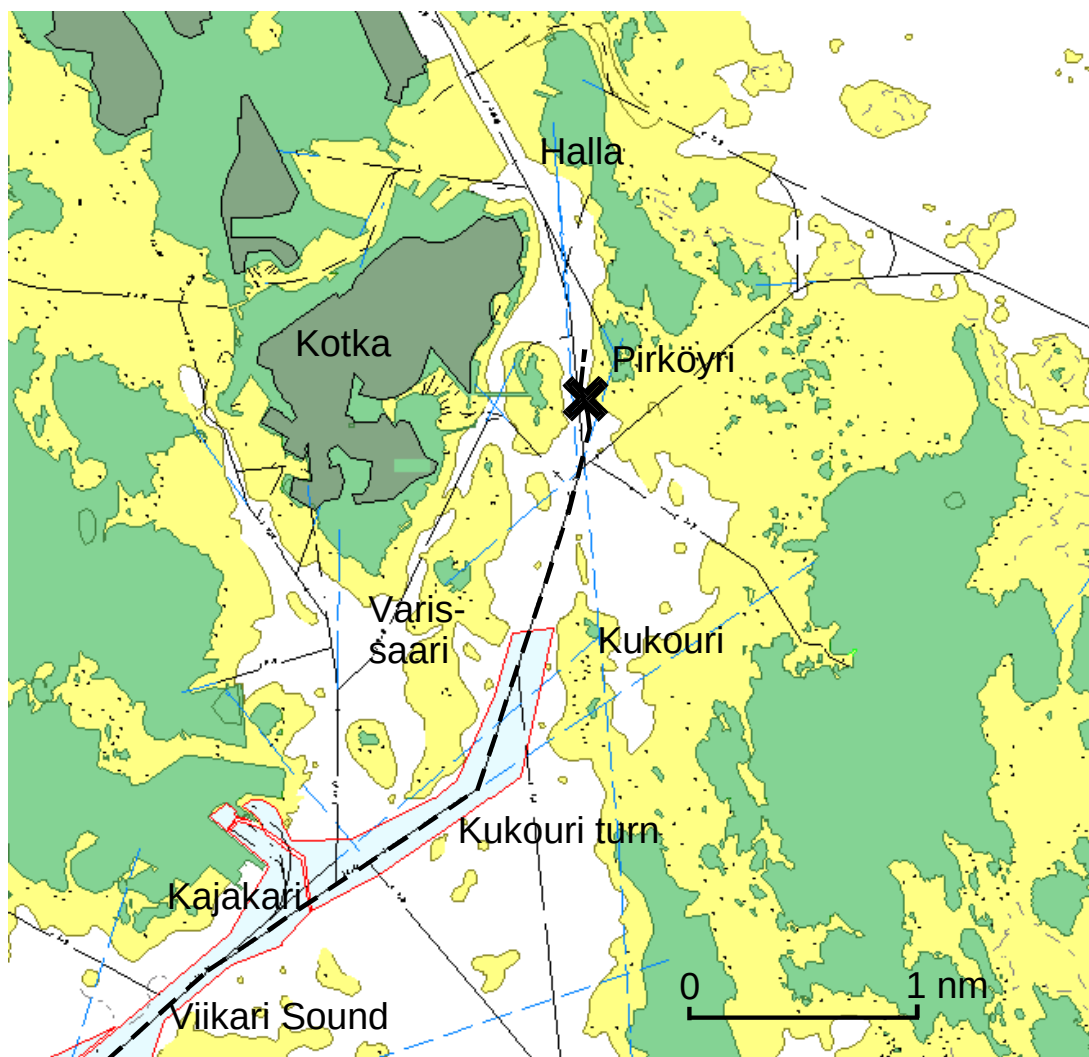
Figure 4. Fairway from Viikari Sound to Pirköyri used by the GERDA

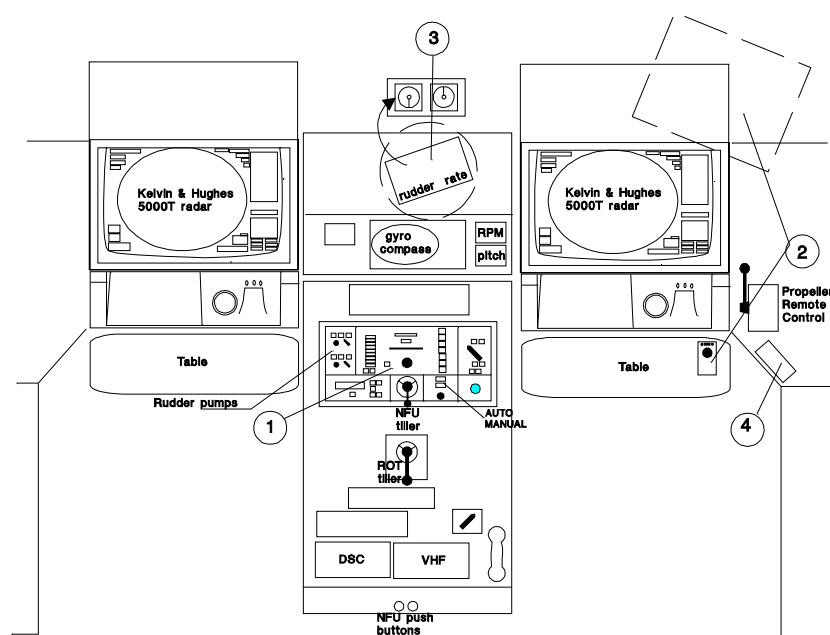
The drawing of the location of the equipment in the cockpit (Figure 6) is based on photographs of the bridge of the GERDA. Therefore, the pictures are not to scale.

1. *Anschütz Nautopilot D.*
2. *Electronic chart. Used with mouse in front of radar.*
3. *Combined turntable rate-of-turn and rudder-angle indicator.*
4. *Central unit for horn.*

Figure 6. Cockpit arrangement and location of equipment of ms GERDA. Figure drawn from photographs.

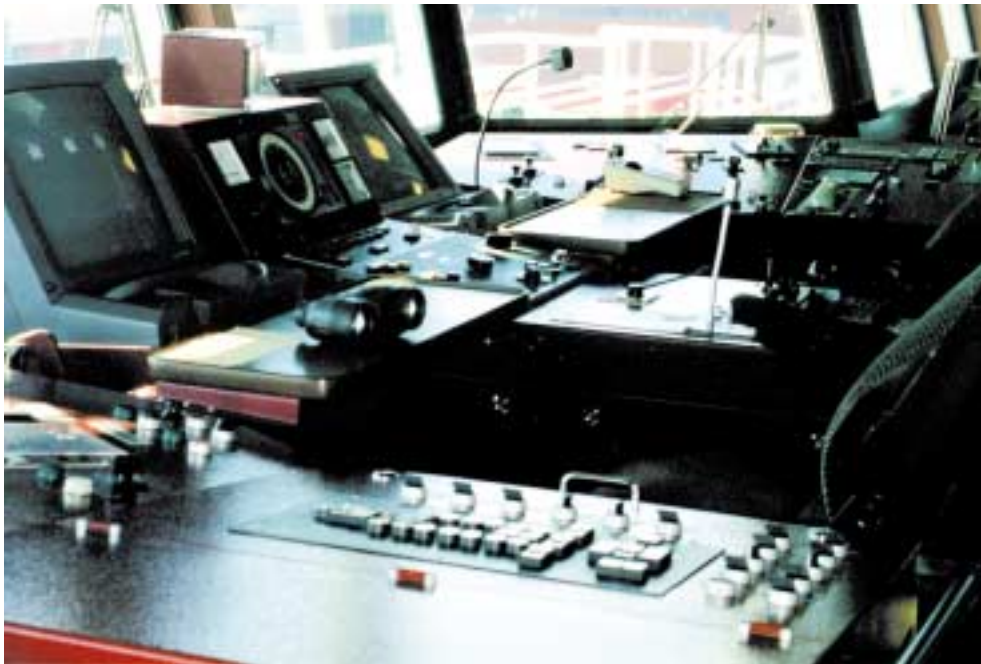
Figure 7. Cockpit radars and steering consoles of ms GERDA

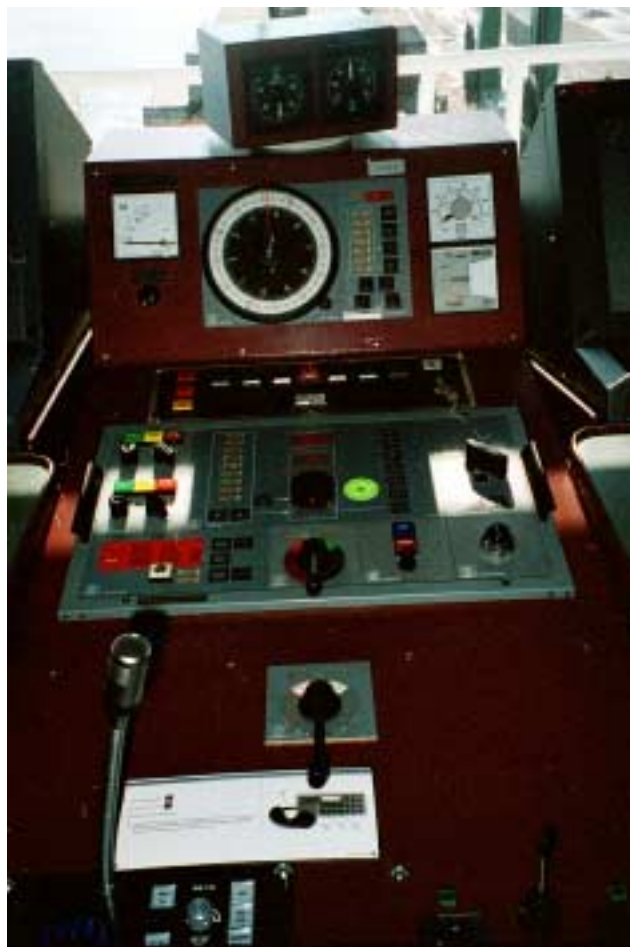
Figure 8. Middle cockpit console with autopilot and rate-of-turn and rudder-angle indicator (see also Figure 6).

The pilot and the master had two feasible steering methods in the Anschütz Nautopilot steering system, which is designed for both open-sea and river traffic. In addition, the middle console had manual steering of the rudder (NFU), which is mainly suited for emergency steering. This equipment is pictured in Figures 8 and 11. The steering methods are:

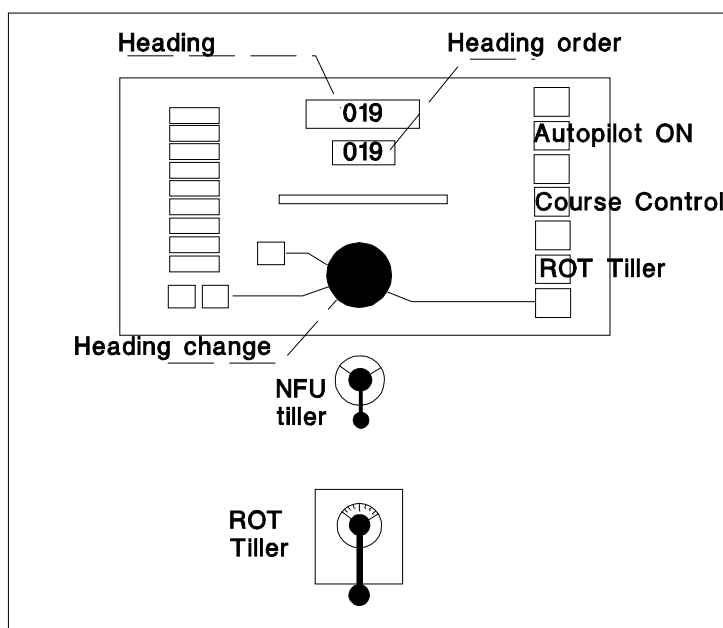
Figure 11. Steering modes for Anschütz Nautocourse D system suitable for piloting. NFU was emergency steering.

**Manual steering of rudder (NFU, Non Follow Up)** is located on the autopilot panel (Figure 11). Turning the lever instantly disengages all the automatic steering modes (override function). This steering mode functions on the Non Follow Up (NFU) principle and overcomes any limitations in the steering system. The rudder turns as quickly as possible to its extreme position. Turning the lever keeps the rudder pump active. The desired rudder angle can be adjusted with the rudder-angle indicator. When the desired angle is reached the pumps are stopped by releasing the lever. A spring returns the lever to its central position. The rudder-angle indicator therefore requires constant monitoring. When steering with the NFU lever it is difficult to observe the radar. NFU steering is usually installed as an emergency steering because it is operationally reliable. It relays the order directly to the rudder machine, overriding any other technology.

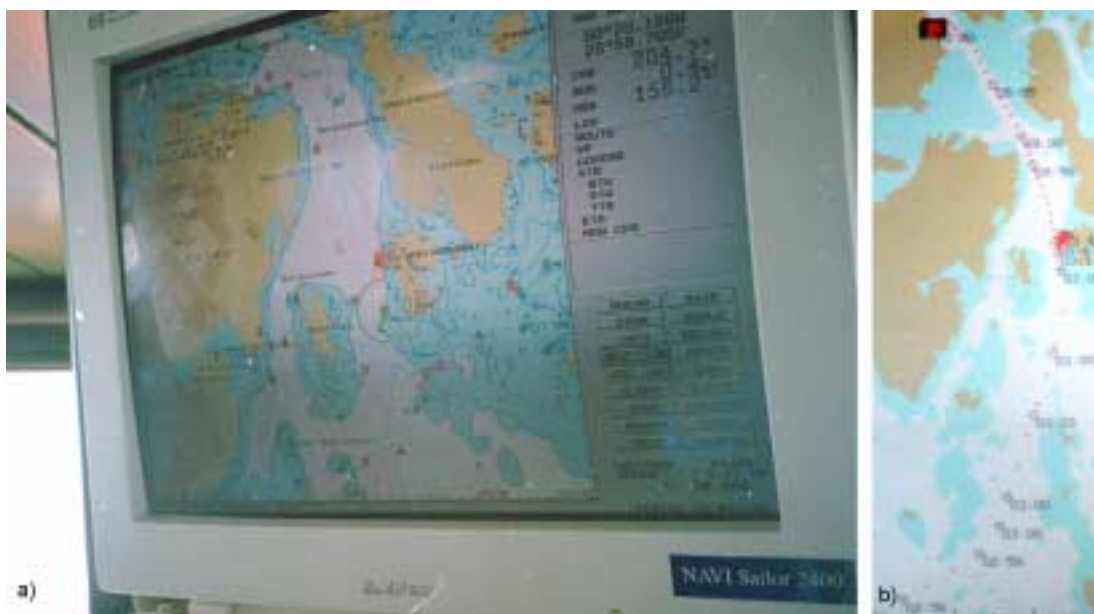
**The monitor for the electronic chart** was mounted in the ceiling to the right of the steering and navigation console (Figures 2 and 12). It was easily visible from the master's seat. The screen could be turned in such a way that the chart could be viewed from both seats of the console. The computer and monitor were made by Hewlett Packard. The electronic chart and the software operating it were Navi Sailor 2400, manufactured in St Petersburg. The resolution of the monitor was good and the chart was drawn in vector form from official paper charts.

which is detectable from the registration at about 04:05 (Figures 12b and 13). The pilot conducted two radiotelephone conversations concerning traffic with the port authority and with ms INOWROCLAW. The last call ended at about 04:04:40 according to the reconstruction. The time is based on the fact that at the end of the call he measured 0.6' as the distance to Pirköyri. The speed was 12 knots. At the end of the call the vessel was near the point where the Pirköyri turn should have been resolutely initiated with a rudder angle of 15°–20°.

Figure 12. a) Monitor for electronic chart mounted in the ceiling (see also Figure 2).

b) Route points of GERDA registered on chart.
