Investigation report

C 5/1998 M

ms BALTIC MERCHANT, grounding in Puumala at Hätingvirta, April 21, 1998

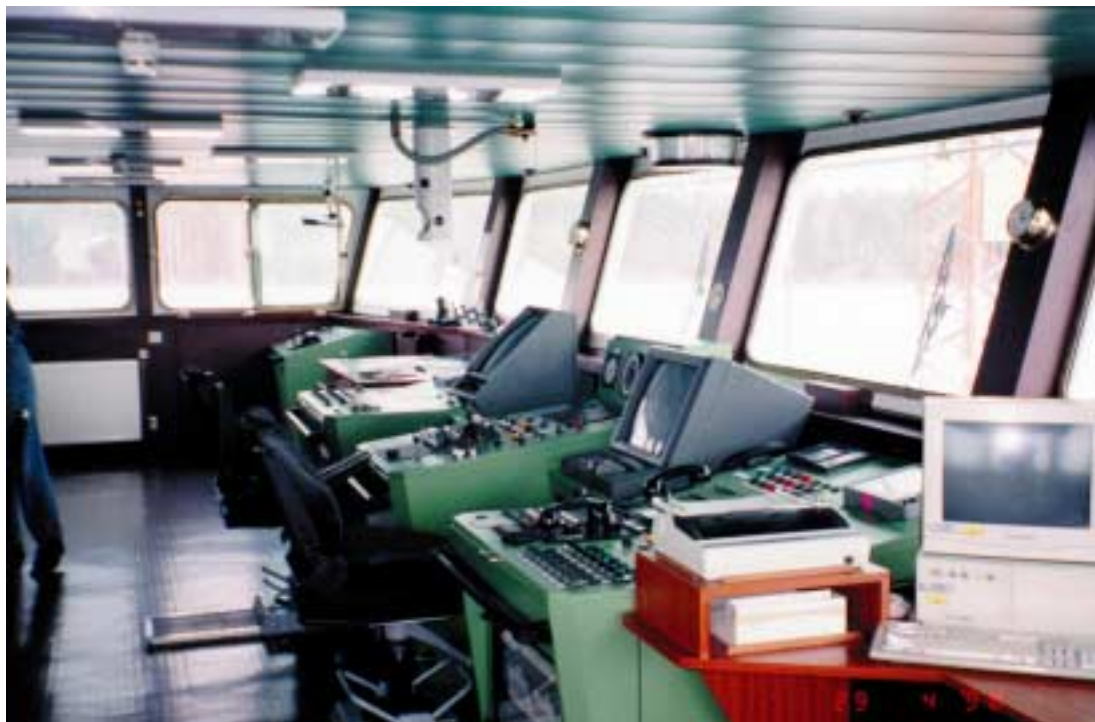
There were two navigation posts in the middle of the bridge with radars. The console in between was occupied mainly by control equipment for the machinery. In addition it had the autopilot and NFU (Non Follow Up) emergency steering (Figure 2).

Figure 2. Bridge view of ms BALTIC MERCHANT

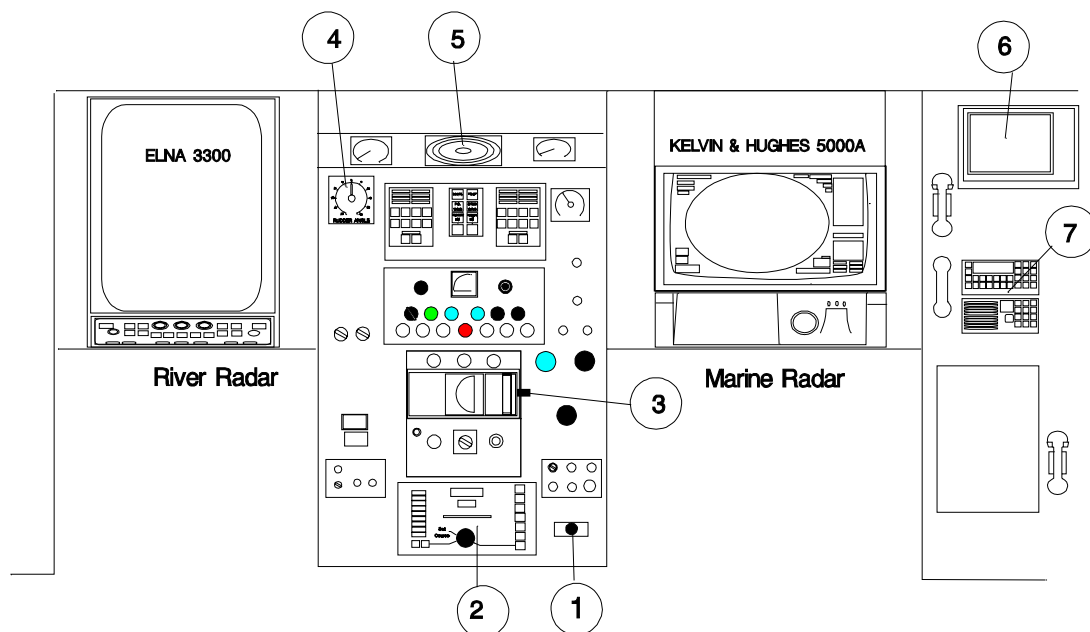
Control positions in the cockpit. There were two control positions in the cockpit. The starboard navigation positions had the Kelvin & Hughes marine radar. The port navigation positions had the ELNA 3300 river radar. NFU manual steering was located on the right hand edge of the console and in the wings of the bridge.

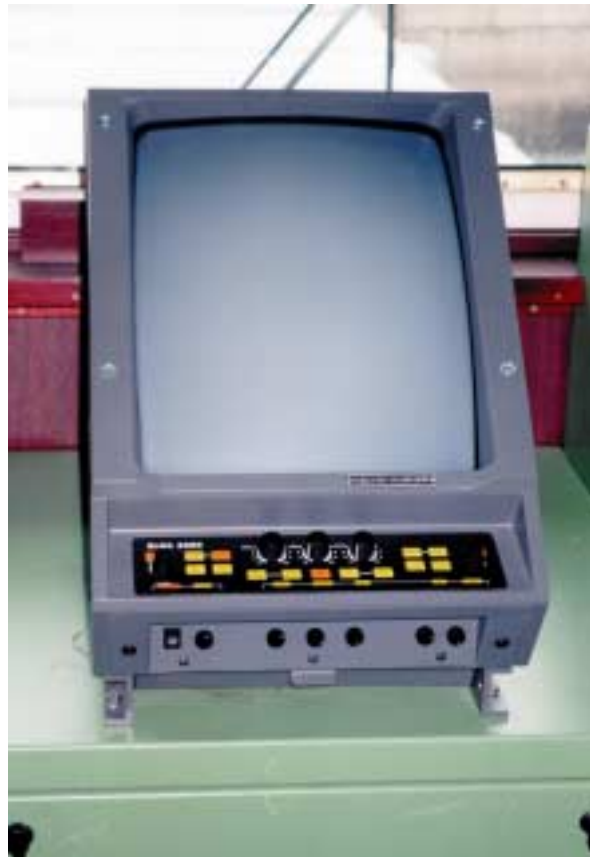
The positive aspect of the ELNA river radar is the clear user interface. It is easy and quick to use. The pilot has clearly expressed this. The pilot preferred to use the river radar and he switched to that when the mate was looking for buoys with the searchlight.

Figure 7. ELNA river radar

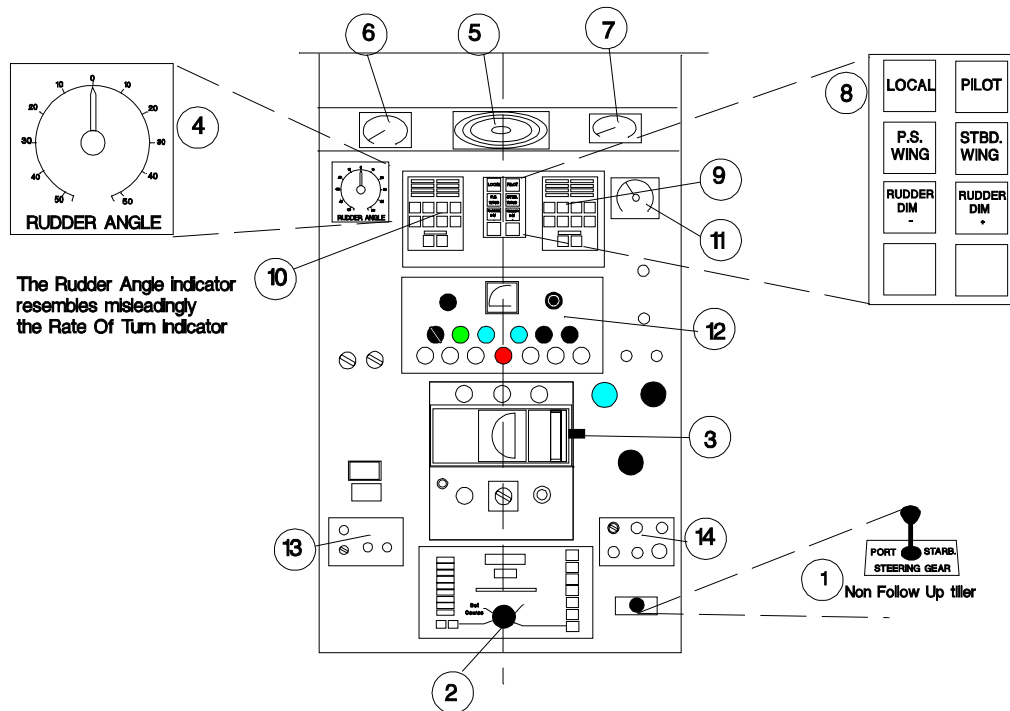
The autopilot based on rate of turn is not compulsory in river traffic but if it is missing, a rate of turn indicator and the use of a helmsman are required. There was no rate of turn indicator on the BALTIC MERCHANT. The rate of turn indicator can be replaced by the rate of turn information presented on the radar screen and the ELNA radar carried this in the upper section of the screen. With regard to the regulations, the steering equipment formed the economically most feasible unit.
