Investigation report

C7/2007L

Emergency landing on Porvoo motorway on 28 September 2007

Cessna 172N, diesel engine TAE 125-01

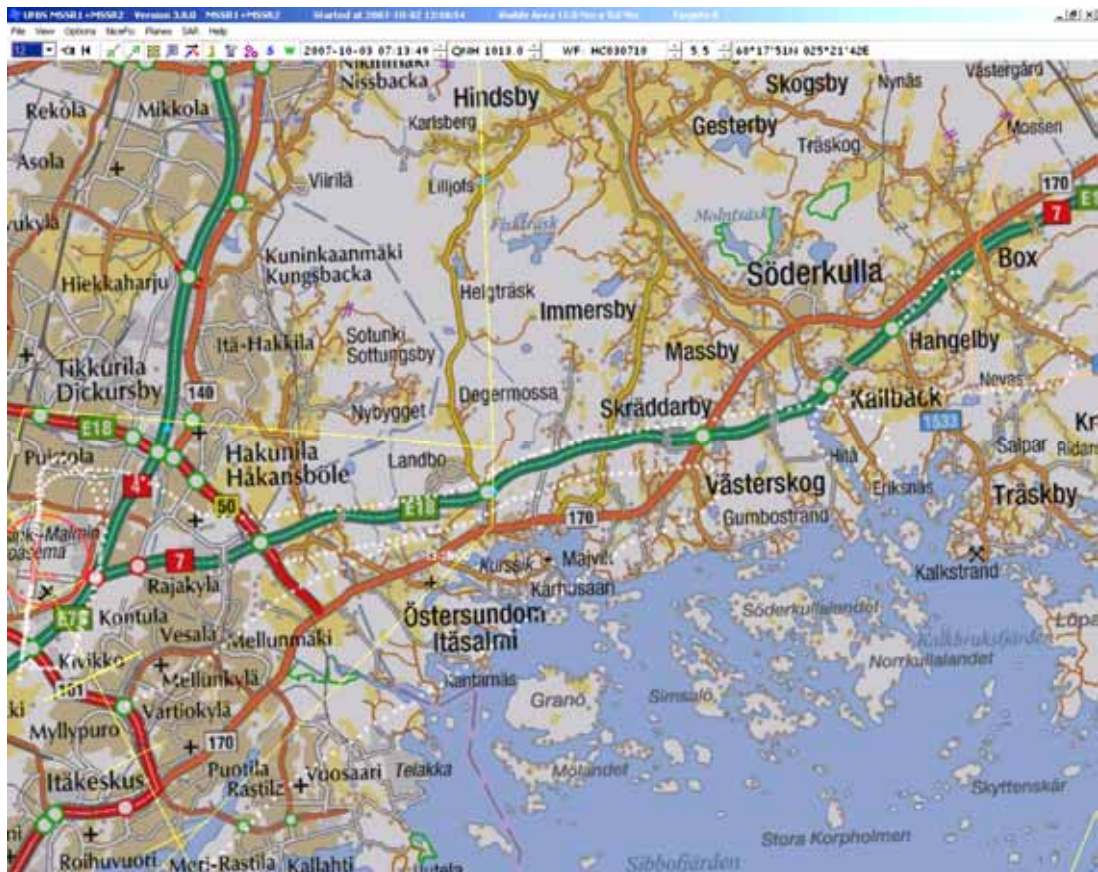
Figure 1 Helsinki-Vantaa aerodrome radar recording of the aircraft's track (upper white dotted line).

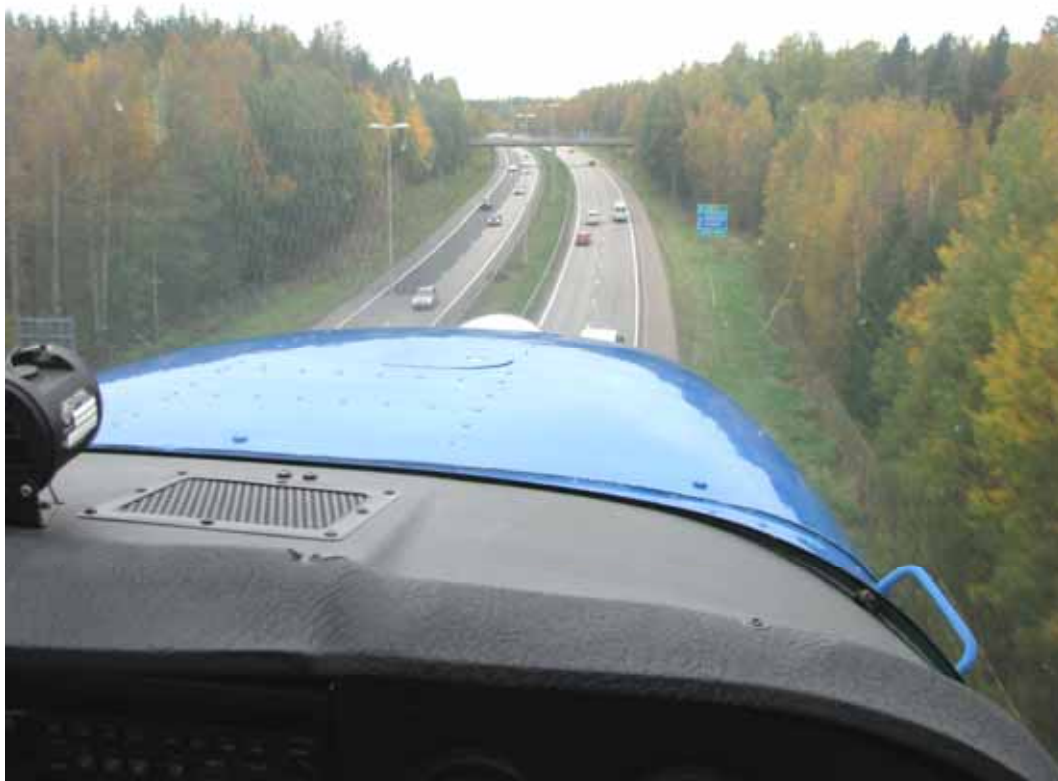
Figure 2 The passenger took this photo as they were approaching the site of the emergency landing. They barely made it over the Hangelby Bridge up ahead.
