Historic Aircraft Accident at Räyskälä on October 16, 2024

L2024-02

SYNOPSIS

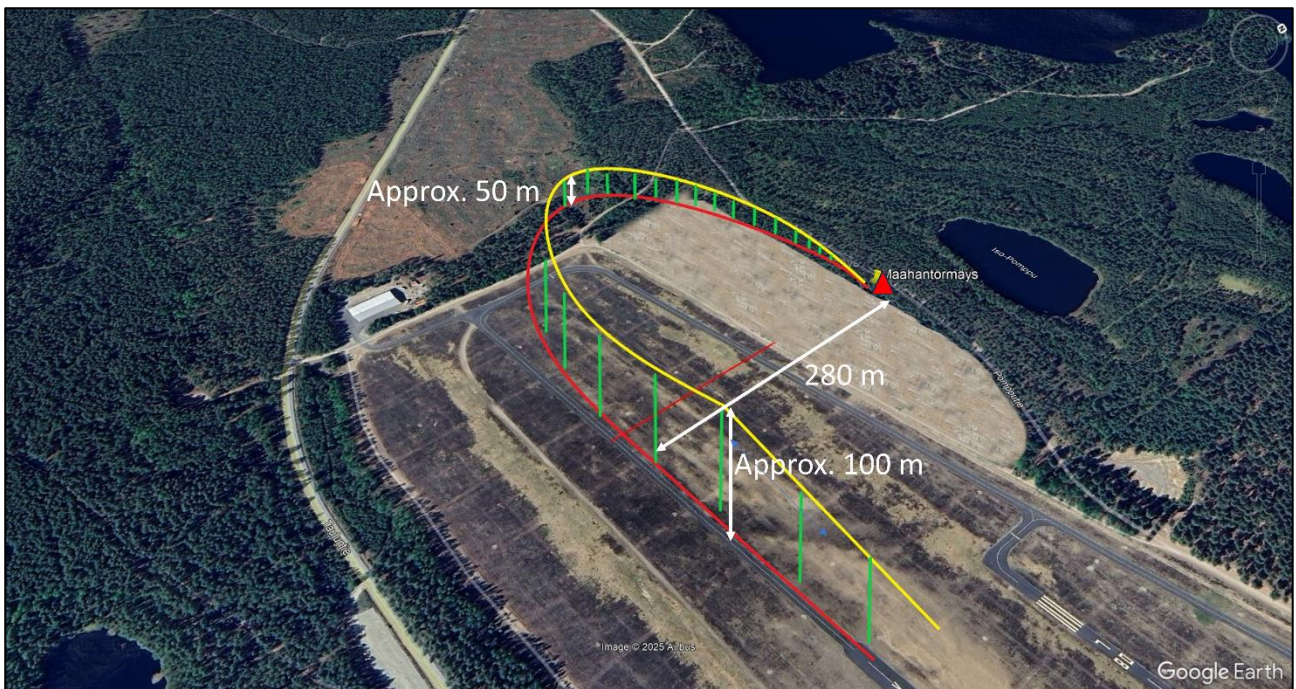
The pilot began takeoff on runway 26L at 1205:35, and the airplane became airborne at 1205:52. The initial climb was normal. Takeoff was performed with the flaps partially extended. While this configuration reduces the length of the takeoff run, it results in a shallower climb angle. By 1206:09, the airplane was about 80 m above ground level (AGL) with the landing gear not fully retracted and continued climb for about 5 s to about 100 m AGL. Soon thereafter, witnesses heard two distinct sounds consistent with momentary loss of engine power followed by a third, less pronounced sound, and then engine noise ceased.

After loss of all engine power, the pilot initiated a steep¹ right-hand turn in an attempt to return to the airfield for landing. During the turn, the airplane lost altitude rapidly, until the right wingtip contacted ground and the airplane impacted a stand of trees bordering the airfield at 1206:30. Both occupants were fatally injured. The wing assembly² and the engine separated from the fuselage on impact, and the wreckage was consumed by fuel-fed fire.

Figure 1. The airplane's computed flight path and altitude. The yellow line represents the airplane's track, while the red line shows the projection of the track on the ground. The green lines represent altitude, and the red triangle denotes the accident site. (Photos: Google Earth, edited by SIAF)

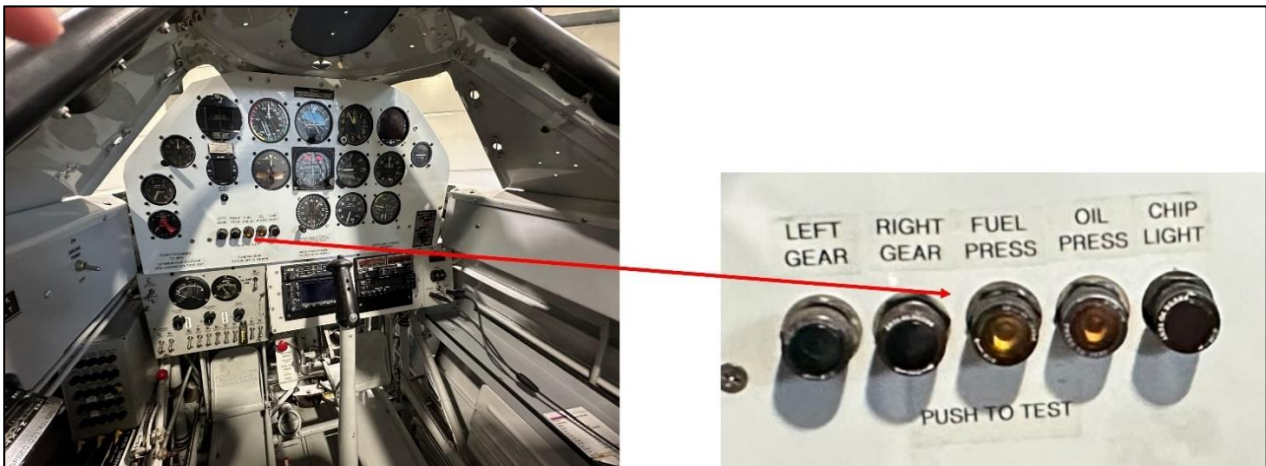
The accident airplane had been modified by replacing the switchover light by fuel pressure warning lights located in an array of annunciator lights on the left side of the front cockpit instrument panel, while in the rear cockpit these lights were in a separate panel adjacent to the cockpit sidewall on the left-hand side. The brightness of the lights was adjustable for varying lighting conditions, for example during a night flight. The lights were tested and found serviceable during the pre-purchase inspection about two weeks before the accident.

Figure 7. The location of the fuel pressure warning light in the front cockpit of OH-NAT. (Photo: Airplane owner, edited by SIAF)

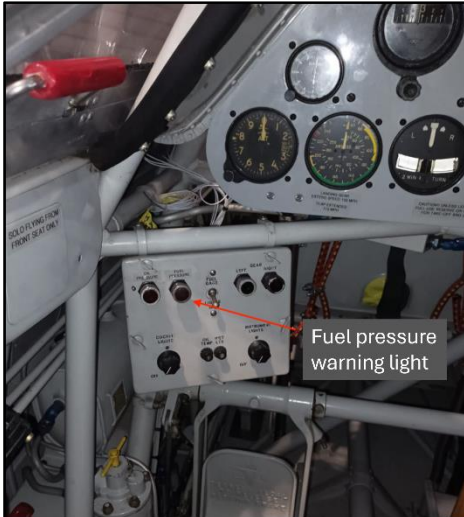
Figure 8. The location of the fuel pressure warning light in the rear cockpit of OH-NAT. (Photo: Airplane owner, edited by SIAF)

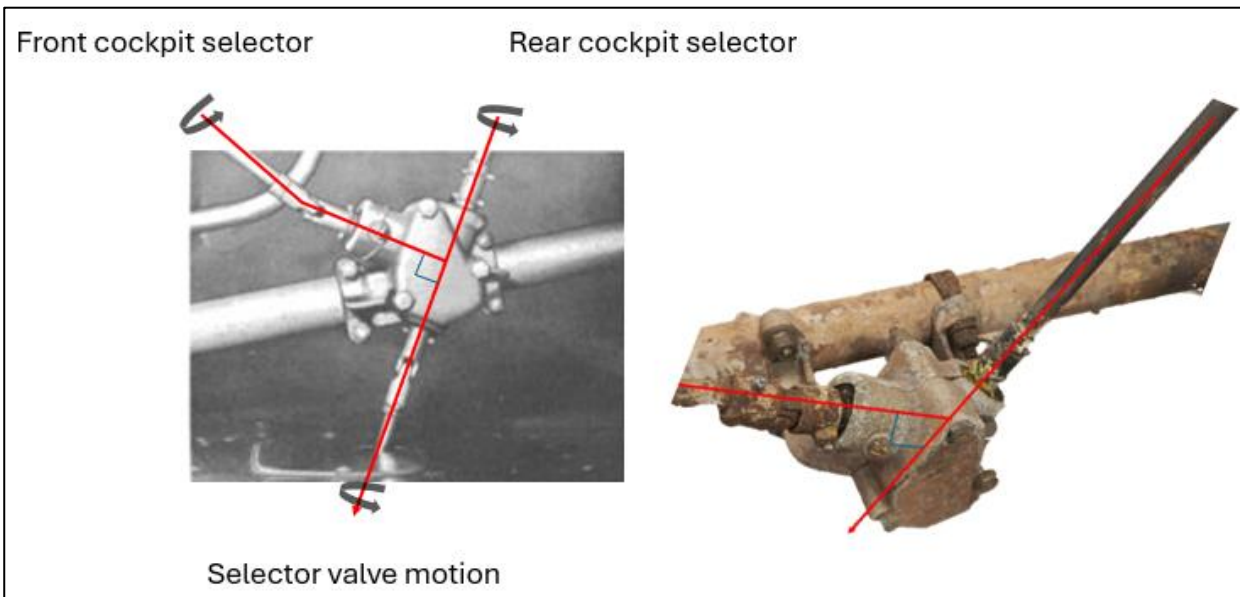
Figure 11. The transmission that combines the fuel selector mechanisms. On the left, an image from the airplane manual; on the right, the transmission of the accident airplane. (Photo: SIAF)

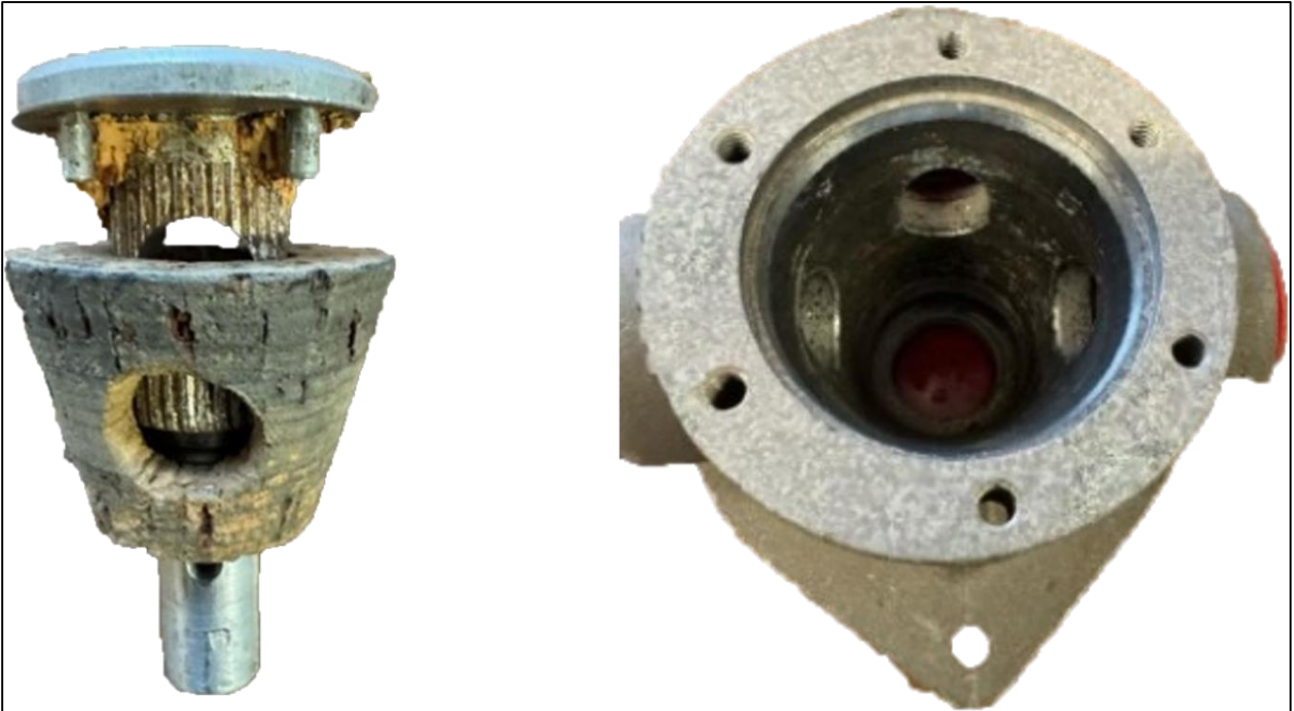
Figure 14. The fuel selector valve from an airplane similar to the accident aircraft. On the left, the seal is pulled down for clarity. On the right, the valve body inside which the seal is rotated by moving a cockpit selector. Fuel ports are also shown. (Photo: SIAF)

Although the selector valve body was consumed by fire, the valve plunger (see figures 14 and 29) was recovered. It had sustained major fire damage, and the cork seal was destroyed. The

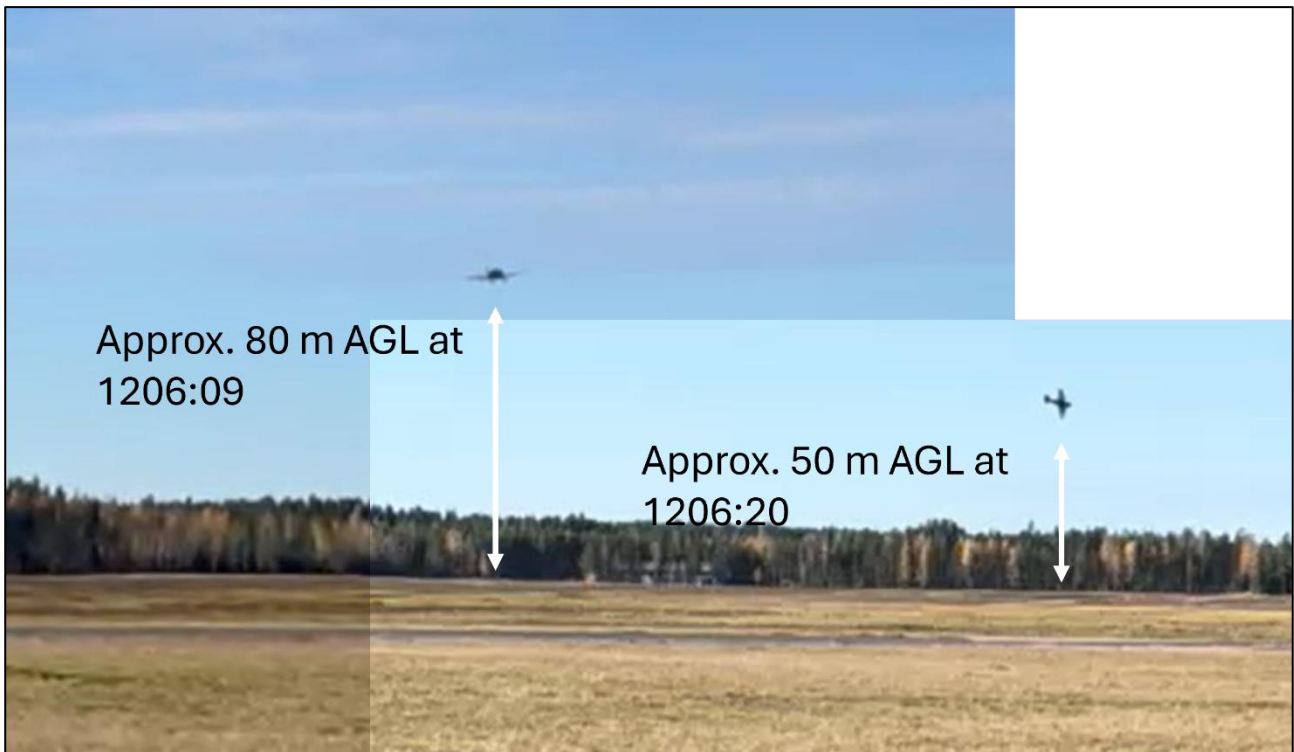
Three video recordings of the accident flight were available to investigators. The first of them, shot from the rear quarter, begins at 1205:19 and lasts 50 s. It shows the takeoff and initial climb. Images suggest that the engine operated normally during initial climb and the climb profile was normal. Recording stops just before the engine cut out as the airplane was climbing on runway heading at about 80 m above ground level (AGL). The second recording begins about 10 s after the cessation of the first at 1206:20 and lasts 1 s. It captured the airplane in a steeply banked turn toward the airfield at about 50 m AGL with the engine inoperative. The third footage, from a different eyewitness located near the southern edge of runway 26L near the liftoff point, also shows the takeoff and initial climb. On this video, the front seat occupant clearly rotates his head down and left as if checking something in the cockpit. This happens 5 s after liftoff. One second later, also the rear seat occupant swivels his head in the similar manner. No video imagery of the ground impact was available.

Figure 20. Screen grabs from video footages. On the left, the airplane is on initial climb; on the right, it is in a steep turn after the engine failure. (Photo: SIAF)

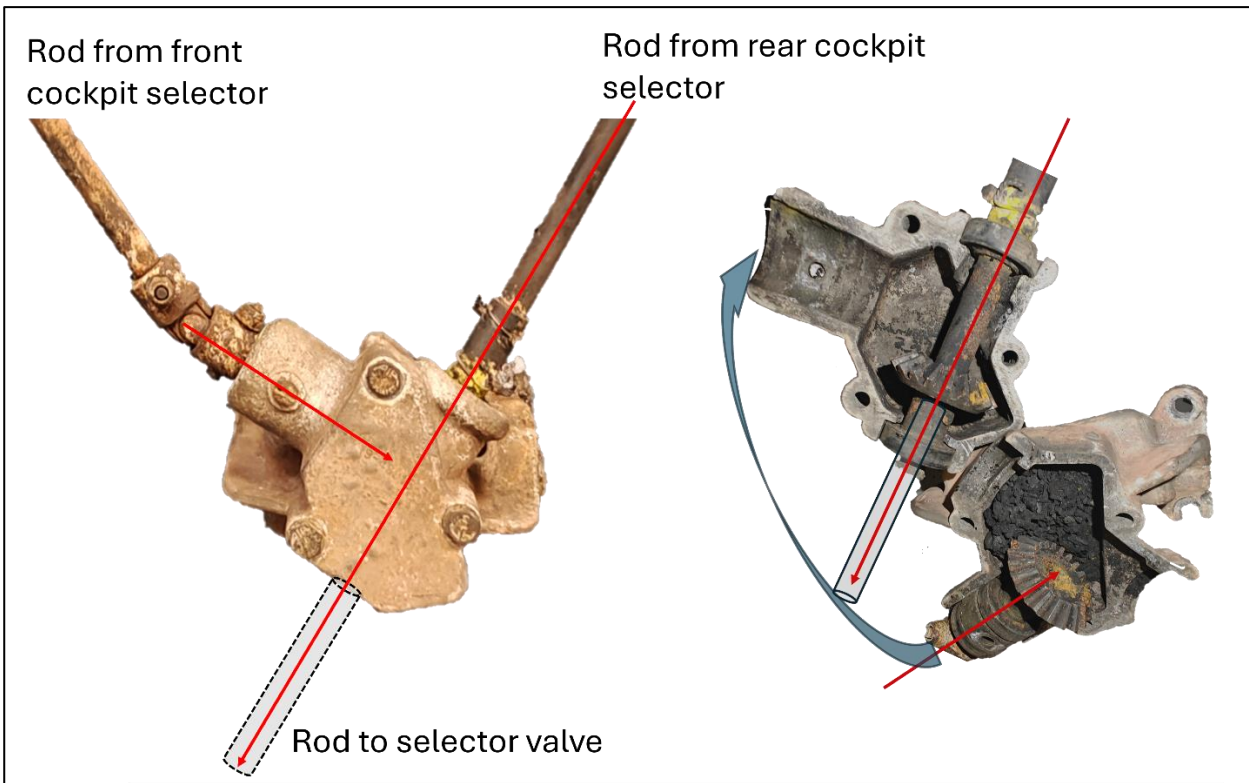
Figure 27. The transmission that connects the control rods coming from the front and rear cockpit fuel selectors. A post-accident view of the transmission is on the left, while the transmission after cover removal is shown on the right. (Photo: SIAF)
